*STATUS OF SUBMERGED AQUATIC VEGETATION IN
NORTH CAROLINA*

*APNEP PARTNERSHIP SAV MONITORING AND ASSESSMENT
TEAM*

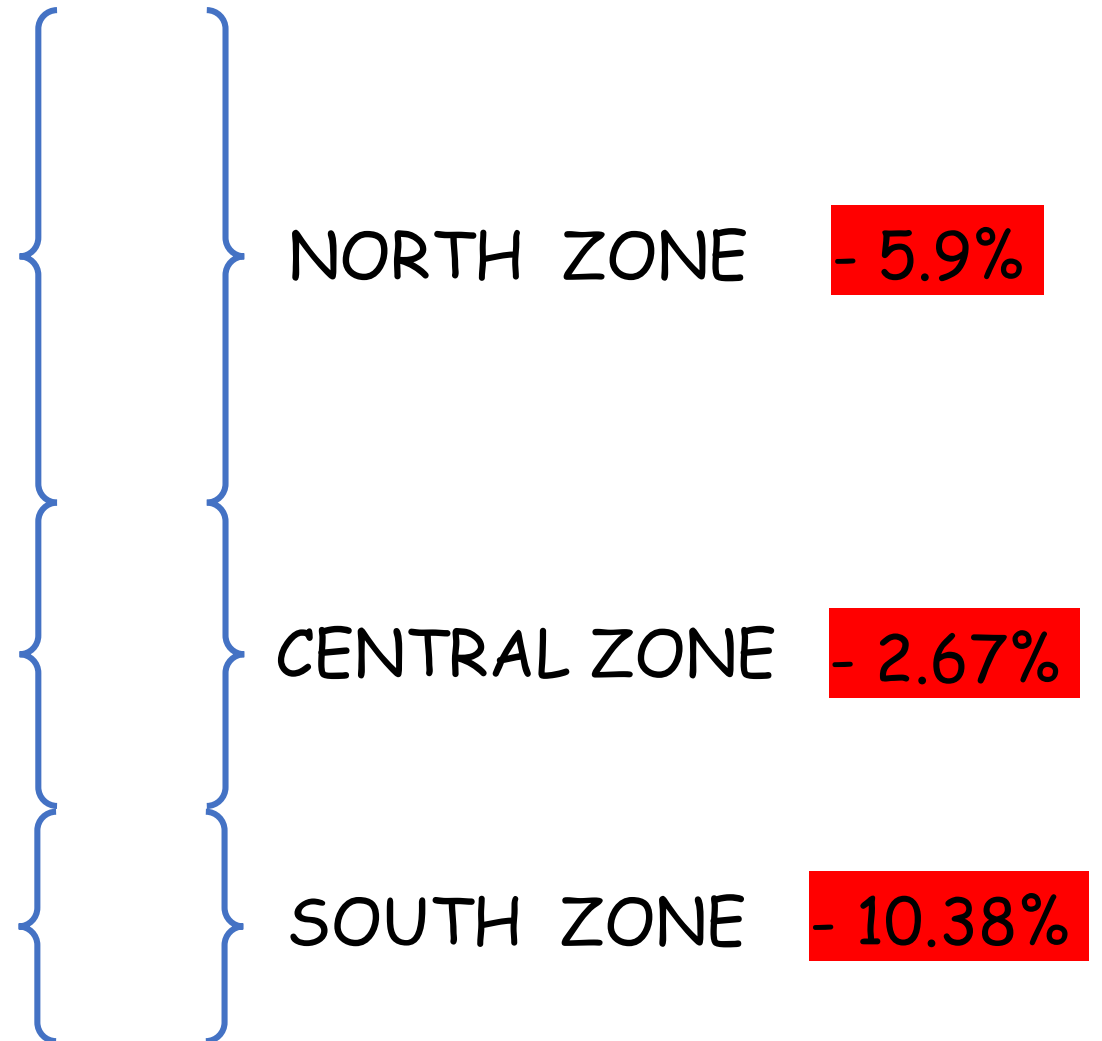
HIGH SALINITY SAV TRENDS

2006 -2013

SOUTH ZONE (-1.5% Y^{-1})

ASSUME THIS RATE DOESN'T CHANGE

BY 2025 THE LOSS ~ 20%

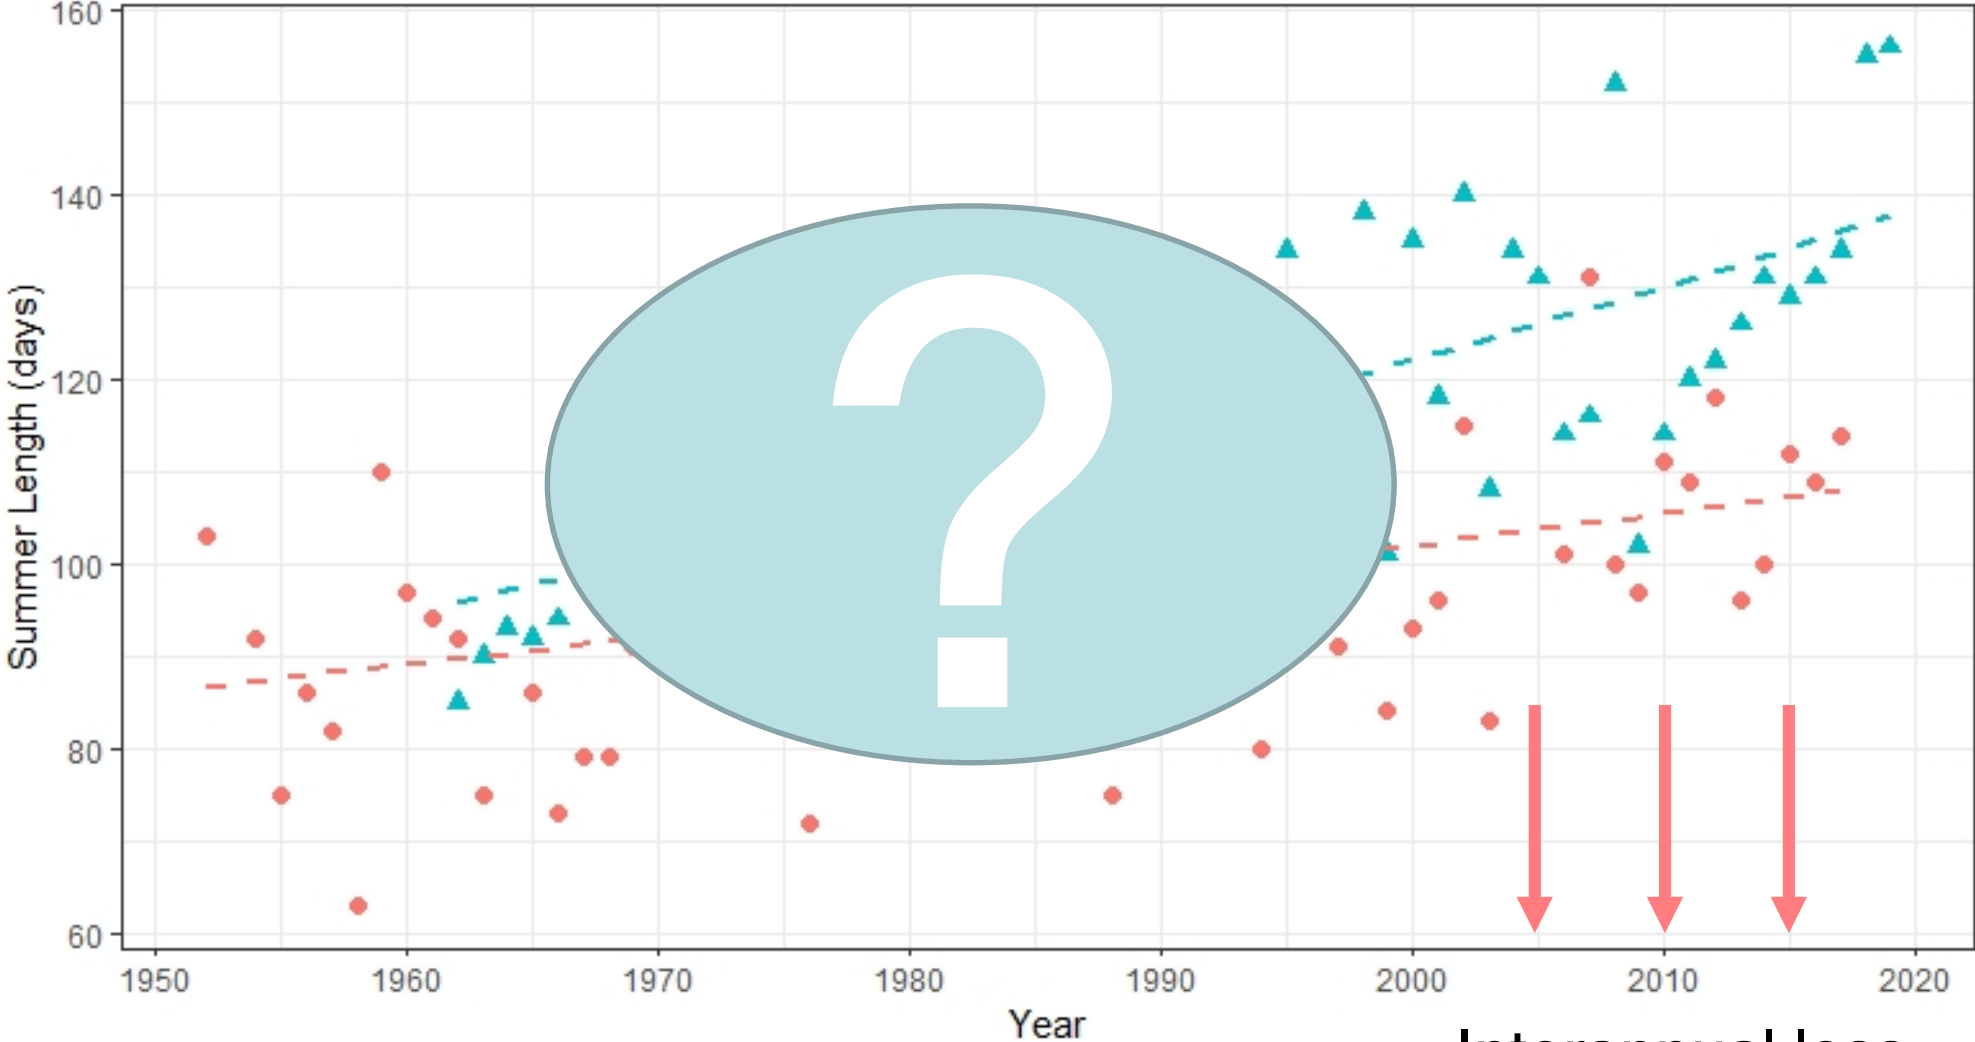
Water Quality: Temperature

CB Data from
Shields et al.
