**MONITORING YEAR 3  
ANNUAL REPORT  
FINAL**

**BUCKWATER BUFFER MITIGATION SITE**  
Orange County, NC

NCDEQ Contract No. 006829  
DMS Project Number 97084  
NCDWR Project Number 2016-0406 v2

Data Collection Period: October 2021  
Draft Submission Date: November 29, 2021  
Final Submission Date: December 13, 2021

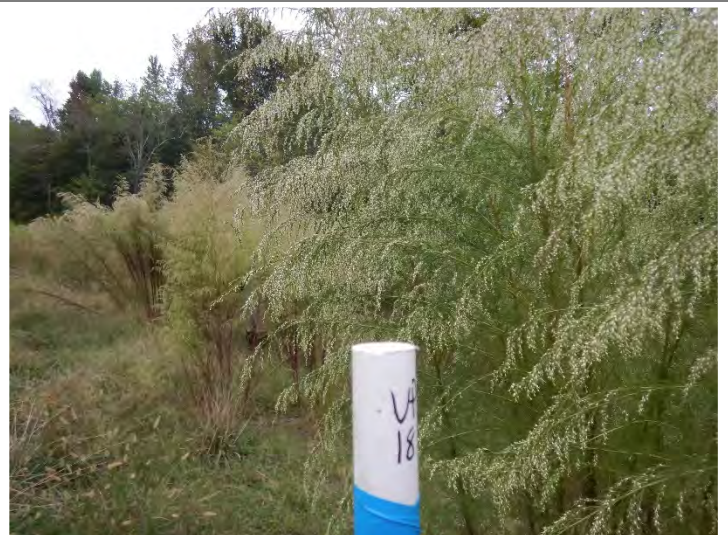
**VEG PLOT 18** (10/13/2021)

Overall, the replanting has been successful, except for one small area along T7 around vegetation plot 18. This area was too small to meet the mapping threshold of low stem density, however Wildlands will do a follow up ring spray treatment to reduce the herbaceous competition during MY4. When including desirable volunteers, vegetation plot 18 meets the final success criteria of 260 stems per acres.

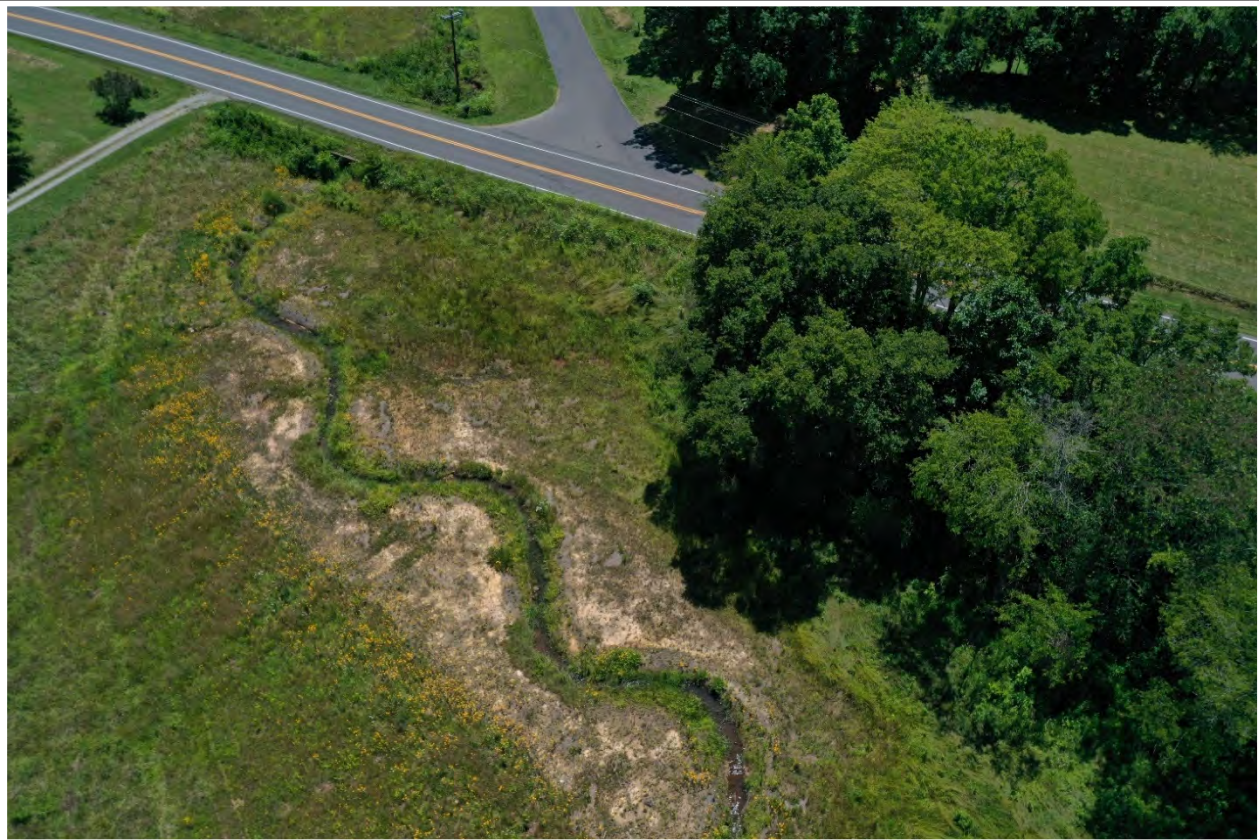
Soil amendments were added to the 1.4-acre area of low vegetative growth identified during MY2 along T5 (upstream of St. Mary's Rd) and T6 (Figure 4a). The soil amendments greatly improved the herbaceous layer in this area during MY3 (Appendix 2 Vegetation Area of Concern Photographs).

**Before – Bare Area Along T5 (6/23/2020)**

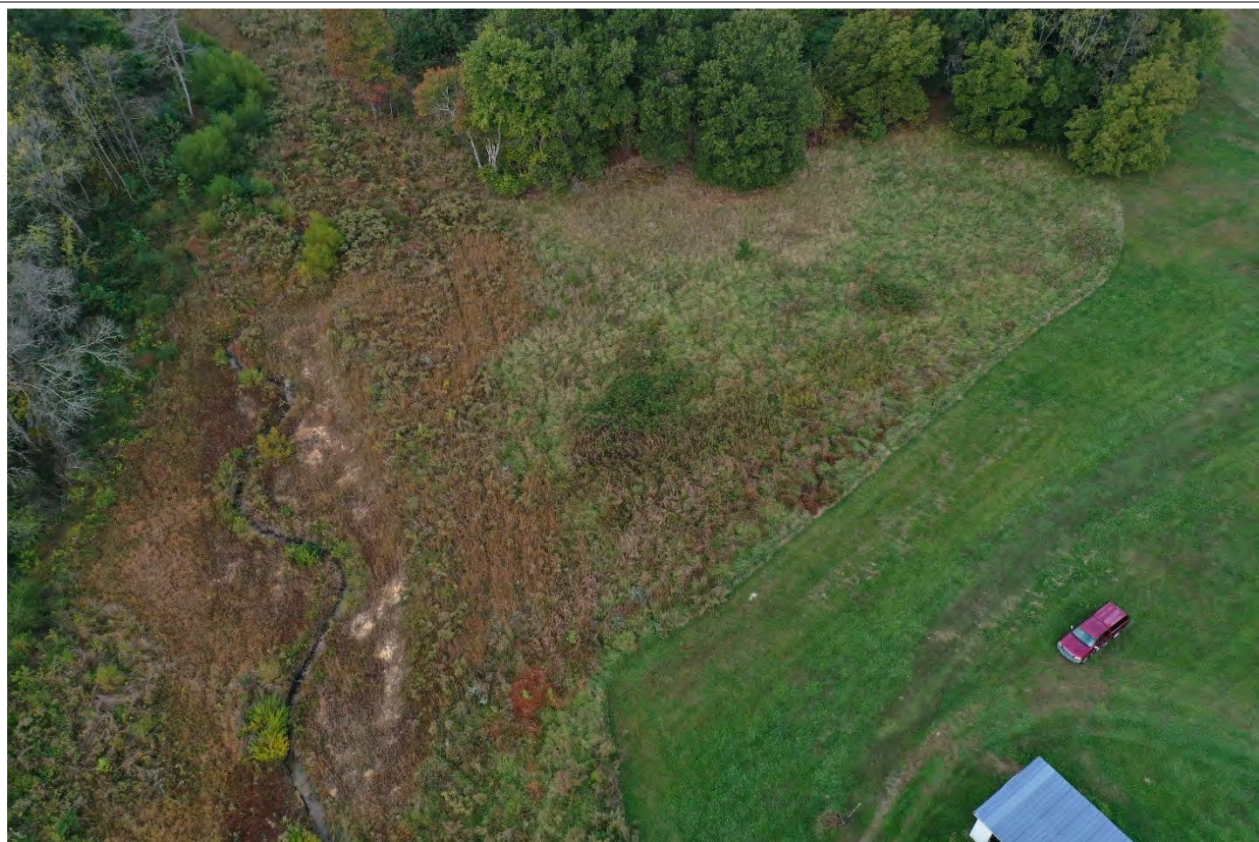
**After – Bare Area Along T5 with Soil Amendments (10/21/2021)**
