**MONITORING YEAR 1
ANNUAL BUFFER REPORT
FINAL**

MCCLENNY ACRES MITIGATION SITE

Wayne County, NC

DMS ID No. 100038

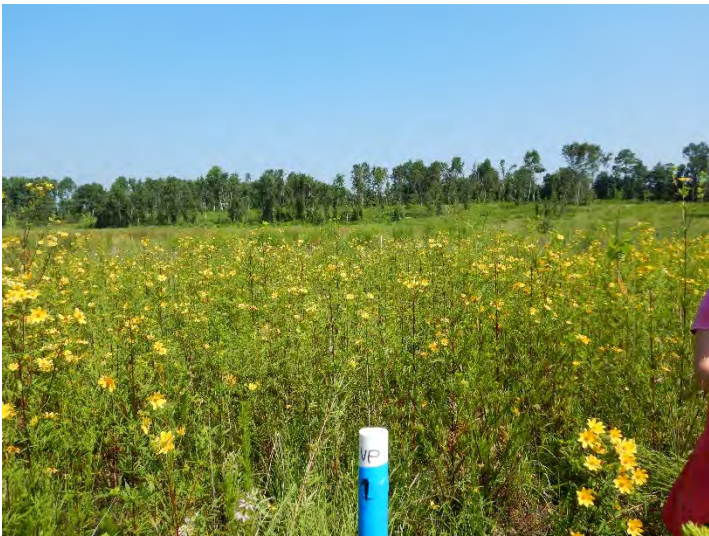
VEG PLOT 1 (9/1/2021)

The 2021 annual vegetation monitoring resulted in an average planted stem density of 587 planted stems per acre. Individual plots range in density from 567 to 647 planted stems per acre. Herbaceous vegetation is well established, and pollinator species have been observed. No invasive vegetation or insufficient plant growth areas were observed during MY1. Refer to Appendix 2 for the Vegetation Condition Assessment Table, Monitoring Plan View Maps, Vegetation Plot and Overview Photographs. Appendix 3 contains Planted and Total Stem Count Data, the Vegetation Plot Criteria Attainment Table, and CVS Plot Metadata.
