**MONITORING YEAR 1
ANNUAL BUFFER REPORT
FINAL**

PERRY HILL MITIGATION SITE

Orange County, NC
NCDEQ Contract No. 7744
DMS Project No. 100093
NCDWR Project No. 2019-0157v2
RFP No. 16-007576

PERRY HILL MITIGATION SITE
Monitoring Year 1 Buffer Report

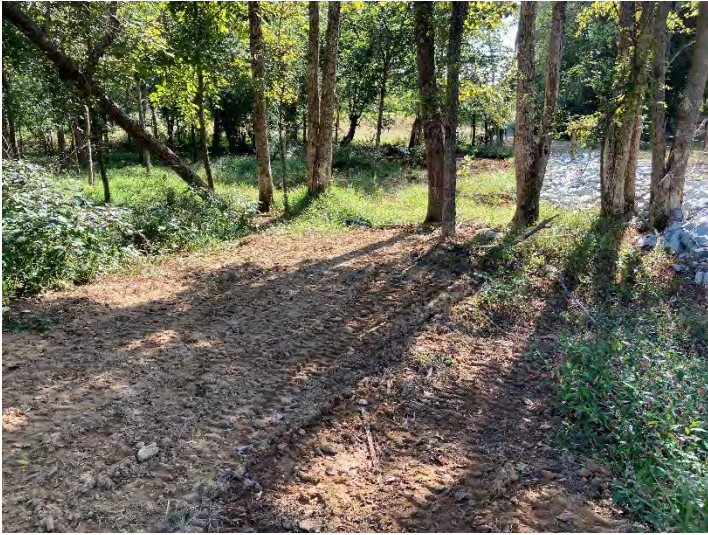
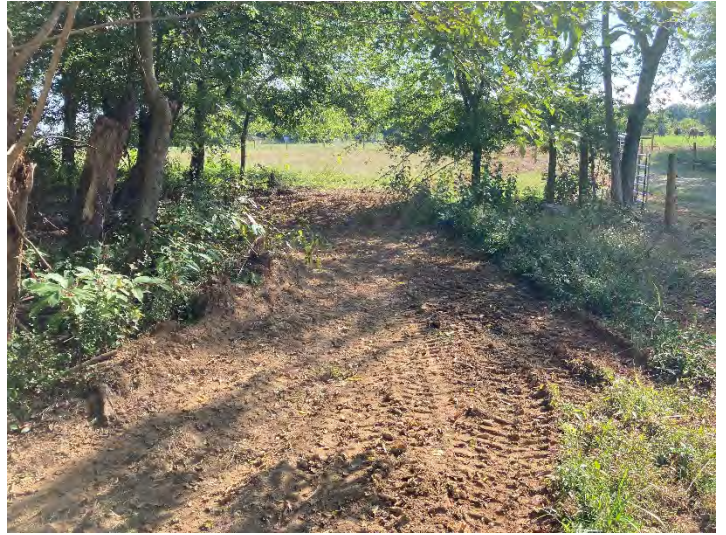
During construction, Wildlands ran conduit through the project crossings to allow the landowner to route waterlines at a later date without disturbing the stream. In October 2021, the landowner installed the water lines without contacting Wildlands staff which resulted in ground disturbance and tree mortality impacts to the easement outside of the internal crossings (see Figures 3-3b and Vegetation Areas of Concern Photographs – Conservation Easement Encroachment in Appendix 2). The encroachment area covers approximately 0.13 acres. Wildlands has discussed the impact with DMS staff including the need to allow for future maintenance of the water lines. Wildlands is currently investigating the proper methods to address the encroachment but most likely there will be some form of documentation widening the internal crossing to encompass the impacted areas and allow for future maintenance of the water lines while avoiding future easement encroachments.

Perry Branch Reach 2 – CE Encroachment (10/04/2021)

Vegetation across the Site is exceeding performance standards and is on track to achieve the final requirement of 260 planted stems per acre. Monitoring Year 1 data shows an average density of 558 planted stems per acre across vegetation plots. Sporadic invasive vegetation was treated in MY1 and follow up treatments are scheduled for winter 2021/2022. To build on the success of previous herbicide ring sprays, additional ring sprays will be applied around the base of trees in areas of high competition with herbaceous vegetation in spring 2022. Wildlands is investigating the proper methods to address the easement encroachment.

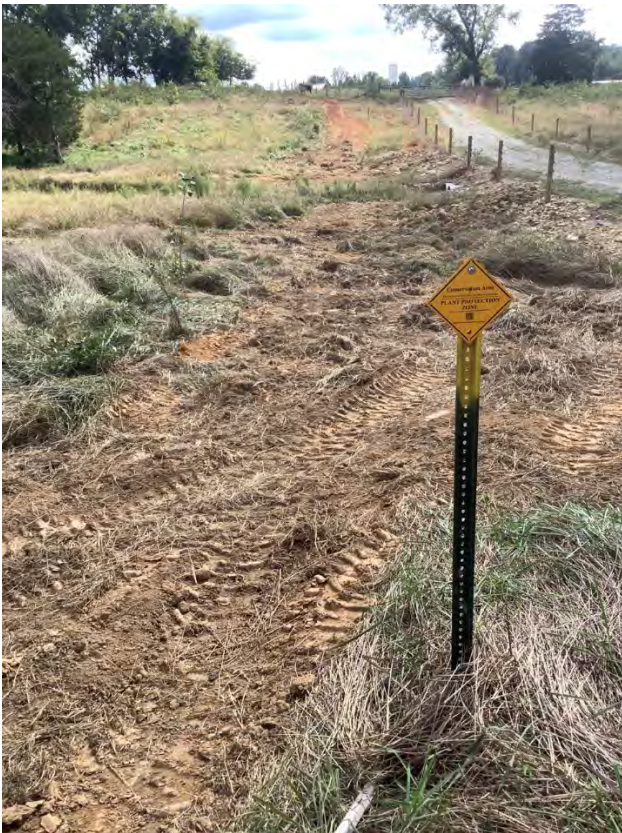
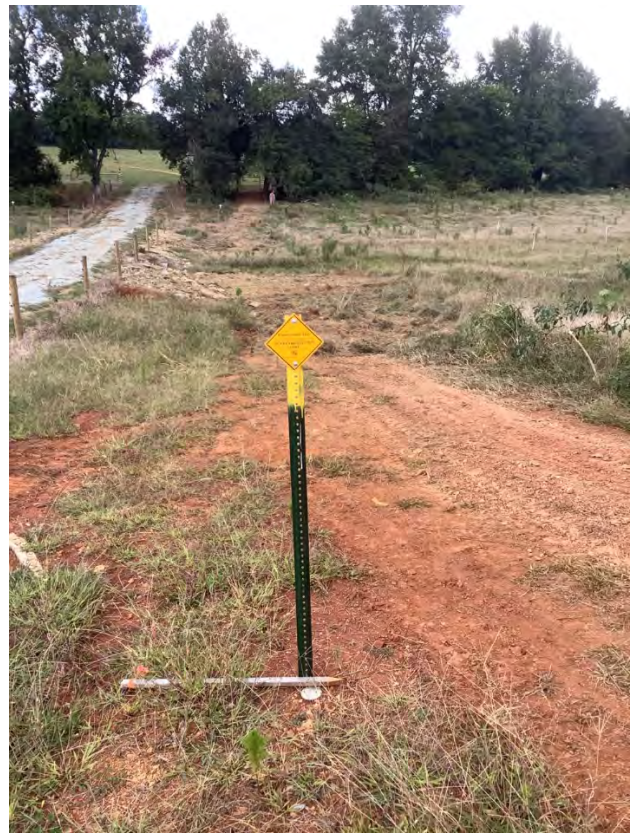
Perry Branch Reach 4 – CE Encroachment (10/04/2021)
