**Bear Basin Restoration Site  
Monitoring Report MY07  
DMS Project # 95362  
DMS Contract # 004741**

**Onslow County, NC  
CU# 03030001  
DWR# 2013-0456  
SAW# 2012-01391**

**Construction Completed: February 2015  
Data Collection: 2021  
Submitted: February 2022**

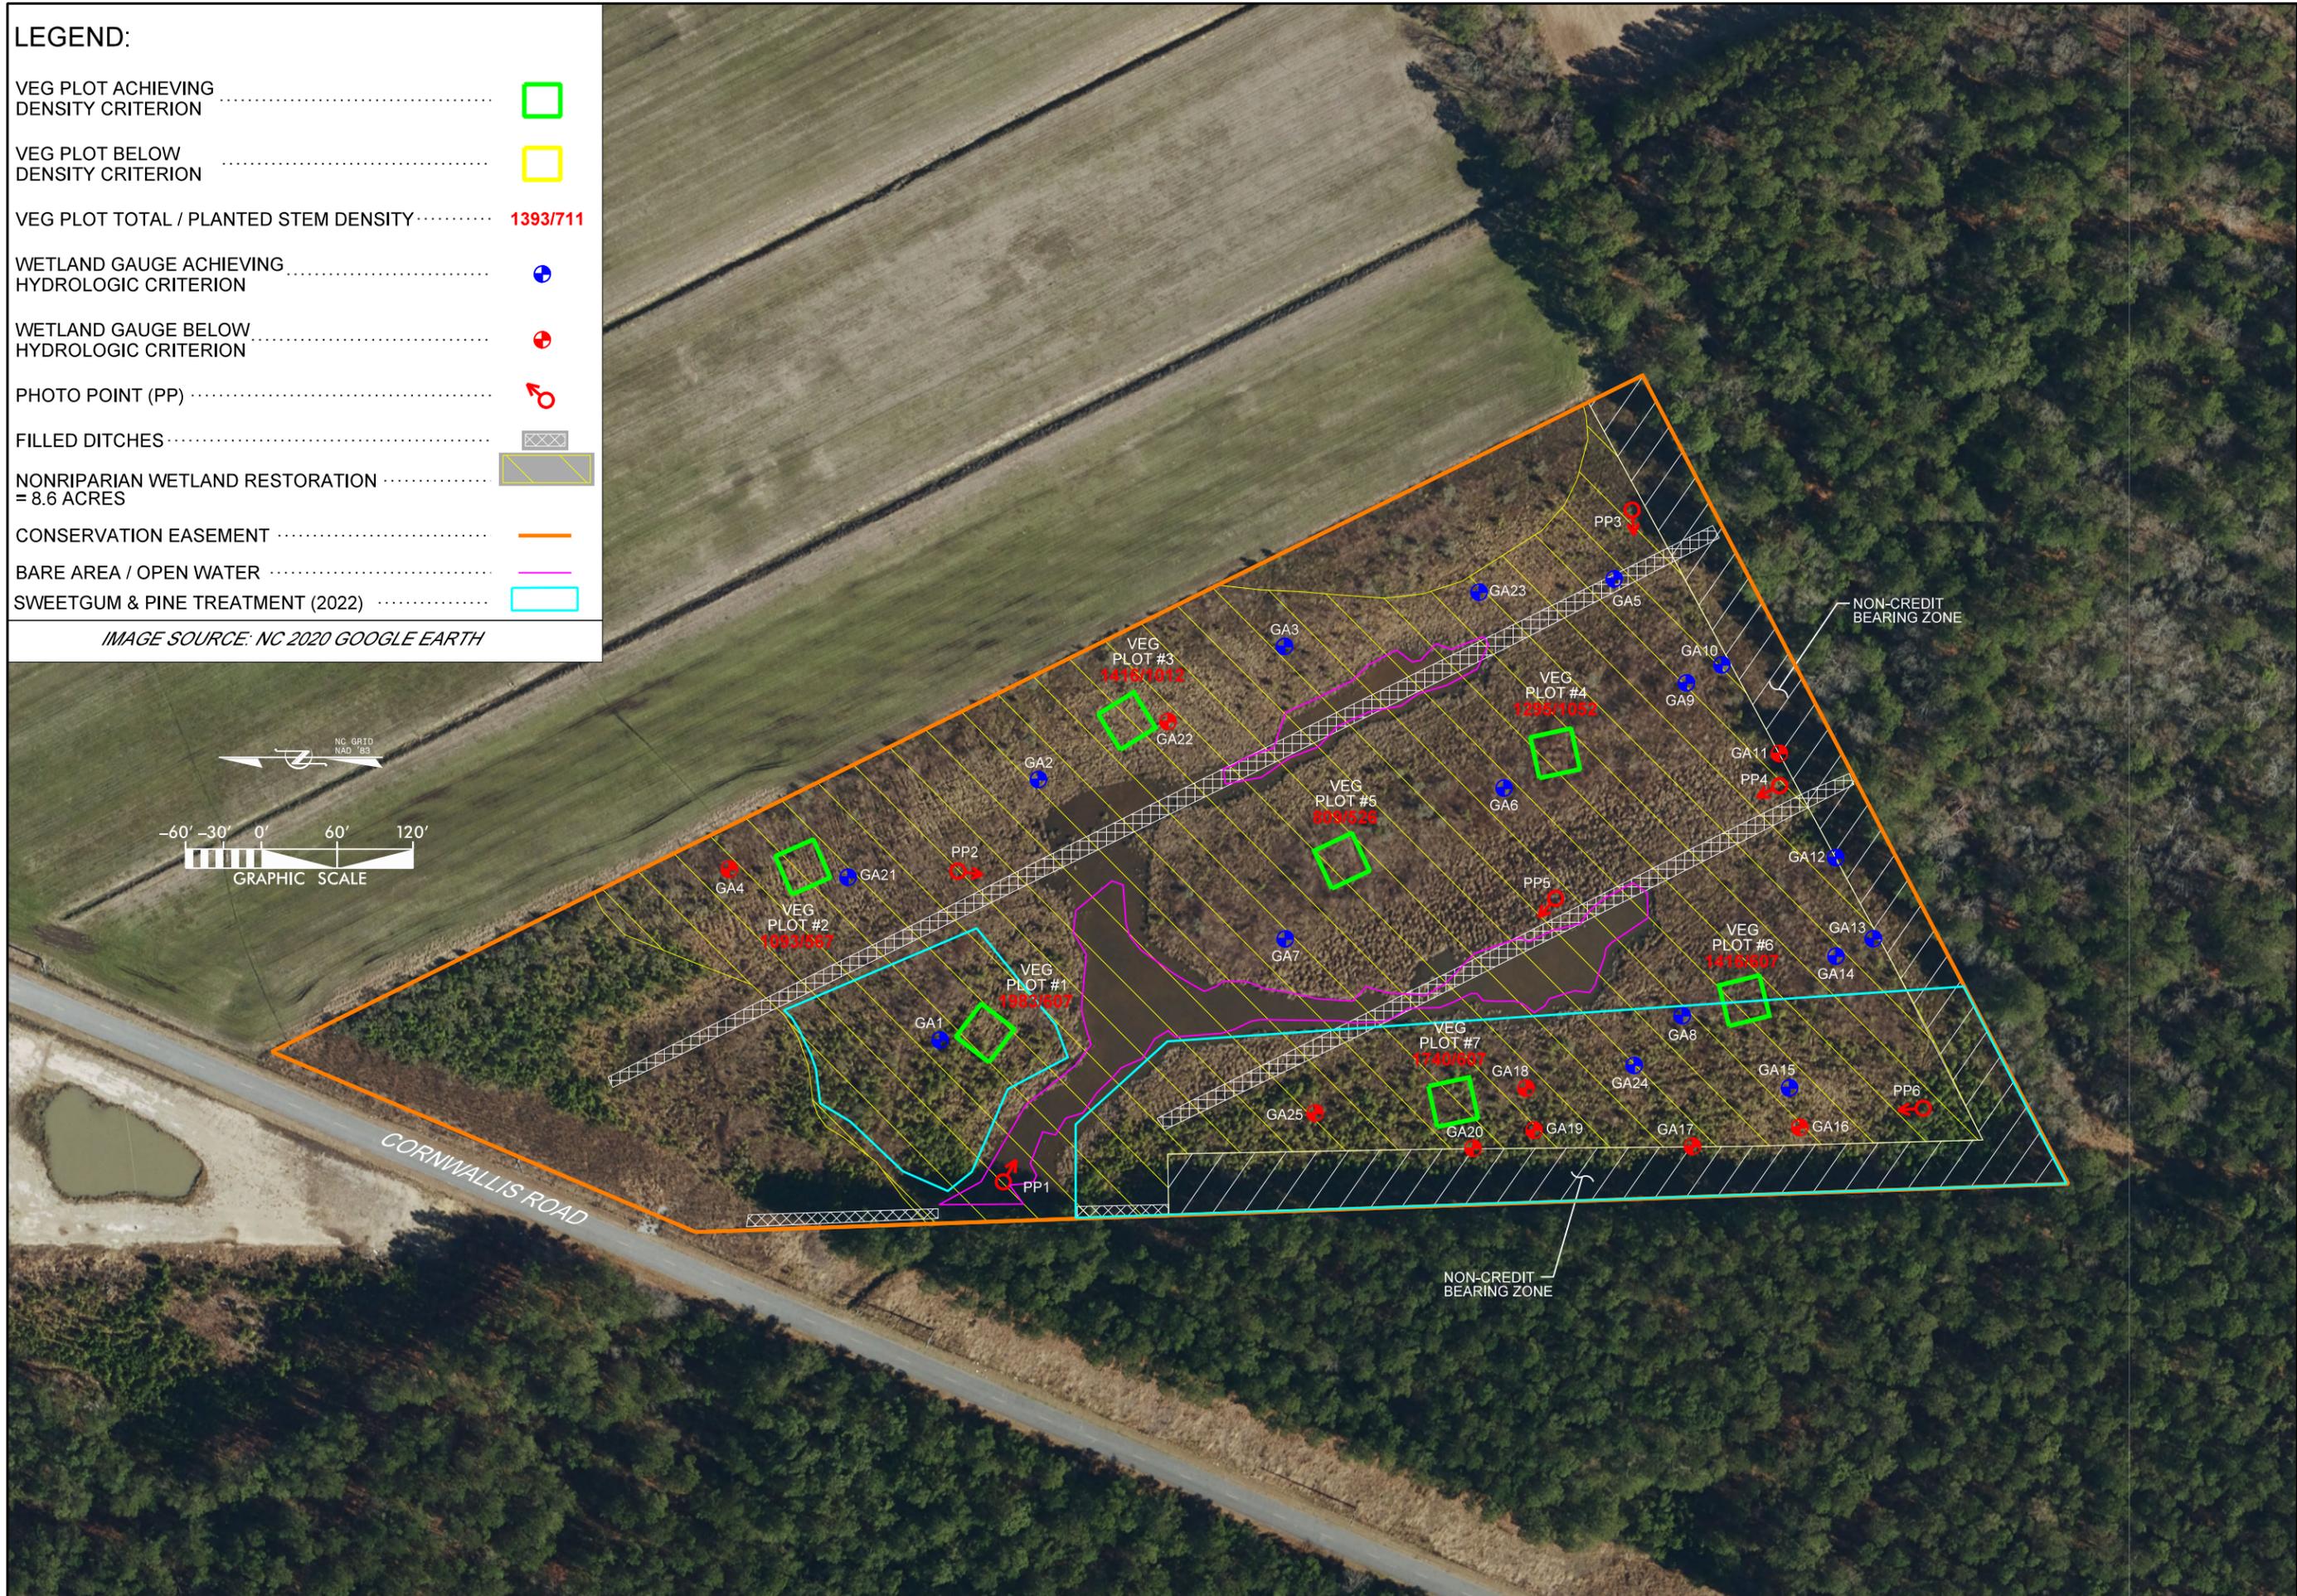
Although the majority of the site has healthy and thriving vegetative cover, there is an area of open water that does not have significant vegetation. Over the course of the year, this area expands and shrinks with the seasons so that it reaches its fullest extent in the winter and its lowest during the summer. This results in areas around the edge that, while inundated during the winter, support vegetation during the summer. Species such as *Juncus effuses*, *Scirpus cyperinus*, *Scirpus atrovirens*, *Carex comosa*, *Carex vulpinodea*, and *Schoenoplectus tabernaemontani* are abundant in these areas. In December 2018, KCI used GPS to map the extent of the area that is inundated to the point of excluding vegetation year round and found it to be 0.87 acres. This area was surveyed again in September 2021 to evaluate whether it had decreased in size as a result of vegetation colonizing the fringes. This survey found the area to be 0.70 acres. It is believed that as the site continues to mature, this area will continue to decrease. See Appendix B – Visual Assessment Data for more information.

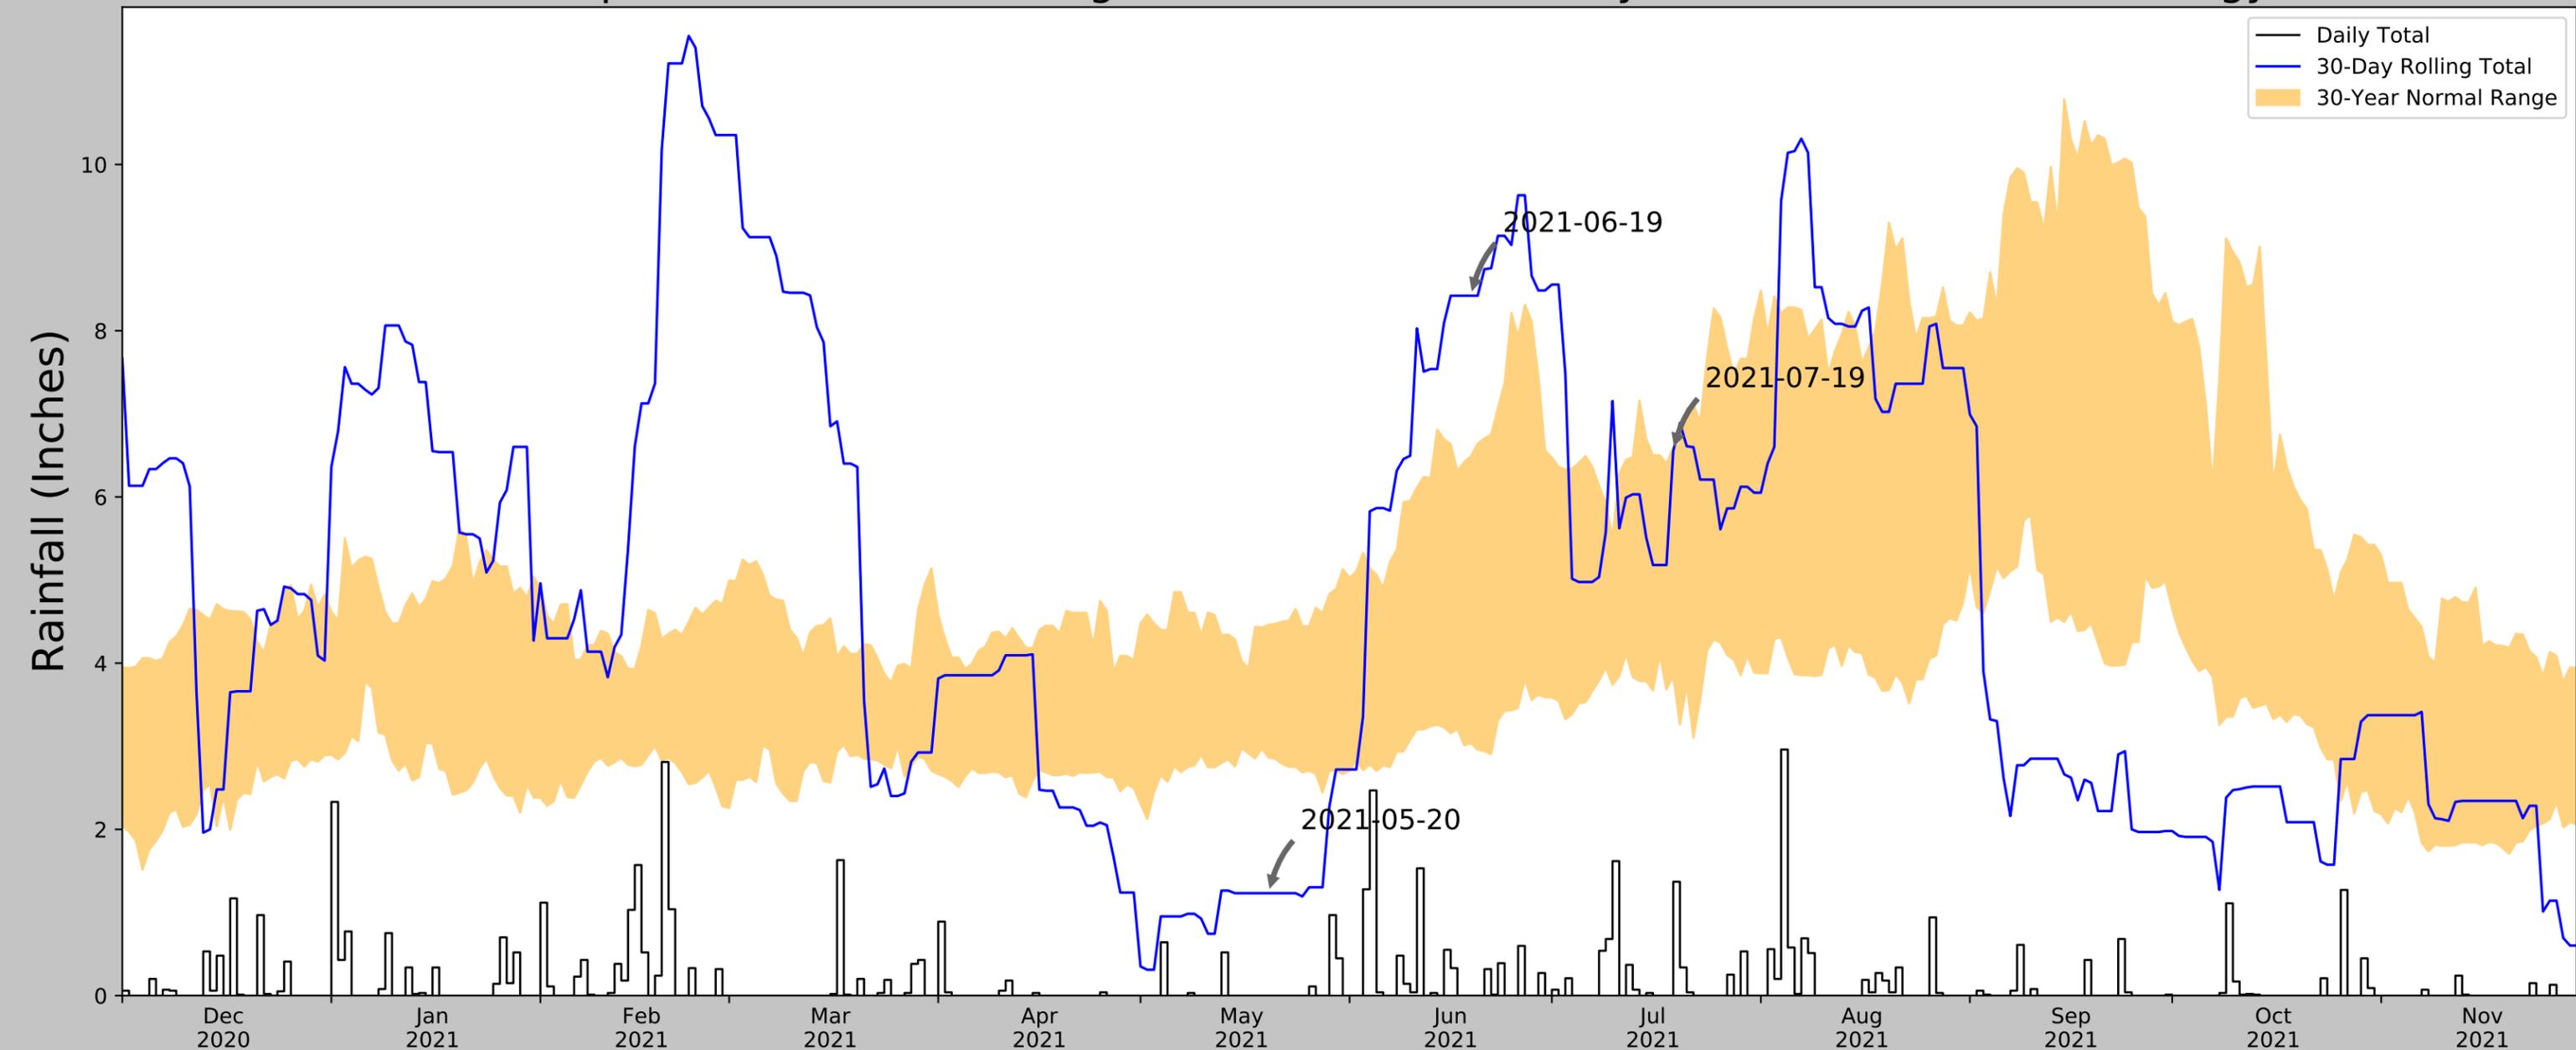
# Antecedent Precipitation vs Normal Range based on NOAA's Daily Global Historical Climatology Network

Coordinates	34.925365, -77.607461
Observation Date	2021-07-19
Elevation (ft)	71.8
Drought Index (PDSI)	Moderate wetness
WebWIMP H <sub>2</sub> O Balance	Wet Season

30 Days Ending	30 <sup>th</sup> %ile (in)	70 <sup>th</sup> %ile (in)	Observed (in)	Wetness Condition	Condition Value	Month Weight	Product
2021-07-19	3.840158	6.596851	6.551181	Normal	2	3	6
2021-06-19	3.035827	6.488977	8.42126	Wet	3	2	6
2021-05-20	2.861811	4.463386	1.232284	Dry	1	1	1
Result							Normal Conditions - 13

The daily rainfall data was obtained from a local weather station in Jacksonville, NC; provided by the NC State Climate Office. For the 2021 year, the month of August experienced average rainfall. January, March, April, May, July, September, and November experienced below average rainfall while February, June, and October recorded above average rainfall. Although the overall rainfall total for the site was average for the year, the first three months of the growing season were extremely dry. The water table is typically at its peak for the growing season during these months since evapotranspiration rates are not yet as high as they are later in the growing season, and the water table is still recharged from the typically wetter winter months. This is the time period that the gauges have historically met the success criteria, which was also true for the successful gauges this year. An evaluation of the rainfall using the USACE's Antecedent Precipitation Tool (APT) further backed up this analysis. The APT assigns a score to each day based on the amount of rainfall the area received in the past 90 days compared to 30 year rainfall averages. Scores between 10 and 14 are classified as "Normal Conditions," while lower scores are classified as "Drier than Normal," and higher scores are classified as "Wetter than Normal." According to the APT, the majority of the months of January, February, June and August were spent in wetter than normal conditions while March, July, and November were mostly under normal conditions. The months of April, May, September, and October were drier than normal for the majority of the month. Overall 12% of the growing season was classified as Wetter than Normal, 57% was classified as Normal Conditions, and 31% was classified as Drier than Normal. The average daily score for the site was 11.2.
