MITIGATION PLAN

BUCKWATER MITIGATION SITE

Orange County, NC
NCDEQ Contract No. 006829
DMS ID No. 97084

Neuse River Basin
HUC 03020201

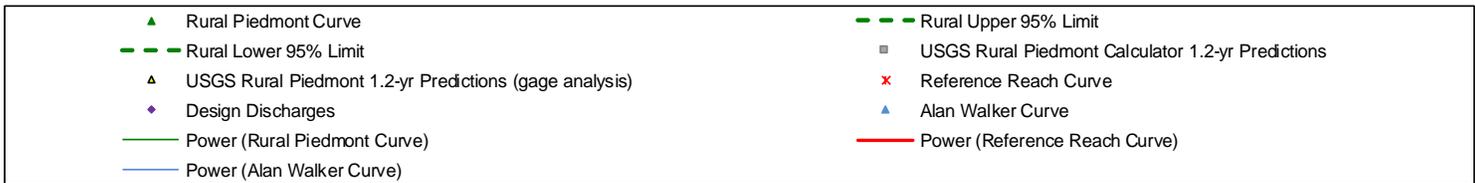
Figure 10 Discharge Analysis
Buckwater Mitigation Site
Neuse River Basin 03020201

North Carolina Piedmont Regional Curve: Discharge

Table 12 gives a summary of the discharge analysis. The grayed cells in Table 11 reflect that the USGS Peak Discharge Estimation for NC Rural Piedmont is for catchments larger than that 0.25 square miles, and so it technically does not apply for project reaches with drainage areas below that size. Figure 10 illustrates the design discharge data.
