As-built Baseline Monitoring Report FINAL Lochill Farm Stream Mitigation Project

DMS Project ID No. 97083, DEQ Contract No. 6828 USACE Action ID No. SAW-2016-00881, DWR# 16-0370 Orange County, North Carolina, Neuse River Basin: 03020201-030030 Baseline Data Collection Period: Dec. 2018 to Feb. 2019

Lochill Farm: As-Built MY0 Stream Station Photo-Points (from January 2019)

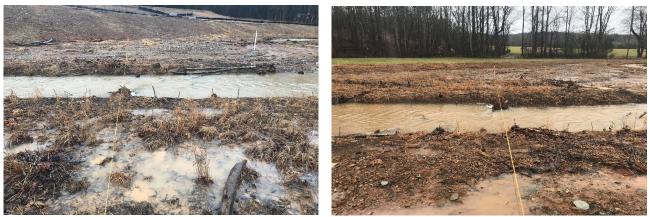
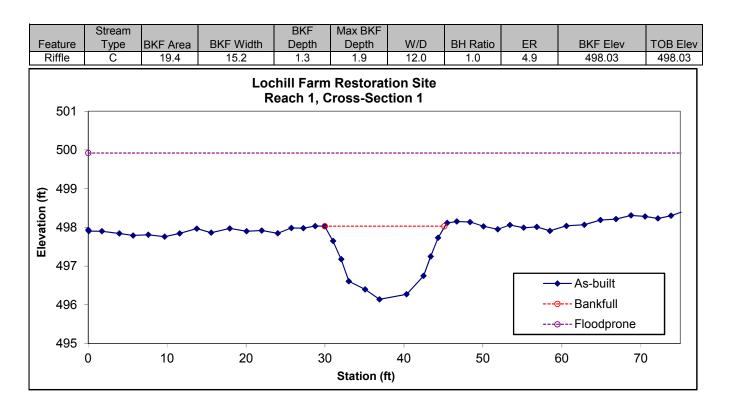
Permanent Cross-Section 1

(As-built Survey Data Collected: December 2018)

Looking at the Left Bank

Looking at the Right Bank

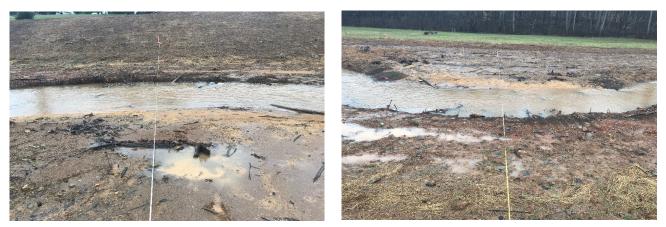
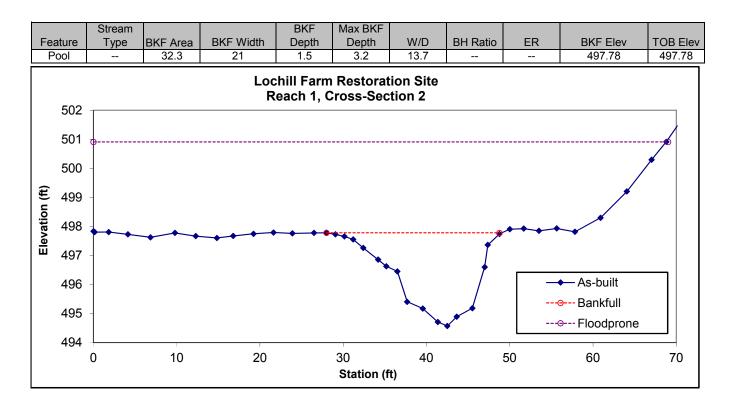
Permanent Cross-Section 2

(As-built Survey Data Collected: December 2018)

Looking at the Left Bank

Looking at the Right Bank

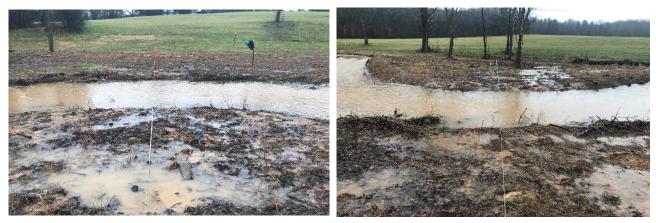
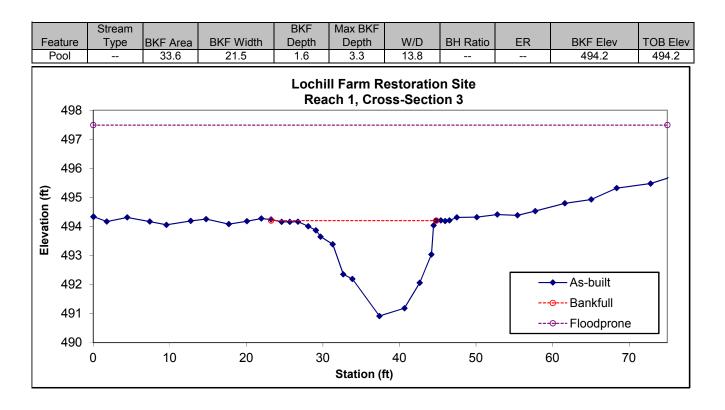
Permanent Cross-Section 3

(As-built Survey Data Collected: December 2018)

Looking at the Left Bank

Looking at the Right Bank

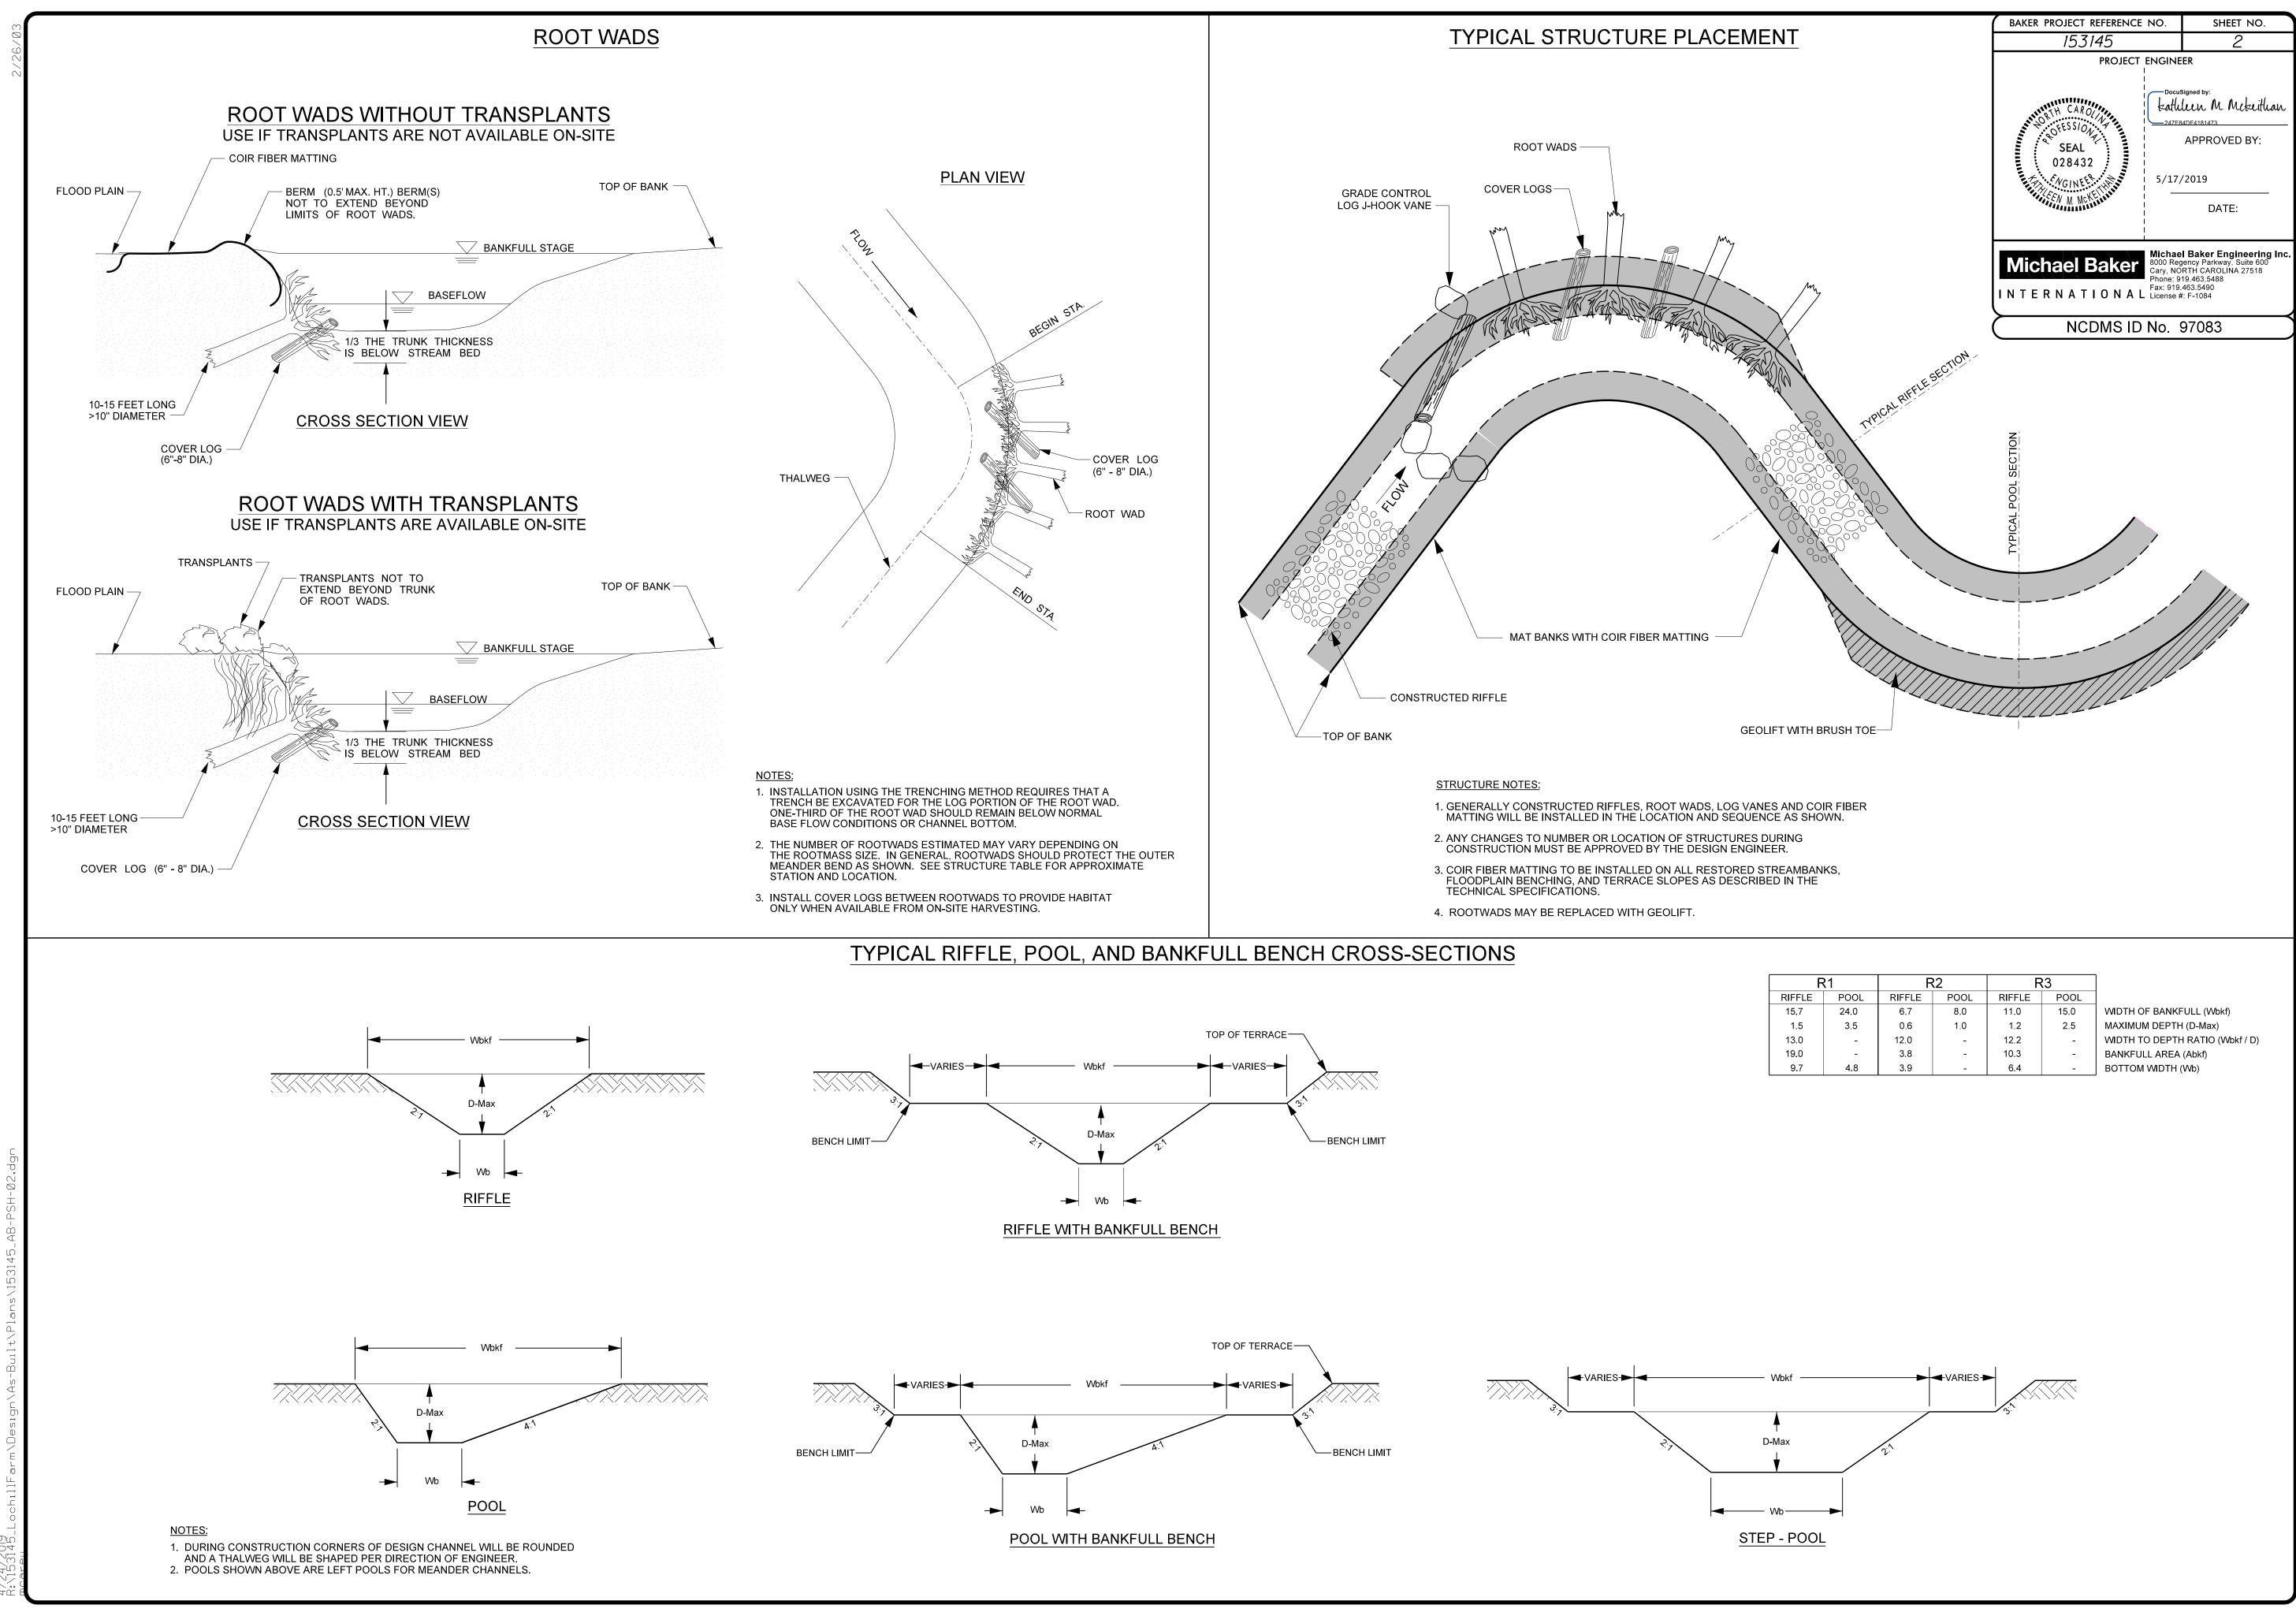
F	۲۱	R2		F		
RIFFLE	POOL	RIFFLE	POOL	RIFFLE	POOL	
15.7	24.0	6.7	8.0	11.0	15.0	WIDTH C
1.5	3.5	0.6	1.0	1.2	2.5	MAXIMUI
13.0	-	12.0	-	12.2	-	WIDTH T
19.0	-	3.8	-	10.3	-	BANKFU
9.7	4.8	3.9	-	6.4	-] воттом
