MITIGATION PLAN

Rough Horn Swamp Restoration Site

Rough Horn Swamp II Restoration Site

Columbus County, North Carolina

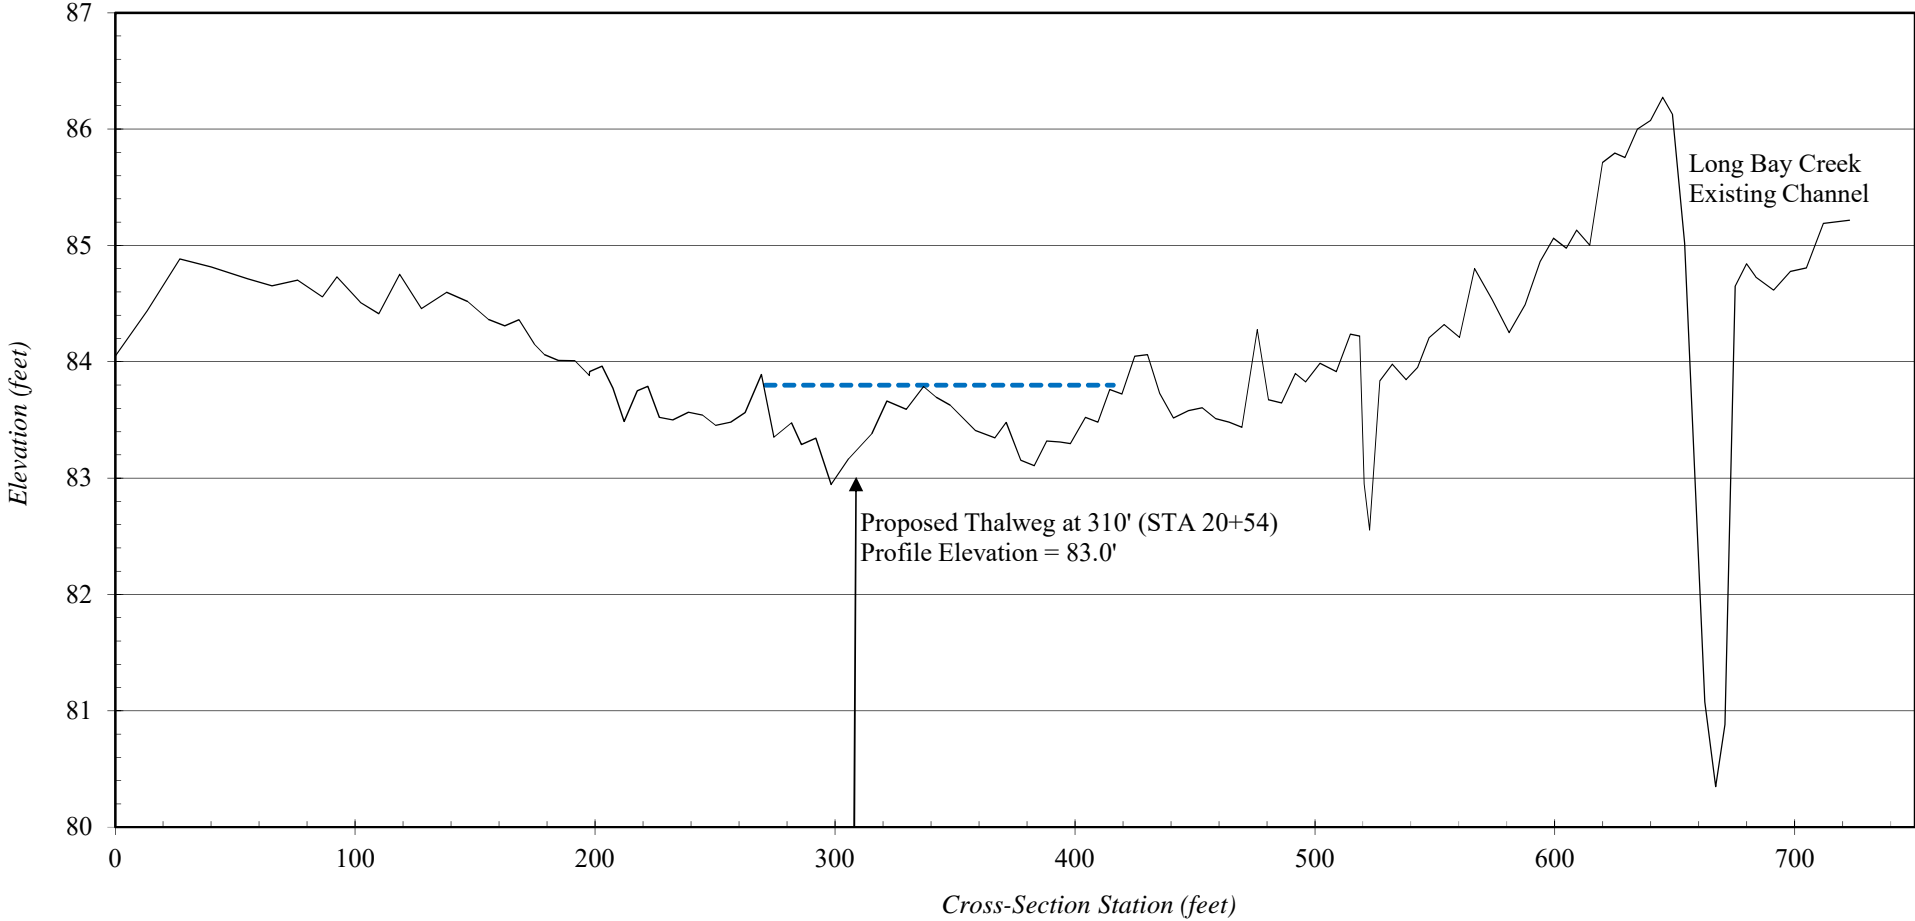
Lumber 03 River Basin, Long Bay Creek, Valley XS 1 at STA 20+54

- - - Approx. Extent of Stream Relocation Area
 — Valley Cross-Section

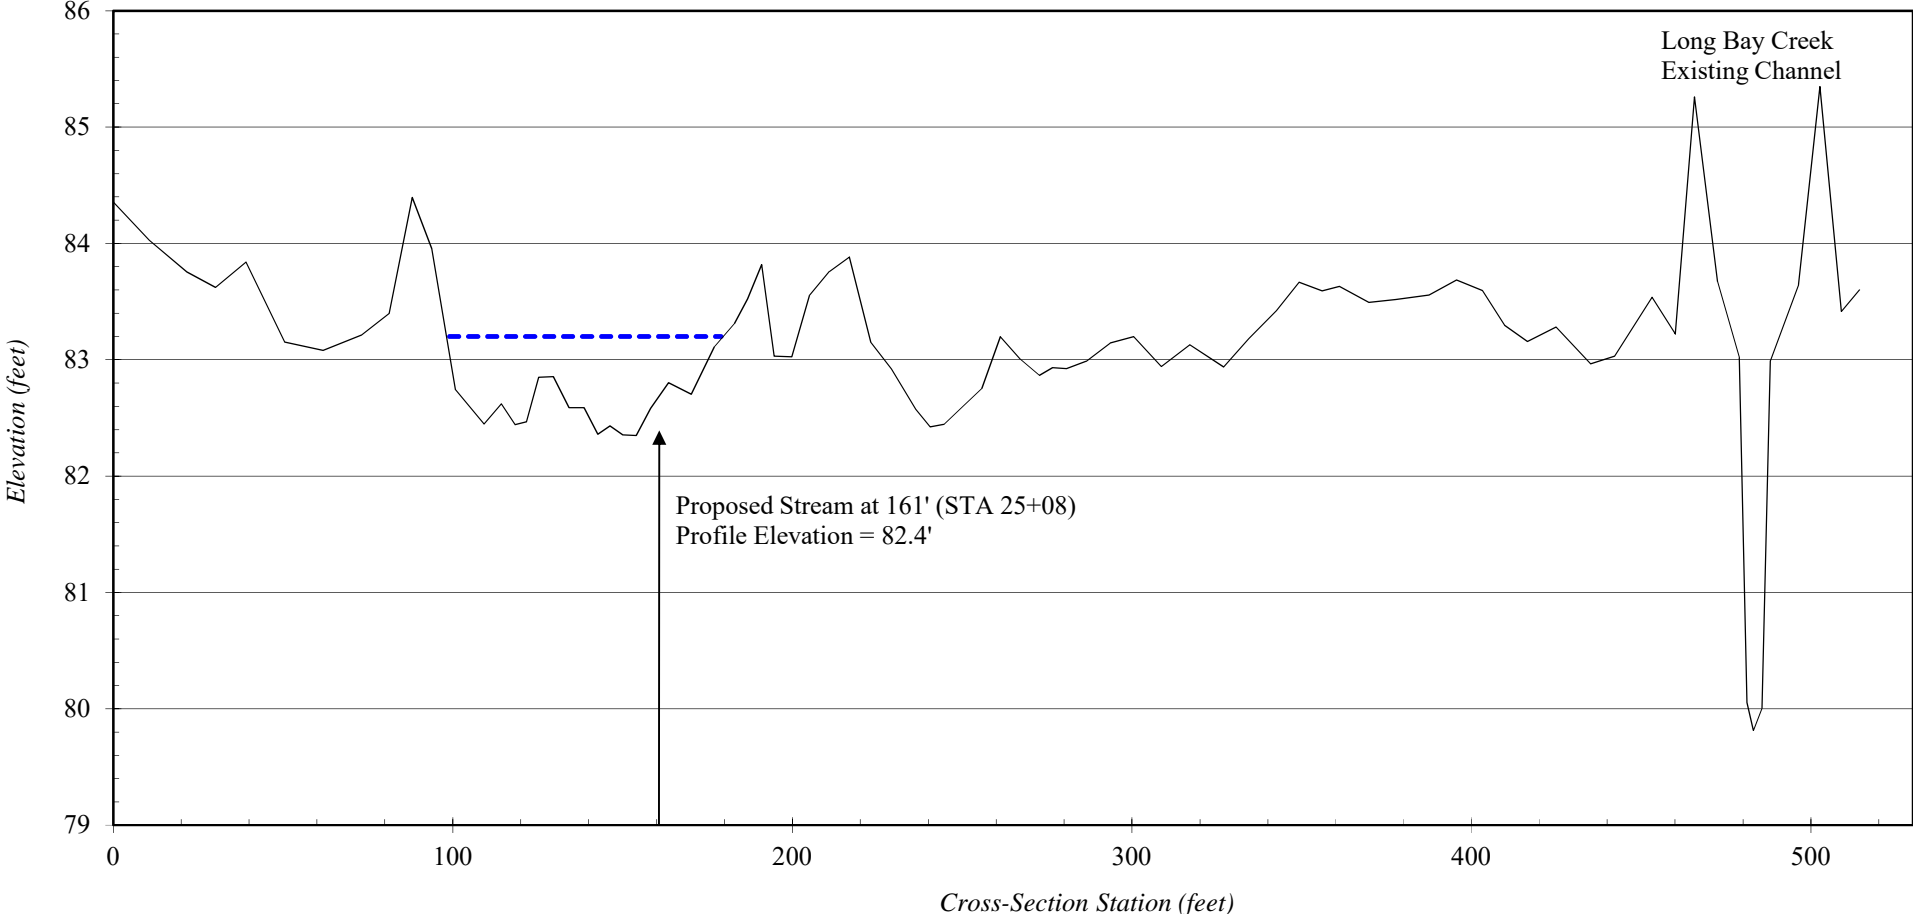
Lumber 03 River Basin, Long Bay Creek, Valley XS 3 at STA 25+08

River Basin:	Lumber 03
Watershed:	Long Bay Creek
XS ID	Valley XS 3 at STA 25+08
Drainage Area (sq mi):	2.81 square miles
Date:	March 2016
Field Crew:	KCI

- - - Approx. Extent of Stream Relocation Area
 — Valley Cross-Section
