MONITORING YEAR 0 ANNUAL REPORT FINAL

SASSARIYA SWAMP MITIGATION SITE

Johnston County, NC
Neuse River Basin
HUC 03020201

DMS Project No. 100040
DMS Contract No. 7425
DMS RFP No. 16-007279
USACE Action ID No. 2018-00432
DWR Project No. 2018-0198
Data Collection Dates: October-March 2021

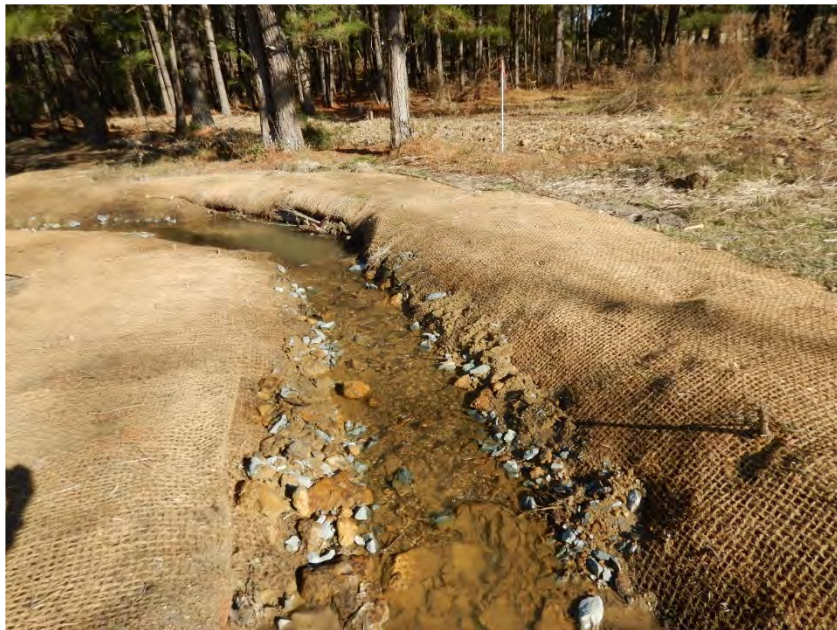
Downstream (01/19/2021)

MY0	MY1	MY2	MY3	MY6	MY7
Bankfull Elevation - Based on AB-Bankfull Area	149.35					
Bank Height Ratio - Based on AB-Bankfull Area	1.00					
Thalweg Elevation	148.45					
LTOB Elevation	149.35					
LTOB Max Depth	0.902					
LTOB Cross Sectional Area	2.47

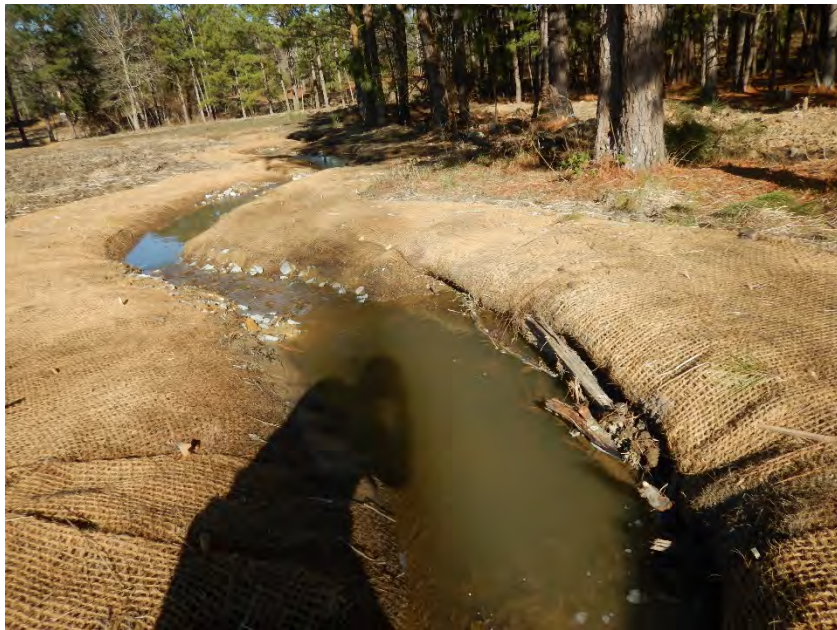
Downstream (01/19/2021)

MY0	MY1	MY2	MY3	MY6	MY7
Bankfull Elevation - Based on AB-Bankfull Area	148.82					
Bank Height Ratio - Based on AB-Bankfull Area	1.00					
Thalweg Elevation	147.78					
LTOB Elevation	148.82					
LTOB Max Depth	1.039					
LTOB Cross Sectional Area	3.20

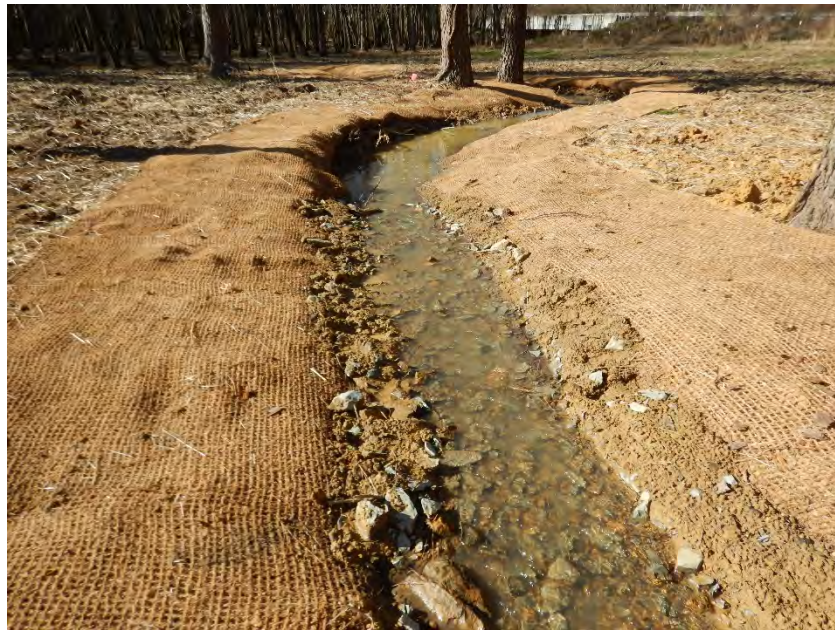
Downstream (01/19/2021)

MY0	MY1	MY2	MY3	MY6	MY7
Bankfull Elevation - Based on AB-Bankfull Area	130.69					
Bank Height Ratio - Based on AB-Bankfull Area	1.00					
Thalweg Elevation	130.04					
LTOB Elevation	130.69					
LTOB Max Depth	0.644					
LTOB Cross Sectional Area	1.67

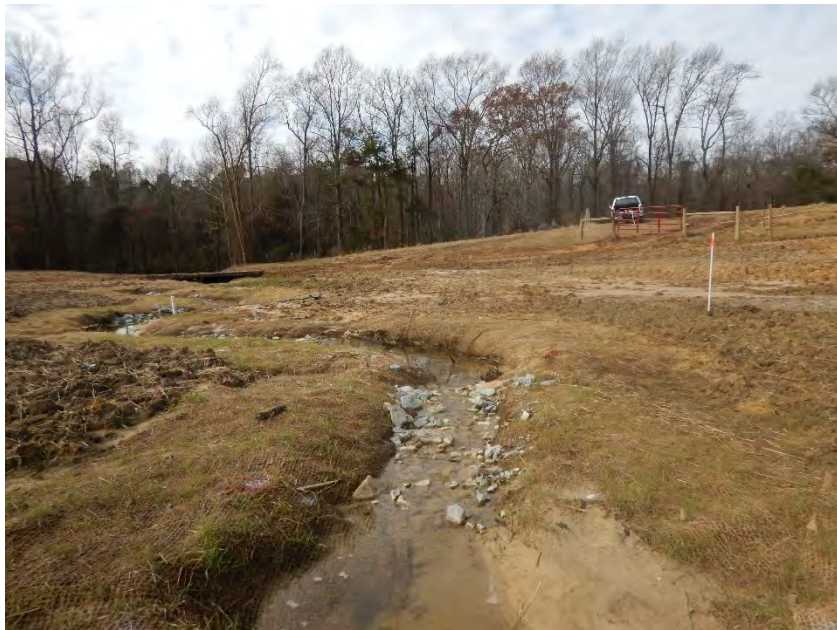
Downstream (01/19/2021)

MY0	MY1	MY2	MY3	MY6	MY7
Bankfull Elevation - Based on AB-Bankfull Area	141.46					
Bank Height Ratio - Based on AB-Bankfull Area	1.00					
Thalweg Elevation	140.66					
LTOB Elevation	141.46					
LTOB Max Depth	0.802					
LTOB Cross Sectional Area	1.99

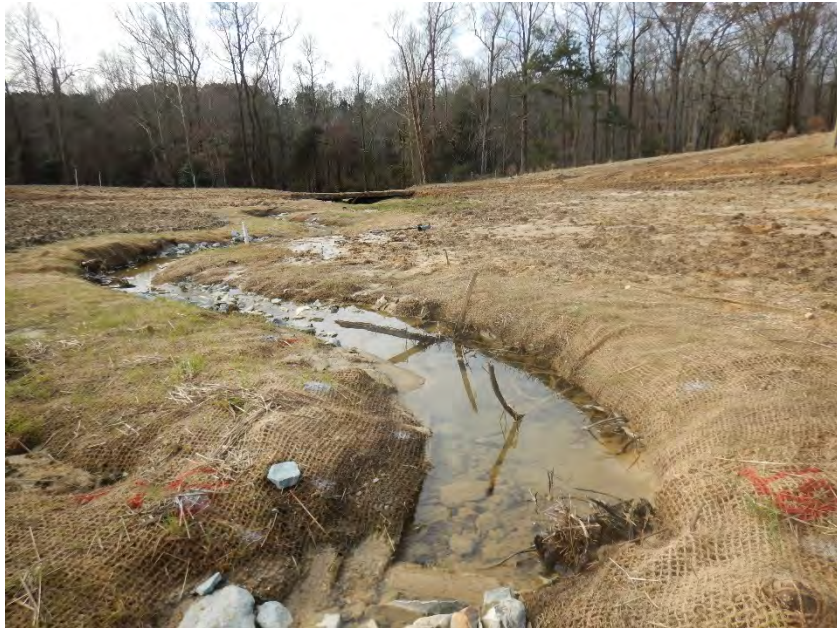
Downstream (01/19/2021)

MY0	MY1	MY2	MY3	MY6	MY7
Bankfull Elevation - Based on AB-Bankfull Area	141.12					
Bank Height Ratio - Based on AB-Bankfull Area	1.00					
Thalweg Elevation	139.53					
LTOB Elevation	141.12					
LTOB Max Depth	1.581					
LTOB Cross Sectional Area	4.88

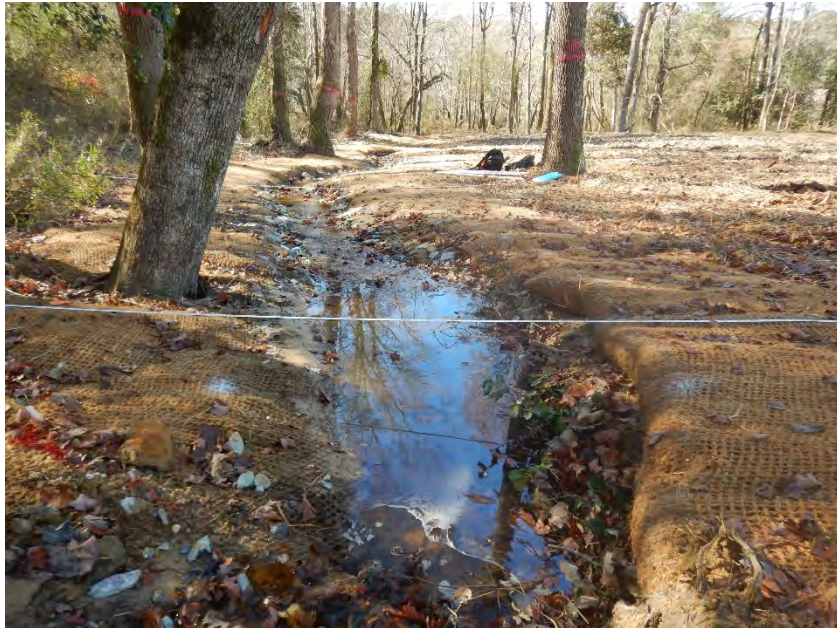
Downstream (01/19/2021)

MY0	MY1	MY2	MY3	MY6	MY7
Bankfull Elevation - Based on AB-Bankfull Area	128.16					
Bank Height Ratio - Based on AB-Bankfull Area	1.00					
Thalweg Elevation	126.70					
LTOB Elevation	128.16					
LTOB Max Depth	1.462					
LTOB Cross Sectional Area	3.25

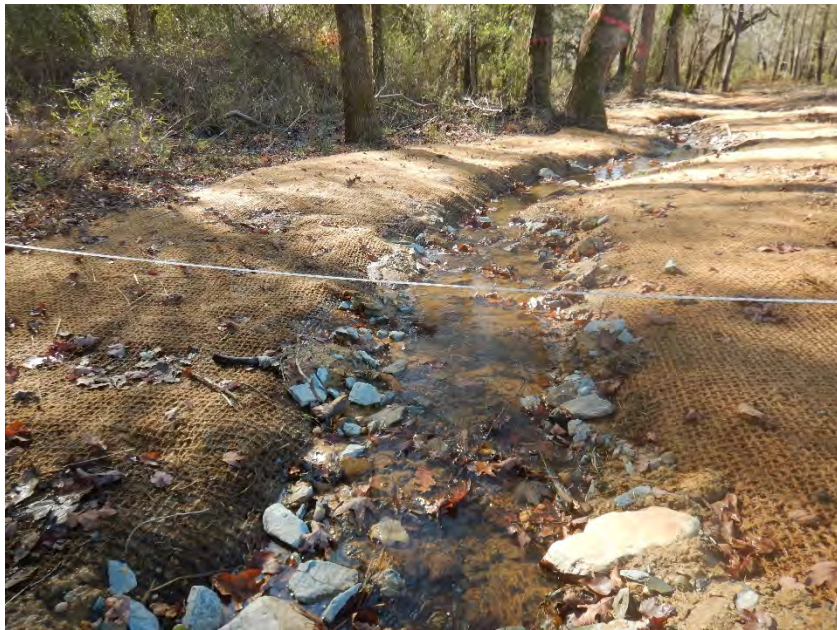
Downstream (01/19/2021)

MY0	MY1	MY2	MY3	MY6	MY7
Bankfull Elevation - Based on AB-Bankfull Area	127.58					
Bank Height Ratio - Based on AB-Bankfull Area	1.00					
Thalweg Elevation	127.06					
LTOB Elevation	127.58					
LTOB Max Depth	0.522					
LTOB Cross Sectional Area	1.50

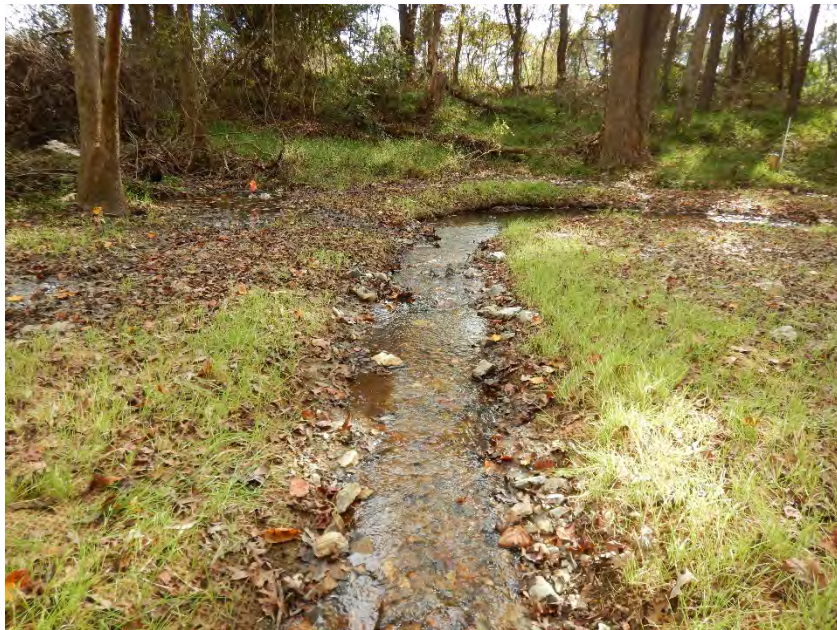
Downstream (01/19/2021)

MY0	MY1	MY2	MY3	MY6	MY7
Bankfull Elevation - Based on AB-Bankfull Area	133.06					
Bank Height Ratio - Based on AB-Bankfull Area	1.00					
Thalweg Elevation	132.36					
LTOB Elevation	133.06					
LTOB Max Depth	0.696					
LTOB Cross Sectional Area	2.49

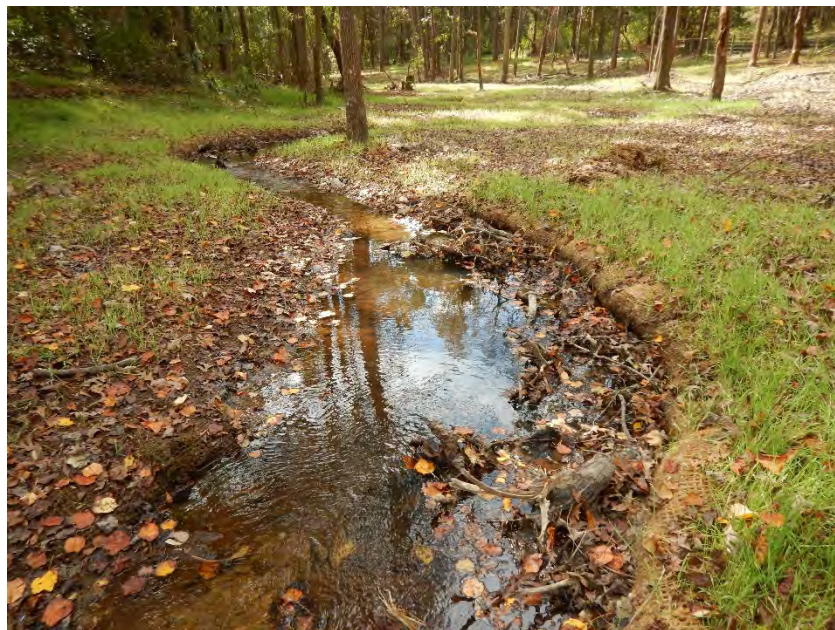
Downstream (01/19/2021)

MY0	MY1	MY2	MY3	MY6	MY7
Bankfull Elevation - Based on AB-Bankfull Area	132.53					
Bank Height Ratio - Based on AB-Bankfull Area	1.00					
Thalweg Elevation	131.03					
LTOB Elevation	132.53					
LTOB Max Depth	1.500					
LTOB Cross Sectional Area	6.97

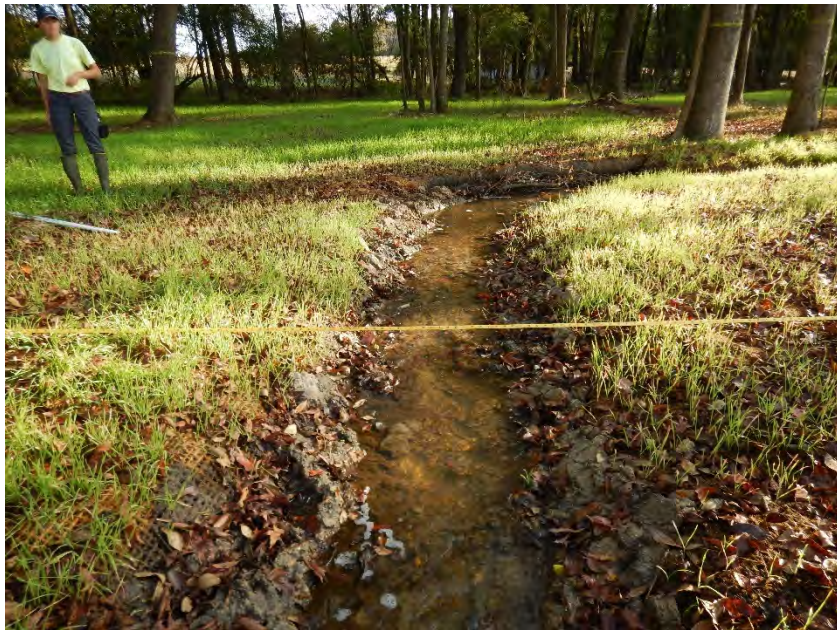
Downstream (01/19/2021)

MY0	MY1	MY2	MY3	MY6	MY7
Bankfull Elevation - Based on AB-Bankfull Area	156.43					
Bank Height Ratio - Based on AB-Bankfull Area	1.00					
Thalweg Elevation	155.62					
LTOB Elevation	156.43					
LTOB Max Depth	0.814					
LTOB Cross Sectional Area	2.69

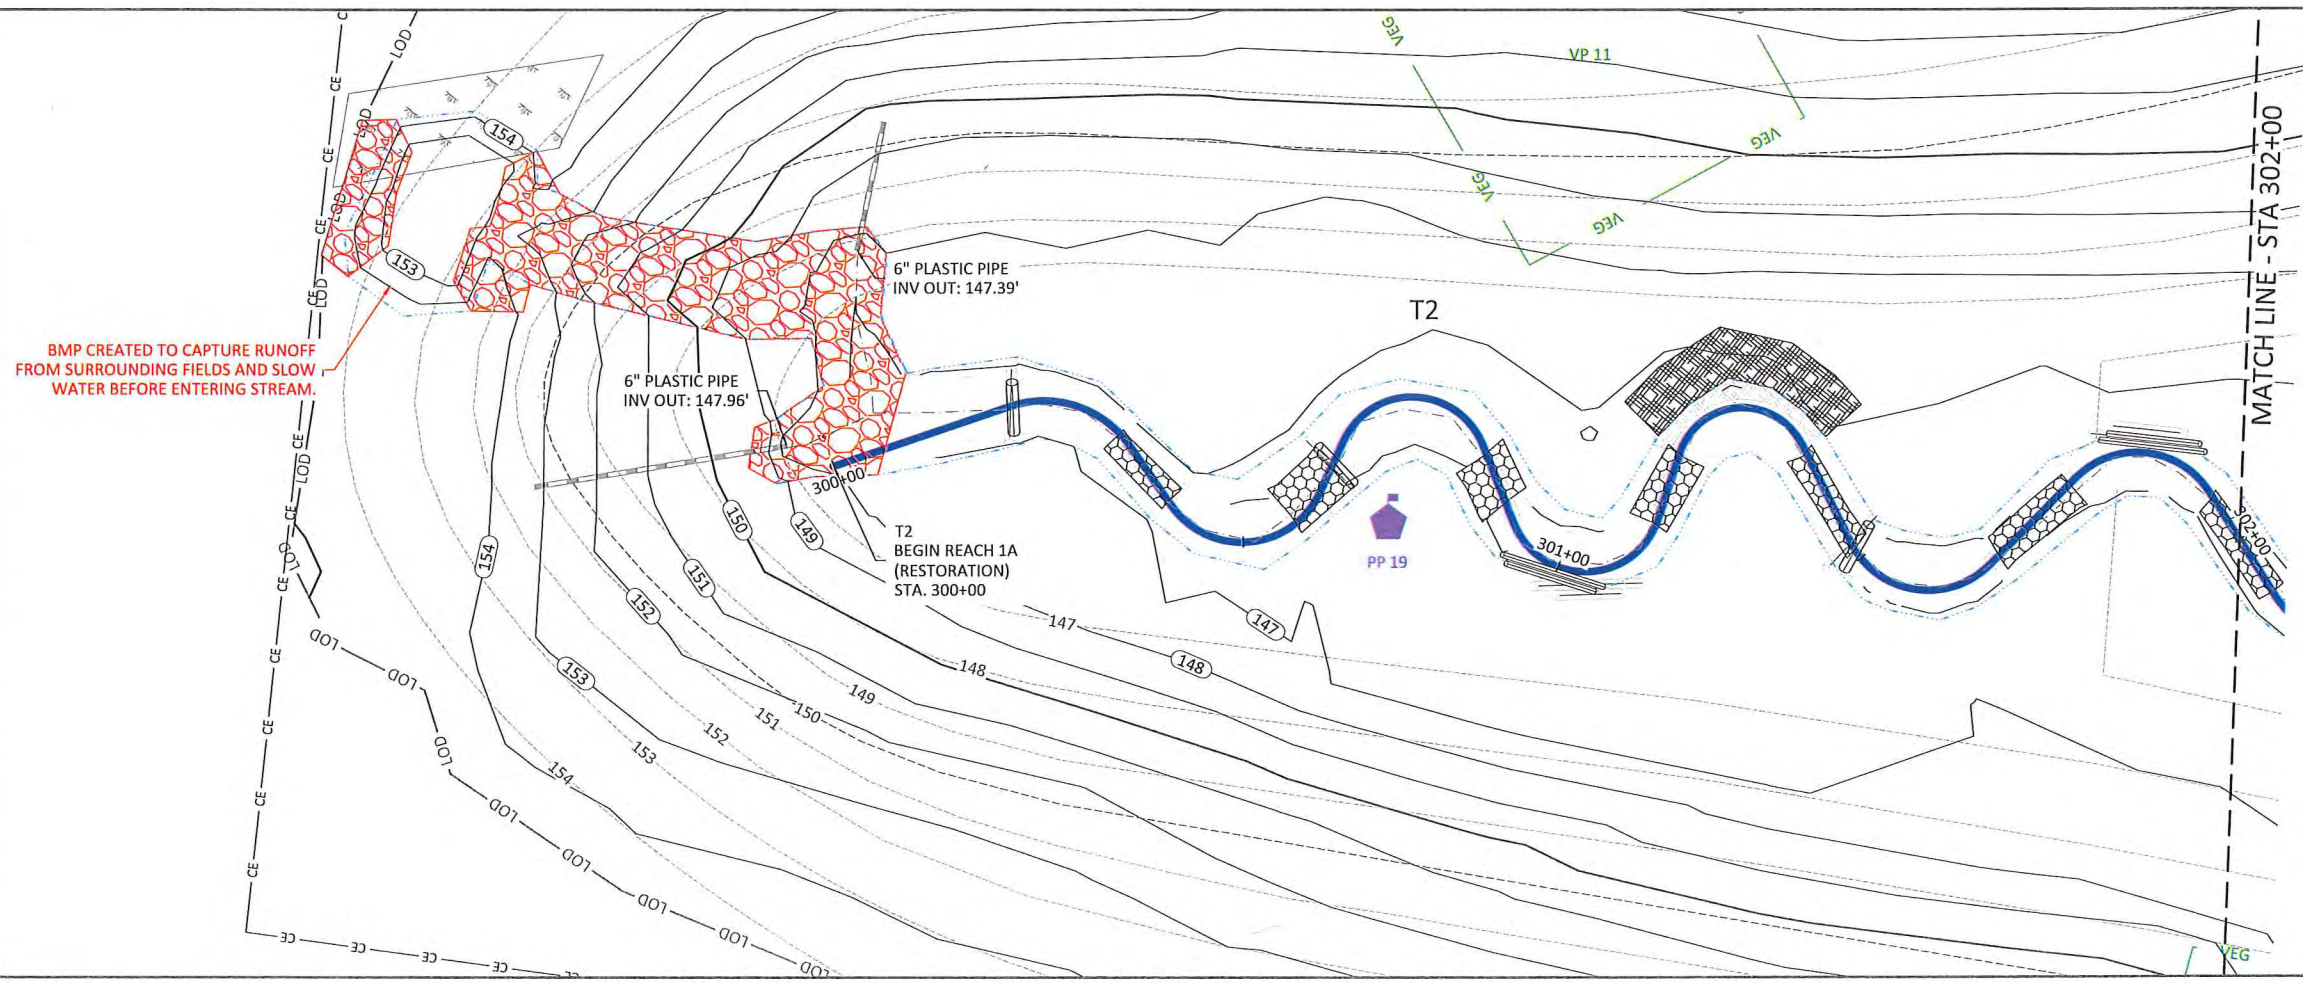
BMP CREATED TO CAPTURE RUNOFF FROM SURROUNDING FIELDS AND SLOW WATER BEFORE ENTERING STREAM.

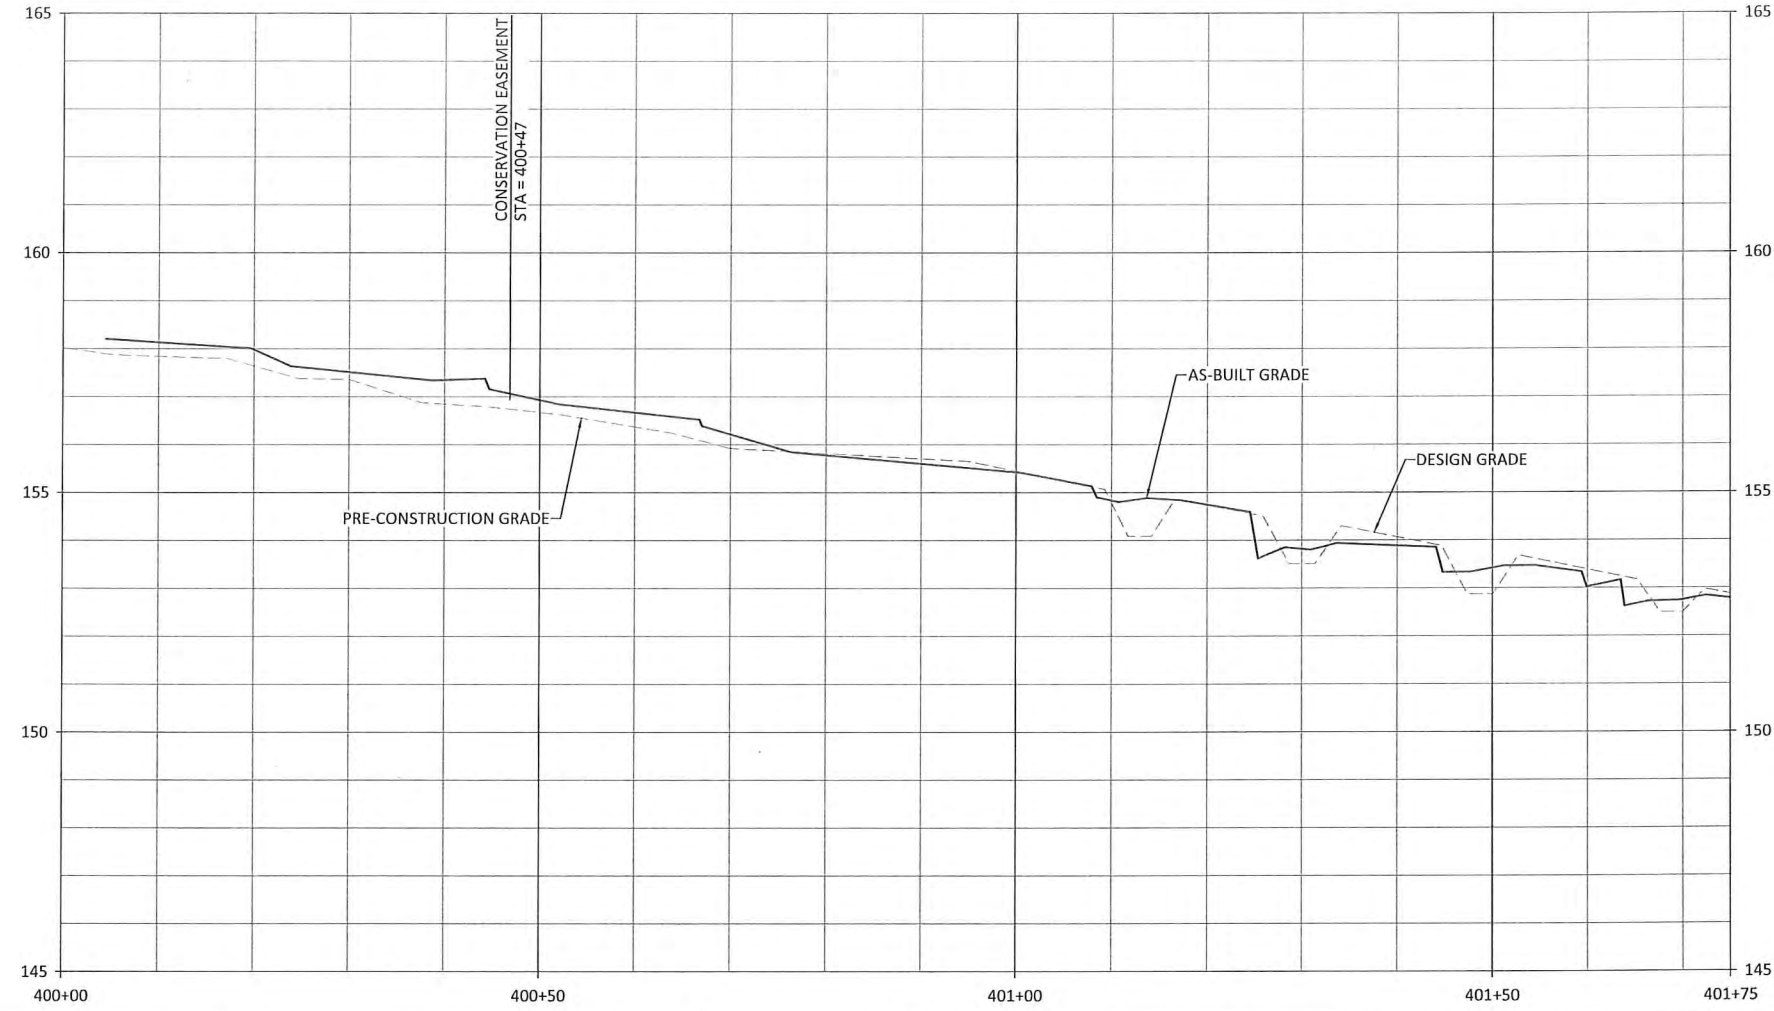
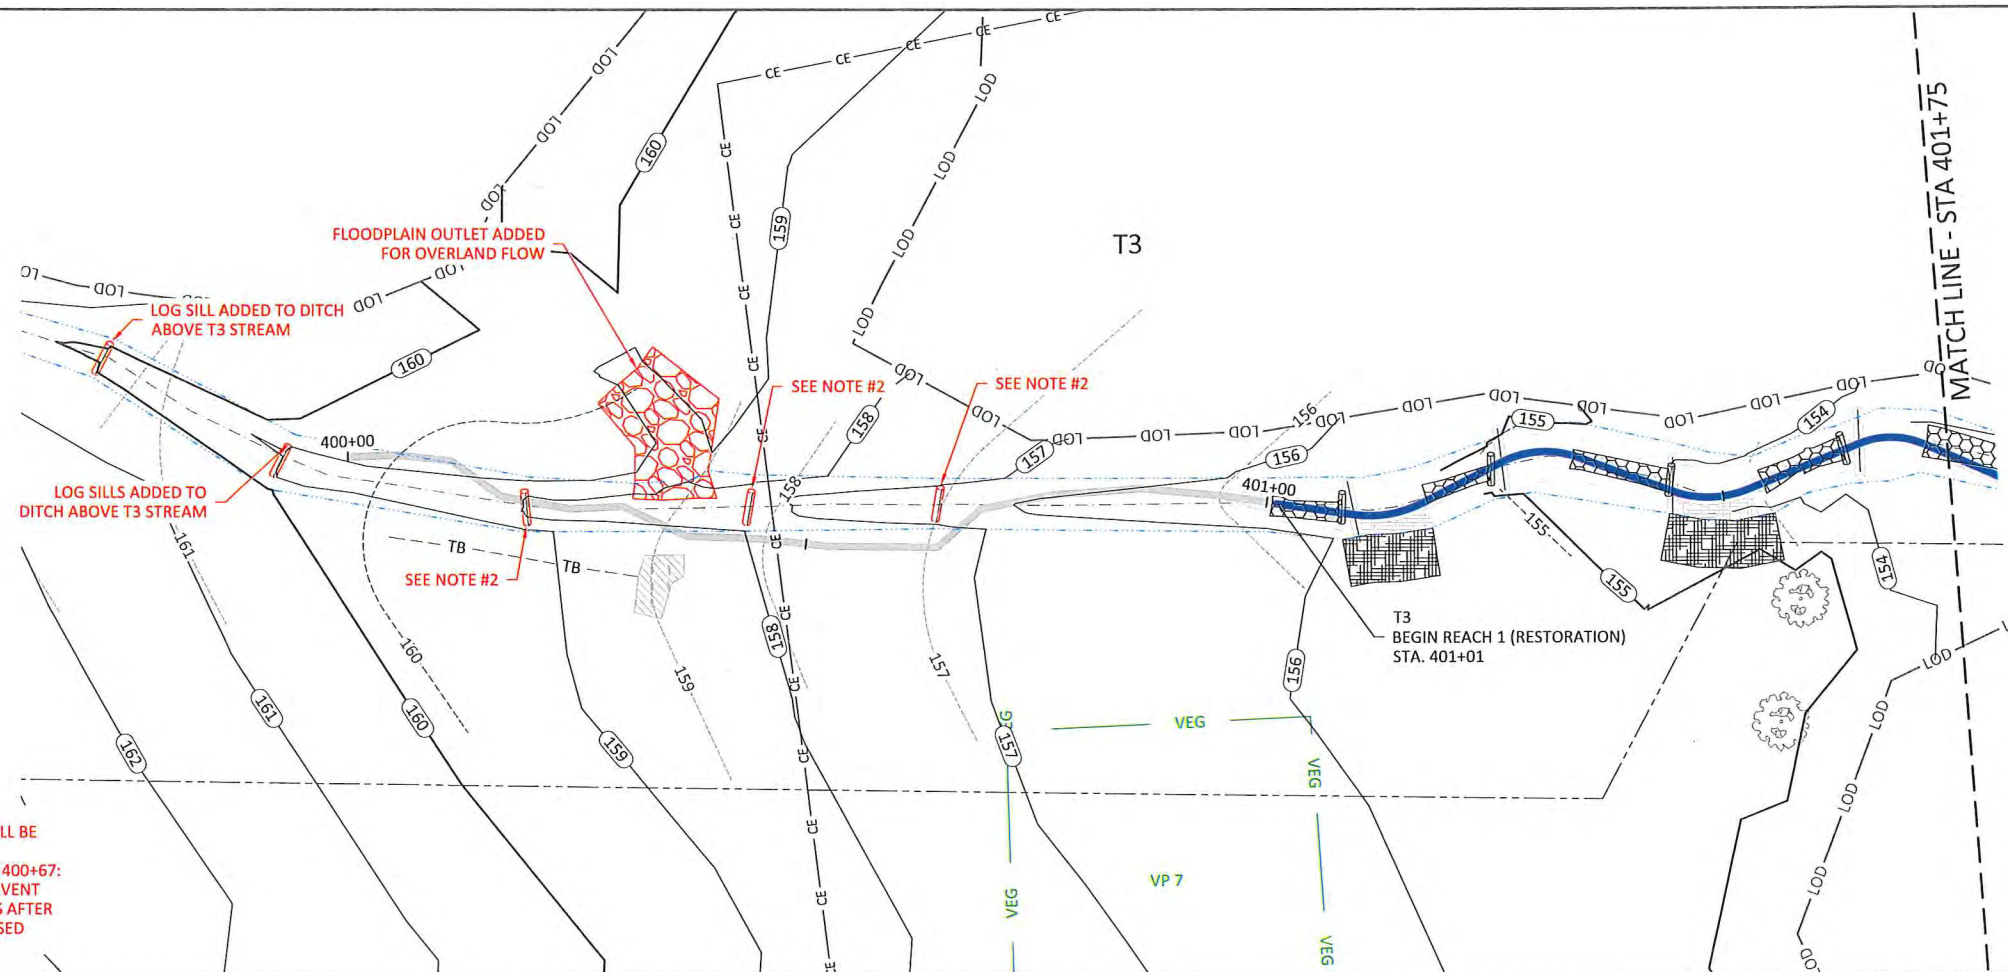
- NOTES:**
1. DEVIATIONS FROM THE DESIGN WILL BE SHOWN IN RED.
 2. STA 400+20, STA 400+44, AND STA 400+67: LOG SILLS WERE INSTALLED TO PREVENT FURTHER EROSION AND HEADCUTS AFTER PRE-CONSTRUCTION STORMS CAUSED EROSION.

- Log sills added to ditch above T3 stream;
- Floodplain outlet added for overland flow;
- STA 400+20, STA 400+44, and STA 400+67 – log sills were installed to prevent further erosion and headcuts after pre-construction storms caused erosion;
- STA 402+15 - 402+22, STA 402+59 - 402+73 and STA 403+05 - 403+15 – brushtoe was not needed in these areas because the roots of trees we saved served to stabilize the banks; and
- Log sill was installed on wetland outlet to prevent further erosion caused by pre-construction storms.

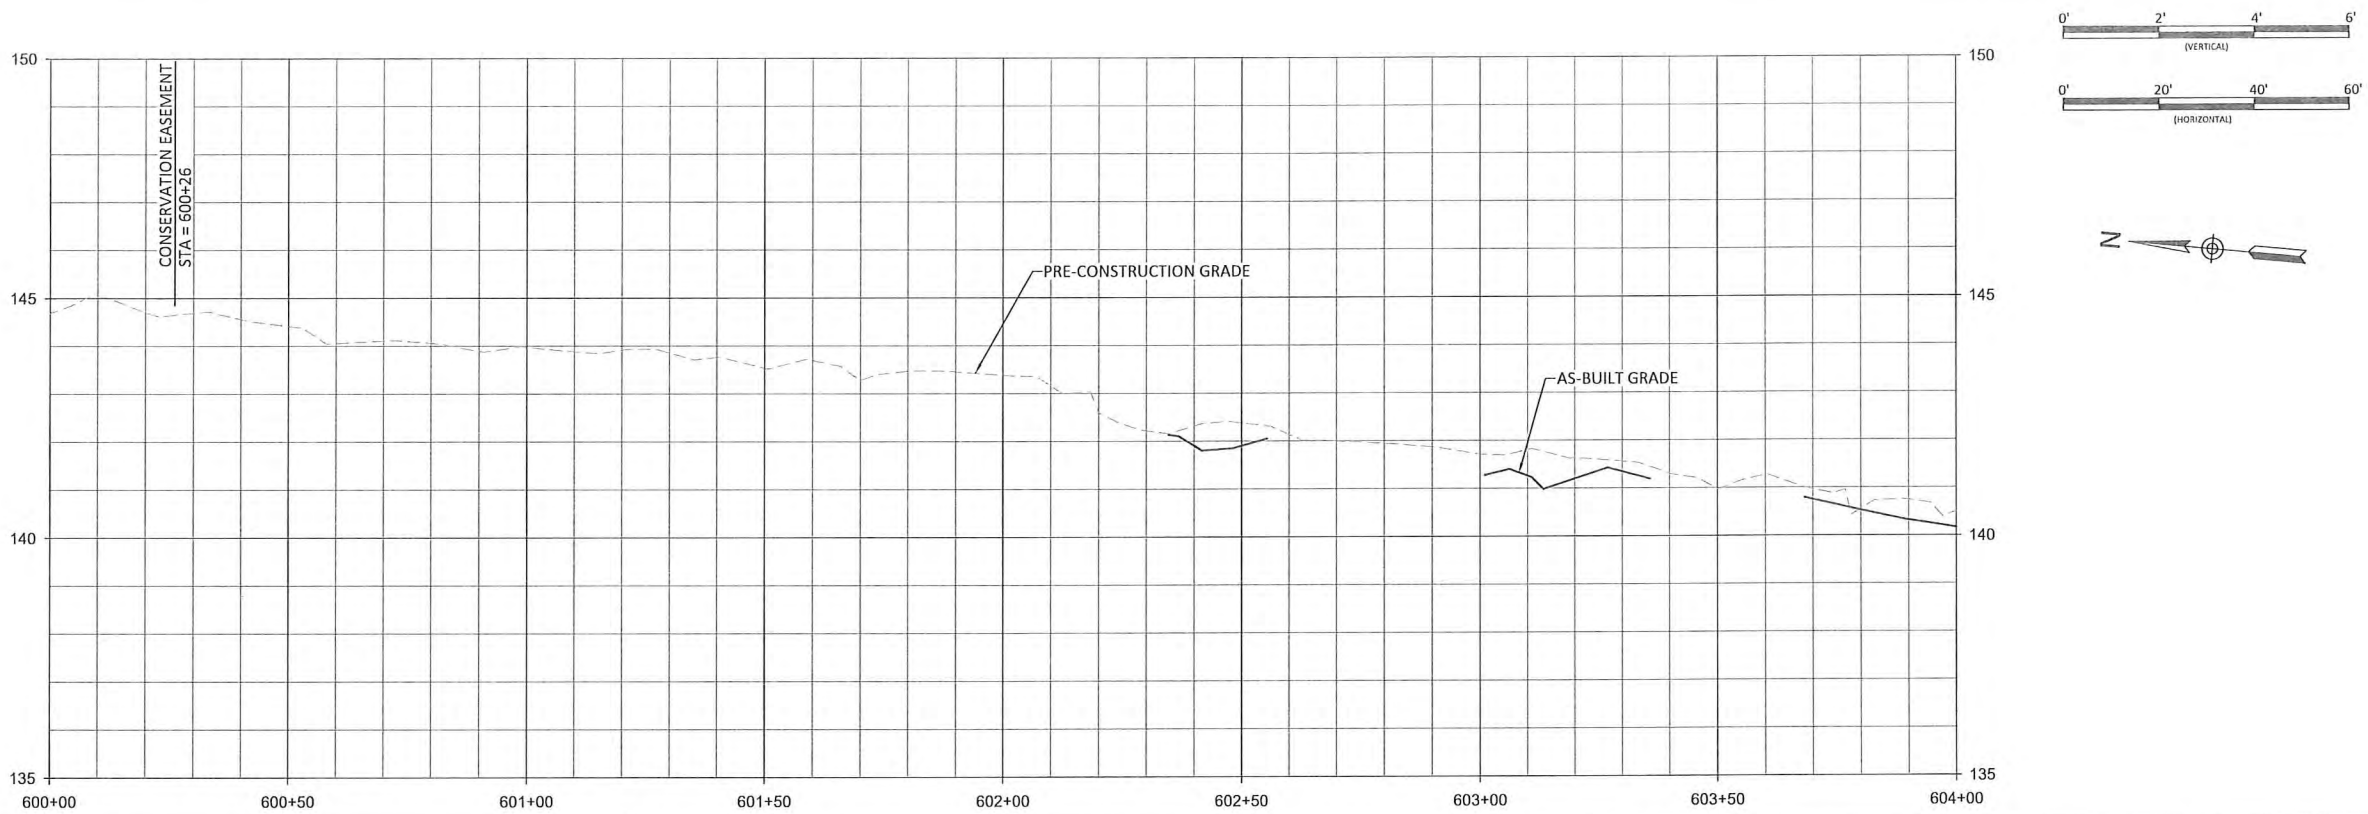
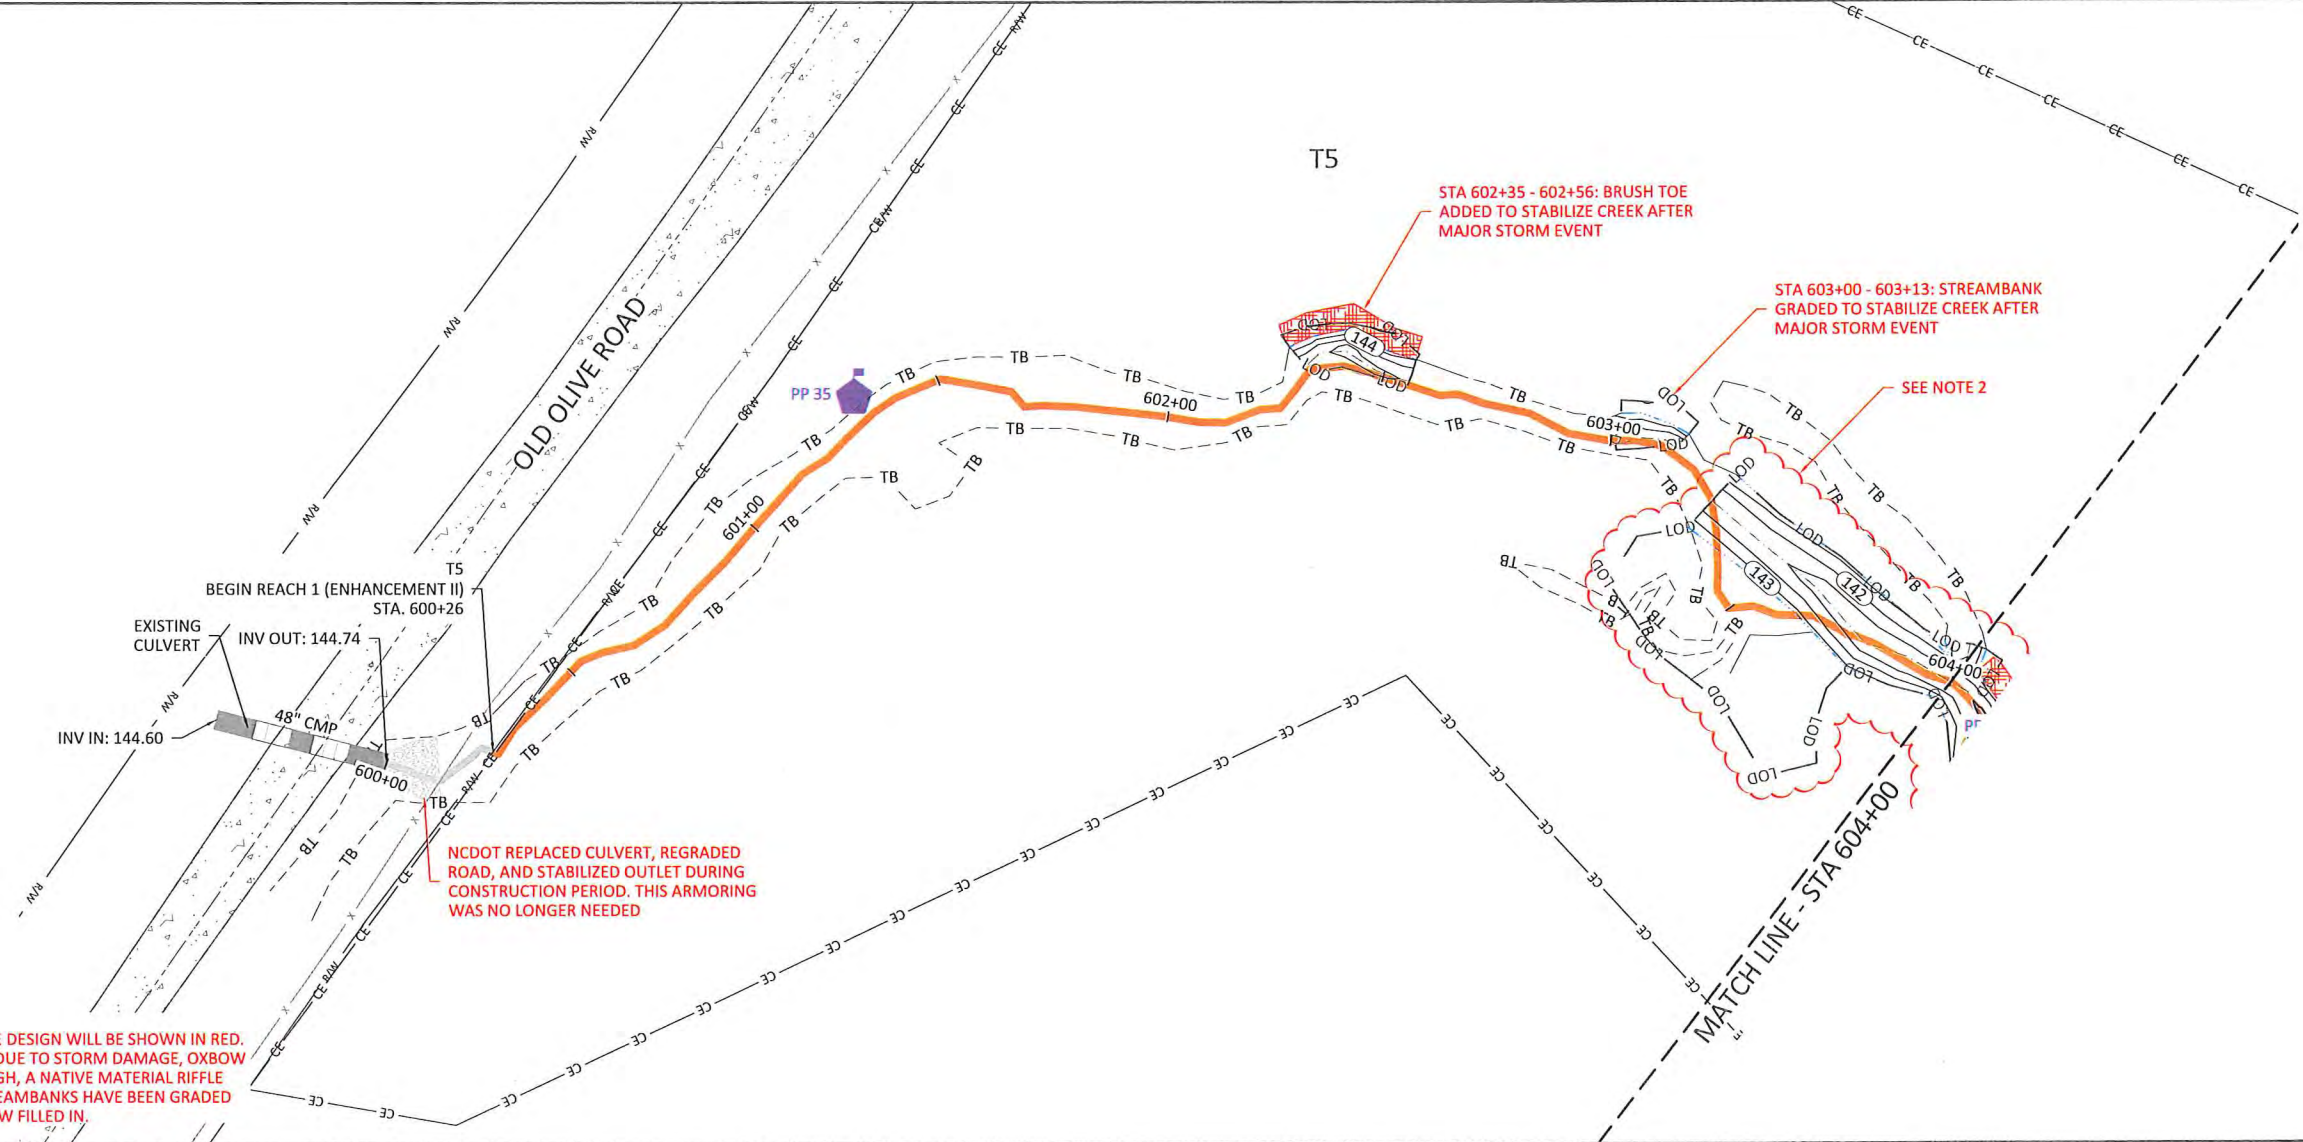
- NOTES:**
1. DEVIATIONS FROM THE DESIGN WILL BE SHOWN IN RED.
 2. STA 603+27 - 605+81: DUE TO STORM DAMAGE, OXBOW HAS BEEN CUT THROUGH, A NATIVE MATERIAL RIFFLE HAS BEEN ADDED, STREAMBANKS HAVE BEEN GRADED AS NEEDED AND OXBOW FILLED IN.

- NDCOT replaced culvert, regraded road, and stabilized outlet during construction period. This armoring was no longer needed;
- STA 602+35 - 602+56 – brushtoe added to stabilize creek after major storm event;
- STA 603+00 - 603+13 – streambank graded to stabilize creek after major storm event;
- STA 603+27 - 605+81 – due to storm damage, oxbow has been cut through, a native material riffle has been added, streambanks have been graded as needed and oxbow filled in; and
- STA 604+02 - STA 604+30 and STA 604+50 - STA 604+54 – brushtoe added for stabilization.

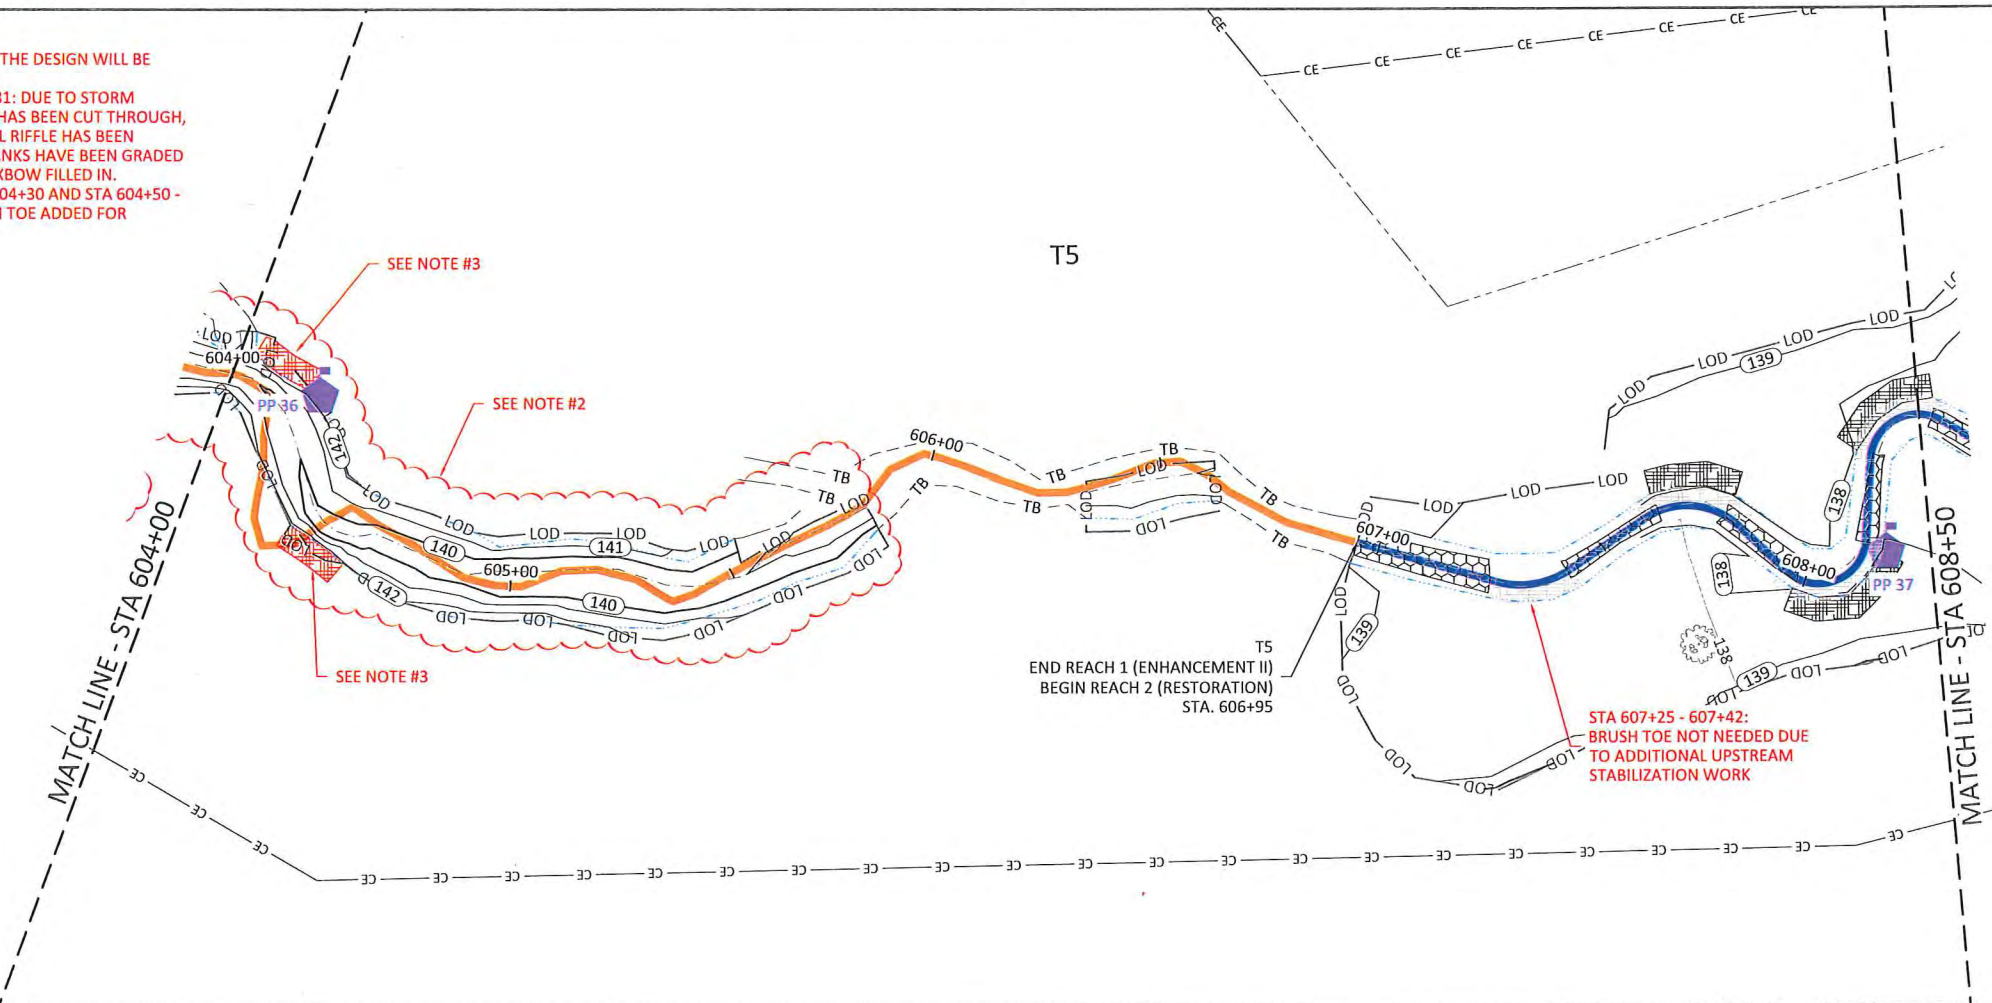
- NOTES:**
1. DEVIATIONS FROM THE DESIGN WILL BE SHOWN IN RED.
 2. STA 603+27 - 605+81: DUE TO STORM DAMAGE, OXBOW HAS BEEN CUT THROUGH, A NATIVE MATERIAL RIFFLE HAS BEEN ADDED, STREAMBANKS HAVE BEEN GRADED AS NEEDED AND OXBOW FILLED IN.
 3. STA 604+02 - STA 604+30 AND STA 604+50 - STA 604+54: BRUSH TOE ADDED FOR STABILIZATION.

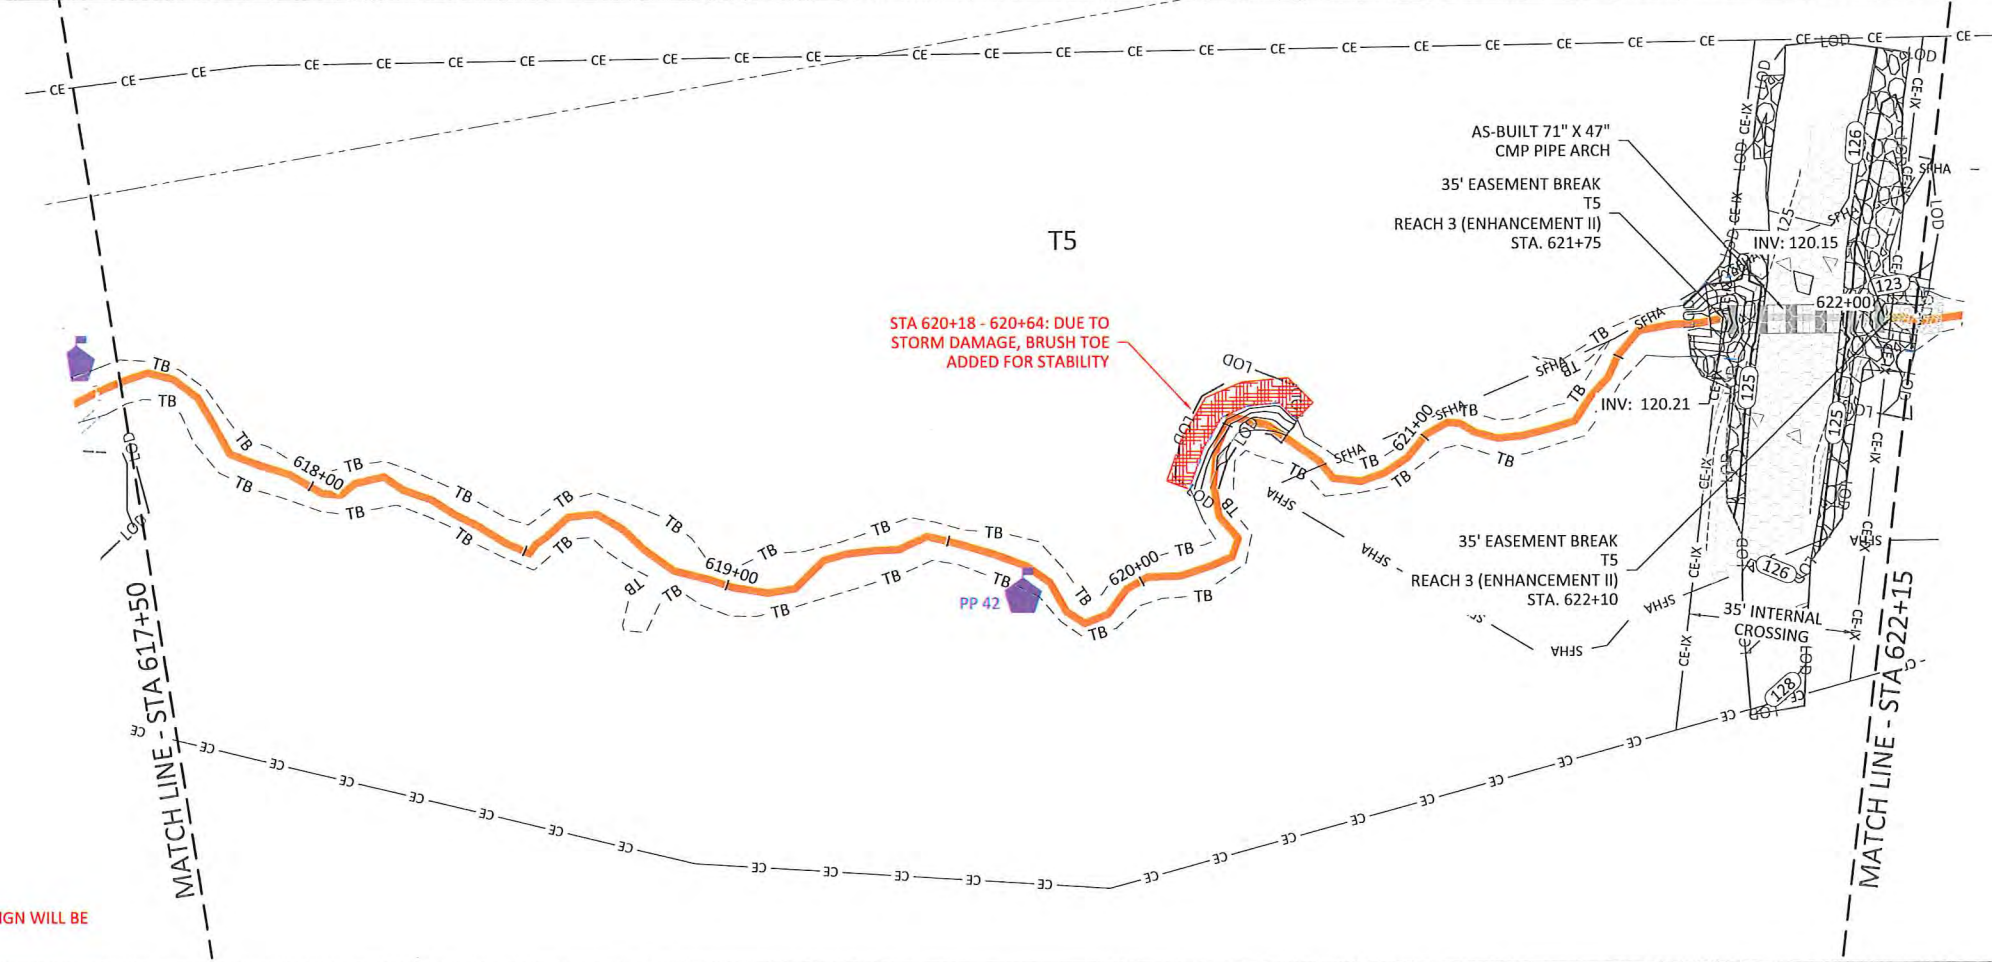
T5
Stream Plan and Profile

STA 620+18 - 620+64: DUE TO STORM DAMAGE, BRUSH TOE ADDED FOR STABILITY

- STA 620+18 - 620+64 – due to storm damage brushtoe added for stability.
