MONITORING YEAR 0 ANNUAL REPORT FINAL

SASSARIYA SWAMP MITIGATION SITE

Johnston County, NC
Neuse River Basin
HUC 03020201

DMS Project No. 100040
DMS Contract No. 7425
DMS RFP No. 16-007279
USACE Action ID No. 2018-00432
DWR Project No. 2018-0198
Data Collection Dates: October-March 2021

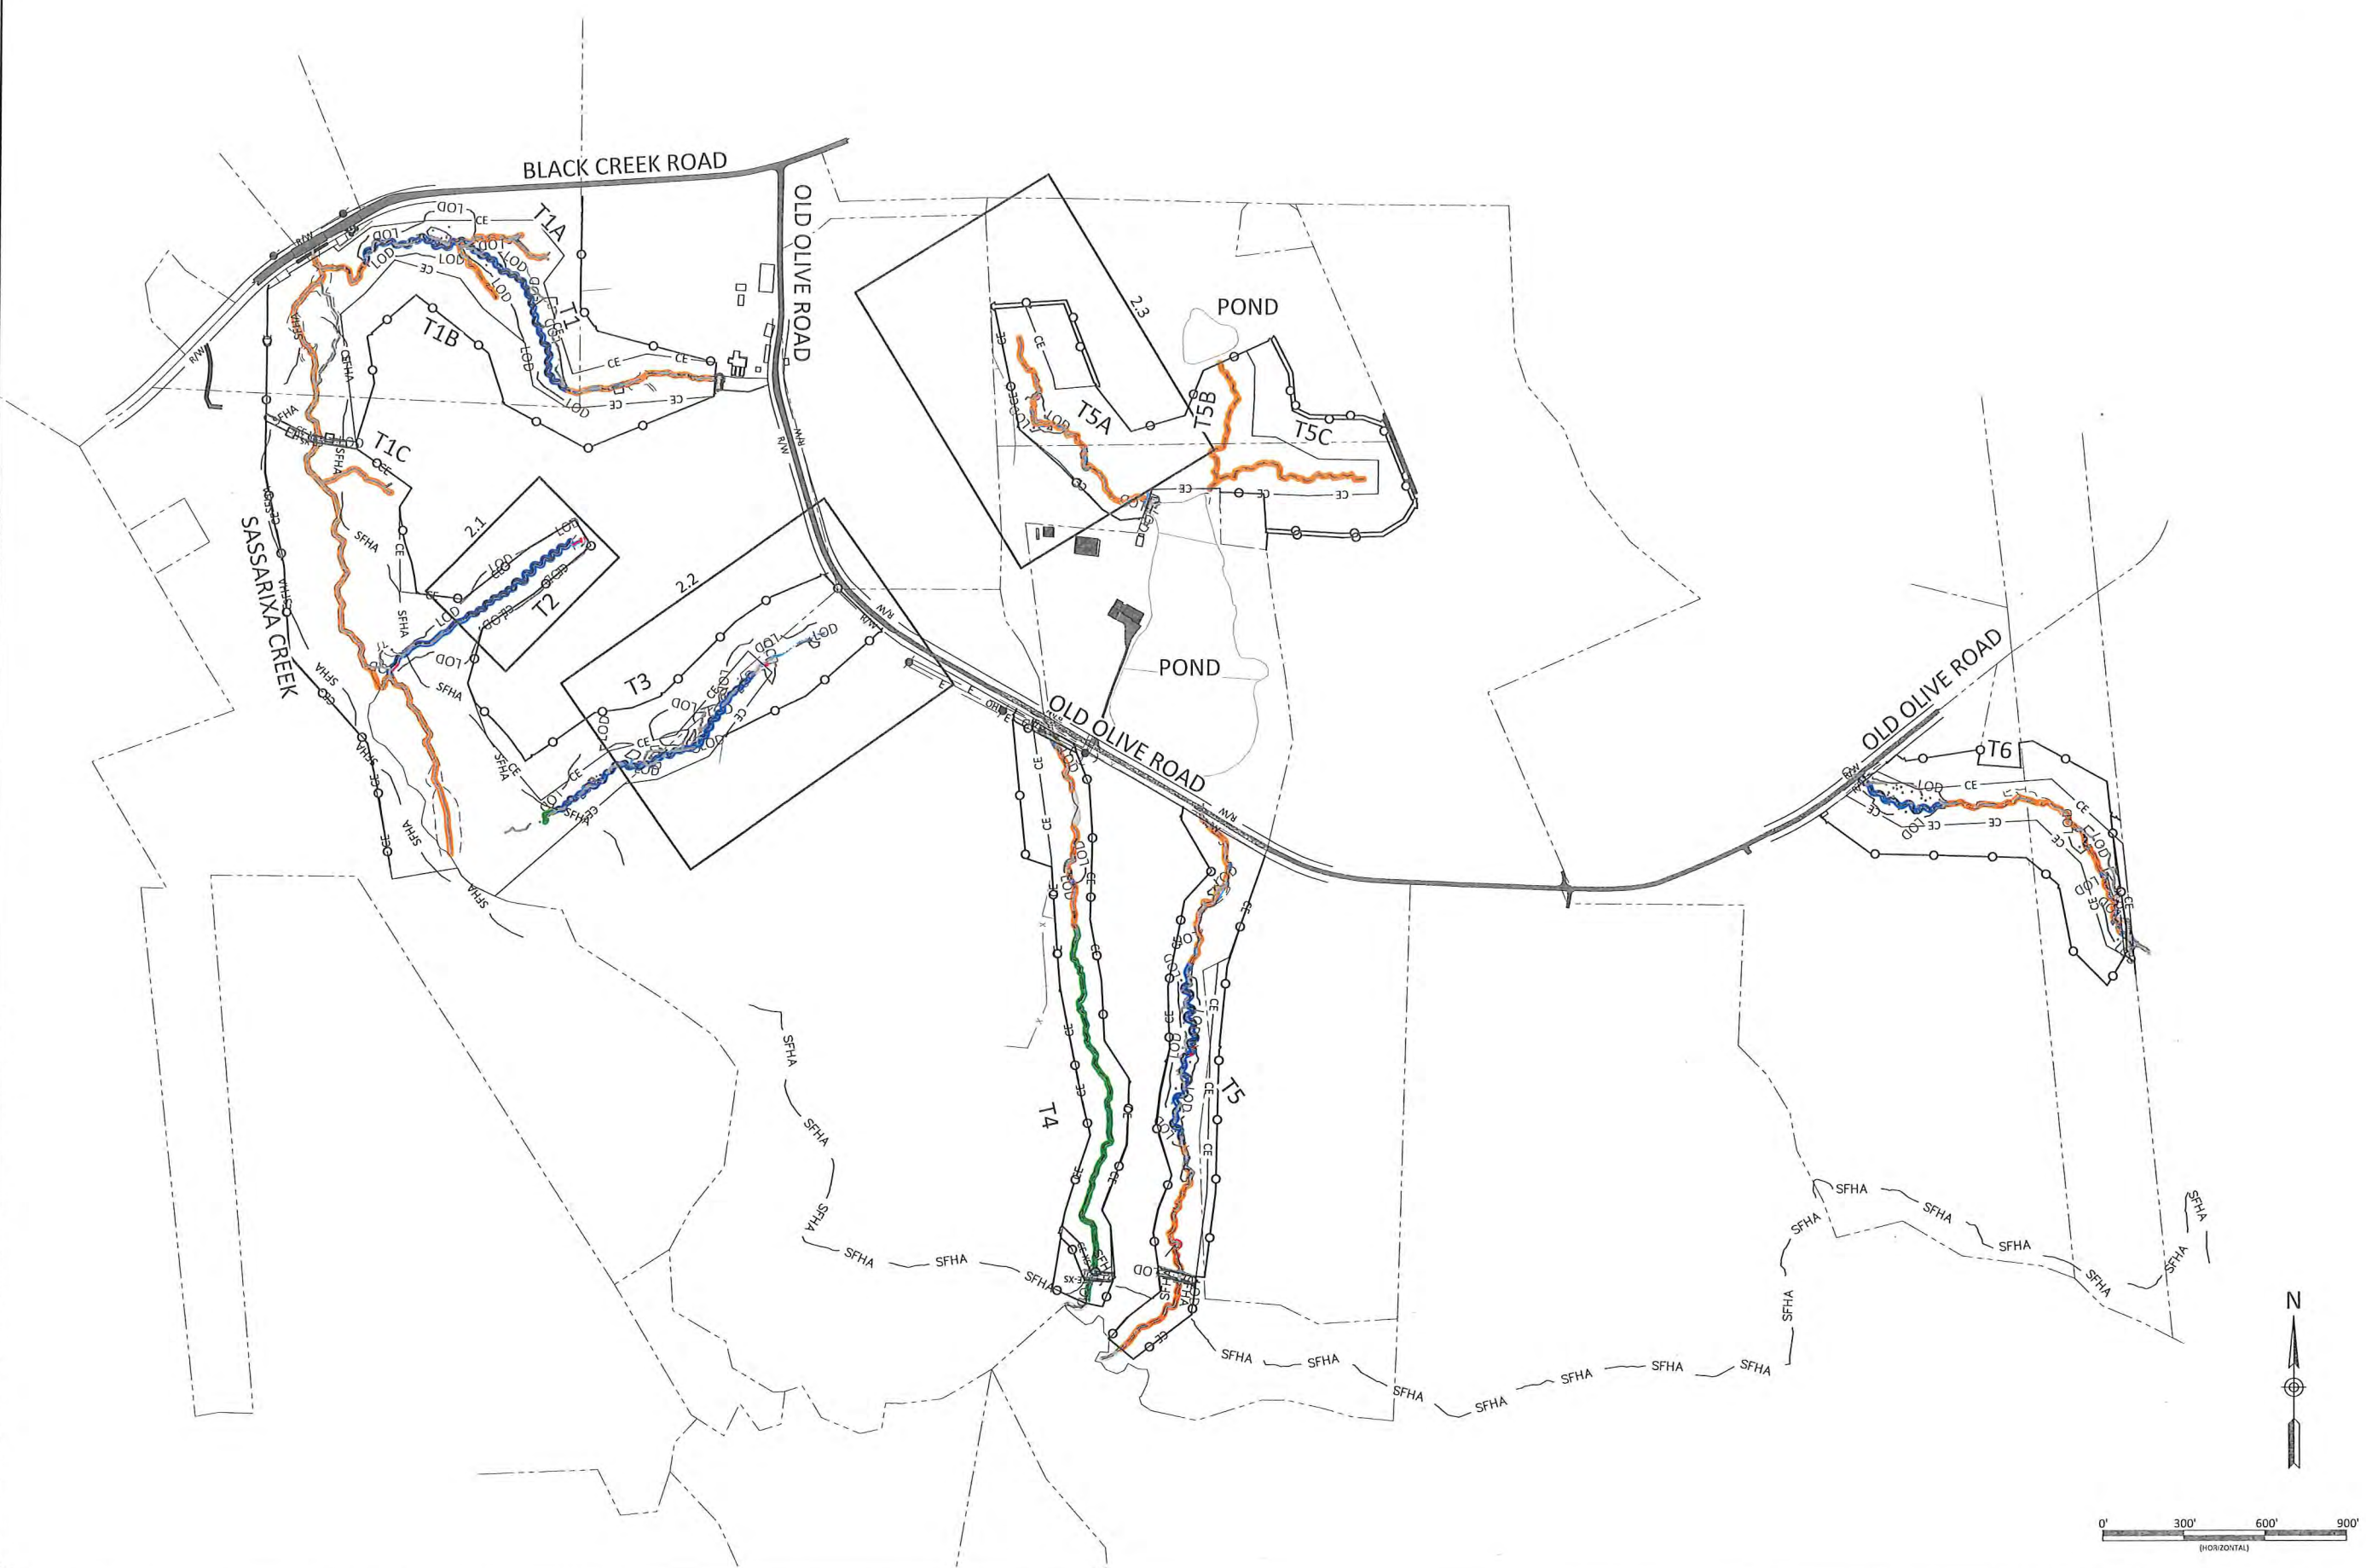
Sassarixa Swamp Mitigation Site
Johnston County, North Carolina
Additional Grading Overview
Additional Grading

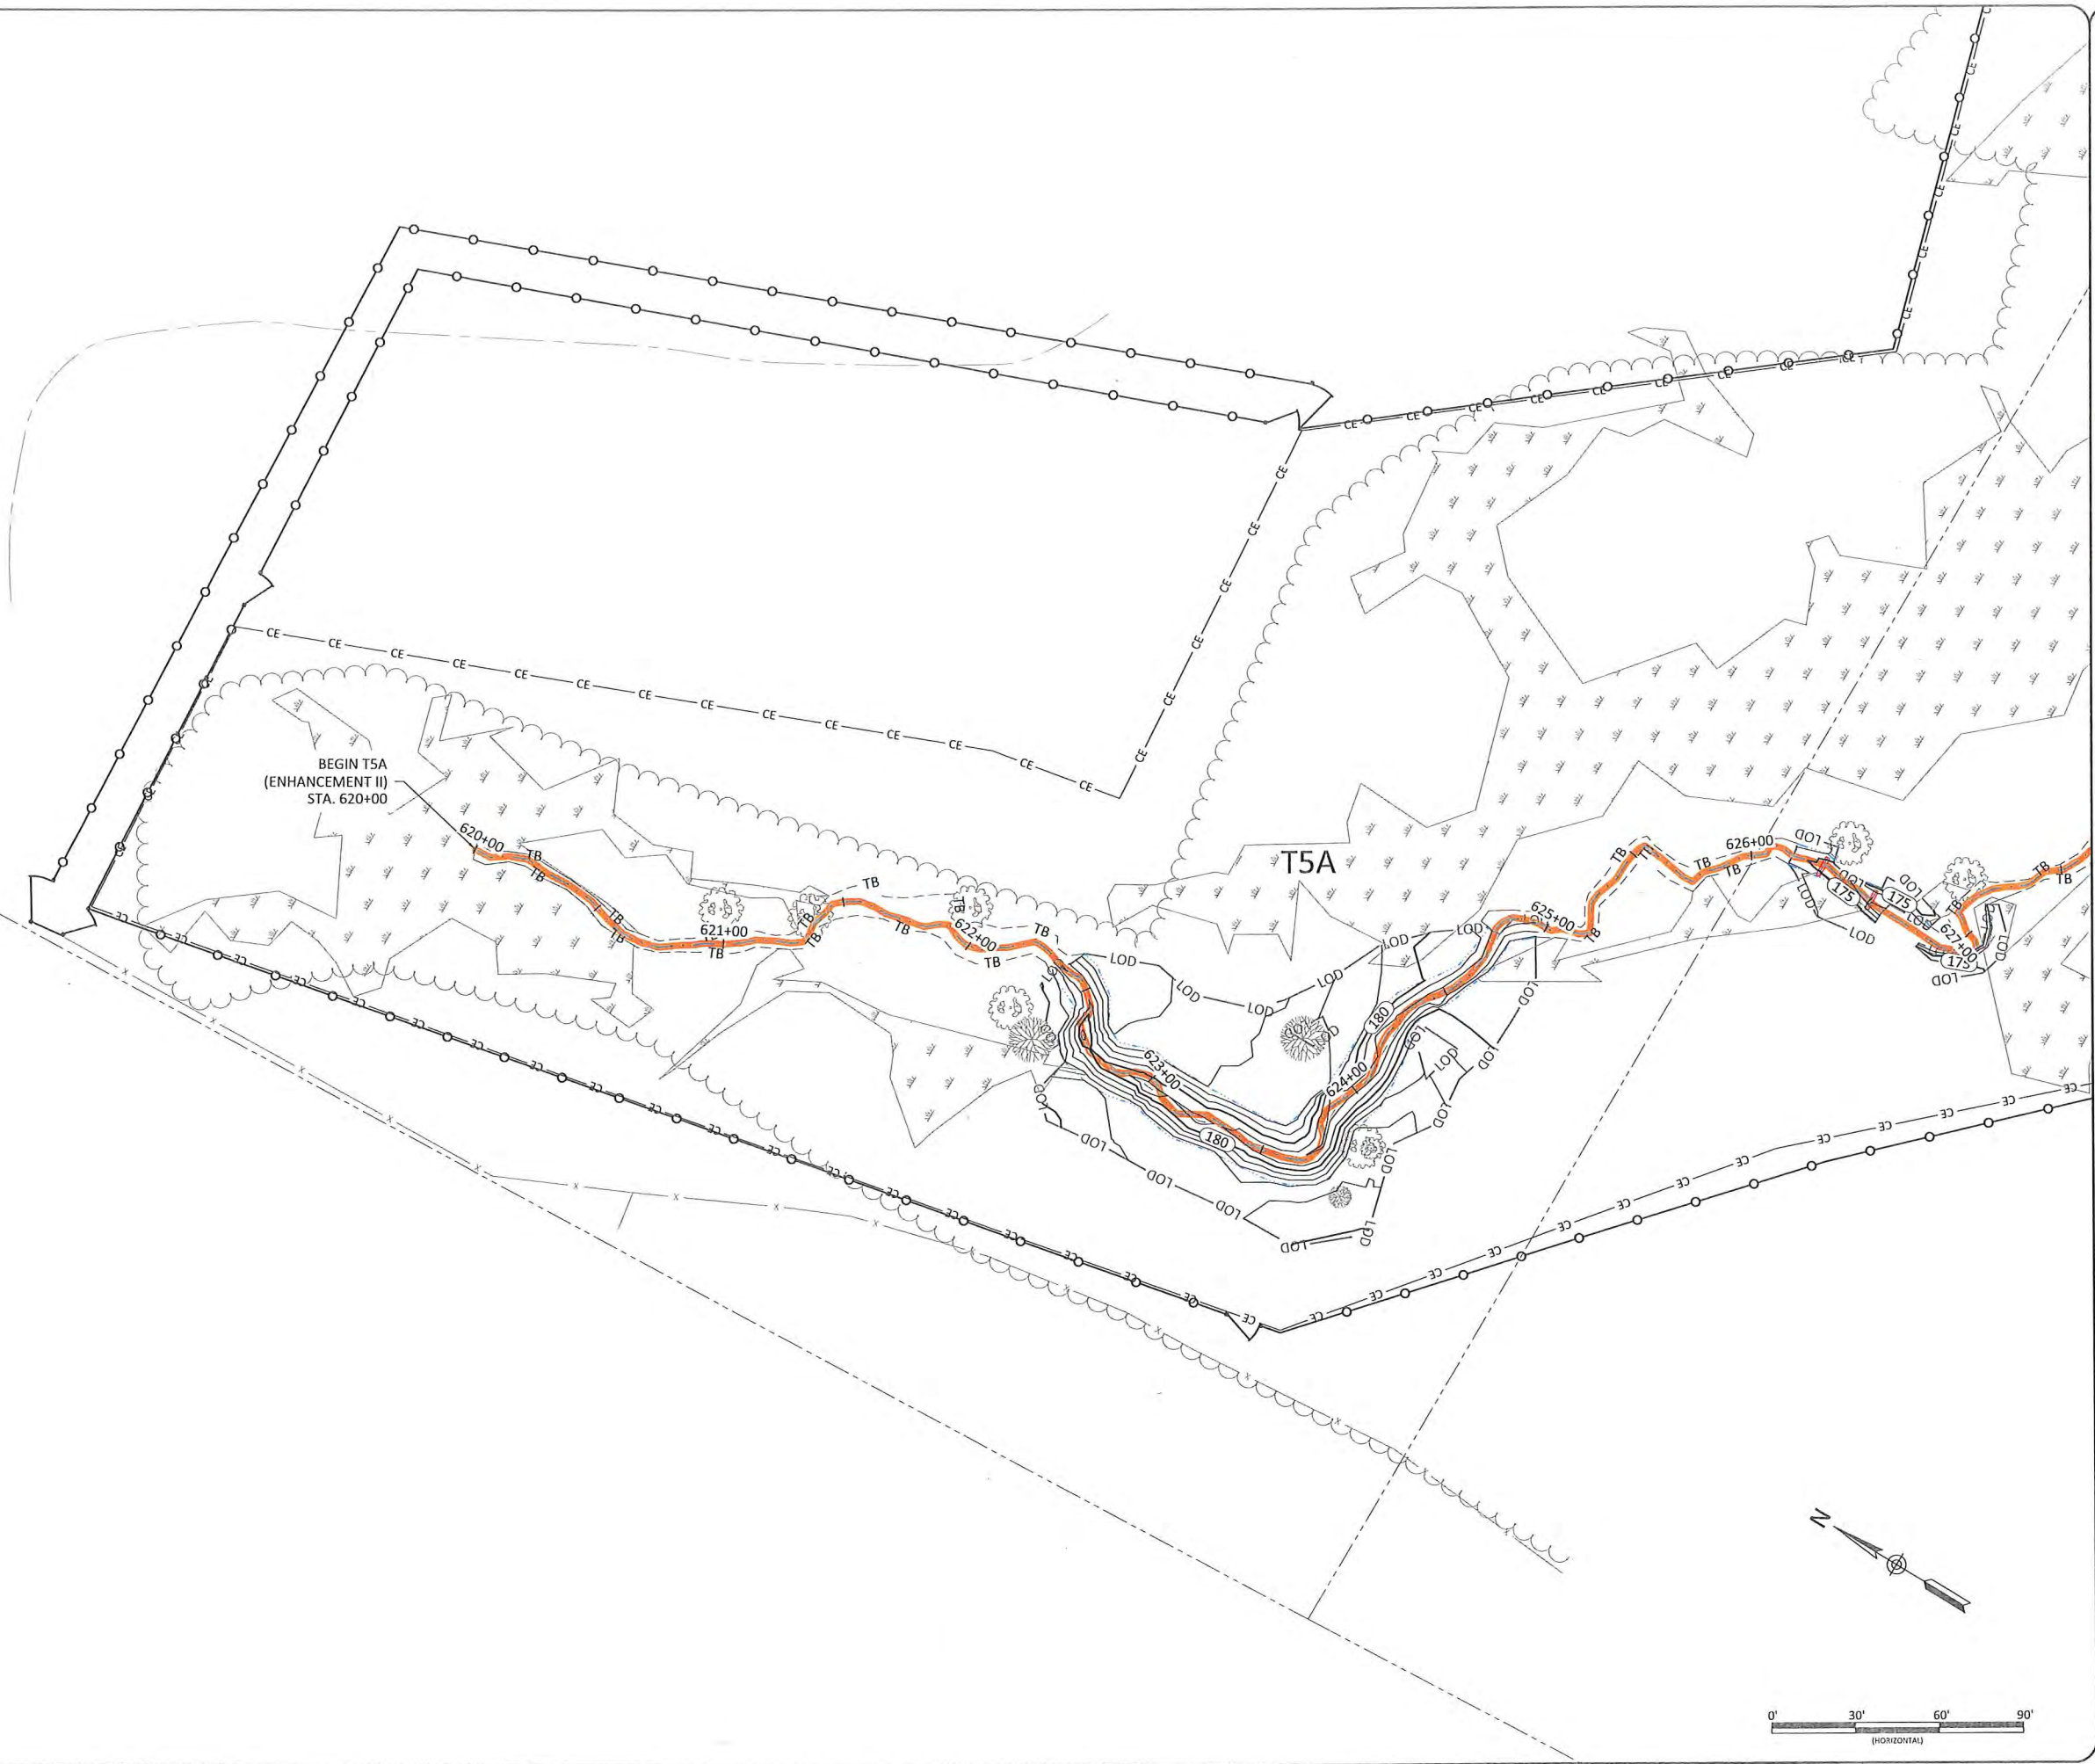
Sassarixa Swamp Mitigation Site
 Johnston County, North Carolina
 T5A Additional Grading
 Additional Grading
