FINAL
AS-BUILT BASELINE
MONITORING REPORT (MY0)

SLINGSHOT CREEK STREAM AND WETLAND MITIGATION SITE
Rockingham County, North Carolina

DMS Project ID No. 100058
Full Delivery Contract No. 7525
USACE Action ID No. SAW-2018-01170
RFP No. 16-007330

Data Collection: May 2020
Submission: August 2020

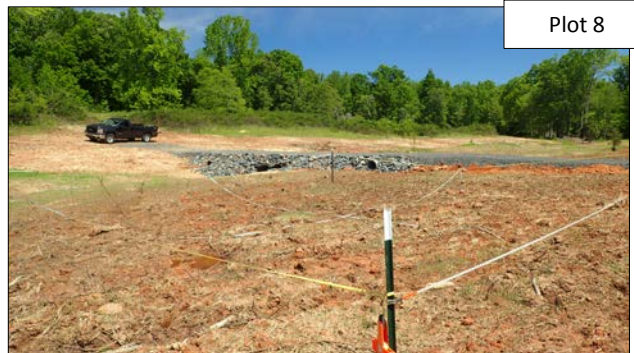
Plot 8

**Slingshot Creek
MY0 (2020) Vegetation Monitoring Photographs (taken May 4, 2020)**

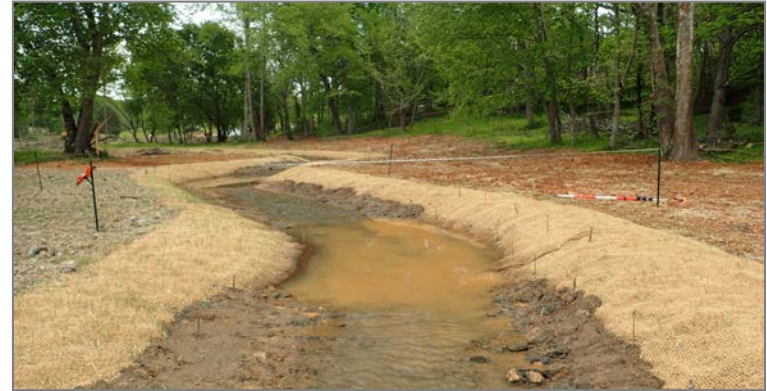
Site	Slingshot Creek
Watershed:	Cape Fear, 03030002
XS ID	Slingshot Creek, XS - 1, Pool
Feature	Pool
Date:	4/28/2020
Field Crew:	Perkinson, Keith

SUMMARY DATA	
Bankfull Elevation:	1201.2
Bankfull Cross-Sectional Area:	18.2
Bankfull Width:	13.4
Flood Prone Area Elevation:	NA
Flood Prone Width:	NA
Max Depth at Bankfull:	2.0
Low Bank Height:	2.0
Mean Depth at Bankfull:	1.4
W / D Ratio:	NA
Entrenchment Ratio:	NA
Bank Height Ratio:	1.0

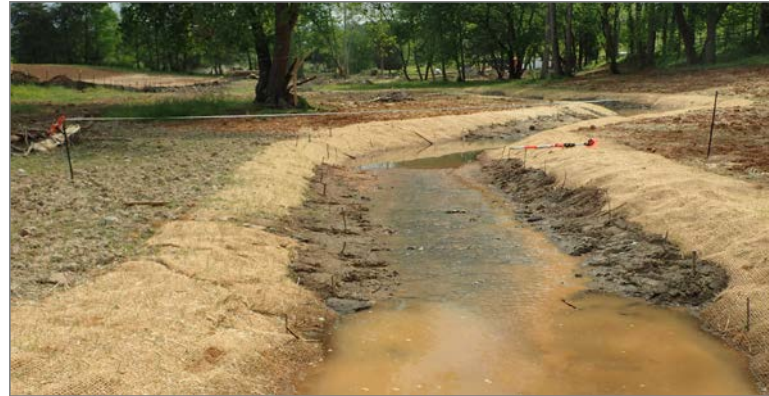
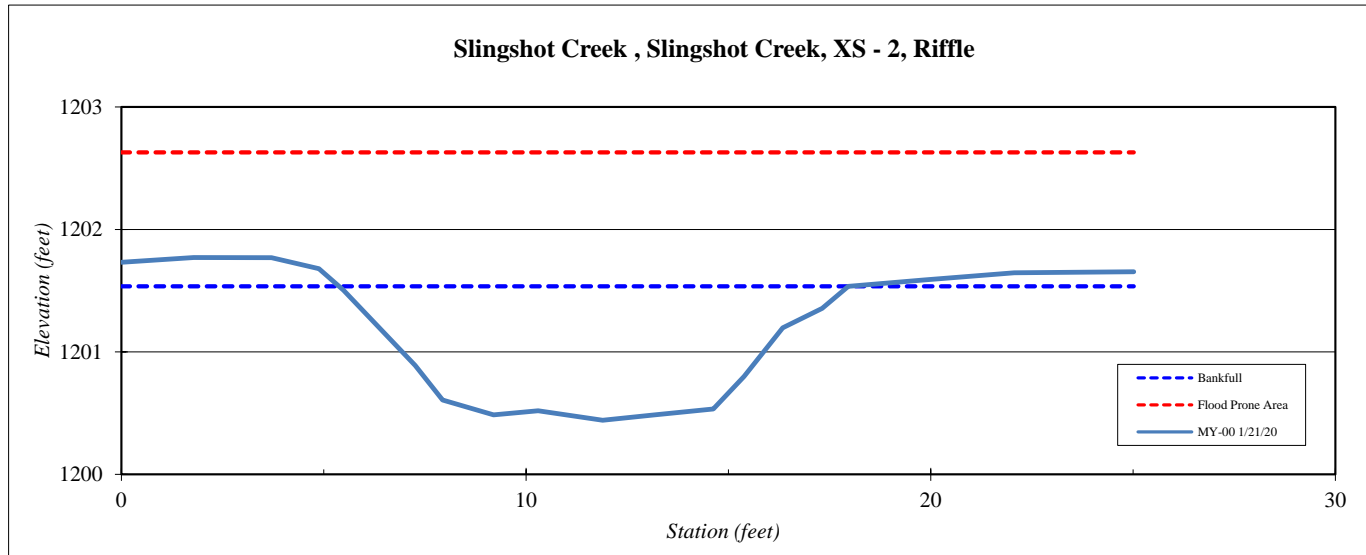
Site	Slingshot Creek
Watershed:	Cape Fear, 03030002
XS ID	Slingshot Creek, XS -2, Riffle
Feature	Riffle
Date:	4/28/2020
Field Crew:	Perkinson, Keith

SUMMARY DATA	
Bankfull Elevation:	1201.3
Bankfull Cross-Sectional Area:	10.8
Bankfull Width:	12.6
Flood Prone Area Elevation:	1202.5
Flood Prone Width:	100.0
Max Depth at Bankfull:	1.2
Low Bank Height:	1.2
Mean Depth at Bankfull:	0.9
W / D Ratio:	14.7
Entrenchment Ratio:	7.9
Bank Height Ratio:	1.0

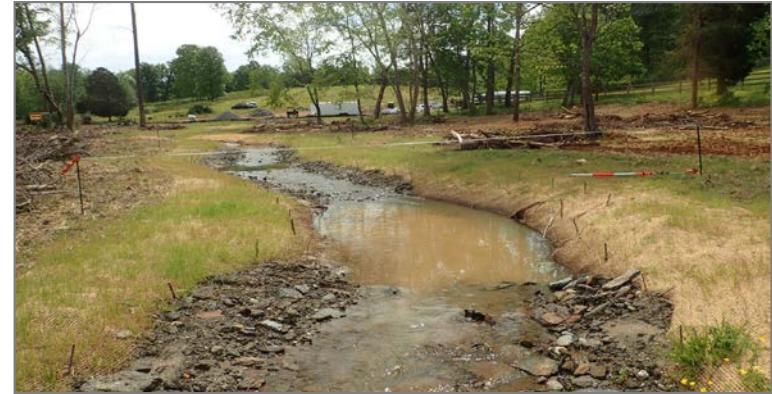
Site	Slingshot Creek
Watershed:	Cape Fear, 03030002
XS ID	Slingshot Creek, XS - 3, Pool
Feature	Pool
Date:	4/28/2020
Field Crew:	Perkinson, Keith

SUMMARY DATA	
Bankfull Elevation:	1204.6
Bankfull Cross-Sectional Area:	22.1
Bankfull Width:	16.1
Flood Prone Area Elevation:	NA
Flood Prone Width:	NA
Max Depth at Bankfull:	2.3
Low Bank Height:	2.3
Mean Depth at Bankfull:	1.4
W / D Ratio:	NA
Entrenchment Ratio:	NA
Bank Height Ratio:	1.0

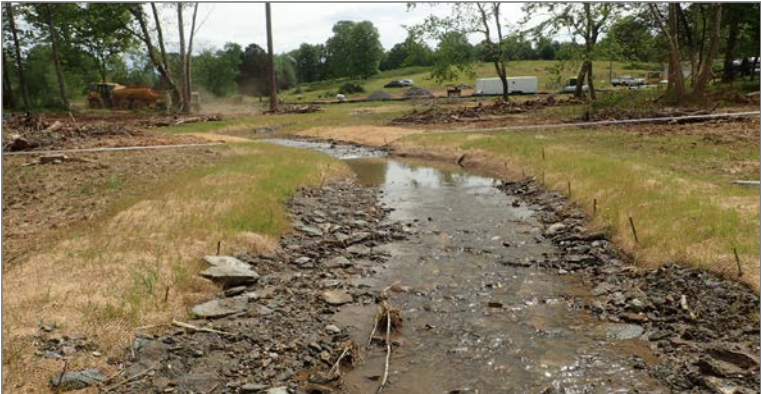
Site	Slingshot Creek
Watershed:	Cape Fear, 03030002
XS ID	Slingshot Creek, XS - 4, Riffle
Feature	Riffle
Date:	4/28/2020
Field Crew:	Perkinson, Keith

SUMMARY DATA	
Bankfull Elevation:	1205.1
Bankfull Cross-Sectional Area:	11.0
Bankfull Width:	12.7
Flood Prone Area Elevation:	1206.3
Flood Prone Width:	100.0
Max Depth at Bankfull:	1.2
Low Bank Height:	1.2
Mean Depth at Bankfull:	0.9
W / D Ratio:	14.7
Entrenchment Ratio:	7.9
Bank Height Ratio:	1.0

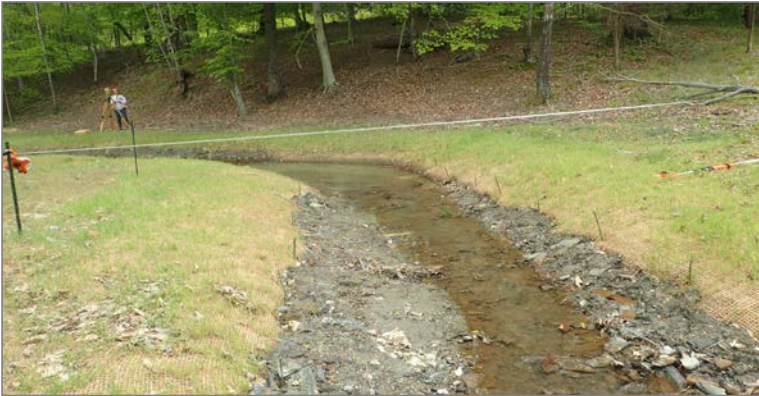
Site	Slingshot Creek
Watershed:	Cape Fear, 03030002
XS ID	Slingshot Creek, XS -5, Riffle
Feature	Riffle
Date:	4/28/2020
Field Crew:	Perkinson, Keith

SUMMARY DATA	
Bankfull Elevation:	1218.4
Bankfull Cross-Sectional Area:	7.4
Bankfull Width:	11.2
Flood Prone Area Elevation:	1219.4
Flood Prone Width:	100.0
Max Depth at Bankfull:	1.0
Low Bank Height:	1.0
Mean Depth at Bankfull:	0.7
W / D Ratio:	16.8
Entrenchment Ratio:	9.0
Bank Height Ratio:	1.0

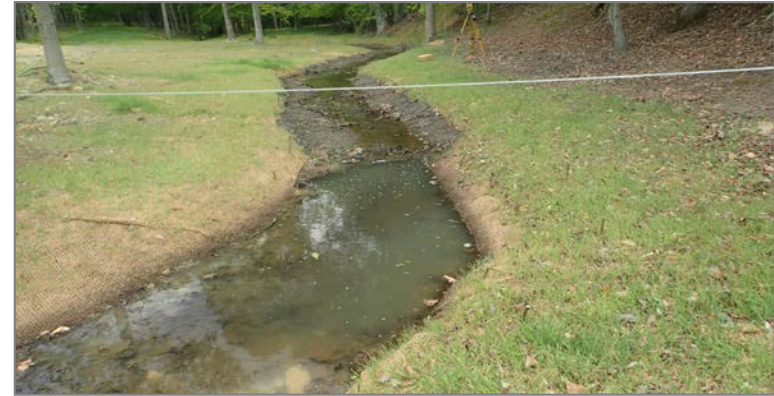
Site	Slingshot Creek
Watershed:	Cape Fear, 03030002
XS ID	Slingshot Creek, XS - 6, Pool
Feature	Pool
Date:	4/28/2020
Field Crew:	Perkinson, Keith

SUMMARY DATA	
Bankfull Elevation:	1218.8
Bankfull Cross-Sectional Area:	14.3
Bankfull Width:	12.1
Flood Prone Area Elevation:	NA
Flood Prone Width:	NA
Max Depth at Bankfull:	1.8
Low Bank Height:	1.8
Mean Depth at Bankfull:	1.2
W / D Ratio:	NA
Entrenchment Ratio:	NA
Bank Height Ratio:	1.0

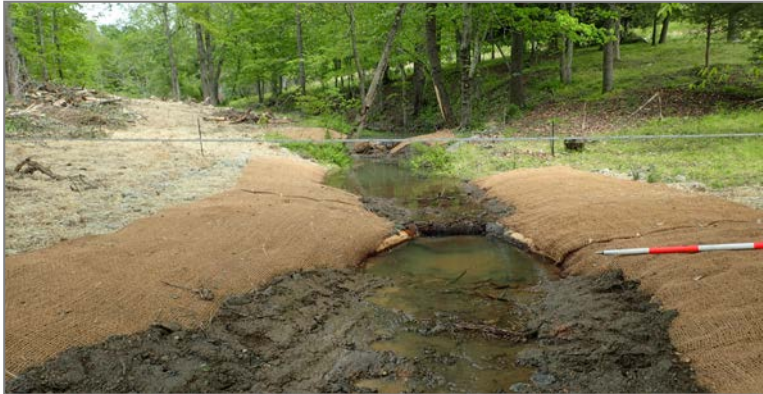
Site	Slingshot Creek
Watershed:	Cape Fear, 03030002
XS ID	Slingshot Creek, XS - 8, Pool
Feature	Pool
Date:	4/28/2020
Field Crew:	Perkinson, Keith

SUMMARY DATA	
Bankfull Elevation:	1224.7
Bankfull Cross-Sectional Area:	16.3
Bankfull Width:	12.4
Flood Prone Area Elevation:	NA
Flood Prone Width:	NA
Max Depth at Bankfull:	2.3
Low Bank Height:	2.3
Mean Depth at Bankfull:	1.3
W / D Ratio:	NA
Entrenchment Ratio:	NA
Bank Height Ratio:	1.0

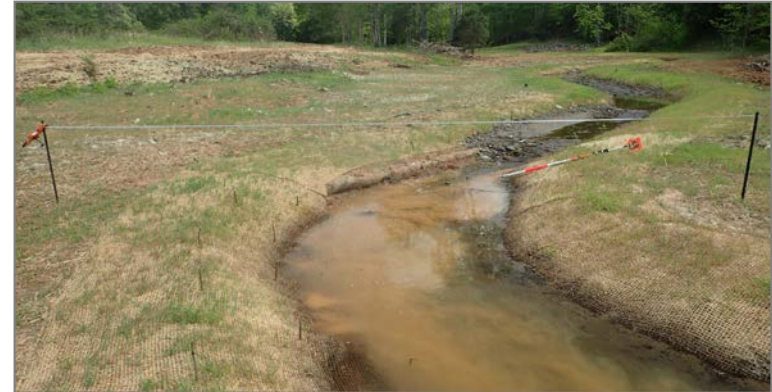
Site	Slingshot Creek
Watershed:	Cape Fear, 03030002
XS ID	UT1, XS - 4, Pool
Feature	Pool
Date:	4/28/2020
Field Crew:	Perkinson, Keith

SUMMARY DATA	
Bankfull Elevation:	1219.6
Bankfull Cross-Sectional Area:	18.1
Bankfull Width:	12.8
Flood Prone Area Elevation:	NA
Flood Prone Width:	NA
Max Depth at Bankfull:	2.4
Low Bank Height:	2.4
Mean Depth at Bankfull:	1.4
W / D Ratio:	NA
Entrenchment Ratio:	NA
Bank Height Ratio:	1.0

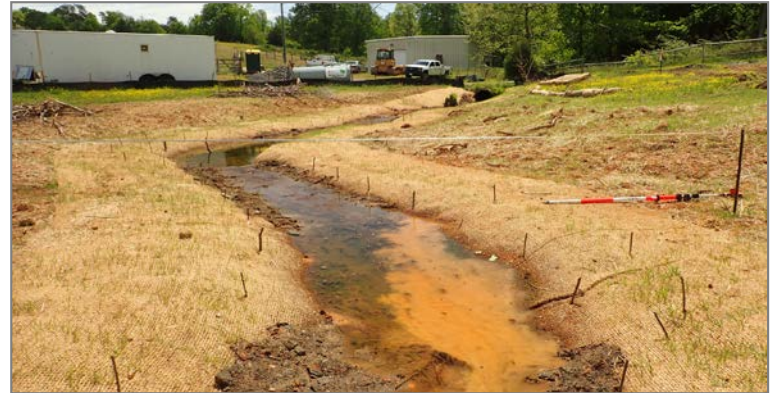
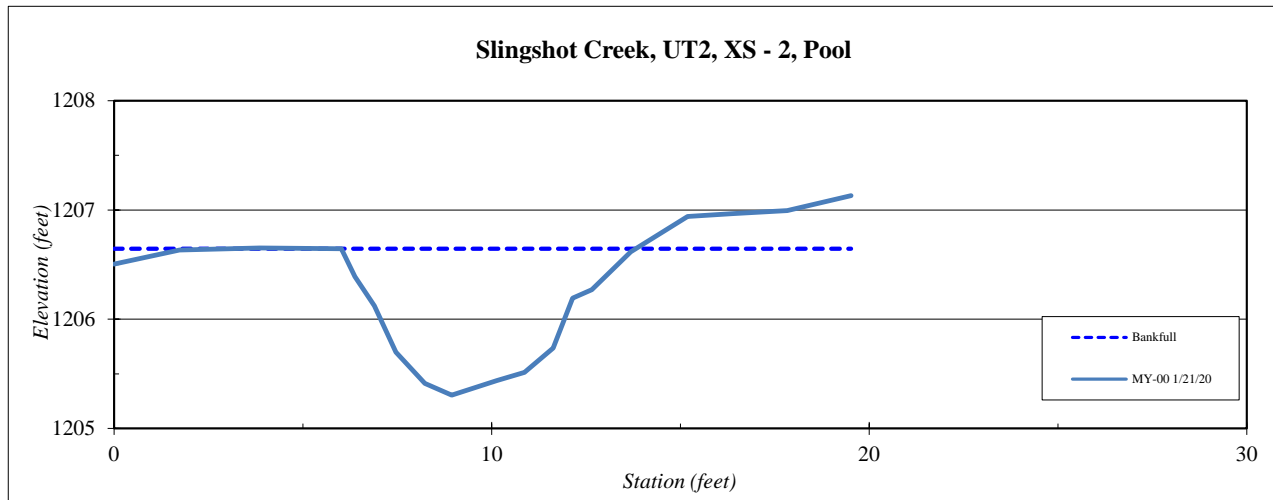
Site	Slingshot Creek
Watershed:	Cape Fear, 03030002
XS ID	UT2, XS - 2, Pool
Feature	Pool
Date:	4/28/2020
Field Crew:	Perkinson, Keith

SUMMARY DATA	
Bankfull Elevation:	1206.6
Bankfull Cross-Sectional Area:	6.3
Bankfull Width:	7.8
Flood Prone Area Elevation:	NA
Flood Prone Width:	NA
Max Depth at Bankfull:	1.3
Low Bank Height:	1.3
Mean Depth at Bankfull:	0.8
W / D Ratio:	NA
Entrenchment Ratio:	NA
Bank Height Ratio:	1.0
