Year 1 Monitoring Report
Bear Swamp Stream & Wetland Mitigation Project

Monitoring Year 1

NCDEQ Contract No. 7516
DMS RFP No. 16-007337
DMS ID No. 100054
USACE Action ID No. SAW-2018-01154
NCDWR ID: 20180782
Lumber River Basin
HUC 03040203

Bear Swamp Stream and Wetland Mitigation Project
Year 1 Monitoring Report
DMS Project ID #100054
Robeson County, North Carolina

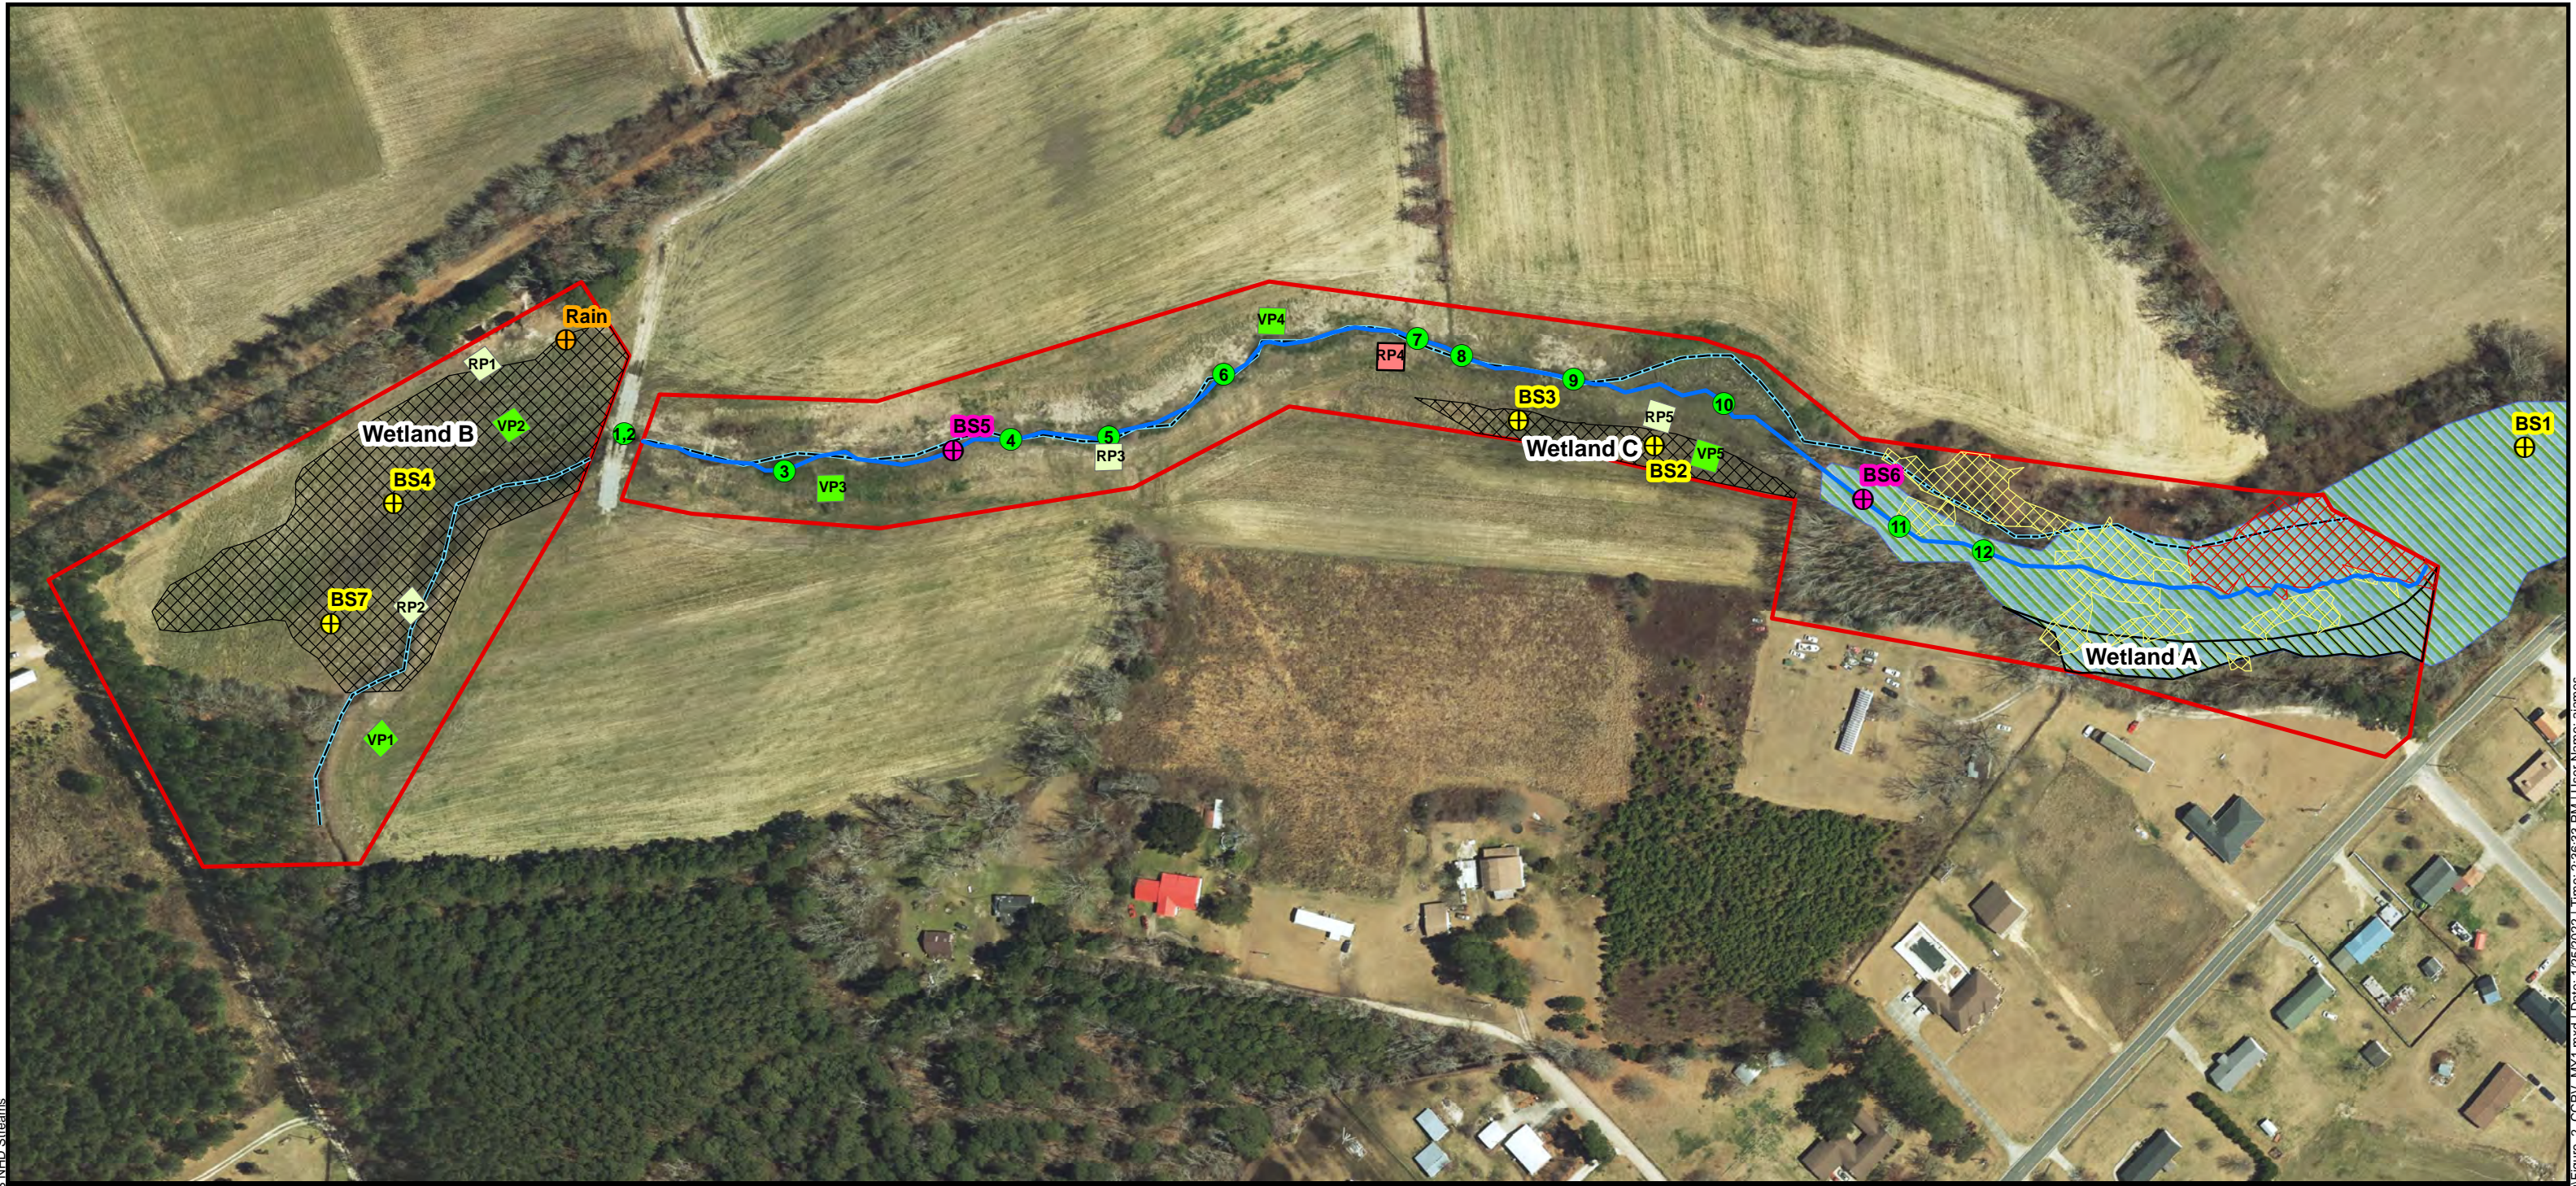
CURRENT CONDITION PLAN VIEW: ASSET MAP

Because this project utilizes valley restoration, a full longitudinal profile was not required per the mitigation plan. A small pilot channel was dug along the low point of the valley during construction to route flow; the thalweg of this channel is shown on the CCPV (Figure 2). No significant movement of this channel was noted during MY1.

- **CCPV Maps:** *The maximum species concentration is 50%. Please show any vegetation plots that exceed this criteria on the CCPV Map.*
 - **The vegetation plot exceeding the 50% maximum species concentration has been indicated on the CCPV.**

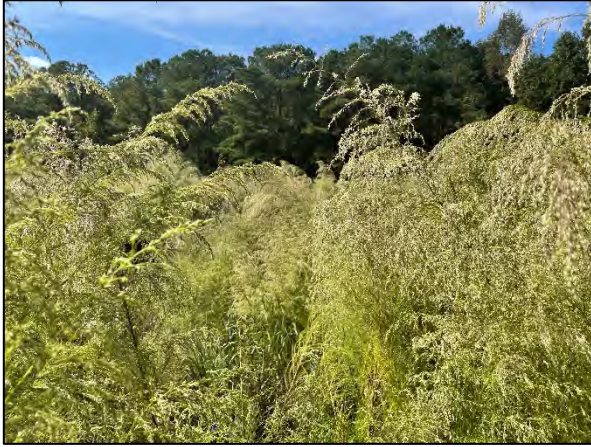
Veg Plot 1 F – East Corner (10/13/2021)

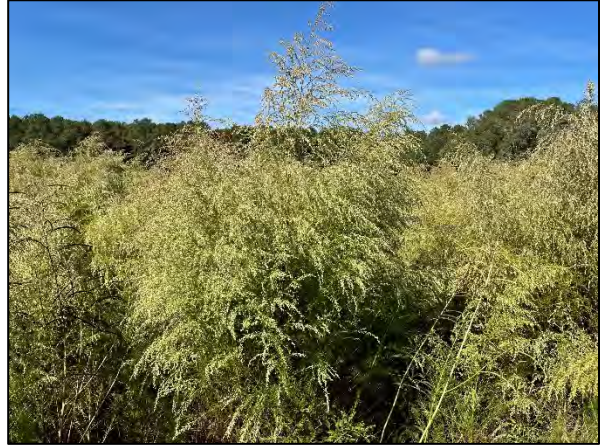
Veg Plot 2 F – East Corner (10/13/2021)

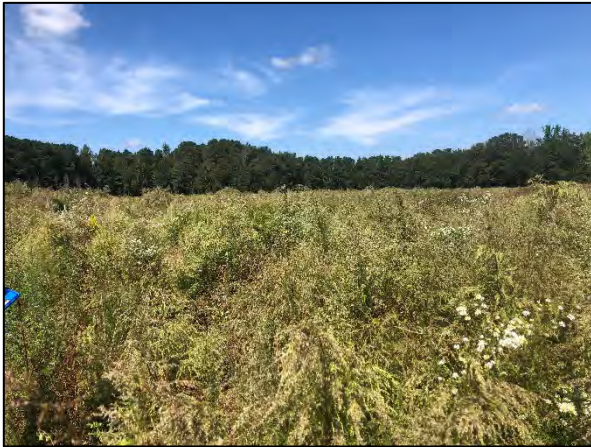
Veg Plot 3 F – SE Corner (10/13/2021)

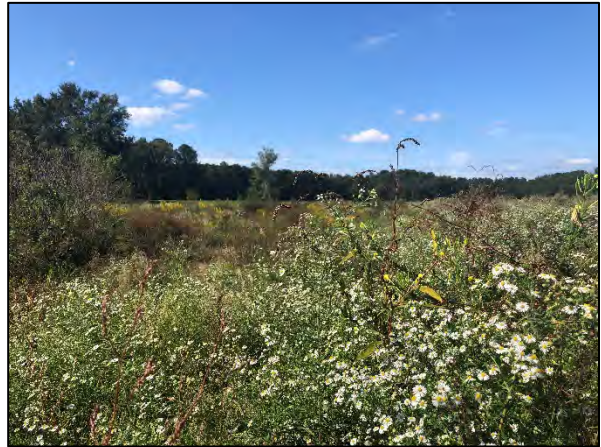
Veg Plot 4 F – SE Corner (10/13/2021)

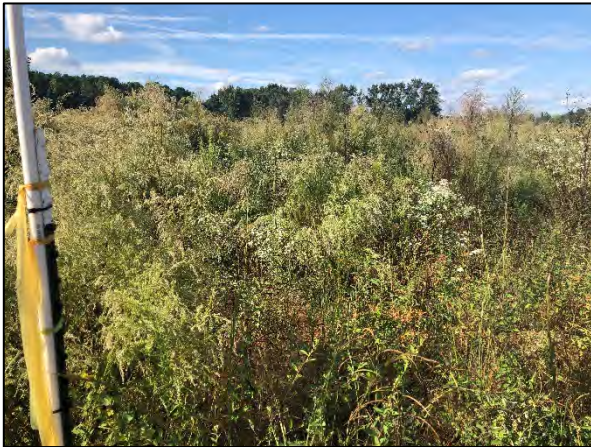
Veg Plot 5 F – SE Corner (10/13/2021)

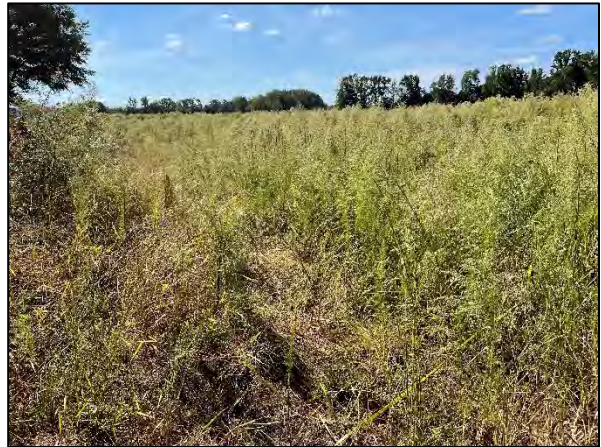
Veg Plot 1 R – NW Corner (2021)

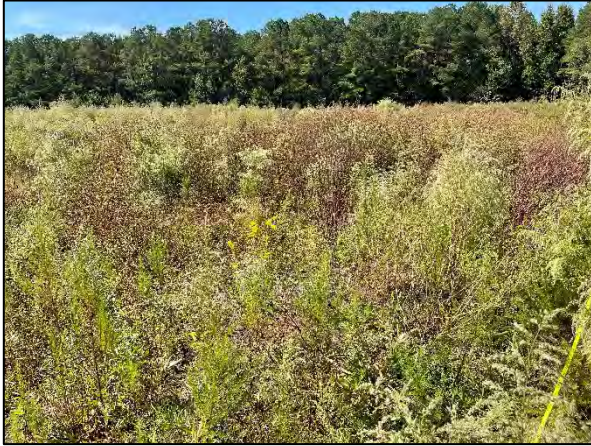
Veg Plot 2 R – NE Corner (10/13/2021)

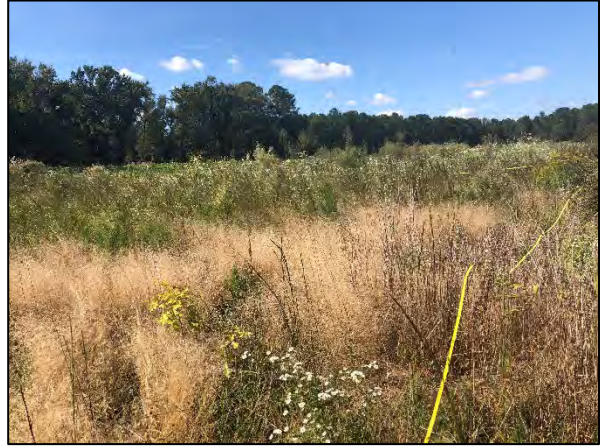
Veg Plot 3 R – SE Corner (10/13/2021)

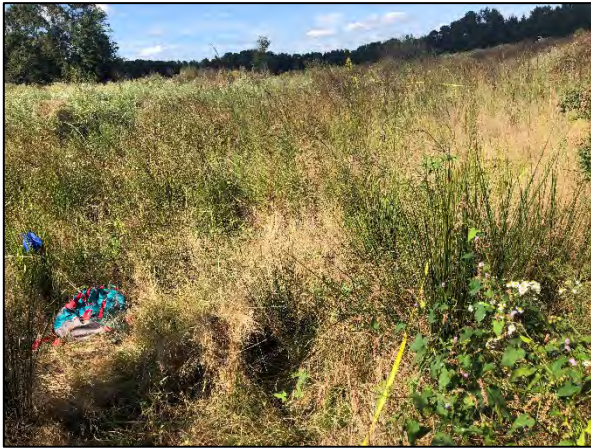
Veg Plot 4 R – SE Corner (10/13/2021)

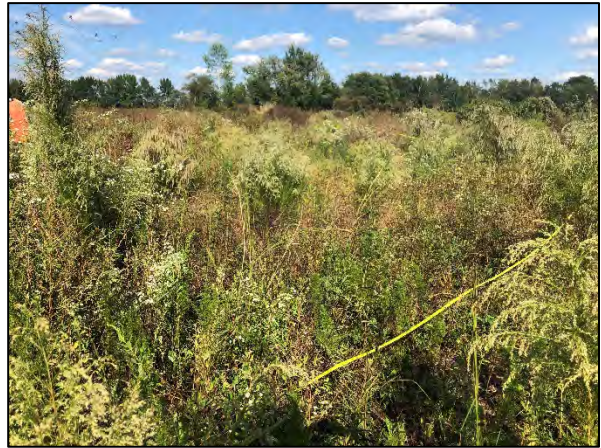
Veg Plot 5 R – SW Corner (10/13/2021)

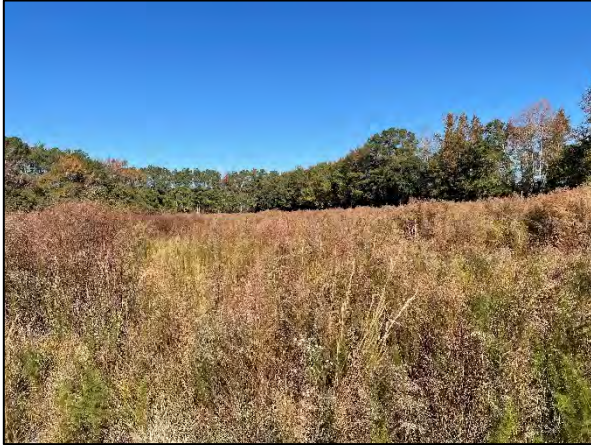
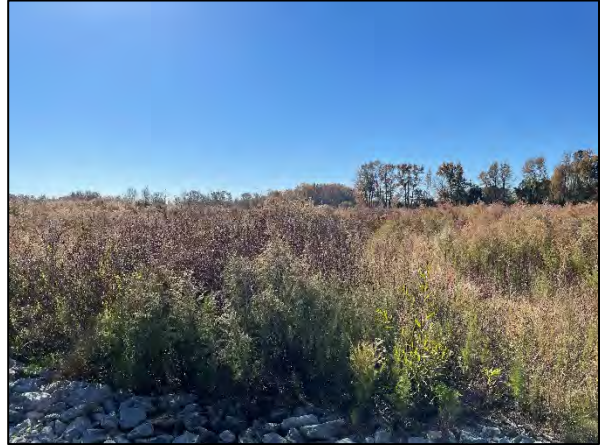
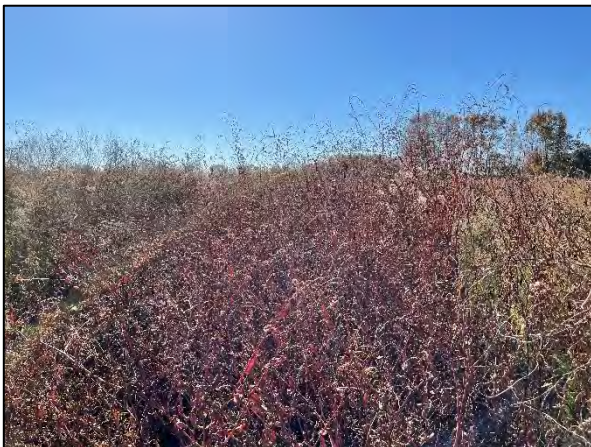
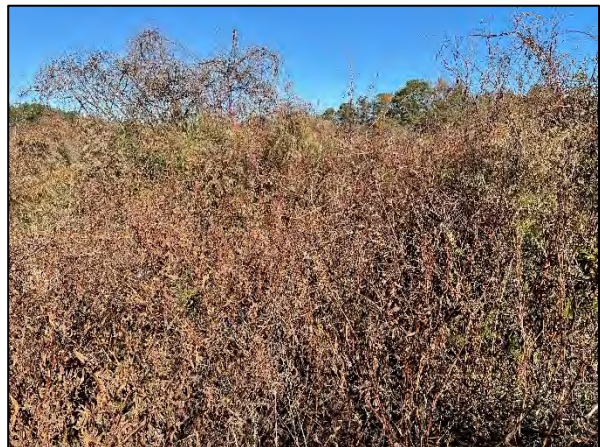
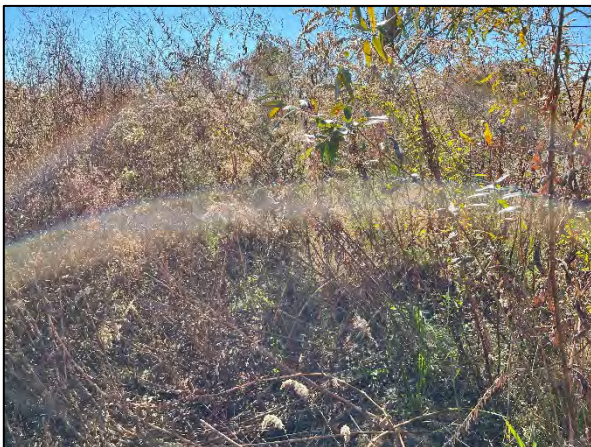
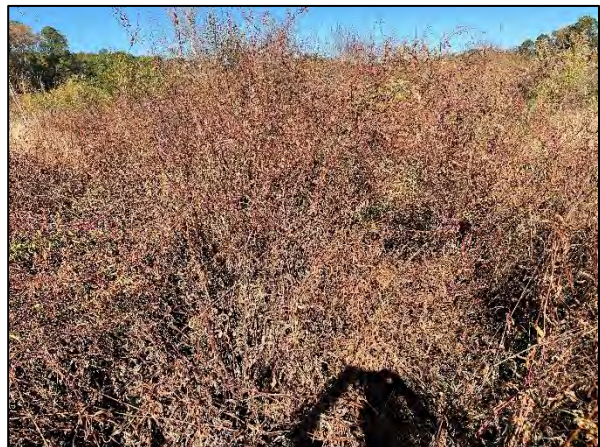
Stream photo points and visual assessments indicate that the restored channel and in-stream structures are in good condition and performing as intended. Along much of the alignment outside the forested area, the channel is full of hydrophytic vegetation (e.g., *Persicaria* spp.) and the riparian area is also densely vegetated. This vegetation, as well as the low energy nature of the system, likely prevents instability in the channel and adjacent riparian area.

Photo Point 1 – Sta. 10+00
Facing Upstream Towards Wetland B (11/17/2021)

Photo Point 2 – Sta. 10+00
Facing Downstream (11/17/2021)

Photo Point 3 – Sta. 11+75
Facing Downstream (11/17/2021)

Photo Point 4 – Sta. 14+60
Facing Upstream (11/17/2021)

Photo Point 5 – Sta. 15+90
Facing Downstream (11/17/2021)

Photo Point 6 – Sta. 17+45
Facing Upstream (11/17/2021)

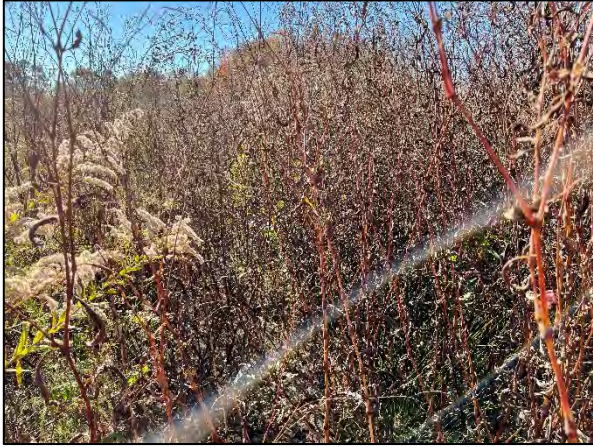
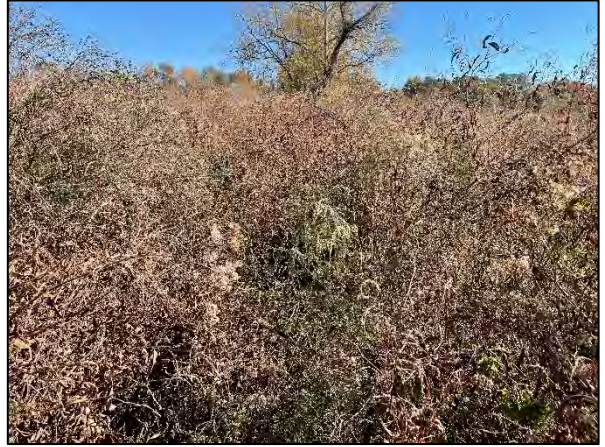
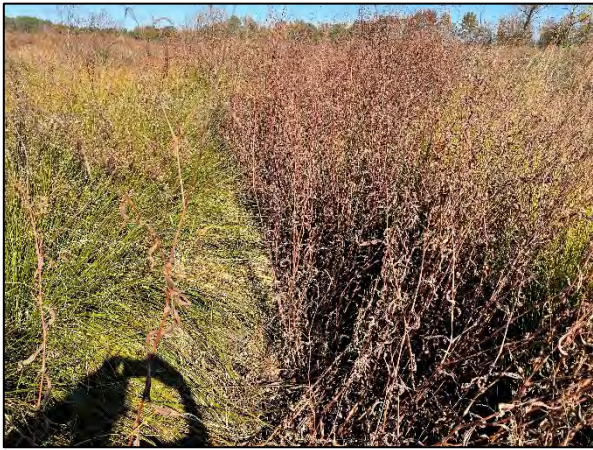
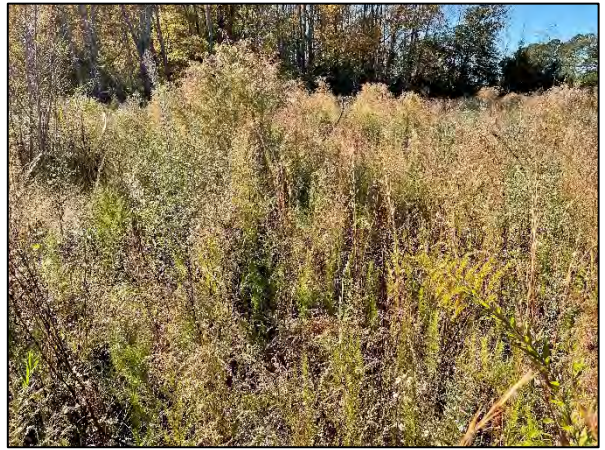
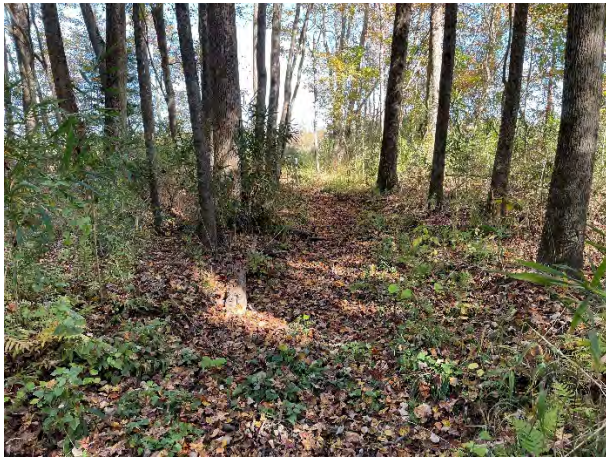
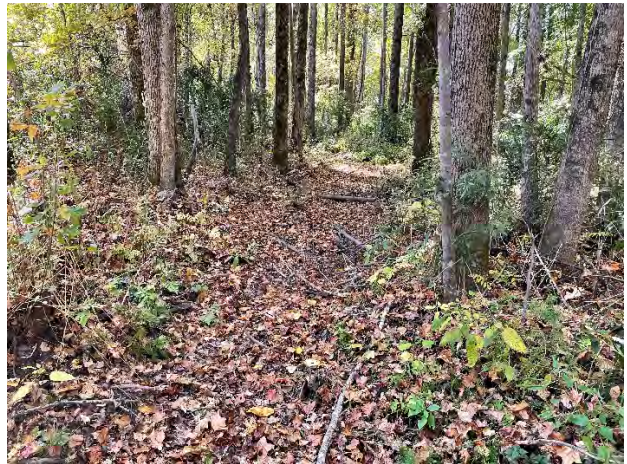
Photo Point 7 – Sta. 20+00
Facing Downstream (11/17/2021)

Photo Point 8 – Sta. 20+50
Looking Upstream at Ditch from Stream (11/17/2021)

Photo Point 9 – Sta. 21+90
Facing Upstream (11/17/2021)

Photo Point 10 – UT1 Reach 3, Sta. 23+80
Facing Downstream (11/17/2021)

Photo Point 11 – Sta. 26+50
Facing Upstream, Towards BS6 (11/17/2021)

Photo Point 12 – Sta. 27+50
Facing Downstream (11/17/2021)

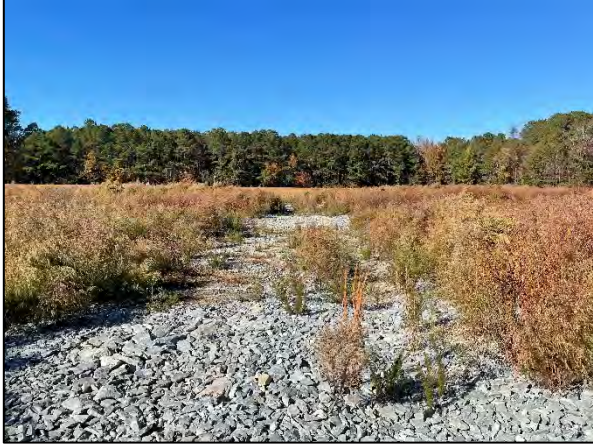
Permanent Ford Crossing
Facing West (11/17/2021)

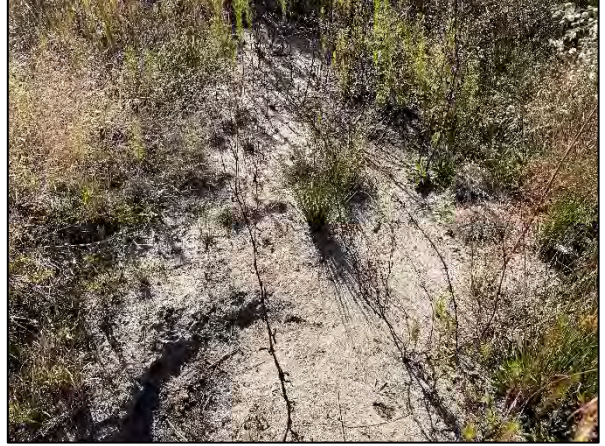
Headwater stream (or valley) restoration requires that evidence of channel formation be documented during each monitoring year. Applicable field indicators of channel formation are found in RGL 05-05 and outlined in the 2016 USACE Guidance; these indicators change based on monitoring year. The main indicators of channel formation for Monitoring Year 1 documented on the site include sediment deposition and matted vegetation. Representative photos of these indicators are found in the photolog in Appendix A.

Evidence of channel formation: sediment deposition in
channel (11/17/2021)

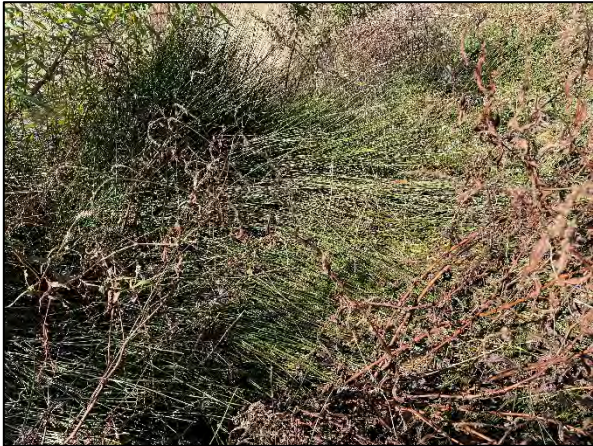
Evidence of channel formation: bent vegetation along
channel (11/17/2021)

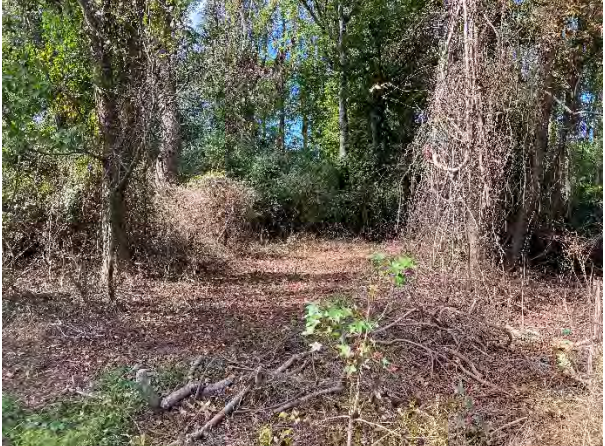
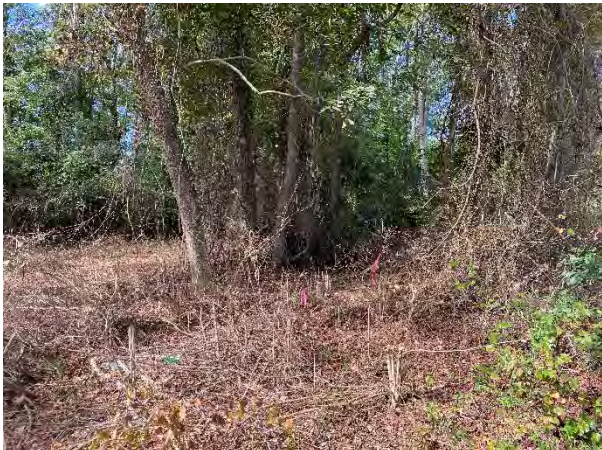
Chinese privet (*Ligustrum sinense*) was the most common non-native invasive species found within the forested section of the easement. Several other non-native invasive species were identified along the field edge of the forested section, including Japanese privet (*Ligustrum japonicum*) and Chinaberry

Areas of Chinese privet treated with herbicide
(10/21/2021)

- There are still untreated areas of Chinese privet (*Ligustrum sinense*) in the forested section of the easement, though less than half of what was present remains. EPR is prioritizing planting of already treated areas (0.85 acre) in February 2022 with woody species from the Mitigation Plan but will continue to treat the remaining privet areas in the spring, early summer, and fall of 2022. By the end of MY2, all invasive areas will be treated.

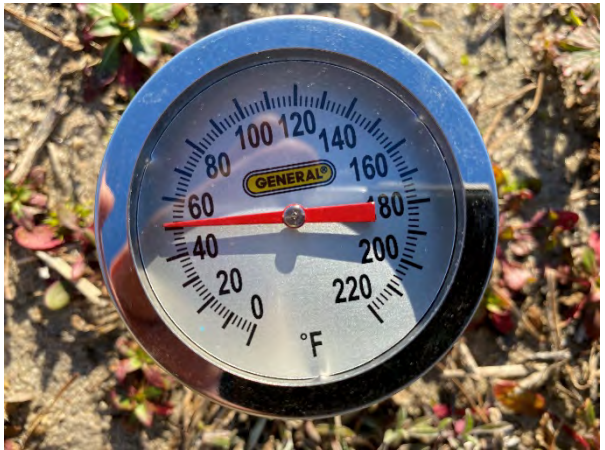
Soil temperature reading at 20 inches on 2/24/2021

- **Per the Final Mitigation Plan, the beginning of the growing season “will be confirmed annually by soil temperatures exceeding 41 degrees Fahrenheit at 20 inches (50cm) depth, which will be corroborated with observations of bud burst. Soil temperatures will be collected in early March of each monitoring year and will be reported in the annual monitoring report.” There is no confirmation requirement given for the end of the growing season. Photos of soil temperature and bud burst are provided in the photolog for the beginning of the growing season.**

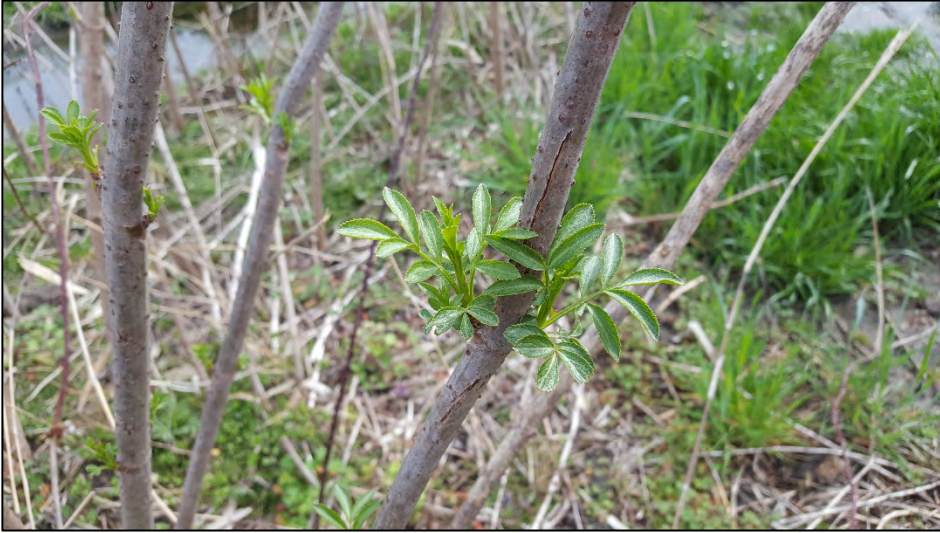
Bud burst observed 3/2/2021

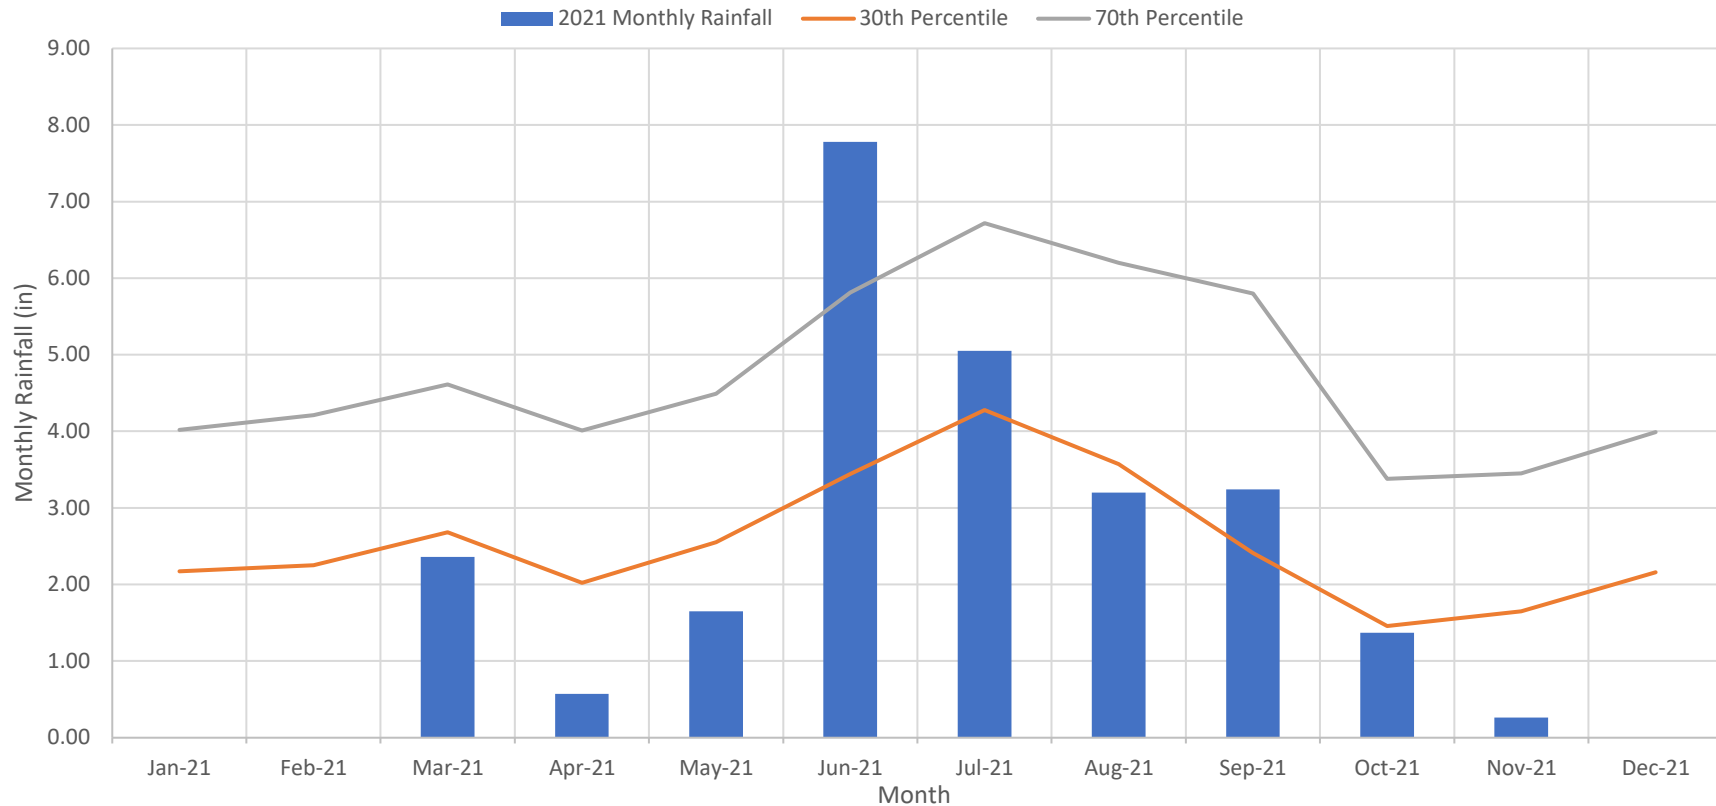
Bear Swamp Stream and Wetland Mitigation Project
Figure 3. Monthly Rainfall Data
Monitoring Year 1 - 2021

Monthly rainfall totals over the growing season are shown on Figure 3 (Appendix C), including an overlay of WETS-derived 30th and 70th percentile monthly rain totals. Rainfall was below the 30th percentile for six months of the growing season, leading to very dry conditions. Approximately ten (10) weeks were categorized as ‘moderate drought’ in this area of Robeson County by the NC drought monitor² (mainly in late April, May, and early to mid-November).

Note: Historic rainfall data from WETS Station: Lumberton, NC, 1971-2019. Project rainfall data from HOBO Tipping Bucket Rain Gauge located on-site, except for 10/10-11/17 when data from NC State Climate Office (Station ID WCON7 in Lumberton) was used as an estimate due to Rain Gauge data collection failure.

*Note: Bear Swamp rain gage data banks were full so no rain data was collected from 10/10-11/17. See note for data between this time period.

- **2.1.4 Stream Hydrology:** *Rain gauge data are required per the approved mitigation plan. Data collection ceased after October 10th due to the gauge memory being full. Please revise the field methodology or equipment to prevent loss of data during MY2.*

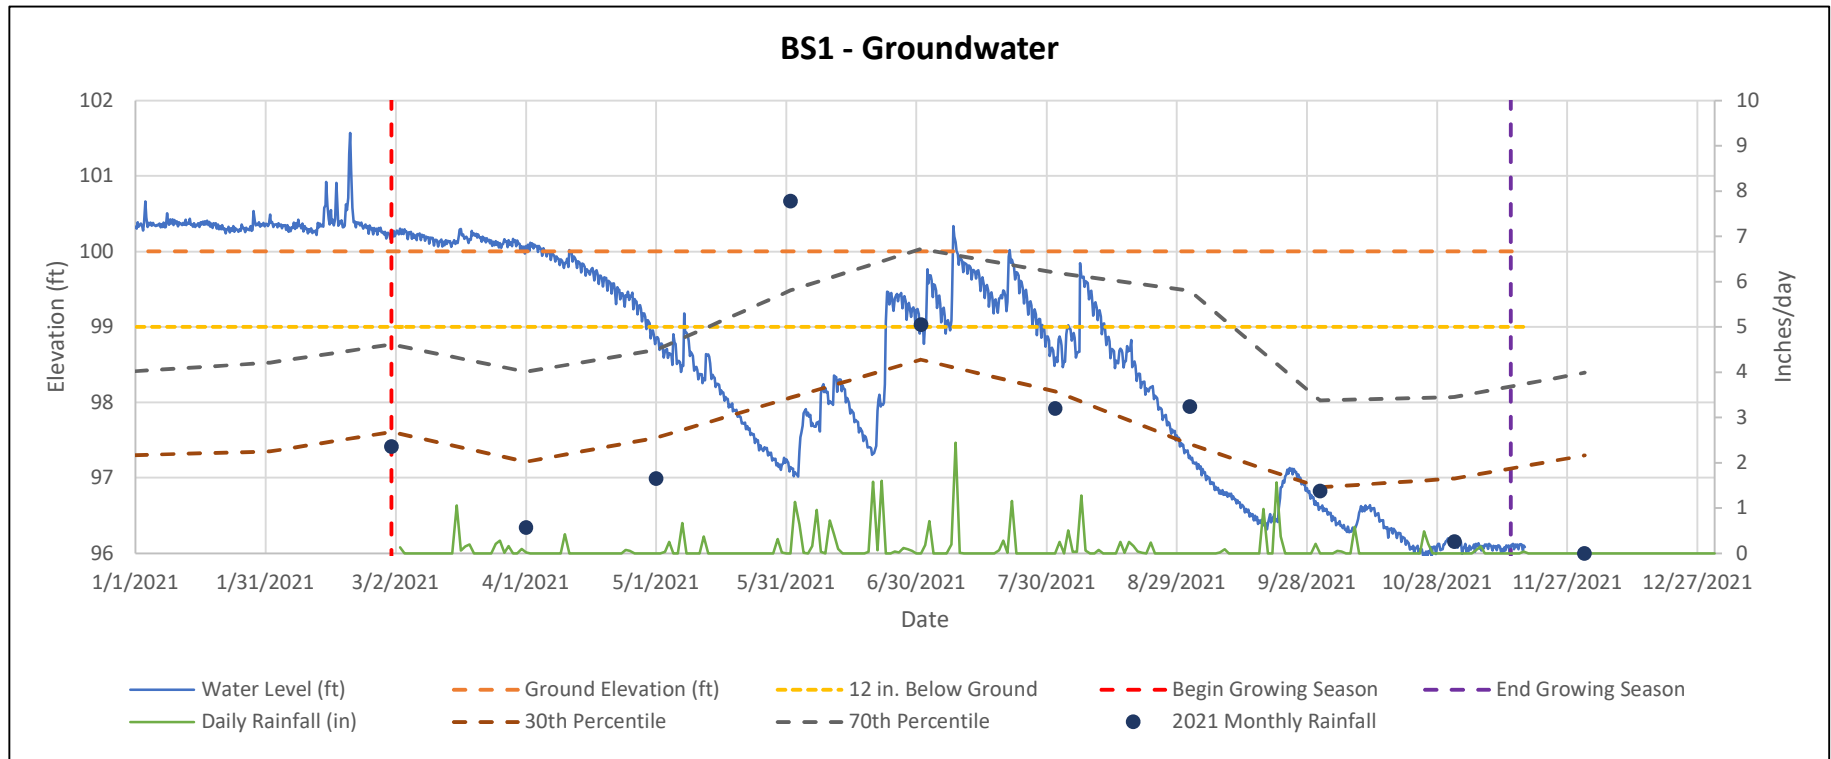
Bear Swamp Year 1 (2021) Groundwater Data

| Growing Season Information (Year 1 - 2021) | | |
|--|---|---|
| Total Cumulative Successful Days Within Growing Season | | 106 |

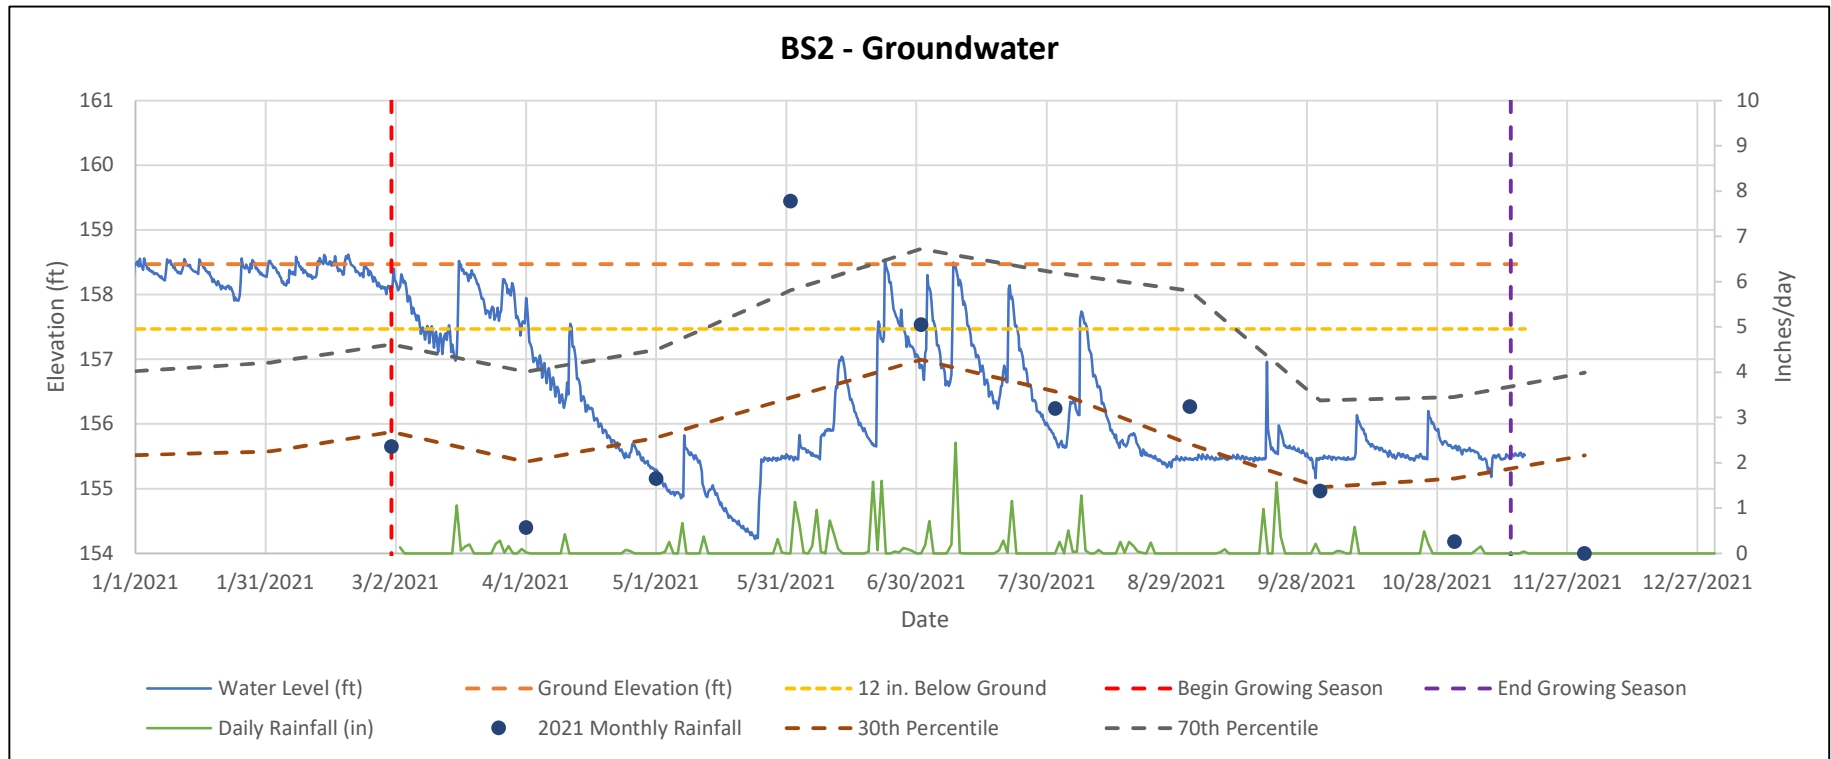
Bear Swamp Year 1 (2021) Groundwater Data

| Growing Season Information (Year 1 - 2021) | | |
|--|---|---|
| Total Cumulative Successful Days Within Growing Season | | 47 |

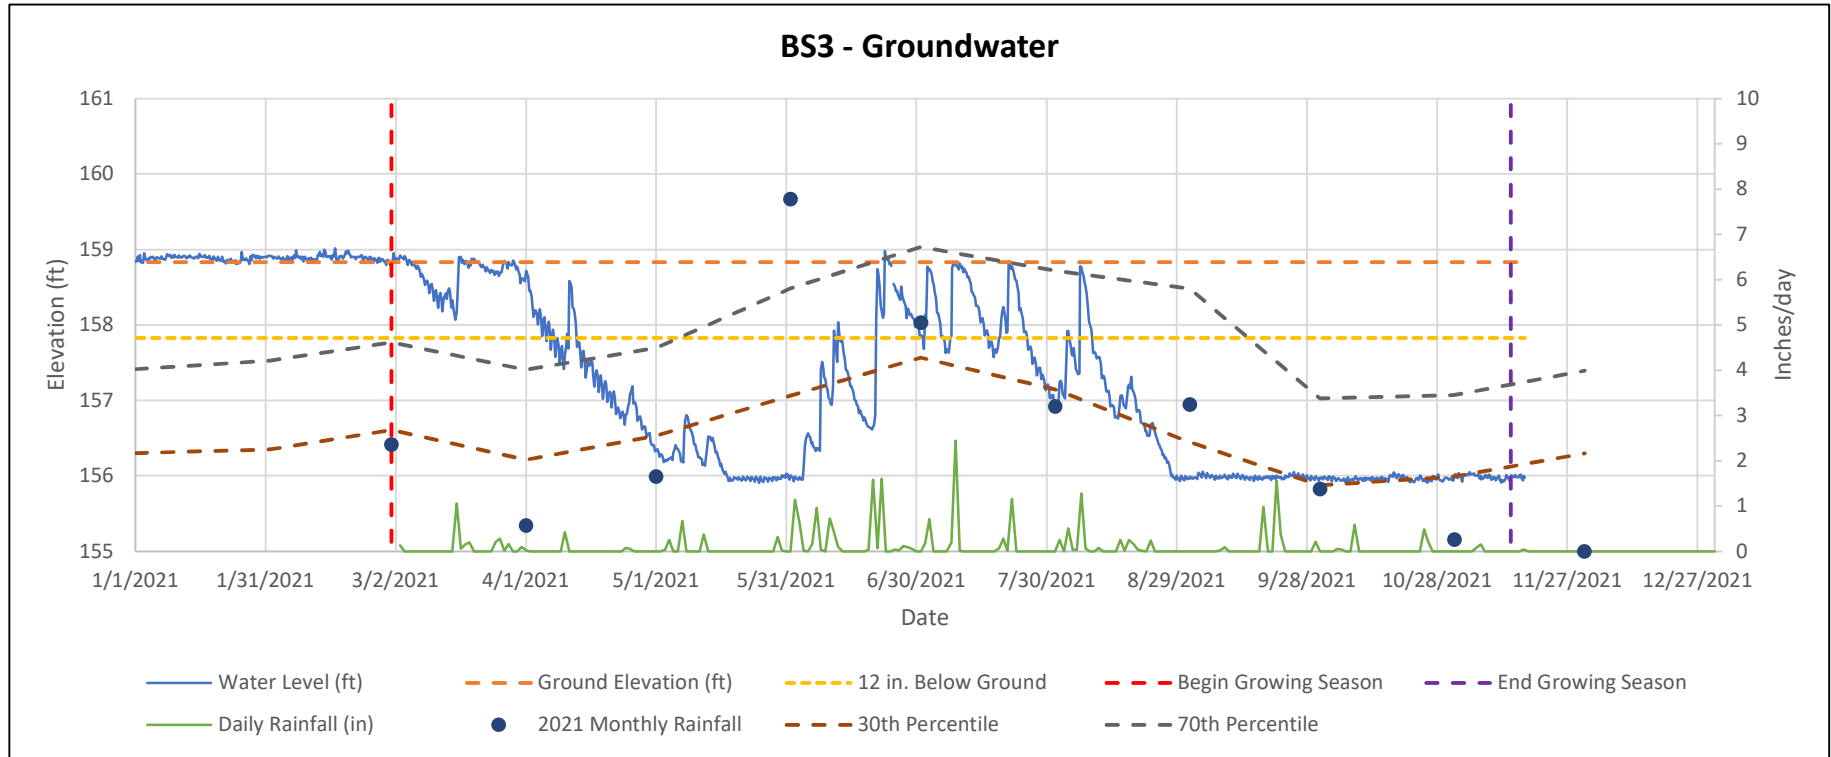
Bear Swamp Year 1 (2021) Groundwater Data

| Growing Season Information (Year 1 - 2021) | | |
|--|---|---|
| Total Cumulative Successful Days Within Growing Season | | 83 |

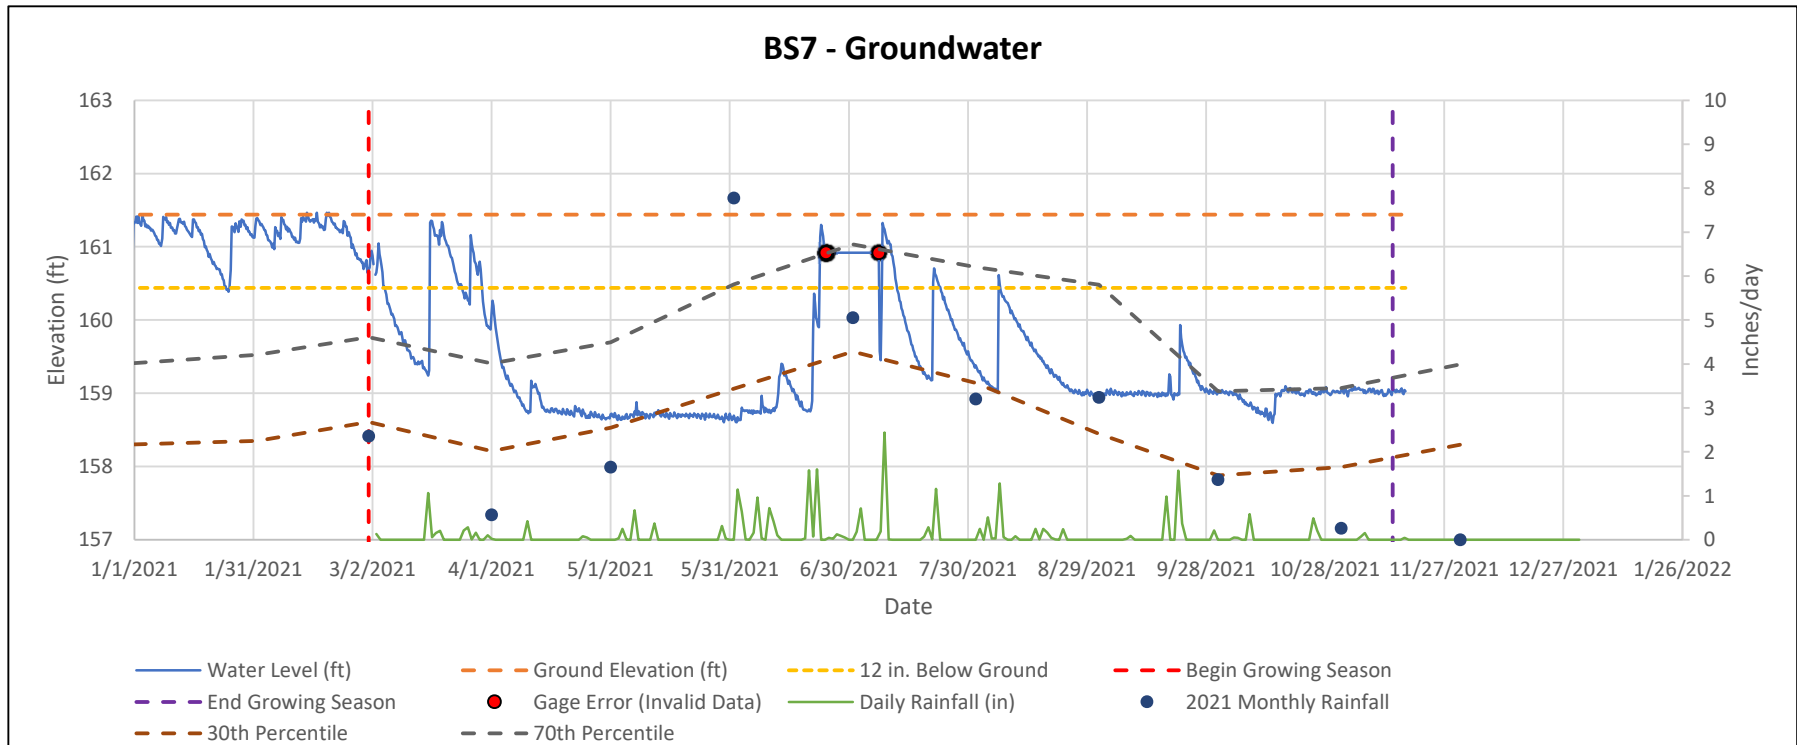
Bear Swamp Year 1 (2021) Groundwater Data

based on the data from BS4 and rainfall during this period, it is likely that the water table would have been above 12 inches for much of this time. The elevation of the well was adjusted and a new bentonite seal at the new elevation was installed on July 7 to fix this issue.

-Rainfall data from HOBO Tipping Bucket Rain Gauge located at the Bear Swamp Stream and Wetland Mitigation Project except for 10/10-11/17 where data from NC State Climate Office was used.
 -Percentile lines in reference to WETS historic monthly Rainfall data for Lumberton, NC
 -Well screen potentially exposed between 6/24 and 7/7; therefore, number of successful days within growing season may be over-estimated

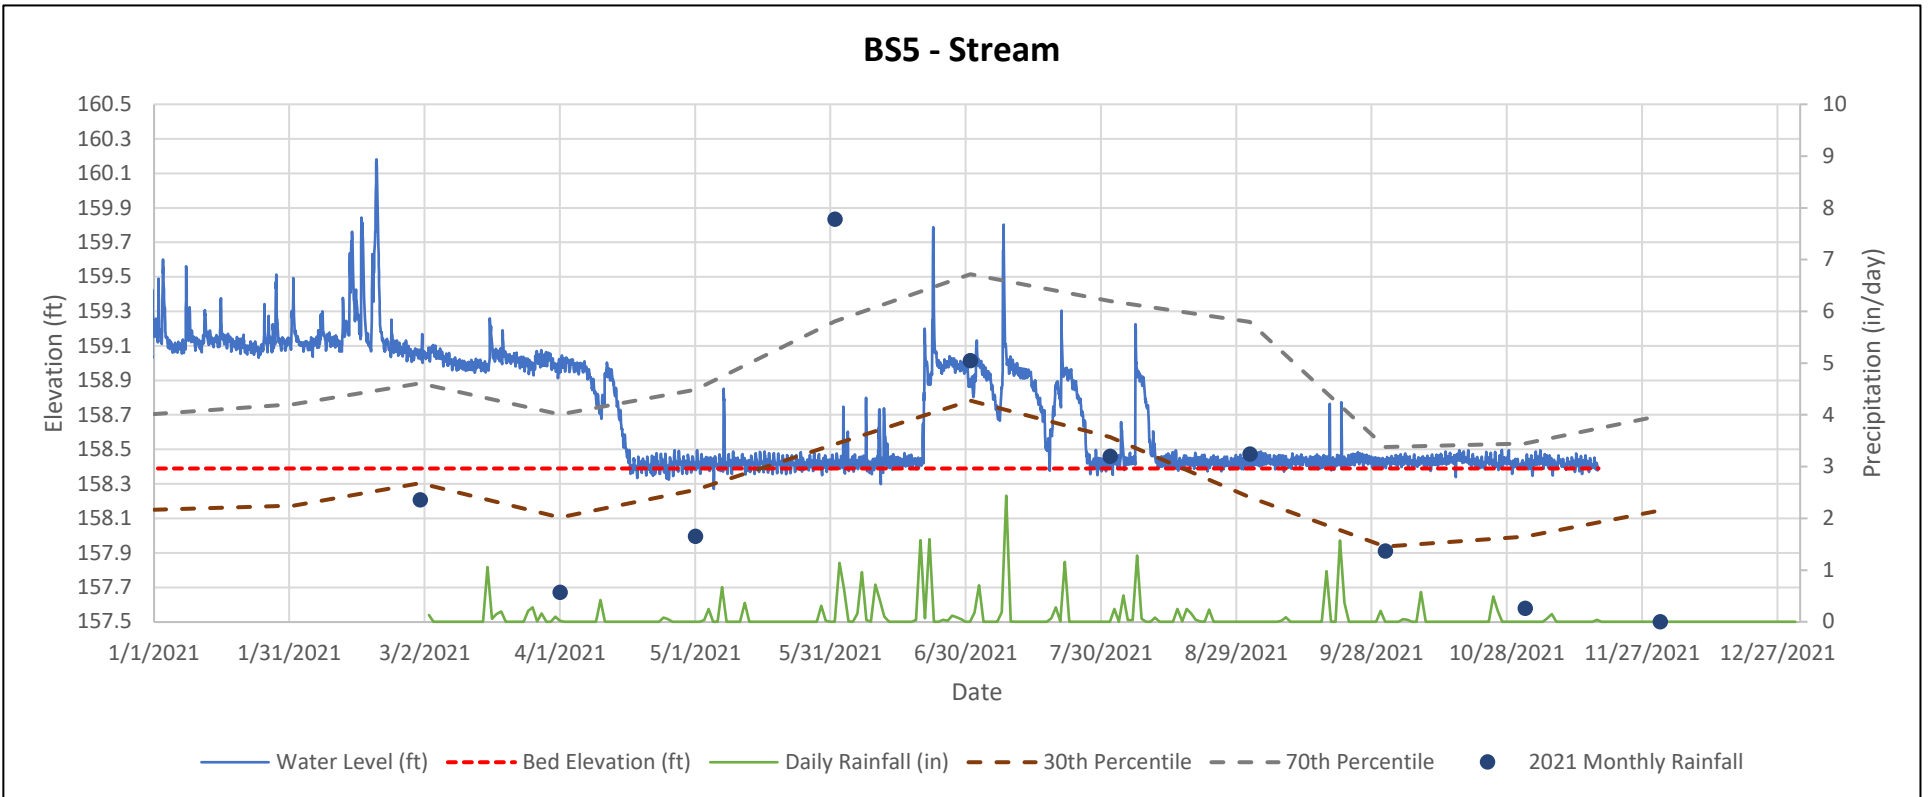
Bear Swamp Year 1 (2021) Streamflow Data

| Goal | Objective/Treatment | Likely Functional Uplift | Performance Criteria | Measurements | Cumulative Monitoring Results |
|--|--|--|--|---|--|
| Repair channelized streams | <ul style="list-style-type: none"> Restore appropriate bed form diversity, headwater stream/wetland form, and install in-stream structures to provide appropriate habitat. Restore self-sustaining stream/wetland headwaters | <ul style="list-style-type: none"> Functional uplift will be achieved by reducing the impact of adjacent agriculture and restoring natural riparian vegetation, appropriate stream form, and adjacent headwater wetlands. | <ul style="list-style-type: none"> Continuous surface flow within the valley or creculation must be documented each year for at least 30 consecutive days. | <p><u>Stream Hydrology Monitoring</u></p> <p>2 pressure transducers and a rain gauge will record precipitation and streamflow data continuously through the monitoring period.</p> | <p>Flow gauge data from MY1 indicate that the project stream met the established success criteria of 30 days or more of consecutive flow throughout the year.</p> |
