# FINAL MITIGATION PLAN

## CRANE MITIGATION SITE

Lee County, North Carolina

DMS Project ID No. 100165

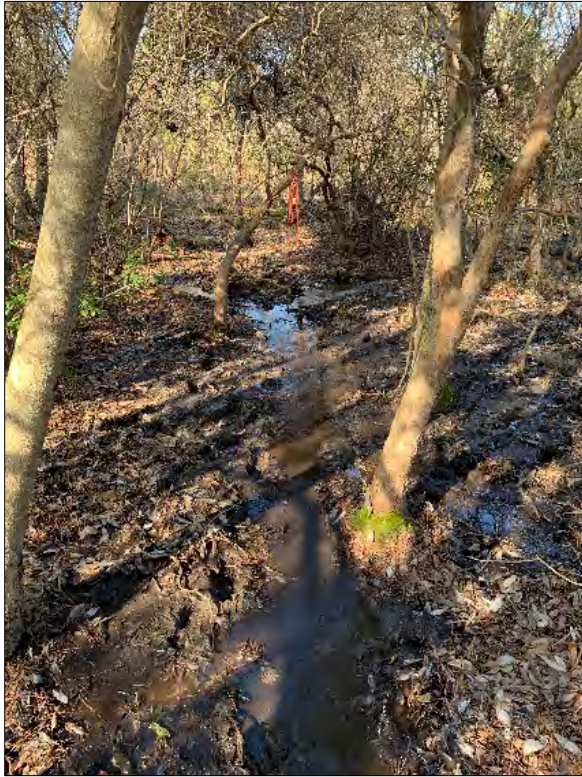
UT 1 – The main receiving stream within the Site begins just offsite as a braided, headwater system that meanders through a recent cutover. At one time, the stream was ditched and moved to the edge of the floodplain. Disturbance (likely from timber activities) has resulted in the ditch filling and hydrology braiding through the cutover headwater reach. This area is underlain by soils of the Johnston series, which are typically found in floodplains and swamps of the Coastal Plain. Johnston soils are characterized by a high concentration of organic matter from extensive wetness and a lack of organic matter oxidation. Before timber harvest, this portion of the Site was likely characterized as a Sandhills streamhead swamp

or Coastal Plain small stream swamp. However, the area has been timbered and all that remains are a few saplings of red maple (*Acer rubrum*), water oak (*Quercus nigra*), pond pine (*Pinus palustris*), American holly (*Ilex opaca*), titi (*Cyrilla racemiflora*) with herbaceous vegetation including sedges (*Carex* sp.), rushes (*Juncus effusus*), and broom sedge (*Andropogon gerardii*).

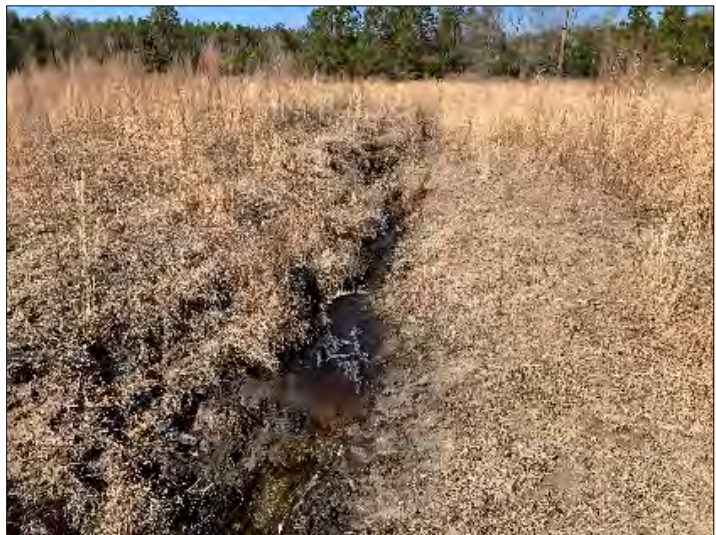
UT 1 substrate is predominantly sand. The lower reaches are devoid of woody vegetation on both banks throughout the Site. Vegetation is predominantly pasture grass, including fescue (*Festuca* sp.) and coastal Bermuda (*Cynodon* sp.). Fields are not regularly maintained, and a significant amount of opportunistic species have colonized, including broom sedge, dog fennel (*Eupatorium capillifolium*), rough cocklebur (*Xanthium strumarium*), pigweed (*Amaranthus hybridus*), and other species common to overgrazed areas. Several seepage areas and mires exist and are primarily composed of rushes, sedges, and smartweed (*Polygonum* spp).

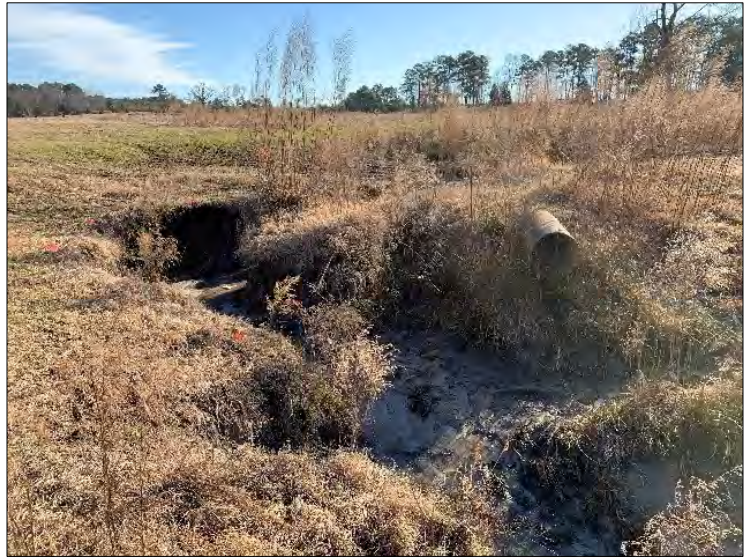
UT 2 – Upstream from the Site, the tributary extends to and along Rocky Fork Church Rd. The channel originates near the road and coalesces into a swampy area partially impounded by an agriculture crossing at the Site boundary. As the stream enters the Site, a headcut has incised the channel to approximately 4.4 feet. Headcut migration has been hindered by the agriculture crossing. Once into the Site, it is difficult to discern if the channel was excavated or incised to a point that sinuosity was lost. As UT 2 continues downstream, it shallows until it enters the delta-like setting, similar to UT 1.

UT 2 is mapped by the NRCS as Wehadkee, which occurs on floodplains and streams. Similar to UT 1, the channel is characterized by pasture. As the channel reaches the delta-like formation, more trees begin to occur, primarily red maple. These trees are frequently inundated and are buttressing from exposure to standing water. Livestock has access to the entirety of the reach, and farm debris commonly occurs in and around the channel. Channel substrate is predominantly sand.

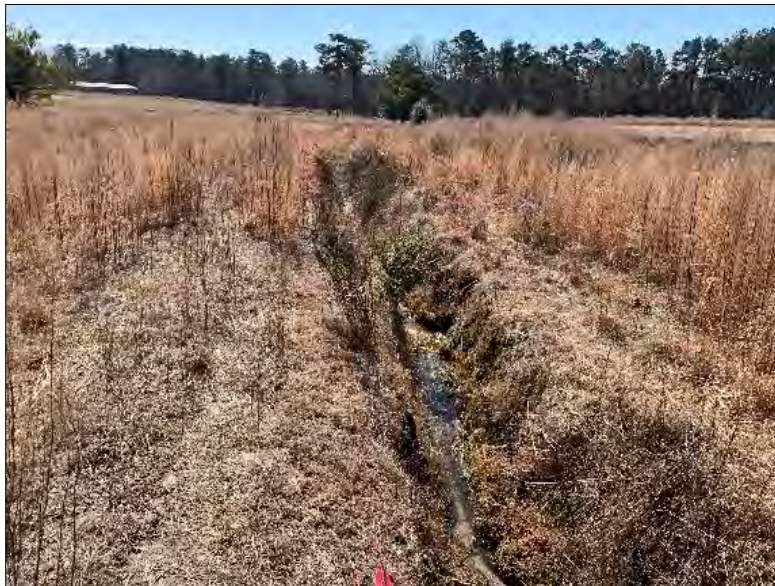
UT 3 – Originates within the Site at a springhead seep. The entire reach of UT 3 has been ditched and straightened and ranges in depth from 4.3 feet in the upper reaches to 1.4 feet in the lower reaches before converging with UT 1. UT 3 has been directed around its historic floodplain to direct drainage quickly through the Site. Currently, the low floodplain occurs adjacent to the existing channel and is characterized by thick *Juncus* mats and ponded conditions.

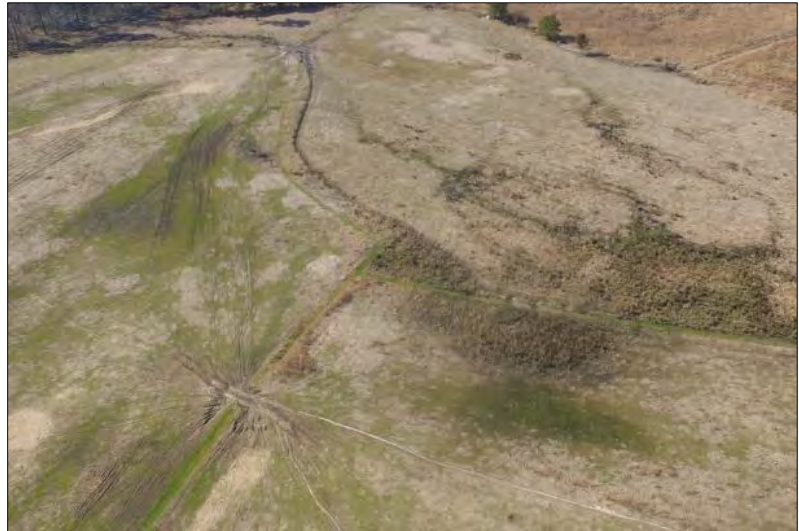
UT 4 – Originates offsite as a ditch draining seepages and ponded pockets of rushes. The ditch traverses pasture, enters the Site, and becomes a jurisdictional stream (based on an approved PJD) above an existing agricultural crossing. Livestock access the stream and have wallowed out the stream channel upstream of the crossing to form a shallow pool that is teeming with fish and tadpoles. UT 4 crosses through a failing pipe and continues as a ditched stream for a short distance (373 ft) before converging with UT 1. Although the channel is not extensively incised, the bank-height-ratios range from 1.1 to 1.6.

As with other Site tributaries, UT 4 is underlain by Wehadkee soils that have been cleared and are impacted by livestock. The channel substrate is sand.

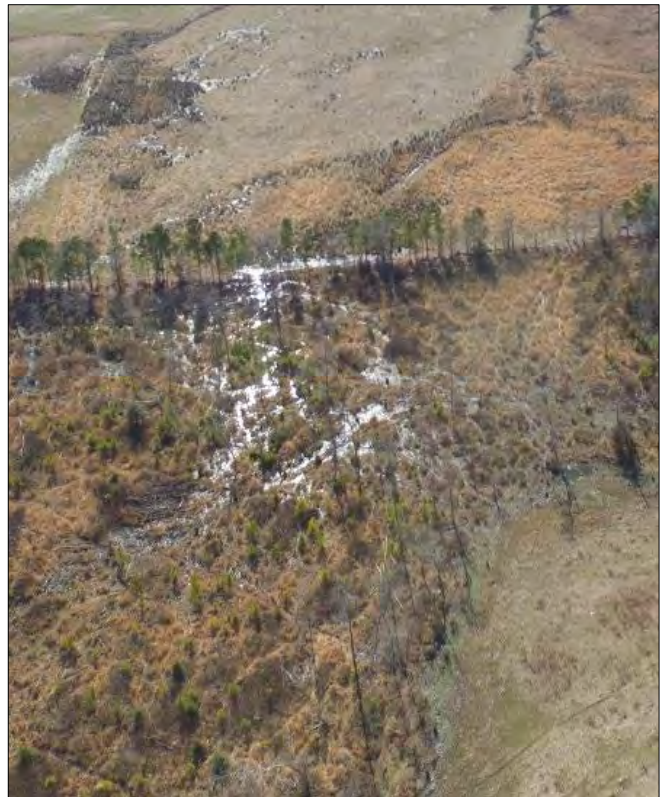
UT 5 – Despite UT 5 having a large drainage area (47 acres), the channel doesn't develop a jurisdictional channel until low in the alluvial valley, approximately 320 feet from its convergence with UT 1. The channel is 3 to 4 feet in depth and erodes laterally from incision due to a lack of deep-rooted vegetation and livestock trampling. The topographic crenulation for UT 5 extends upstream to a pond. The pond discharges into the timbered headwaters and flows overground into the pasture. Ultimately a knickpoint in the pasture serves as the origination point for UT 5. At this point, UT 5 is characterized by pasture grasses with pockets of rushes and sedges.

UT 5 is mapped by the NRCS as Wehadkee soils all the way to the pond. Aerial photography collected by a licensed drone pilot indicates that surface hydrology extends up the valley for a significant distance. This reach was likely a braided tributary before disturbance from timber harvest and livestock trampling.

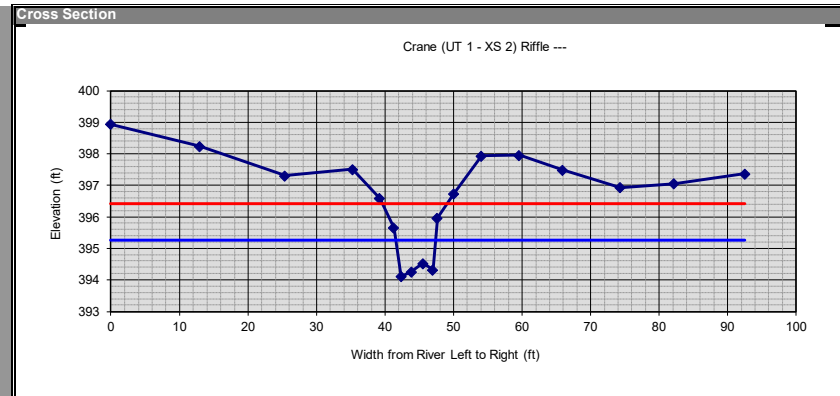
section: Crane (UT 1 - XS 2)  
Riffle  
---  
---

description: Crane (UT 1 - XS 2)  
height of instrument (ft): 500.00

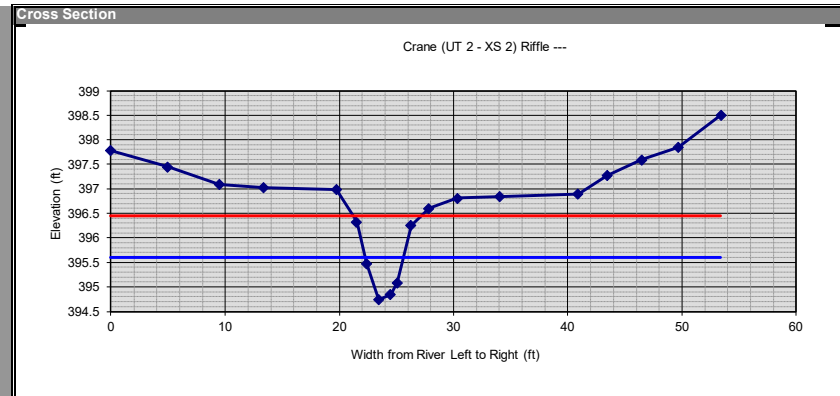
section: Crane (UT 2 - XS 2)  
Riffle  
---  
---

description: Crane (UT 2 - XS 2)  
height of instrument (ft): 500.00

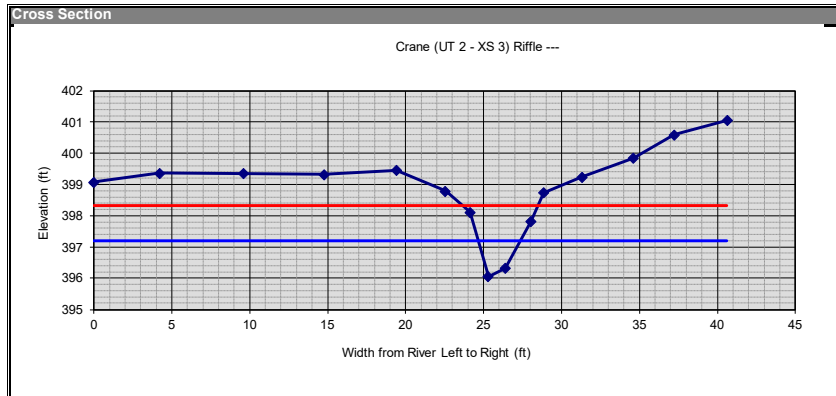
section: Crane (UT 2 - XS 3)

Riffle  
---  
---

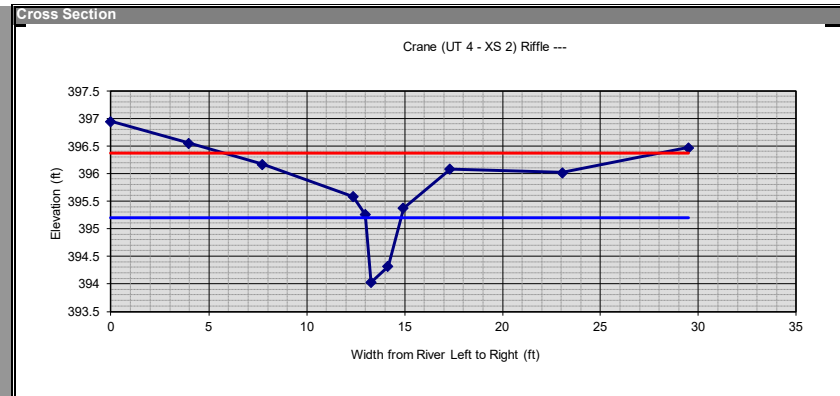
section: Crane (UT 4 - XS 2)  
Riffle  
---  
---

description: Crane (UT 4 - XS 2)  
height of instrument (ft): 500.00

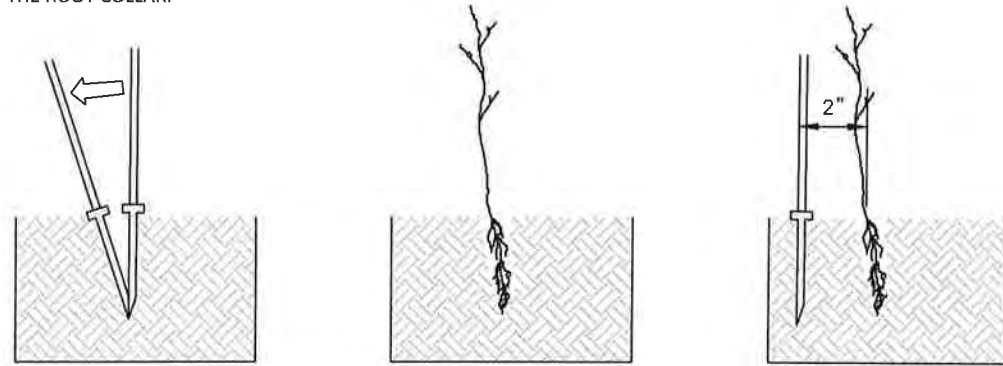
1. INSERT PLANTING BAR 12" INTO THE GROUND AS SHOWN AND PULL HANDLE TOWARD PLANTER.
2. REMOVE PLANTING BAR AND PLACE SEEDING AT CORRECT DEPTH.
3. INSERT PLANTING BAR 2 INCHES TOWARD PLANTER FROM SEEDING.
