**Year 3 Monitoring Report**

**RES Randleman Group A  
Riparian Buffer Mitigation Project**

**DMS Project # 100046 (Contract # 7427)**

**February 2022**

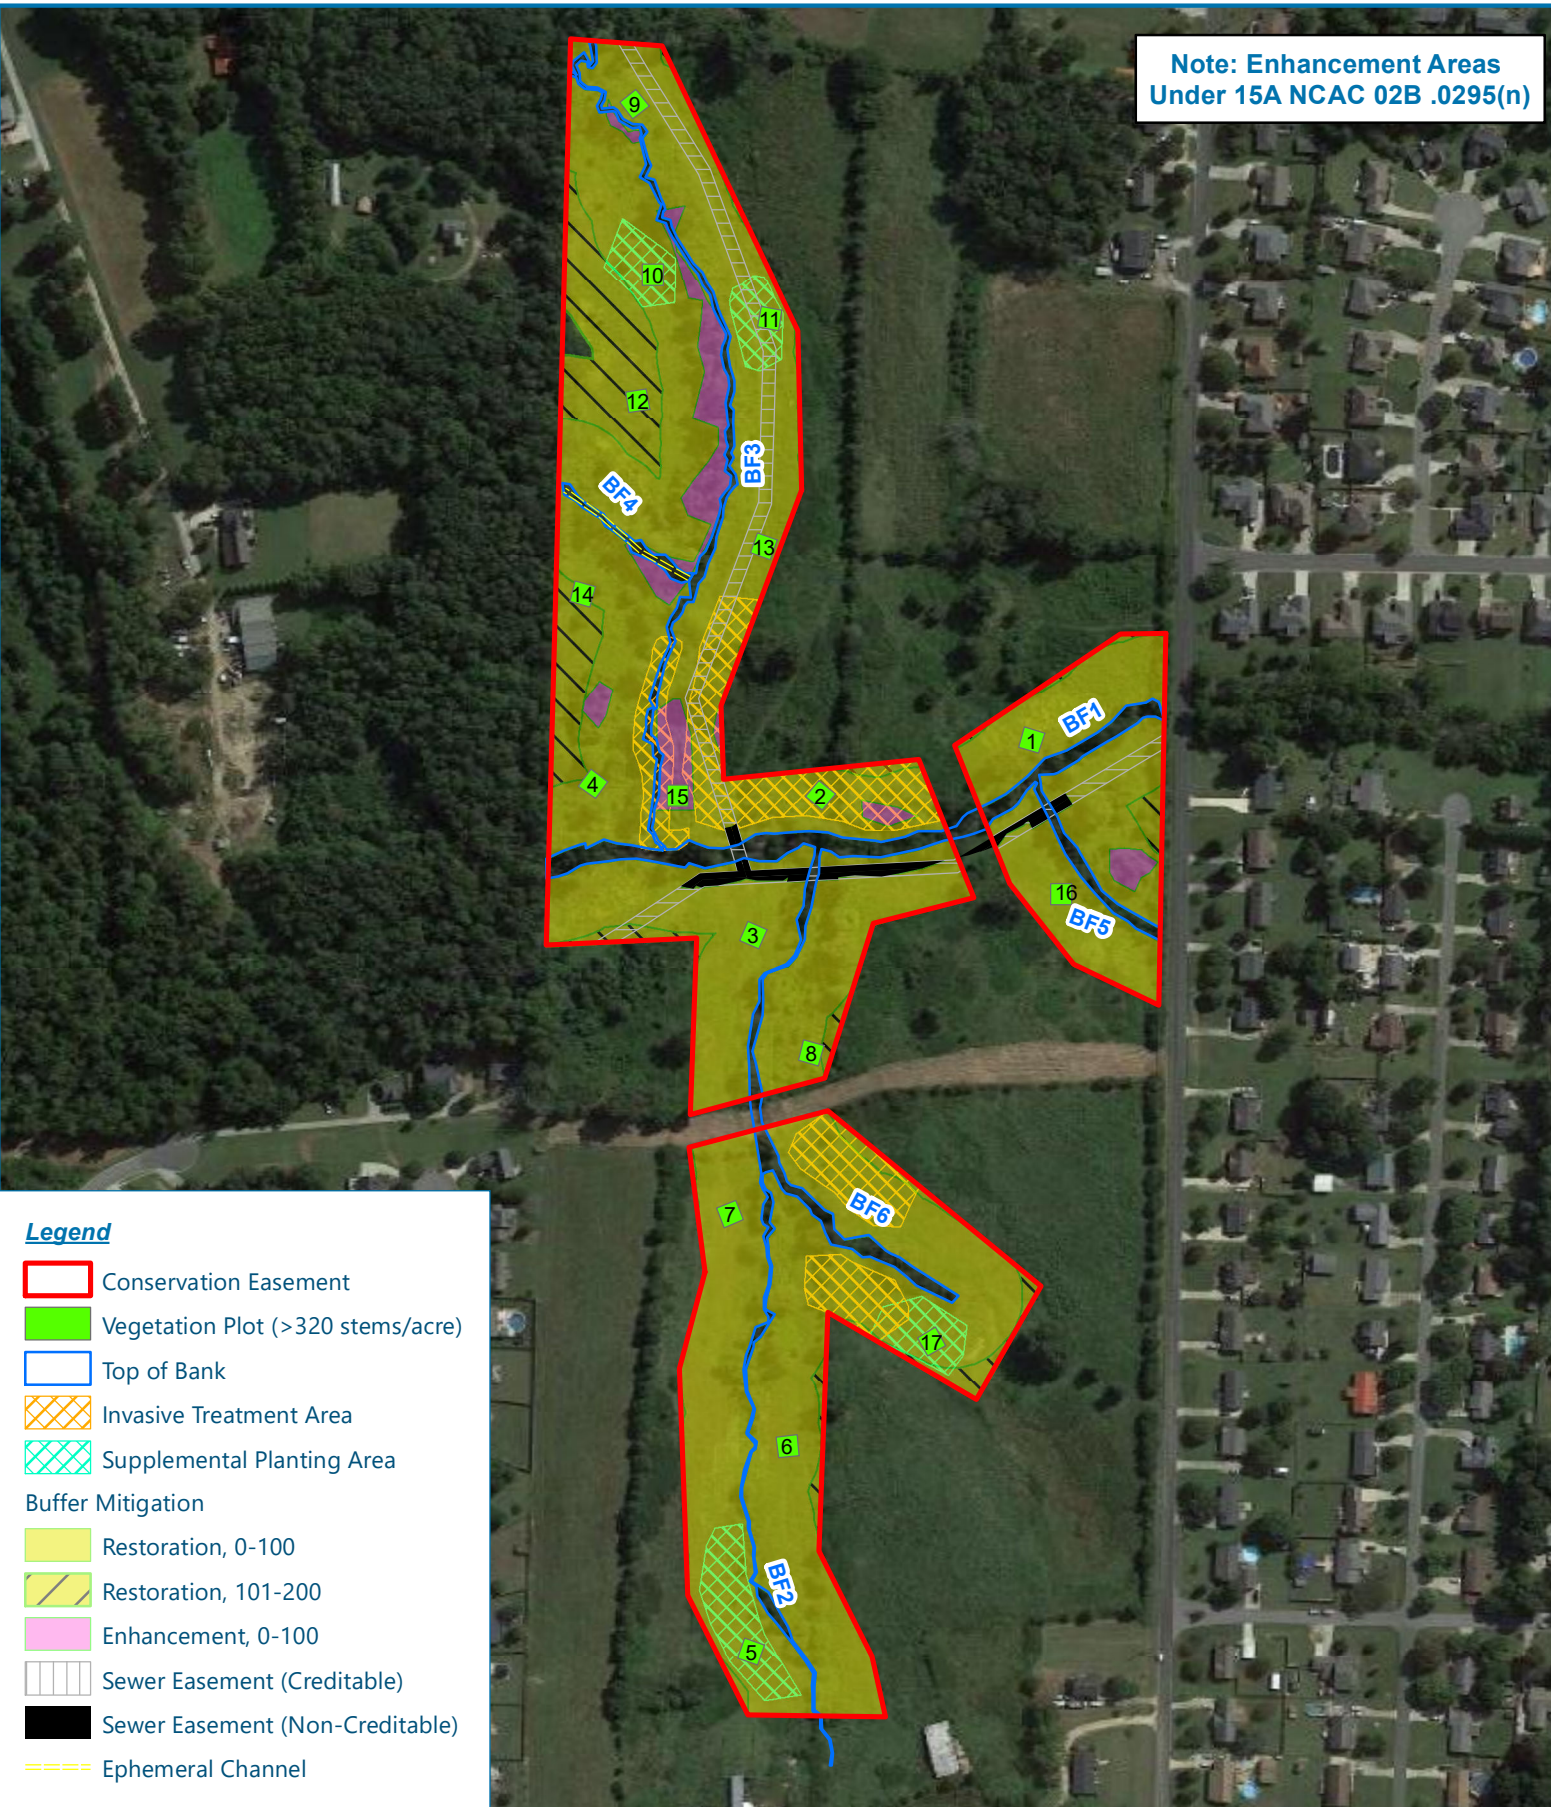
Figure 2a. Current Conditions Plan View

- Conservation Easement
- Vegetation Plot (>320 stems/acre)
- Top of Bank
- Invasive Treatment Area
- Supplemental Planting Area
- Buffer Mitigation
  - Restoration, 0-100
  - Restoration, 101-200
  - Enhancement, 0-100
  - Sewer Easement (Creditable)
  - Sewer Easement (Non-Creditable)
  - Ephemeral Channel

Visual assessment of vegetation outside of the monitoring plots indicates that the herbaceous vegetation is becoming well established throughout all three Sites. Small, localized areas of Chinese privet, tree of heaven, and princess tree were treated at Schmid Creek in October 2021. Small, localized areas of Chinese privet and Bradford pear were treated at Pequod in November 2021. Invasive treatment areas in the CCPV maps represent the total area in which isolated treatments were applied. Invasive treatments will continue as needed throughout the remainder of the monitoring period. Additionally, minor supplemental planting was performed in and around plots that demonstrated less than 600 stems per acre in MY2. Supplemental bareroot tree species included white oak, willow oak, overcup oak, persimmon, button bush, and sugarberry. This supplemental planting was performed in January 2021 and consisted of approximately 600 bareroot trees total across the three sites. Supplemental planting and invasive treatment areas are provided in the CCPV maps.

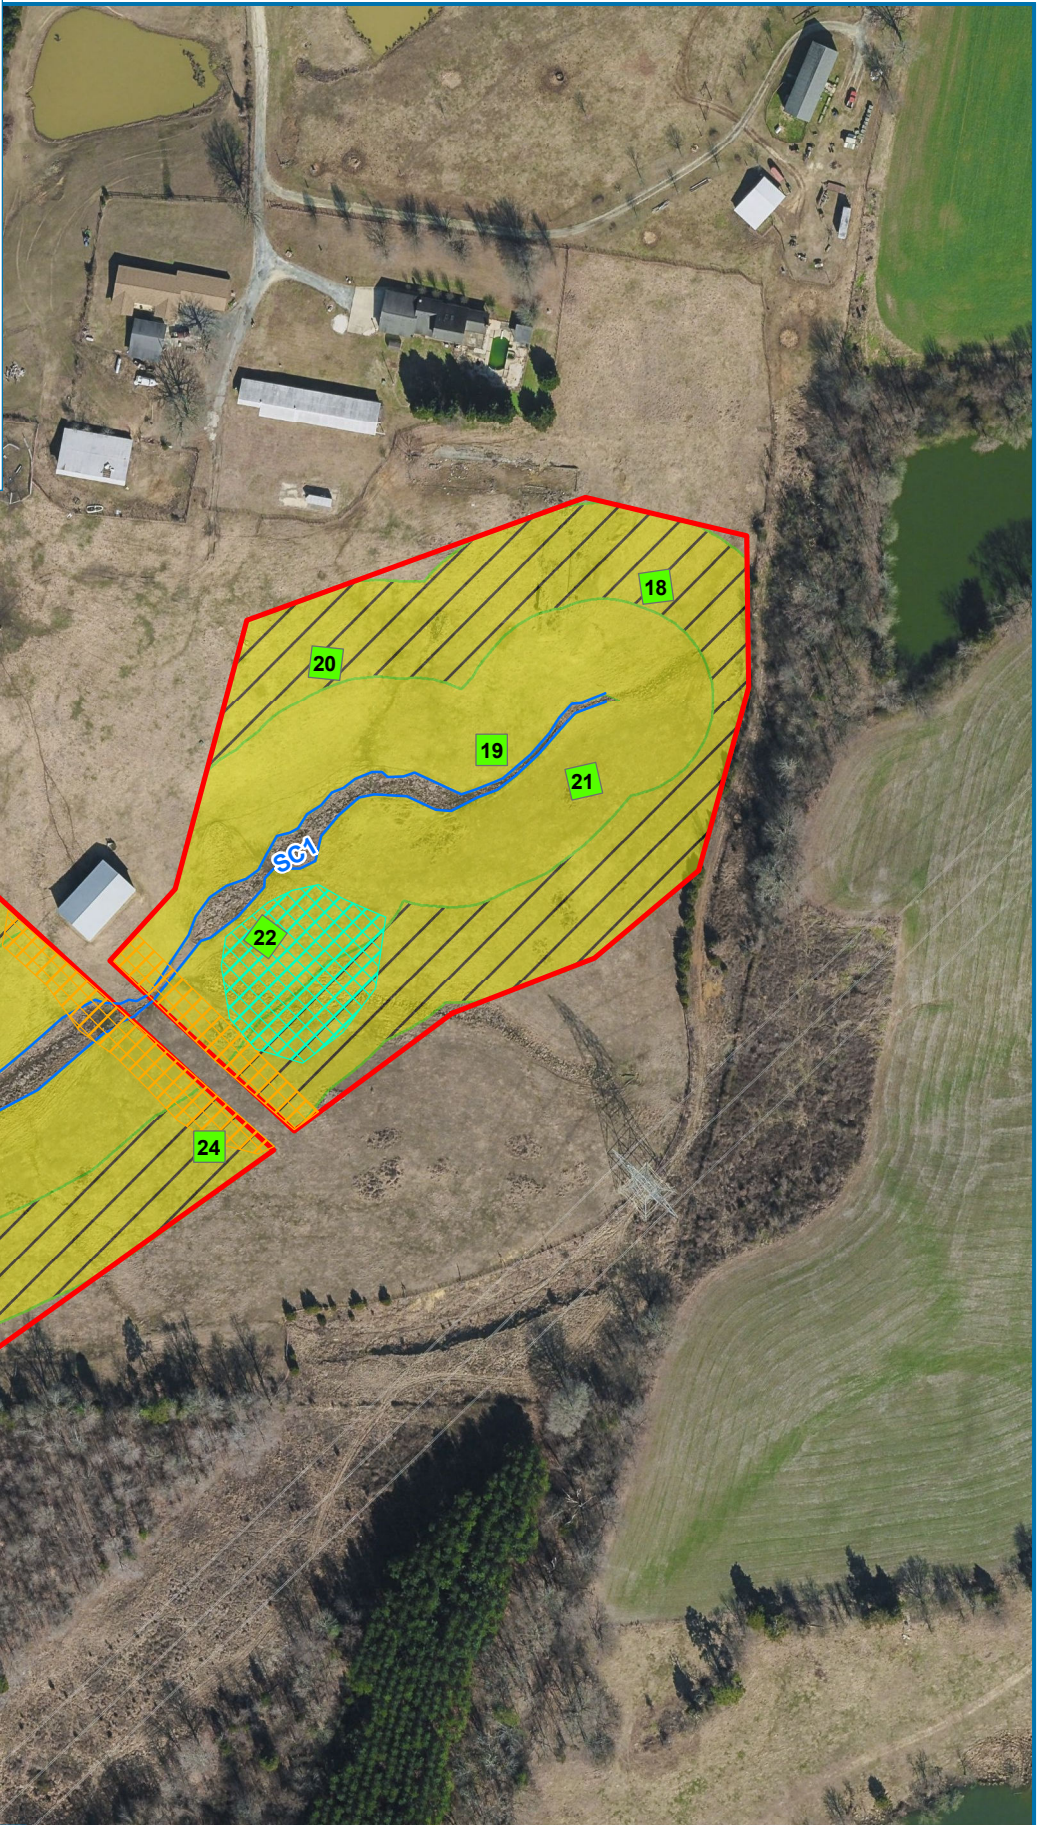
**Figure 2b - Current Conditions Plan View**

-   Conservation Easement
-   Vegetation Plot (>320 stems/acre)
-   Invasive Treatment Area
-   Supplemental Planting Area
- Buffer Mitigation
  -   Restoration, 0-100
  -   Restoration, 101-200
-   Top of Bank

Livestakes 2020
