MONITORING YEAR 1 ANNUAL REPORT FINAL

WYANT LANDS MITIGATION SITE

Lincoln County, NC
Catawba River Basin
HUC 03050102
(03050103 Expanded Service Area)

DMS Project No. 100067
DMS Contract No. 7244
DMS RFP No. 16-007133
USACE Action ID No. SAW-2017-02609
DWR Project No. 2018-0177
Data Collection Dates: October 2021 - January 2022

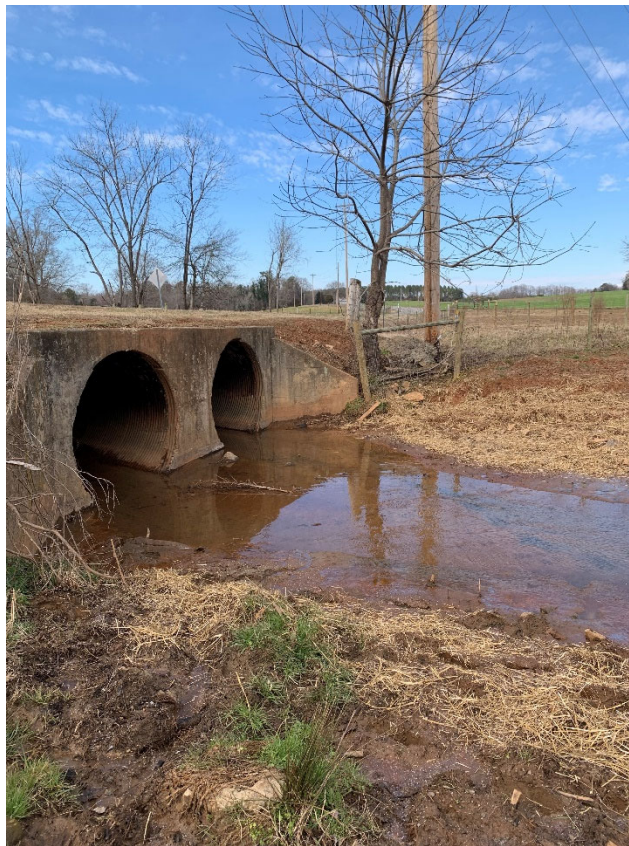
UT1 – Bank Erosion 202+00 (12/22/2021)

Overall, stream areas of concern on Site were minimal. An area of aggradation on the upper section of Wyant Creek R1 was observed. The sediment is expected to move through the system. A 21-foot portion of scoured stream bank on UT1 was noted. This area is heavily vegetated and is considered stable and not expected to worsen. Minimal localized piping around a log sill was discovered. This structure will be monitored but failure is not expected. Wildlands will continue to monitor these areas and adaptive management maintenance measures will be implemented as necessary to benefit the ecological health of the Site.

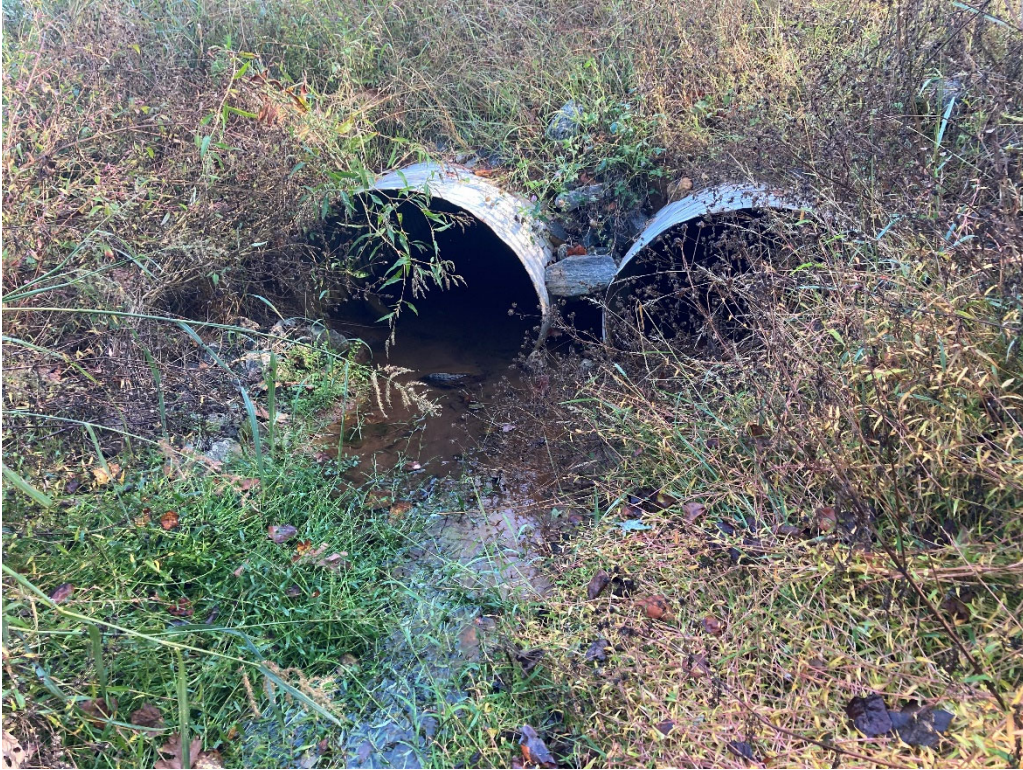
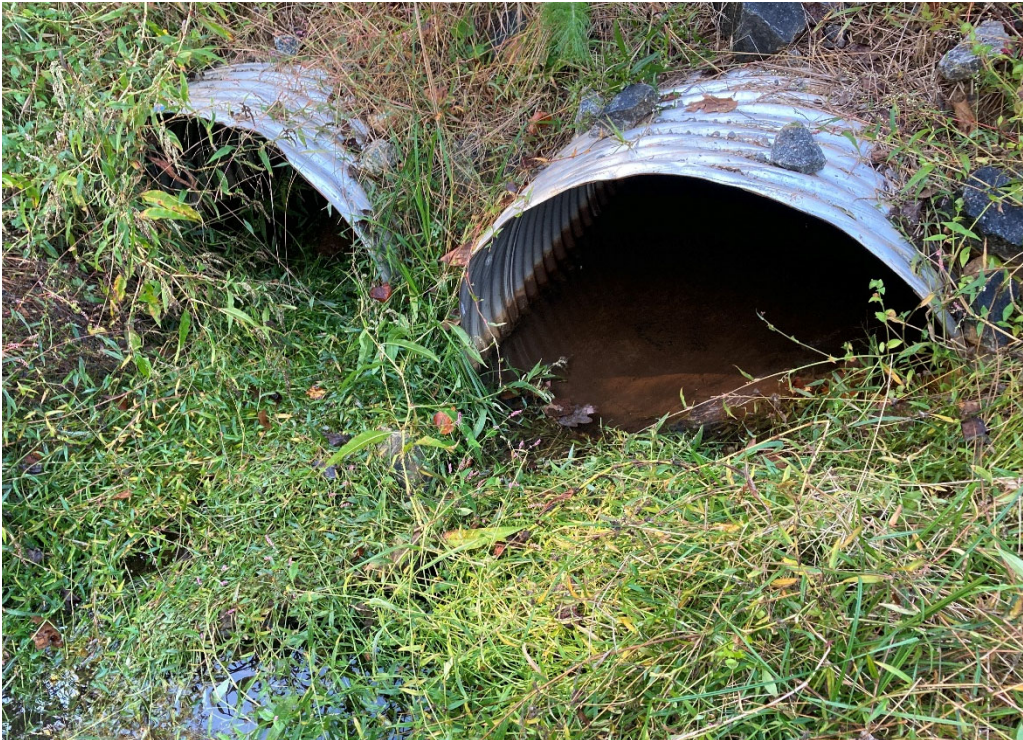
UT2 Culvert Photos:

4. It's DWR understanding that Wildlands to working to resolve the severe bank instability and sediment loading occurring within the stream crossings on either side of Wyant Road observed by the IRT during the October 2020 site visit. DWR is very concerned about associated water quality impacts. If a remediation effort has not been implemented by the April DMS credit release meeting, DWR will likely recommend at least partial withholding of MY1 stream credits.
-
-
-

Wildlands Response: Wildlands is implementing additional vegetative methods (seed and straw) to the areas of concern. Wildlands will evaluate the condition of the crossings prior to addendum construction and if deemed necessary will use more hardened methods (add rock or similar) to stabilize the crossing areas and reduce sediment inputs from the ford crossings into the project streams. Wildlands anticipates addendum construction to be performed prior to the April DMS credit release meeting.
