Monitoring Year 2 Report
FINAL
2021

Rough Horn Swamp Restoration Site
Monitoring Year – MY02

Rough Horn Swamp II Restoration Site

Columbus County, North Carolina

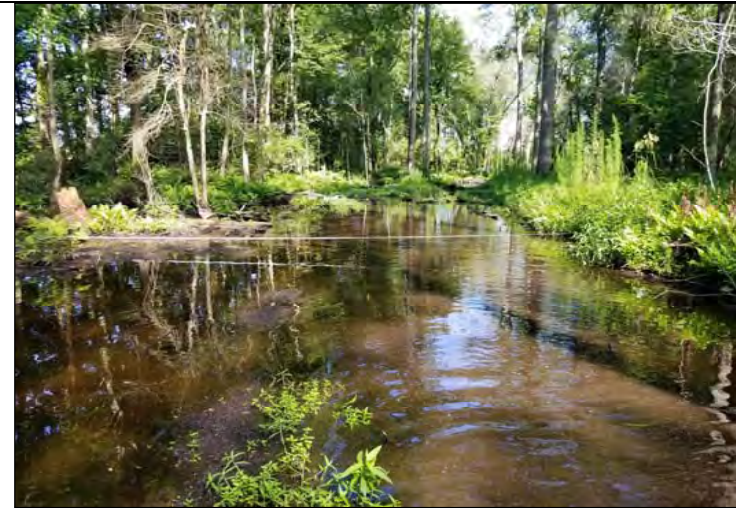
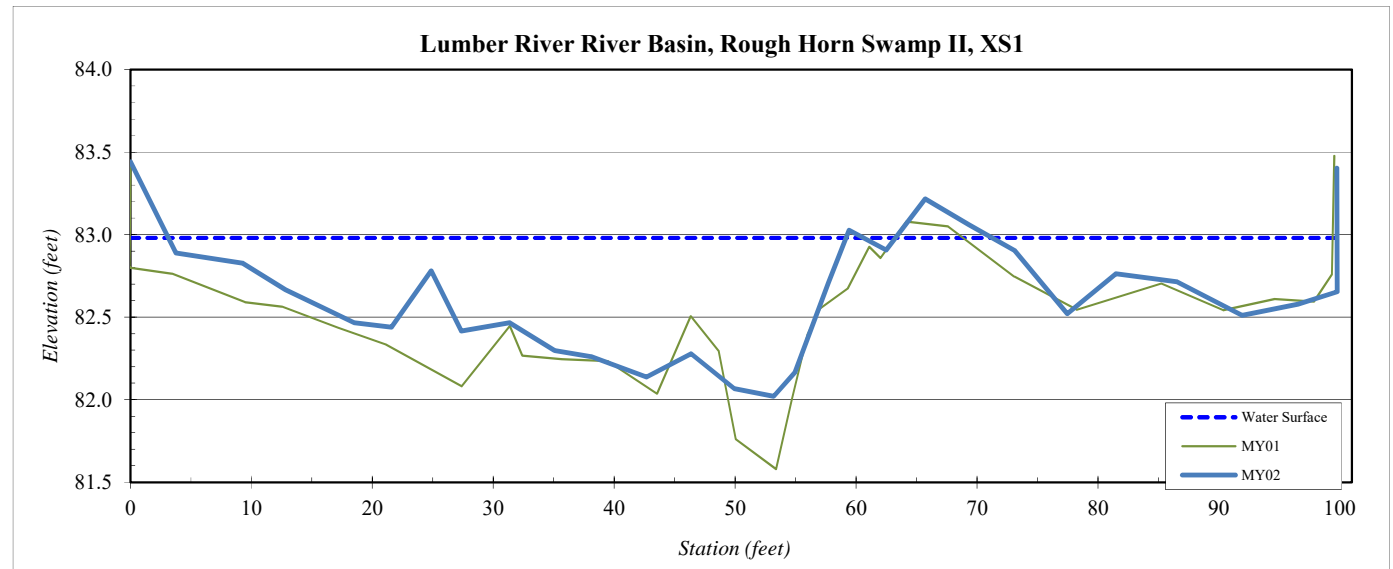
River Basin:	Lumber River
Site:	Rough Horn Swamp II
XS ID	XS1
Drainage Area (sq mi):	1.50
Date:	6/23/2021
Field Crew:	T. Seelinger, C. Pristupa

The Monitoring Year 2 cross-section survey found the stream stable and functioning as designed. Because the project streams are part of a headwater system with multiple flow paths, traditional cross-sections measurements such as cross-sectional area, bank height ratio, and entrenchment ratio cannot be calculated. These cross-sections were set to span the entire 100 foot width of the stream valley to monitor where and how the water is flowing through this valley. All three cross-sections showed evidence of the development of multiple flow paths. XS3, because of its proximity to the culvert under CCC Rd. showed the most evidence of having a single flow path, but even this cross-section demonstrated multiple flow paths.
