MITIGATION PLAN

LAUREL VALLEY MITIGATION SITE

Burke County, NC
NCDEQ Contract No. 7875-02
DMS ID No. 100140

Catawba River Basin
HUC 03050101

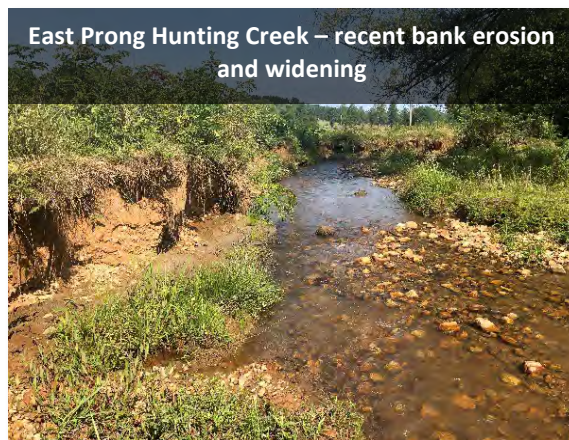
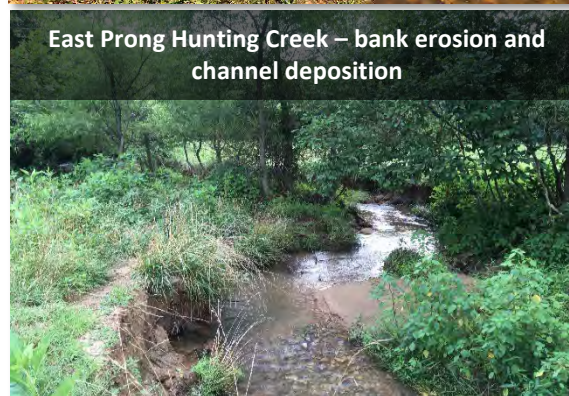
Reach Summary Information	
Parameters	East Prong Hunting Creek
Length of Reach (Linear Feet)	1,356
Valley confinement (Confined, moderately confined, unconfined)	Unconfined
Drainage area (acres)	1,274
Perennial, Intermittent, Ephemeral	Perennial
NCSAM Score/Stream Function	Low
NCDWR Water Quality Classification	WS-IV
Width to Depth Ratio (ft/ft)	13.8-18.0
Bank Height Ratio (ft/ft)	1.6-2.0
Gradient (ft/ft)	0.00743
Reachwide d50 (mm)	0.95 (Coarse Sand)
Stream Classification (Existing and Proposed)	Existing: C5, B5c Proposed: C4
Evolutionary Trend	V. Aggradation and widening
FEMA Zone Classification	X

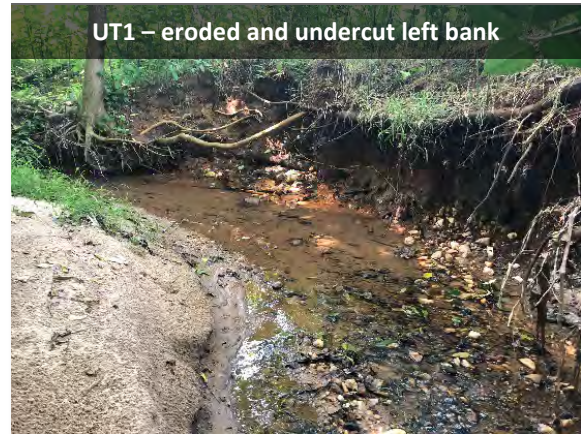
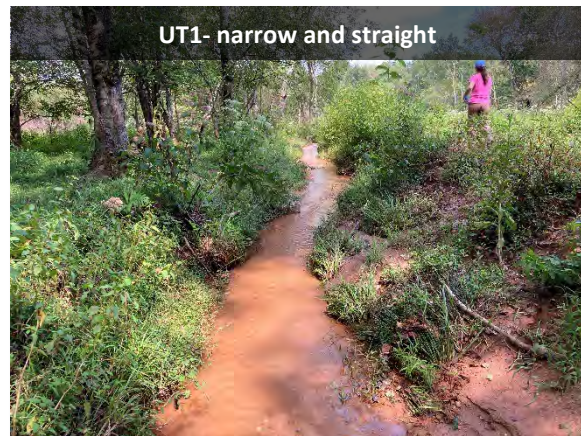
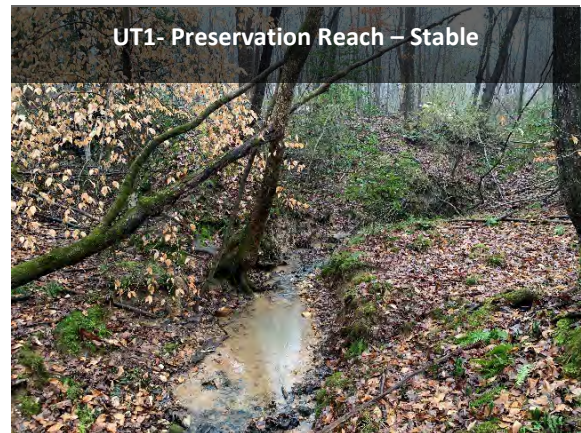
UT1 originates offsite near a quarry as depicted on Figure 3. The quarry produced crushed stone and still has an active permit (NC DEQ Permit # 12-07), although conversations with the landowner indicated that there had been very little traffic to the quarry in the past few years. At the upstream limit within the site, UT1 flows through a narrow, steep, wooded valley with varied habitat including snags, roots mats, pools, and leaf packs. The stream continues in this condition for approximately 400 LF until it flows through a 36" driveway culvert. Cattle do not have access to the reach upstream of the culvert. The outlet end of the culvert is perched approximately one foot above base flow water surface and adjacent stream slopes are eroded. Downstream of the culvert, cattle have access to both sides of the stream. The channel is incised and disconnected from its floodplain while tortuous meanders have caused widespread bank erosion and undercut banks. The right buffer is wide and wooded while the left buffer consists of a narrow row of trees on the edge of an open pasture. Channel substrate consist of gravel and cobble sized material that has been embedded with fine sediment from bank erosion. The abundance of these fine sediments contributed to the assessed reachwide D50 of 0.77 mm (see Table 5 below). The stream leaves the project parcel under a cattle gate and becomes straight with a wooded buffer on the left floodplain and open pasture on the right floodplain. The stream capacity is currently overloaded with fine sediment which settles in the downstream portion of UT1 and has resulted in a braided channel in some sections of the off-property reach. UT1 then flows into a small, in-line pond, possibly the result of human or beaver manipulation, before continuing as a ditch to a culvert under Mt. Home Church Road. UT1 ends in a confluence with another small unnamed tributary a few hundred feet after passing under the road.

Reach Summary Information	
Parameters	UT1
Length of Reach (Linear Feet)	1,841
Valley confinement (Confined, moderately confined, unconfined)	Moderately confined
Drainage area (acres)	136
Perennial, Intermittent, Ephemeral	Perennial
NCSAM Score/Stream Function	Reach 1: High Reach 2: Low
NCDWR Water Quality Classification	WS-IV
Width to Depth Ratio (ft/ft)	6.7-14.3
Bank Height Ratio (ft/ft)	1.6-1.9
Gradient (ft/ft)	0.00879
Reachwide d50 (mm)	0.77 (Coarse sand)
Stream Classification (Existing and Proposed)	Existing: B5c, G5c Proposed: C4
Evolutionary Trend	IV. Degradation and widening
FEMA Zone Classification	X

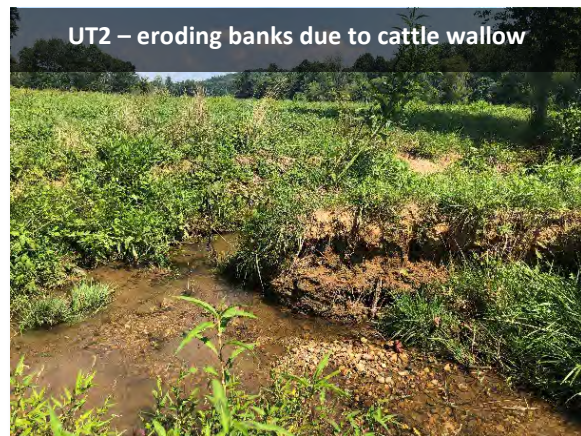
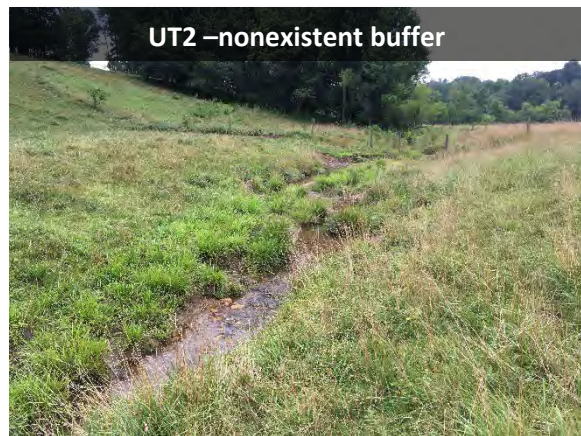
UT2 enters the Site from a wooded upstream parcel and is extensively impacted by cattle activity in the fringe of the woods. The stream then flows out of the woods through an open pasture with no buffer. The channel is moderately incised with alternating bank erosion caused by cattle trampling. The stream continues in this condition for approximately 600 LF before flowing through a perched 24" culvert used as a cattle crossing. Downstream of the culvert, the stream flows another 350 LF through open pasture before entering a narrow-wooded buffer for 150 LF. A considerable volume of sediment is input into the stream within the narrow buffer due to cattle trampling and wallow areas. Downstream of the narrow buffer, the left buffer widens, bank heights decrease, and the stream is relatively stable for approximately 100 LF. Downstream of the stable section, the buffer disappears, and the stream becomes more incised with eroding banks and multiple cattle wallows before connecting with East Prong Hunting Creek. UT2 exhibits low bedform diversity and high sedimentation due to cattle trampling and eroding banks. Incision ranges from low in the stable section to moderate in the rest of the reach. The valley is relatively narrow and moderately confined.

Reach Summary Information	
Parameters	UT2
Length of Reach (Linear Feet)	1371
Valley confinement (Confined, moderately confined, unconfined)	Moderately confined
Drainage area (acres)	155
Perennial, Intermittent, Ephemeral	Perennial
NCSAM Score/Stream Function	Low/Medium
NCDWR Water Quality Classification	WS-IV
Width to Depth Ratio (ft/ft)	8.4-18.7
Bank Height Ratio (ft/ft)	1.3-1.6
Gradient (ft/ft)	0.01767
Reachwide d50 (mm)	3.8 (Very Fine Gravel)
Stream Classification (Existing and Proposed)	Existing: B4, B4c Proposed: C4
Evolutionary Trend	IV. Degradation and widening
FEMA Zone Classification	X

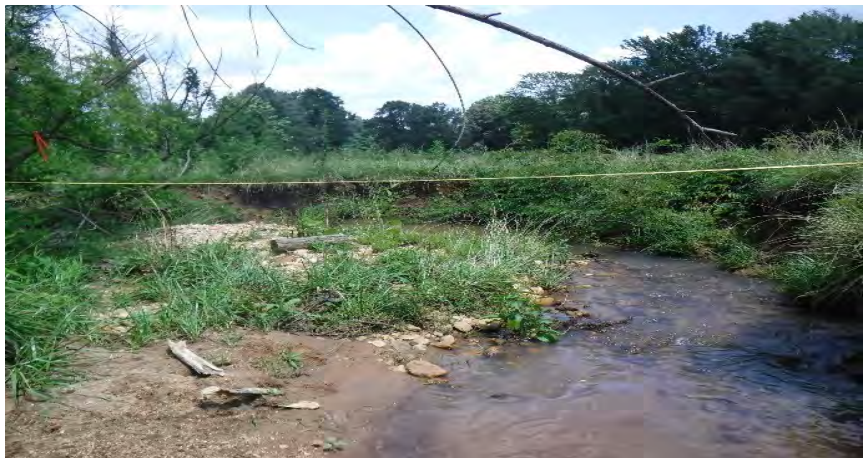
Cross Section 2, EPHC Reach 2

30.8	x-section area (ft.sq.)
23.5	width (ft)
1.3	mean depth (ft)
2.3	max depth (ft)
25.9	wetted perimeter (ft)
1.2	hyd radi (ft)
18.0	width-depth ratio
225.0	W flood prone area (ft)
9.6	entrenchment ratio
1.6	low bank height ratio

View Downstream

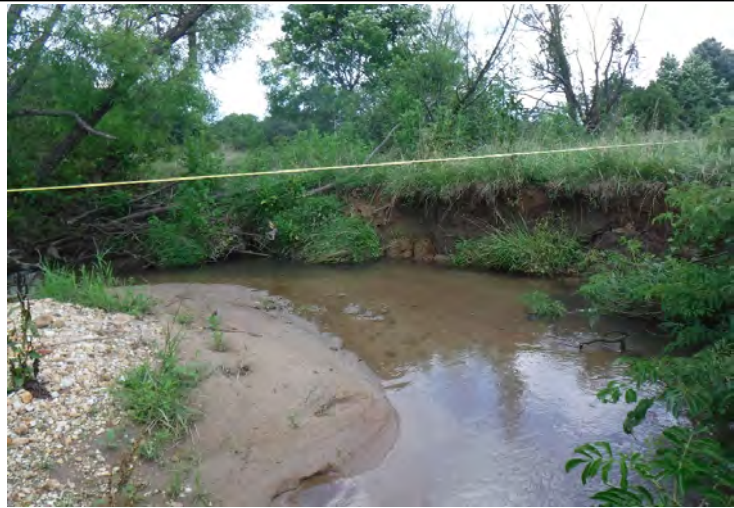
Cross Section 3, EPHC Reach 2

- 29.9 x-section area (ft.sq.)
- 28.5 width (ft)
- 1.0 mean depth (ft)
- 2.2 max depth (ft)
- 30.3 wetted perimeter (ft)
- 1.0 hyd radi (ft)
- 27.2 width-depth ratio
- 40.0 W flood prone area (ft)
- 1.4 entrenchment ratio
- 1.8 low bank height ratio

View Downstream

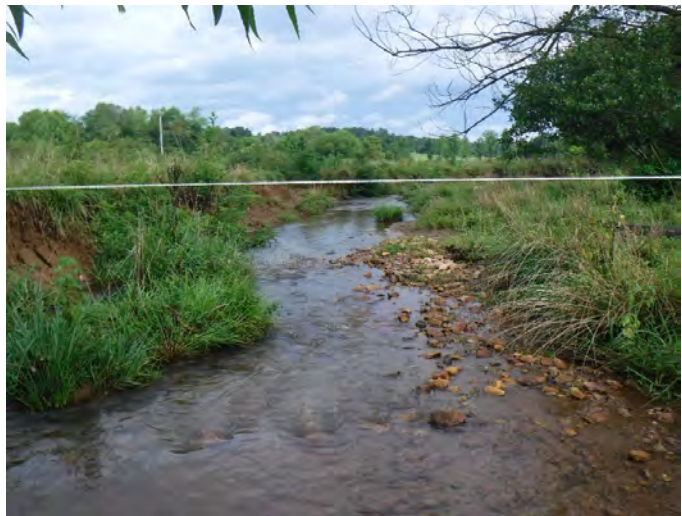
Cross Section 4, UT2

- 29.1 x-section area (ft.sq.)
- 20.1 width (ft)
- 1.5 mean depth (ft)
- 2.0 max depth (ft)
- 21.8 wetted perimeter (ft)
- 1.3 hyd radi (ft)
- 13.8 width-depth ratio
- 46.0 W flood prone area (ft)
- 2.3 entrenchment ratio
- 2.0 low bank height ratio

View Downstream

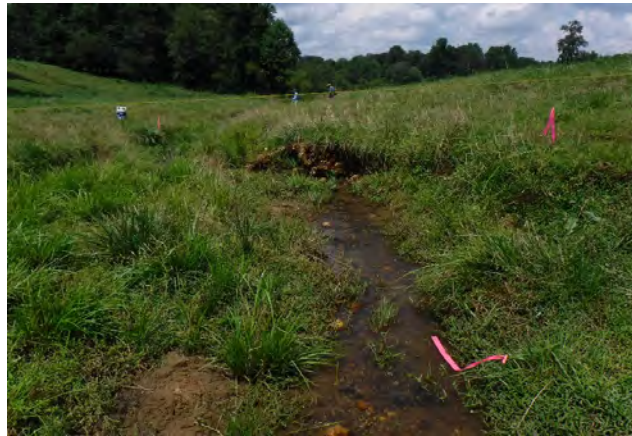
Cross Section 5, UT2

- 11.3 x-section area (ft.sq.)
- 14.5 width (ft)
- 0.8 mean depth (ft)
- 1.3 max depth (ft)
- 15.0 wetted perimeter (ft)
- 0.7 hyd radi (ft)
- 18.7 width-depth ratio
- 1.6 low bank height ratio

View Downstream

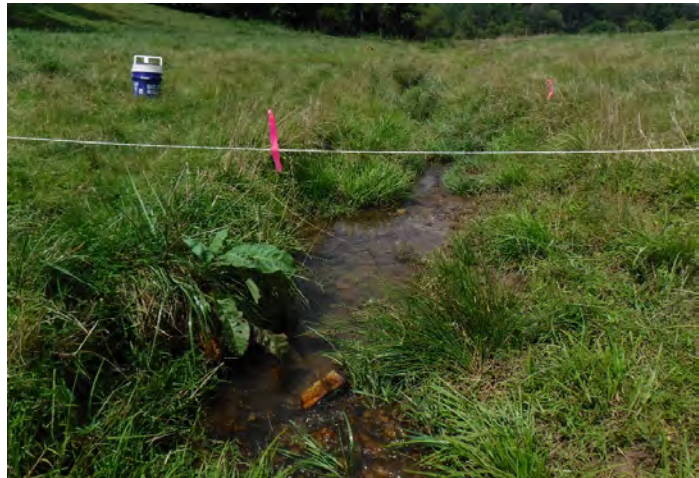
Cross Section 6, UT2

- 7.4 x-section area (ft.sq.)
- 7.3 width (ft)
- 1.0 mean depth (ft)
- 1.8 max depth (ft)
- 9.1 wetted perimeter (ft)
- 0.8 hyd radi (ft)
- 7.2 width-depth ratio
- 22.5 W flood prone area (ft)
- 3.1 entrenchment ratio
- 1.2 low bank height ratio

View Downstream

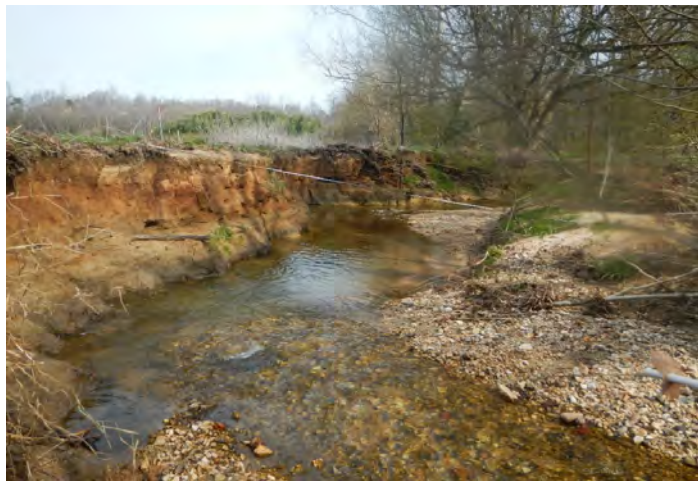
Cross Section 7, UT1 Reach 2

- 6.9 x-section area (ft.sq.)
- 7.6 width (ft)
- 0.9 mean depth (ft)
- 1.6 max depth (ft)
- 9.3 wetted perimeter (ft)
- 0.7 hyd radi (ft)
- 8.4 width-depth ratio
- 23.5 W flood prone area (ft)
- 3.1 entrenchment ratio
- 1.3 low bank height ratio

View Downstream

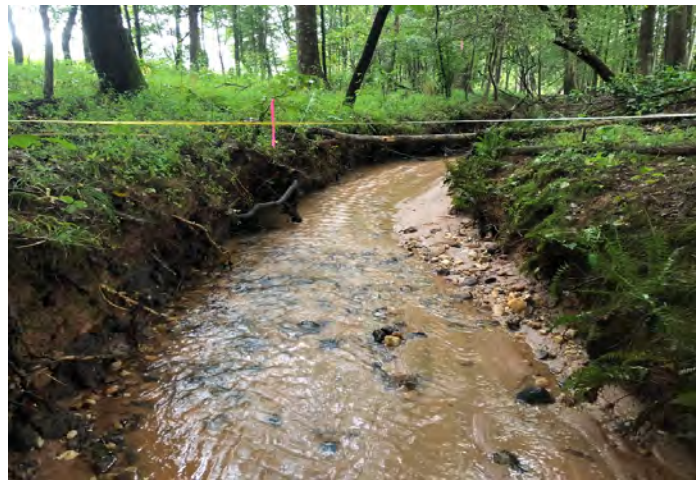
Cross Section 8, UT1 Reach 2

- 7.9 x-section area (ft.sq.)
- 7.3 width (ft)
- 1.1 mean depth (ft)
- 1.2 max depth (ft)
- 9.0 wetted perimeter (ft)
- 0.9 hyd radi (ft)
- 6.7 width-depth ratio
- 8.0 W flood prone area (ft)
- 1.1 entrenchment ratio
- 1.9 low bank height ratio

View Downstream

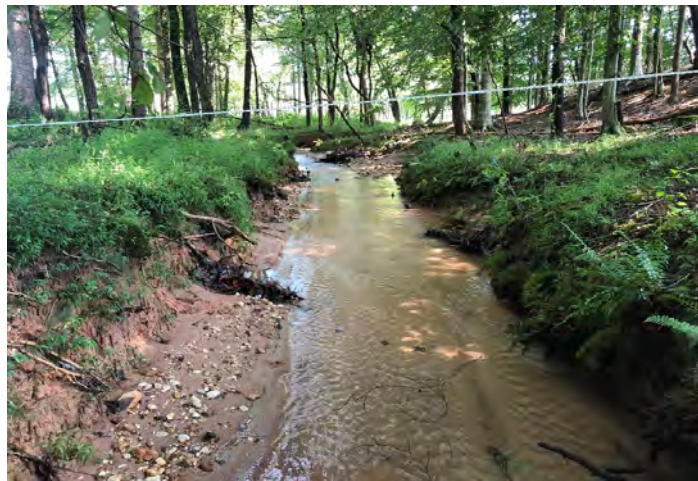
Cross Section 9, UT1 Reach 2

- 6.0 x-section area (ft.sq.)
- 6.9 width (ft)
- 0.9 mean depth (ft)
- 1.2 max depth (ft)
- 8.3 wetted perimeter (ft)
- 0.7 hyd radi (ft)
- 7.8 width-depth ratio
- 8.0 W flood prone area (ft)
- 1.2 entrenchment ratio
- 2.4 low bank height ratio

View Downstream

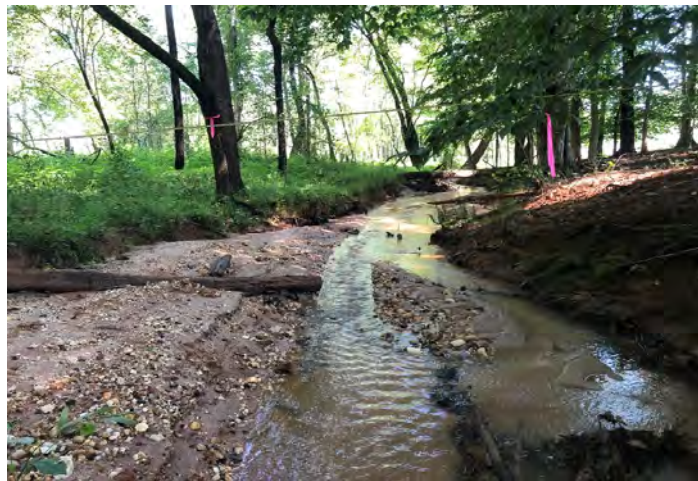
- 8.8 x-section area (ft.sq.)
- 11.3 width (ft)
- 0.8 mean depth (ft)
- 1.3 max depth (ft)
- 12.5 wetted perimeter (ft)
- 0.7 hyd radi (ft)
- 14.3 width-depth ratio
- 22.0 W flood prone area (ft)
- 2.0 entrenchment ratio
- 1.6 low bank height ratio

View Downstream

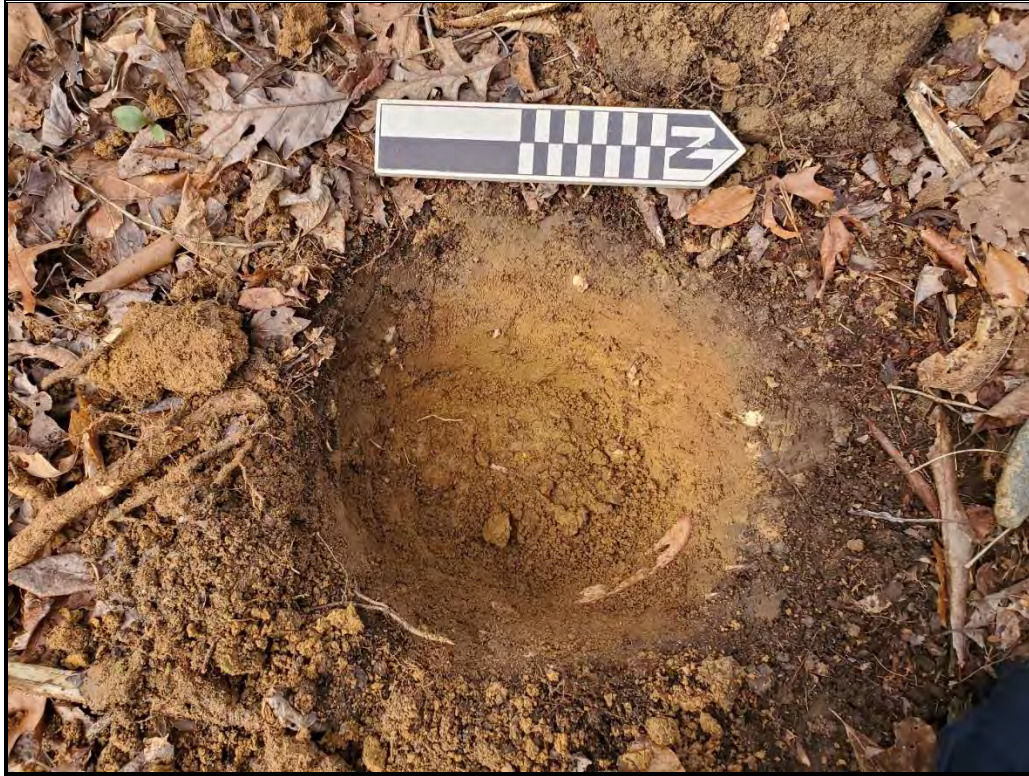
Figure 3.7. Shovel test profile typical of the wooded area, facing west.

Shovel tests in the western wooded area of the APE generally exposed soil profiles comprised of 1 to 5 centimeters of gray (10YR5/1) sandy loam overlying 10 to 15 centimeters of brownish yellow (10YR6/6) sandy loam overlying reddish yellow (7.5YR6/6) loamy clay (Figure 3.7). Elsewhere in the APE, two different soil profiles were generally exposed. The first consisted of approximately 10 to 20 centimeters of dark grayish brown (10YR4/2) sandy loam overlying strong brown (7.5YR5/6) loamy clay (Figure 3.8). The second was comprised of approximately 10 to 20 centimeters of dark yellowish brown (10YR4/4) sandy loam overlying brown (7.5YR4/4) loamy clay (Figure 3.9). These two soil profiles were encountered consistently throughout the APE. In the areas of the APE close to standing water, soil profiles generally consisted of mottled dark gray (10YR4/1) and brown (10YR4/3) sandy loam which terminated in standing water below approximately 15 centimeters (Figure 3.10).

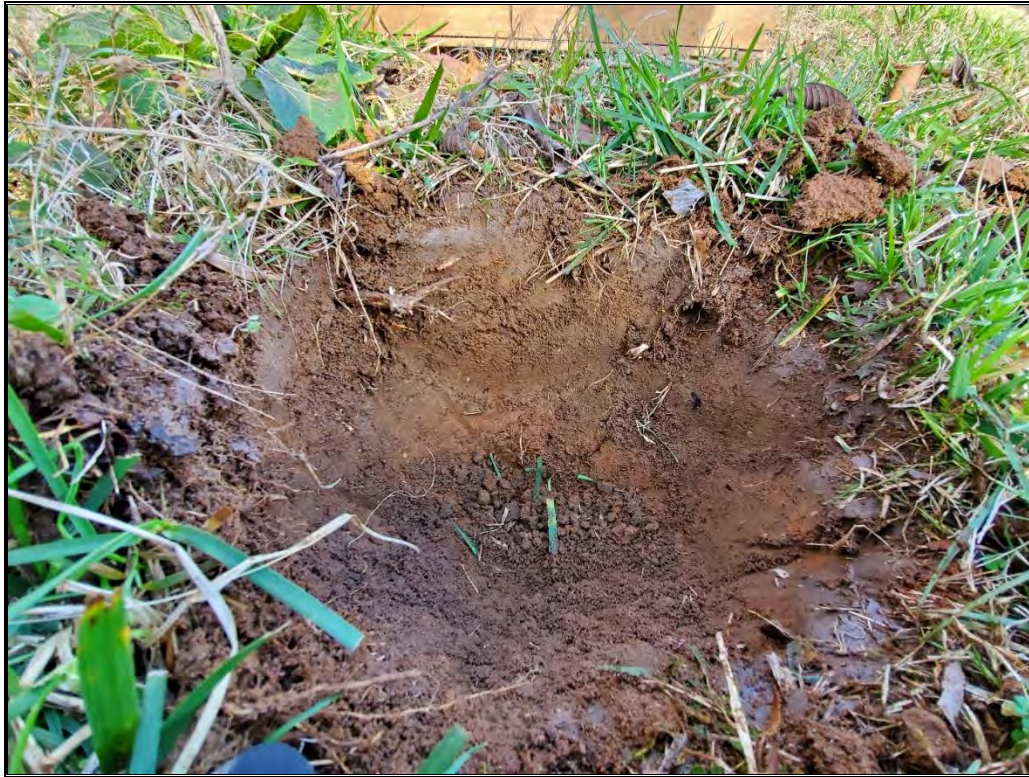
Figure 3.8. Representative shovel test profile from the APE, facing north.

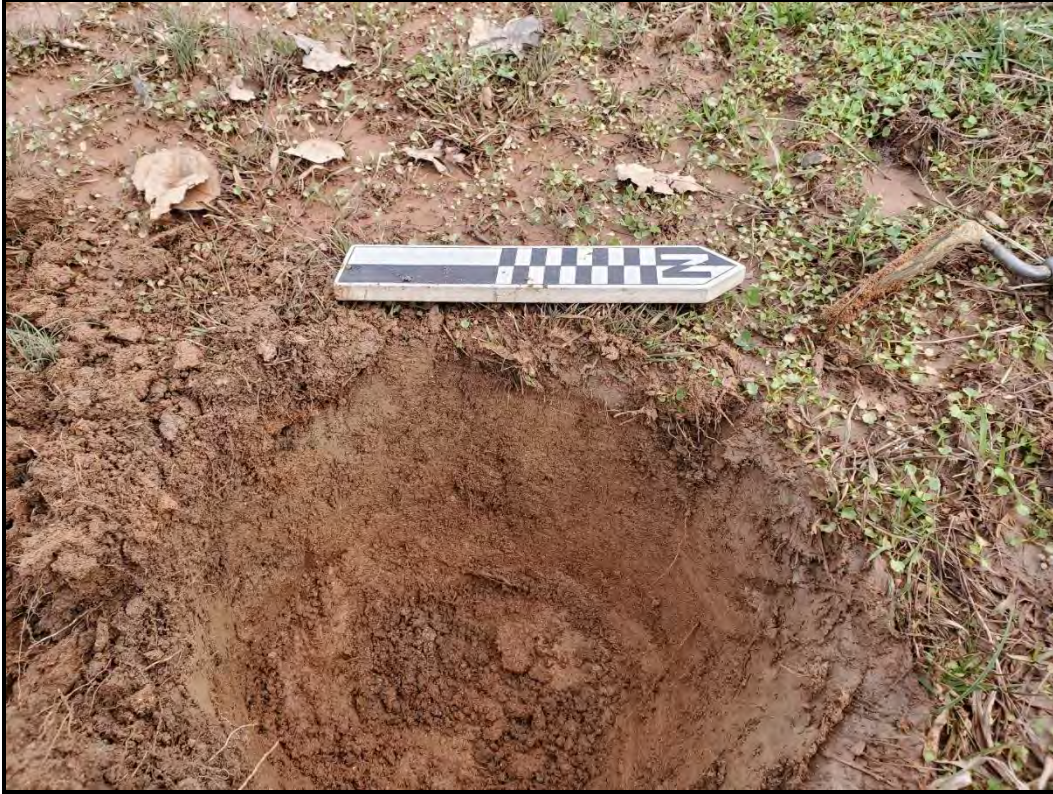
Figure 3.9. Representative shovel test profile from the APE, facing west.

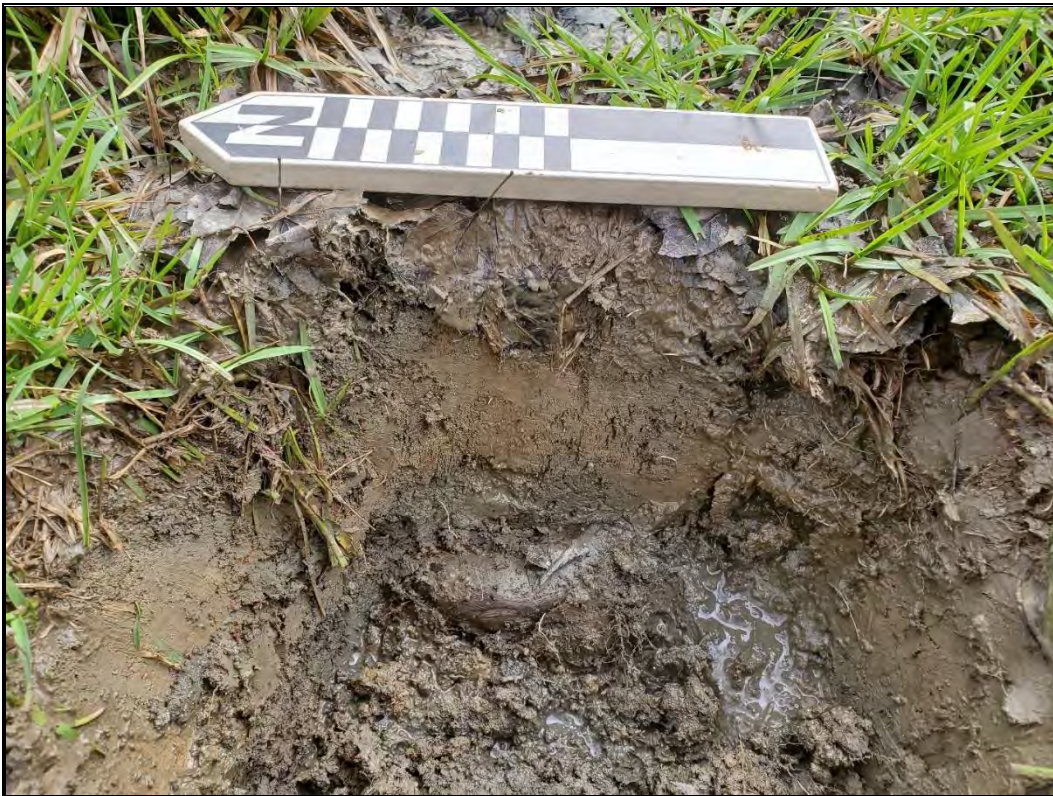
Figure 3.10. Shovel test profile typical of saturated areas, facing east.
