MYO MONITORING REPORT

Swamp Grape Stream and Wetland Mitigation Site

Robeson County, North Carolina

DMS Project No. 100115

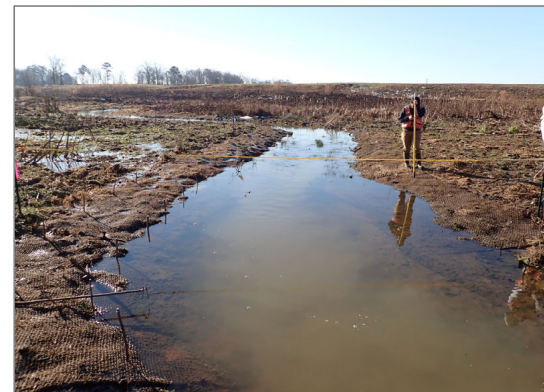
Station	Elevation
0.0	109.8
2.7	109.7
4.8	109.5
6.5	108.7
8.0	108.3
8.9	108.0
10.0	108.1
10.1	108.1
11.9	107.8
13.6	107.9
14.9	108.0
15.4	109.1
16.1	109.1
17.2	109.4
18.0	109.8
19.8	109.7
22.1	109.9

SUMMARY DATA	
Bankfull Elevation:	109.50
Bank Height Ratio:	1.00
Thalweg Elevation:	107.77
LTOB Elevation:	109.50
LTOB Max Depth:	1.73
LTOB Cross Sectional Area:	13.9

Stream Type	E/C 5
--------------------	-------

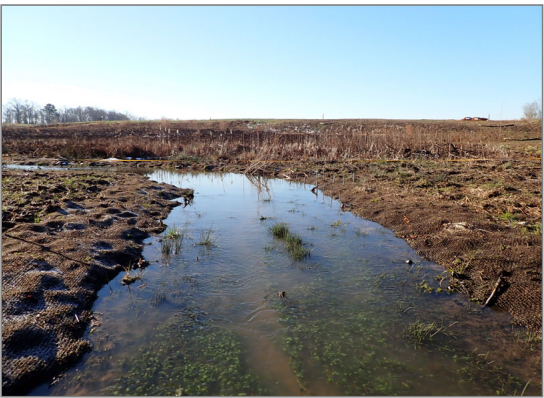
Station	Elevation
0.0	110.1
3.9	110.1
5.7	109.8
7.0	109.3
7.8	109.1
9.0	108.9
11.0	109.0
12.5	108.8
14.6	109.0
15.4	109.0
16.3	109.4
17.6	109.6
18.2	109.8
18.9	109.9
20.6	110.1
22.0	110.0

SUMMARY DATA	
Bankfull Elevation:	110.09
Bank Hieght Ratio:	1.00
Thalweg Elevation:	108.75
LTOB Elevation:	110.09
LTOB Max Depth:	1.34
LTOB Cross Sectional Area:	12.8

Stream Type	E/C 5
--------------------	-------

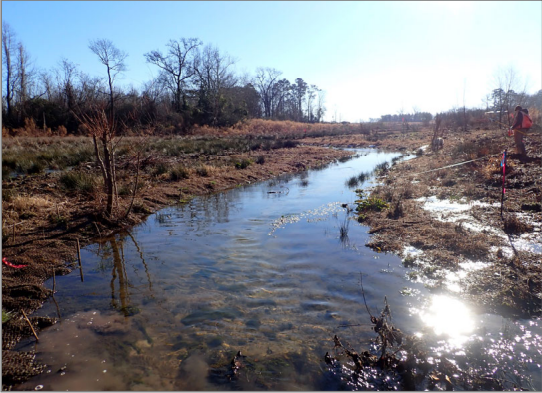
Station	Elevation
0.0	110.3
2.4	110.4
4.8	110.1
6.6	109.5
8.5	109.1
10.2	108.6
11.6	108.6
12.9	108.7
14.3	108.8
15.2	109.1
16.4	109.2
18.0	109.8
19.8	110.3
21.5	110.5
23.3	110.6
24.5	110.6

SUMMARY DATA	
Bankfull Elevation:	110.37
Bank Height Ratio:	1.00
Thalweg Elevation:	108.60
LTOB Elevation:	110.37
LTOB Max Depth:	1.77
LTOB Cross Sectional Area:	17.8

Stream Type E/C 5

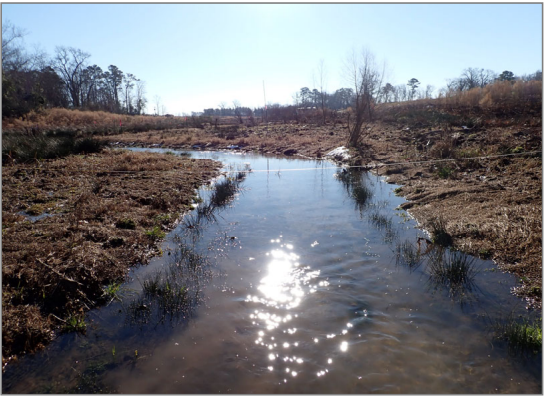
Station	Elevation
0.0	110.9
3.9	110.8
7.2	110.7
10.0	110.4
12.0	110.1
13.5	109.7
14.8	109.4
16.5	109.3
17.6	109.3
19.2	109.4
20.8	109.3
21.9	109.7
22.7	110.0
24.8	110.5
27.2	110.5
29.6	110.5
32.7	110.5

SUMMARY DATA	
Bankfull Elevation:	110.50
Bank Height Ratio:	1.00
Thalweg Elevation:	109.30
LTOB Elevation:	110.50
LTOB Max Depth:	1.20
LTOB Cross Sectional Area:	11.9

Stream Type	E/C 5
--------------------	-------

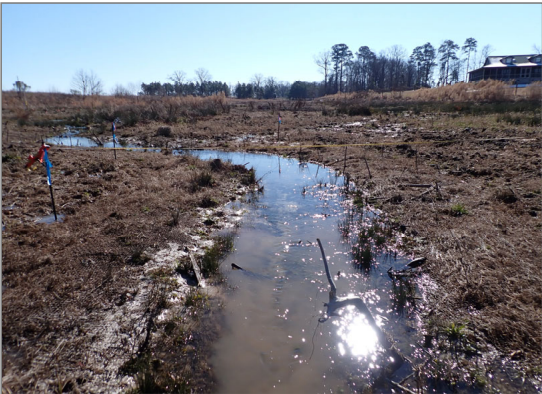
Station	Elevation
0.0	113.8
1.0	113.9
3.1	113.8
5.4	113.7
6.4	113.5
7.8	113.3
8.8	113.1
9.8	113.0
10.8	113.0
11.1	113.1
12.2	113.4
13.7	113.6
14.8	113.8
16.2	113.9
17.9	113.8
19.0	113.8

SUMMARY DATA	
Bankfull Elevation:	113.72
Bank Height Ratio:	1.00
Thalweg Elevation:	113.01
LTOB Elevation:	113.72
LTOB Max Depth:	0.70
LTOB Cross Sectional Area:	3.4

Stream Type	E/C 5
-------------	-------

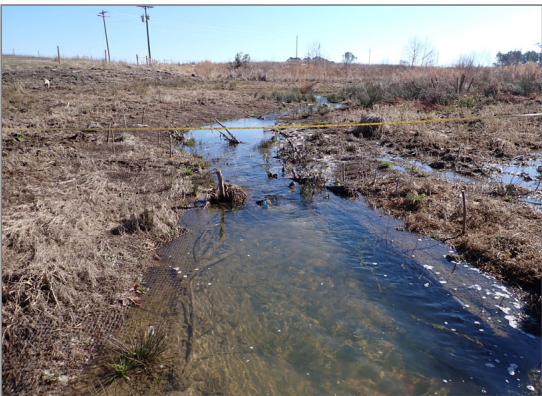
Station	Elevation
0.0	113.8
1.4	113.9
3.1	114.0
4.2	113.8
4.9	113.6
5.8	113.2
6.2	113.4
7.0	112.1
7.7	112.0
8.8	111.8
9.8	111.9
10.6	111.9
11.1	112.0
11.5	112.1
11.9	112.9
12.4	113.1
12.9	113.6
13.5	113.8
14.4	113.8
14.9	113.9
16.1	114.05
18.8	114.0

SUMMARY DATA	
Bankfull Elevation:	113.96
Bank Height Ratio:	1.00
Thalweg Elevation:	111.84
LTOB Elevation:	113.96
LTOB Max Depth:	2.11
LTOB Cross Sectional Area:	13.1

Stream Type	E/C 5
--------------------	-------

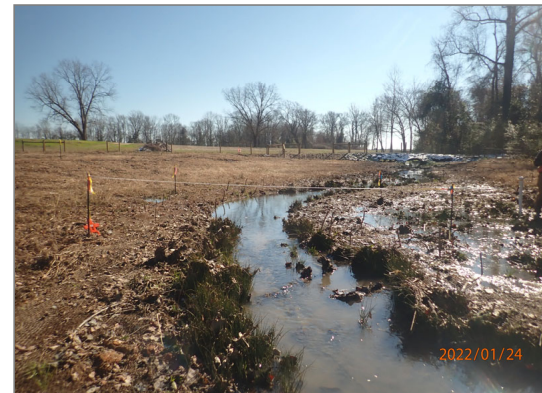
Station	Elevation
0.0	120.2
2.4	120.3
4.4	120.4
5.8	120.4
6.6	119.8
7.2	120.0
8.0	119.8
8.6	119.9
10.0	119.9
11.0	120.1
12.2	120.5
12.9	120.7
13.9	120.8
14.6	120.7
18.0	120.8

SUMMARY DATA	
Bankfull Elevation:	120.40
Bank Height Ratio:	1.00
Thalweg Elevation:	119.79
LTOB Elevation:	120.40
LTOB Max Depth:	0.60
LTOB Cross Sectional Area:	2.9

Stream Type E/C 5

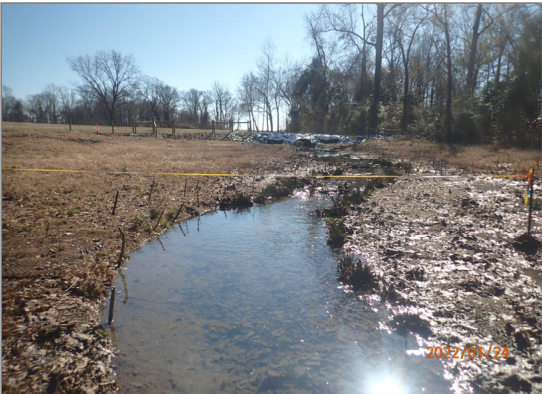
Site	Swamp Grape Site
Watershed:	Lumber River Basin, 03040204
XS ID	UT1, XS - 8, Pool
Feature	Pool
Date:	9/29/2021
Field Crew:	Perkinson

Station	Elevation
0.0	120.4
1.9	120.4
4.8	120.4
6.4	120.1
7.6	119.9
8.8	119.4
9.8	119.2
10.4	119.2
11.2	119.1
11.9	119.7
13.1	119.8
13.2	120.4
15.8	120.6
17.0	120.8
19.1	120.8

SUMMARY DATA	
Bankfull Elevation:	120.44
Bank Height Ratio:	1.00
Thalweg Elevation:	119.11
LTOB Elevation:	120.44
LTOB Max Depth:	1.33
LTOB Cross Sectional Area:	6.5

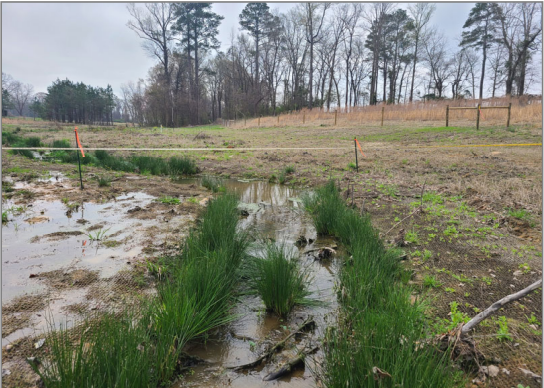
Station	Elevation
0.0	116.6
1.3	116.8
3.0	116.8
4.8	116.6
9.4	116.6
9.6	116.6
11.3	116.9
13.7	116.7
15.0	116.6
16.2	116.5
17.1	116.1
17.8	115.9
18.9	116.0
20.0	115.8
20.4	115.9
21.1	116.2
21.7	116.4
22.6	116.4
23.1	116.7
24.5	116.6
26.0	116.72
27.5	116.7
29.0	116.6

SUMMARY DATA	
Bankfull Elevation:	116.68
Bank Height Ratio:	1.00
Thalweg Elevation:	115.79
LTOB Elevation:	116.68
LTOB Max Depth:	0.89
LTOB Cross Sectional Area:	3.9

Stream Type	E/C 5
-------------	-------

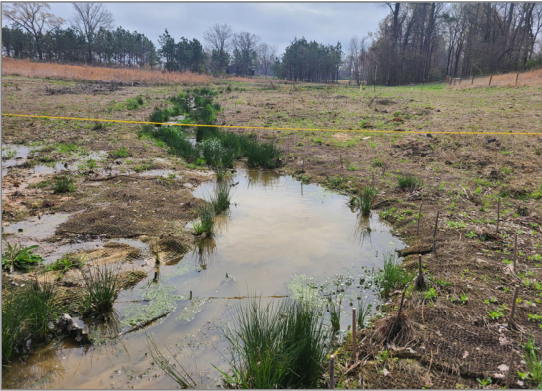
Station	Elevation
0.0	116.8
2.2	116.9
4.2	116.8
4.2	116.8
5.9	116.6
6.4	116.4
7.0	116.1
7.8	115.6
8.9	115.5
10.3	115.5
11.4	115.6
12.4	115.7
13.1	115.8
13.8	116.2
14.5	116.3
15.1	116.5
15.6	116.5
16.9	116.7
17.7	116.7
18.6	116.8
20.0	116.71
21.6	116.8

SUMMARY DATA	
Bankfull Elevation:	116.80
Bank Height Ratio:	1.00
Thalweg Elevation:	115.47
LTOB Elevation:	116.80
LTOB Max Depth:	1.34
LTOB Cross Sectional Area:	9.6

Stream Type	E/C 5
--------------------	-------

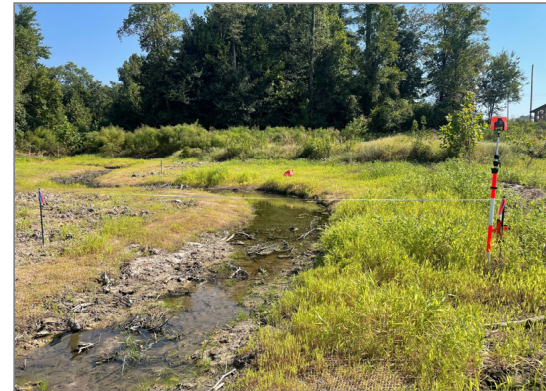
Station	Elevation
0.0	112.6
2.0	112.6
2.1	112.6
3.4	112.6
4.8	112.7
6.3	112.5
6.6	112.2
7.9	112.0
9.6	111.5
10.4	111.9
11.5	112.2
12.3	112.1
13.2	112.1
14.0	112.5
15.2	112.6
16.5	112.8
18.3	112.9
20.4	113.0

SUMMARY DATA	
Bankfull Elevation:	112.69
Bank Height Ratio:	1.00
Thalweg Elevation:	111.54
LTOB Elevation:	112.69
LTOB Max Depth:	1.15
LTOB Cross Sectional Area:	5.9

Stream Type	E/C 5
--------------------	-------

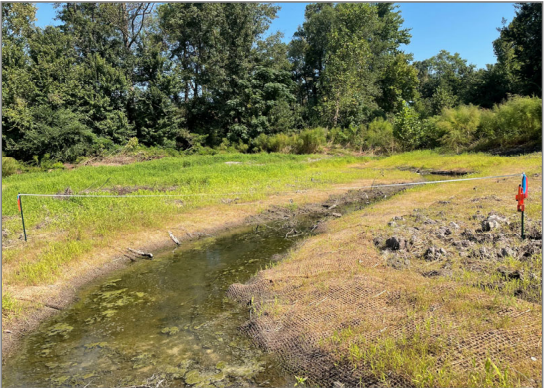
Station	Elevation
0.0	112.9
2.1	112.9
4.1	112.9
6.4	112.8
7.8	112.5
9.0	112.2
10.1	111.8
11.2	111.6
12.2	111.4
12.9	111.3
14.2	111.5
15.2	111.5
16.5	111.8
17.5	112.2
19.0	113.0
20.8	113.0
23.2	113.2

SUMMARY DATA	
Bankfull Elevation:	112.84
Bank Height Ratio:	1.00
Thalweg Elevation:	111.30
LTOB Elevation:	112.84
LTOB Max Depth:	1.54
LTOB Cross Sectional Area:	11.4

Stream Type	E/C 5
-------------	-------

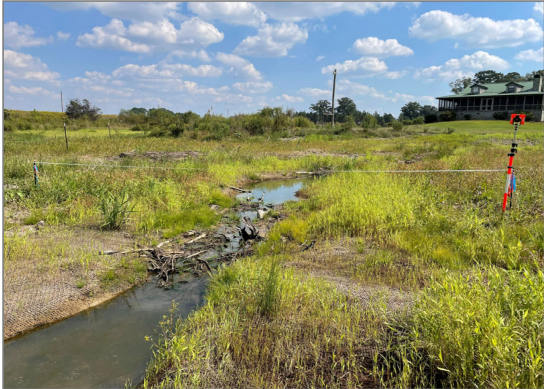
Site	Swamp Grape Site
Watershed:	Lumber River Basin, 03040204
XS ID	UT2, XS - 12, Riffle
Feature	Riffle
Date:	9/29/2021
Field Crew:	Harris, Adams

Station	Elevation
0.0	114.3
3.4	114.2
6.4	114.0
9.5	113.8
11.6	113.7
13.3	113.5
14.3	113.5
15.0	113.3
15.4	113.5
16.1	113.6
17.0	113.9
18.5	114.0
21.2	114.3
24.6	114.1
27.3	114.0
28.7	113.8

SUMMARY DATA	
Bankfull Elevation:	114.20
Bank Height Ratio:	1.00
Thalweg Elevation:	113.28
LTOB Elevation:	114.20
LTOB Max Depth:	0.92
LTOB Cross Sectional Area:	6.0

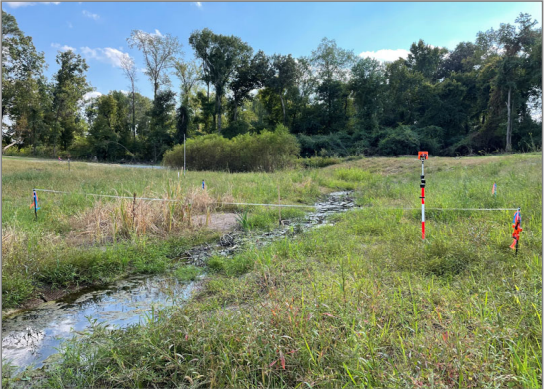
Station	Elevation
0.0	114.8
3.3	115.0
7.0	115.0
10.0	115.0
11.5	114.7
12.3	114.7
12.7	114.4
13.2	114.4
14.3	114.4
14.9	114.3
15.8	114.3
16.5	114.4
17.0	114.6
18.2	114.8
19.5	115.1
21.3	115.0
23.5	115.2
26.2	115.2
28.4	115.2
29.8	115.4

SUMMARY DATA	
Bankfull Elevation:	114.95
Bank Height Ratio:	1.00
Thalweg Elevation:	114.27
LTOB Elevation:	114.95
LTOB Max Depth:	0.68
LTOB Cross Sectional Area:	3.5

Stream Type | E/C 5

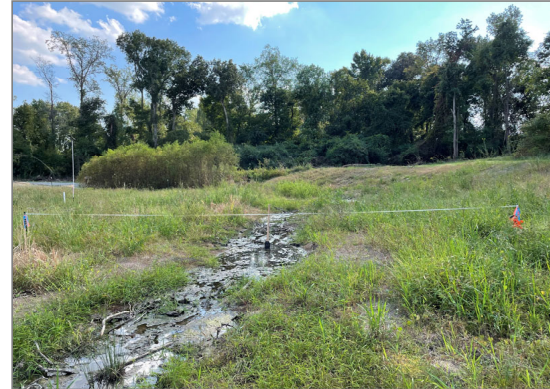
Station	Elevation
0.0	115.4
2.4	115.5
5.3	115.1
8.5	115.2
10.4	115.2
11.3	114.9
12.1	114.4
13.3	114.0
14.4	113.9
15.7	113.8
16.7	114.0
17.9	114.3
18.8	114.7
20.5	114.9
21.9	115.1
24.0	115.1
25.2	115.4
27.5	115.2
29.2	115.3
31.2	115.4

SUMMARY DATA	
Bankfull Elevation:	115.20
Bank Height Ratio:	1.00
Thalweg Elevation:	113.78
LTOB Elevation:	115.20
LTOB Max Depth:	1.42
LTOB Cross Sectional Area:	9.2

Stream Type	E/C 5
-------------	-------

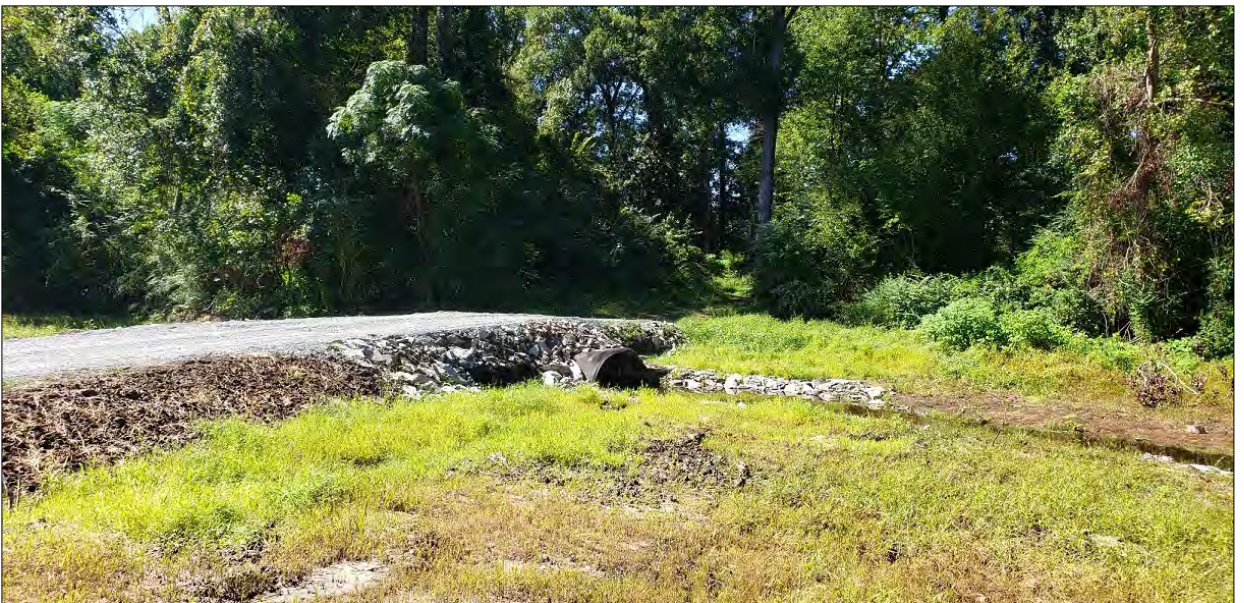
09/23/2021, UT-1 Crossing

The UT-1 crossing was designed as an in-place culvert/crossing upgrade with a final roadbed elevation of 135.00, 3-feet higher than the existing roadbed elevation, and an elevation difference of 9.5-feet between the invert out and roadbed elevation. Given the concern noted above, the following modification to the culvert replacement was made.

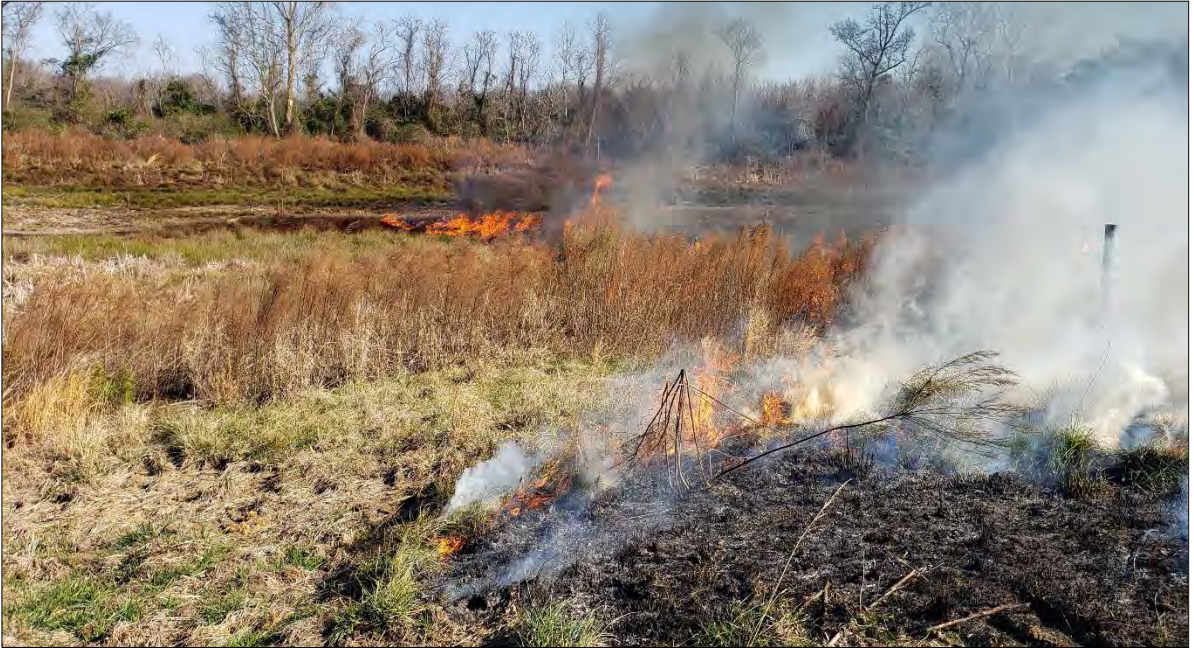
01/14/2022, Controlled burn for herbaceous species control prior to bare-root/live-stake planting

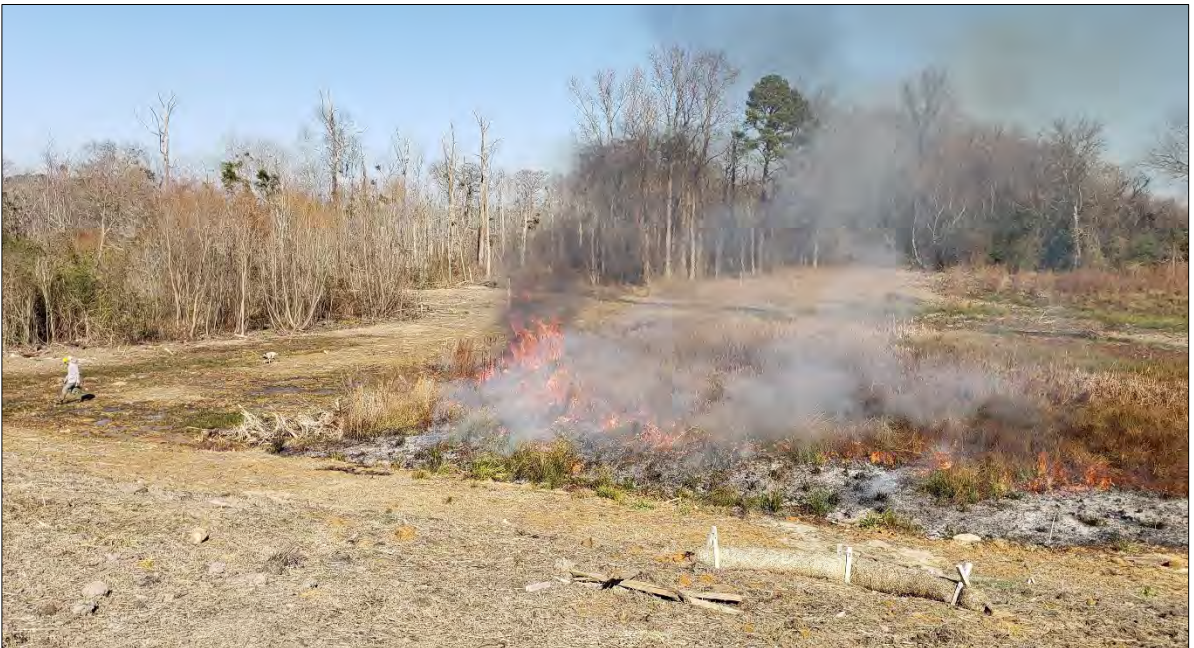
01/14/2022, Controlled burn for herbaceous species control prior to bare-root/live-stake planting

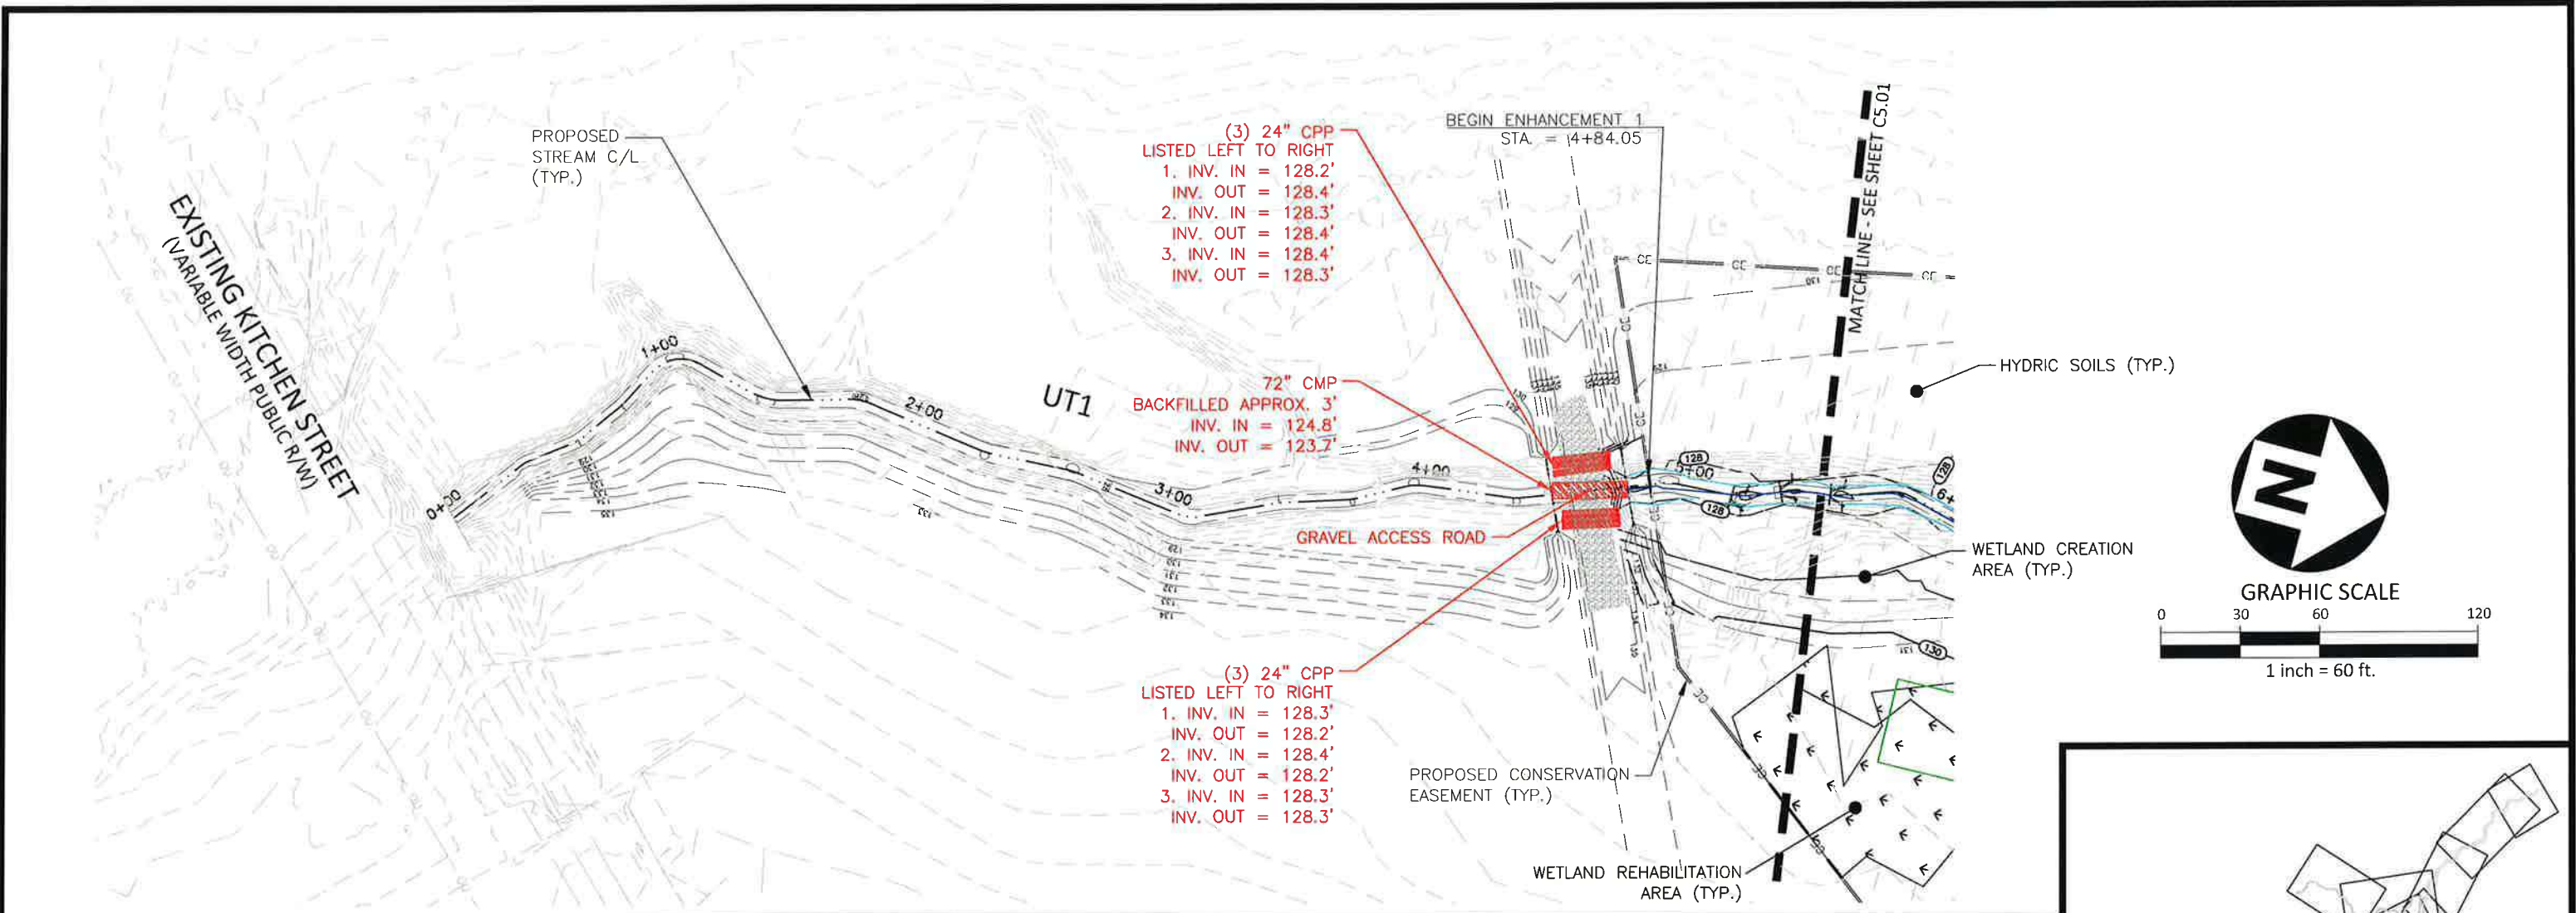
AS-BUILT SITE GRADING
C3.00

(3) 24" CPP LISTED LEFT TO RIGHT
 1. INV. IN = 128.2' INV. OUT = 128.4'
 2. INV. IN = 128.3' INV. OUT = 128.4'
 3. INV. IN = 128.4' INV. OUT = 128.3'

72" CMP BACKFILLED APPROX. 3'
 INV. IN = 124.8' INV. OUT = 123.7'

(3) 24" CPP LISTED LEFT TO RIGHT
 1. INV. IN = 128.3' INV. OUT = 128.2'
 2. INV. IN = 128.4' INV. OUT = 128.2'
 3. INV. IN = 128.3' INV. OUT = 128.3'

Response: We have removed the as-built grading drawing and replaced it with a figure showing topographic contour lines.
