Baseline Monitoring Report

MAPLE SWAMP BUFFER MITIGATION SITE

Edgecombe County, NC

DMS ID No. 100189

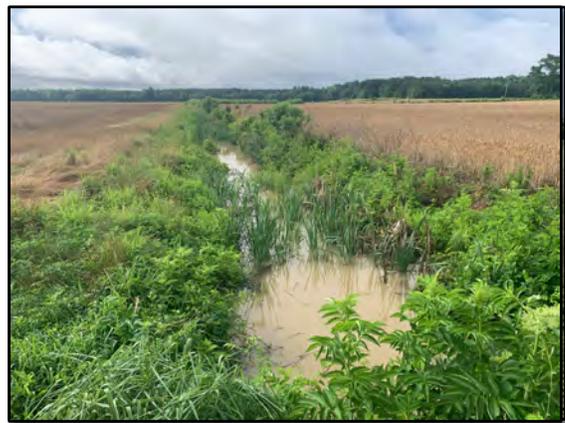
NW view at Project origin (June 2021)

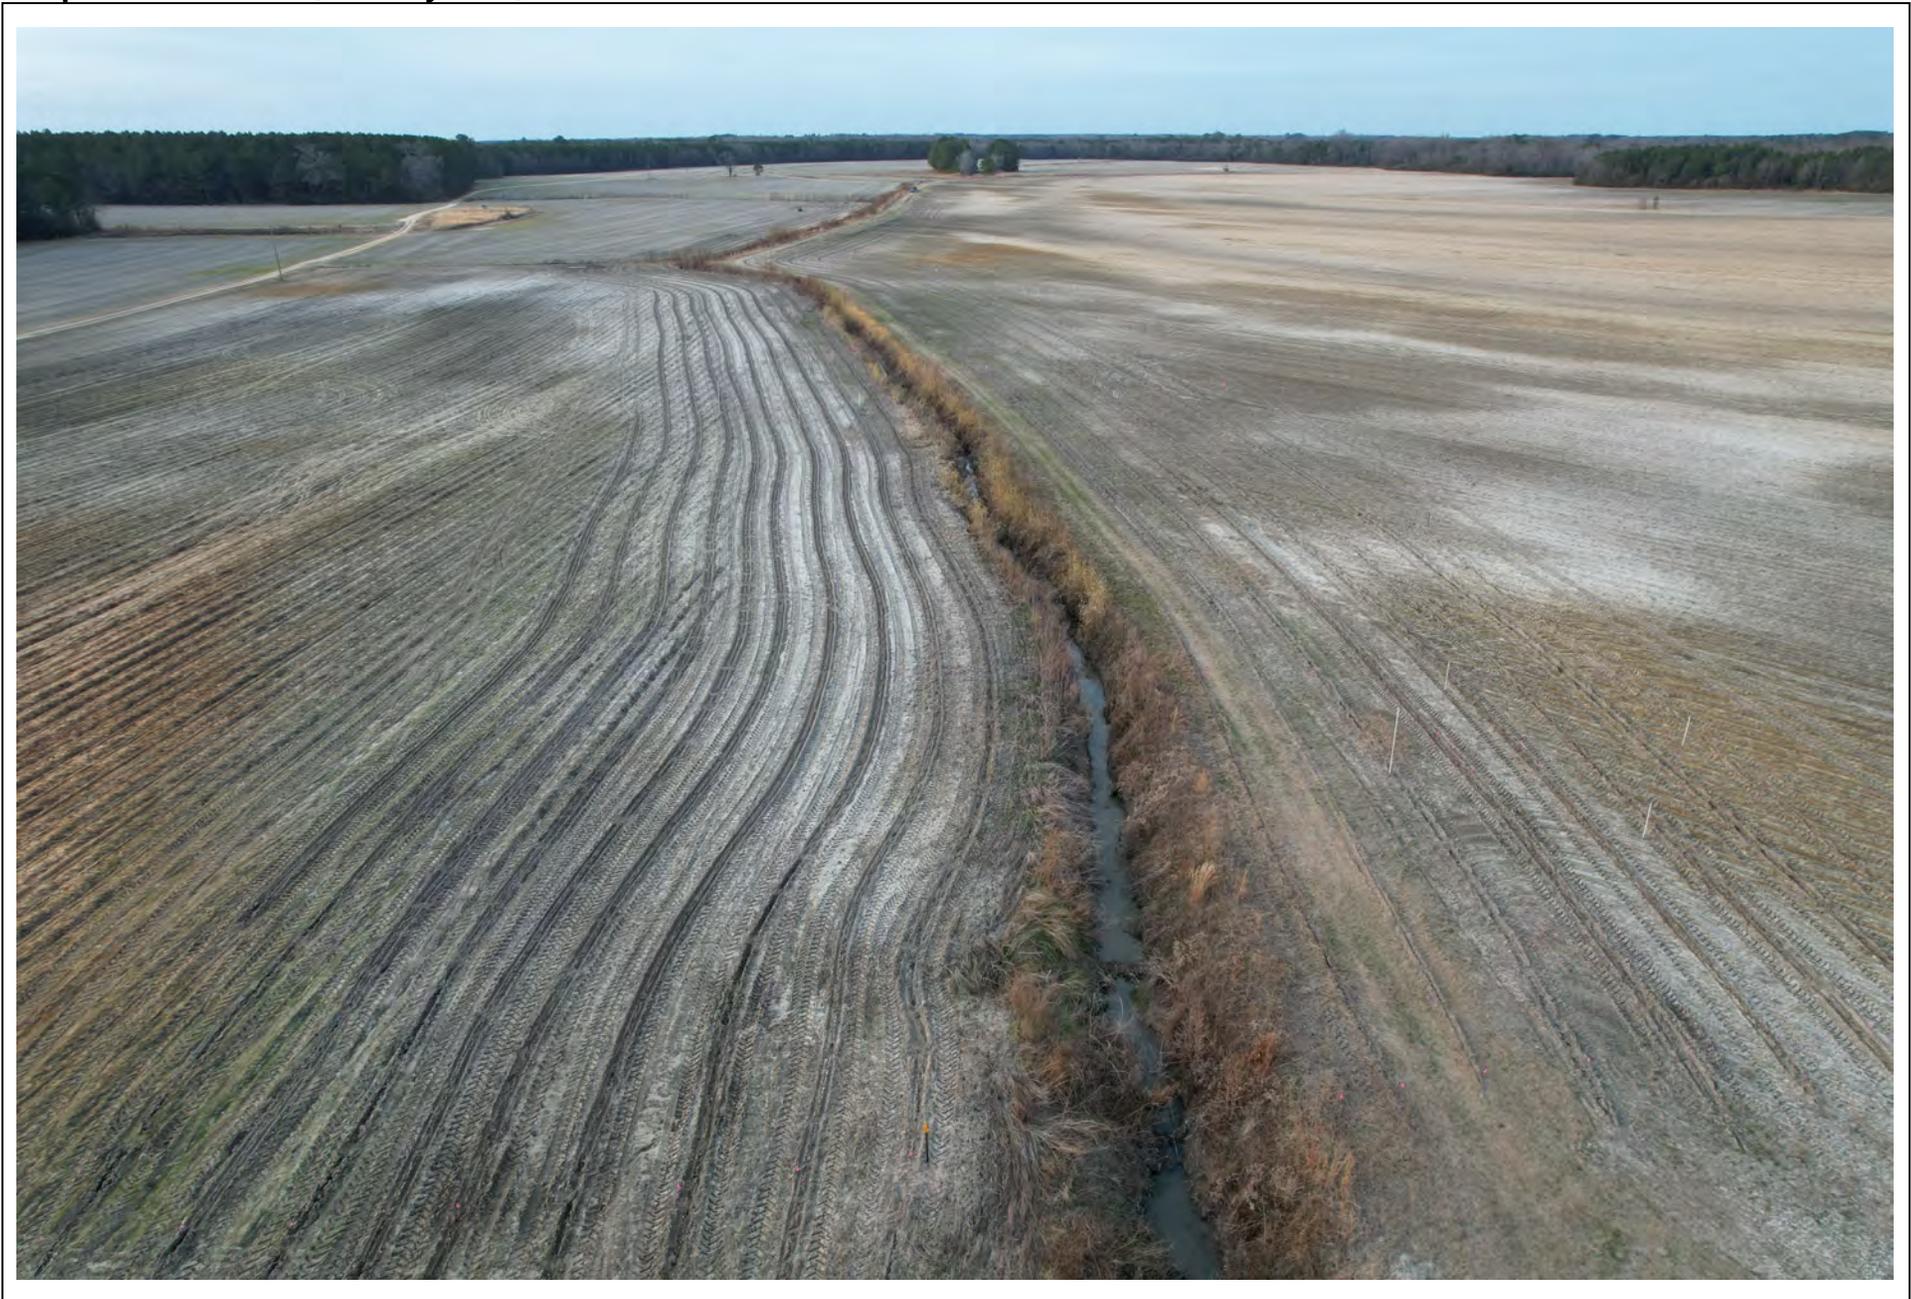
Site post construction (February 2022)
