AS-BUILT BASELINE MONITORING REPORT

DOUBLE H FARMS MITIGATION SITE

Alleghany County, NC
DEQ Contract No. 7608
DMS Project No. 100082

Data Collection Period: September 2021 – January 2022
Submission Date: April 29, 2022

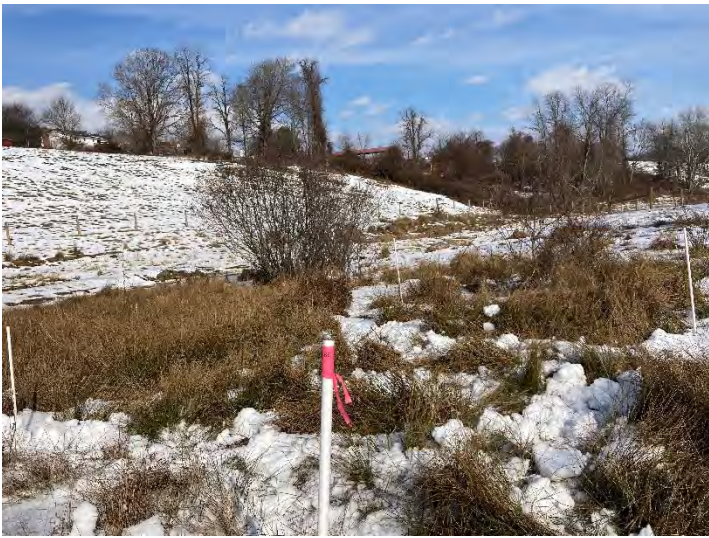
BOG VEGETATION PLOT 1 (1/27/2022)

Bog Plot 1					
Absolute Plot Cover	Species ¹			Wetland Indicator Status	Dominant Species?
	Scientific Name	Common Name	% of total cover		
95%	<i>Juncus effusus</i>	Soft Rush	80%	FACW	Y
	<i>Carex lurida</i>	Shallow Sedge	5%	OBL	N
	<i>Microstegium vimineum</i>	Japanese Stiltgrass	5%	FAC	N
	<i>Unknown grass sp.</i>	N/A	5%	N/A	N

1. Plots were covered in snow at the time of the MY0 assessment. Dormant species were difficult to ID to species and a more thorough review will be conducted in MY1.

The herbaceous bog turtle habitat as visually monitored in MY0. Both bog vegetation plots had at least 80% vegetated cover and the dominant species had a wetland indicator status of FACW. There were no native woody species or invasive species observed in either plot. During the time of data collection in January 2022, snow cover obscured portions of the plots making it difficult to identify species and estimate coverage. However, in both plots *Juncus effusus* was clearly dominant as is clearly visible in the bog vegetation plot photos. More detailed herbaceous data will be reported in the Year 1 monitoring report. Summary data and photographs of each plot can be found in Appendix 3.

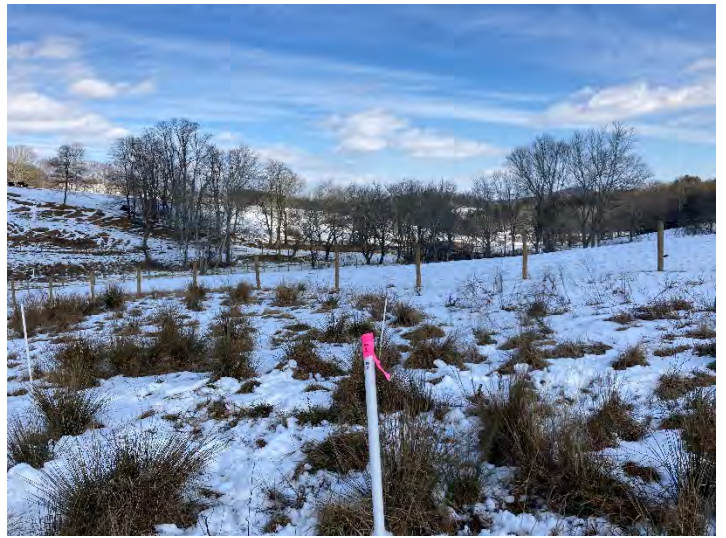
BOG VEGETATION PLOT 2 (1/27/2022)

Bog Plot 2					
Absolute Plot Cover	Species ¹			Wetland Indicator Status	Dominant Species?
	Scientific Name	Common Name	% of total cover		
95%	<i>Juncus effusus</i>	Soft Rush	75%	FACW	Y
	<i>Carex lurida</i>	Shallow Sedge	5%	OBL	N
	<i>Bidens laevis</i>	Smooth Beggarticks	5%	OBL	N
	<i>Microstegium vimineum</i>	Japanese Stiltgrass	5%	FAC	N
	<i>Unknown sedge sp.</i>	N/A	5%	N/A	N

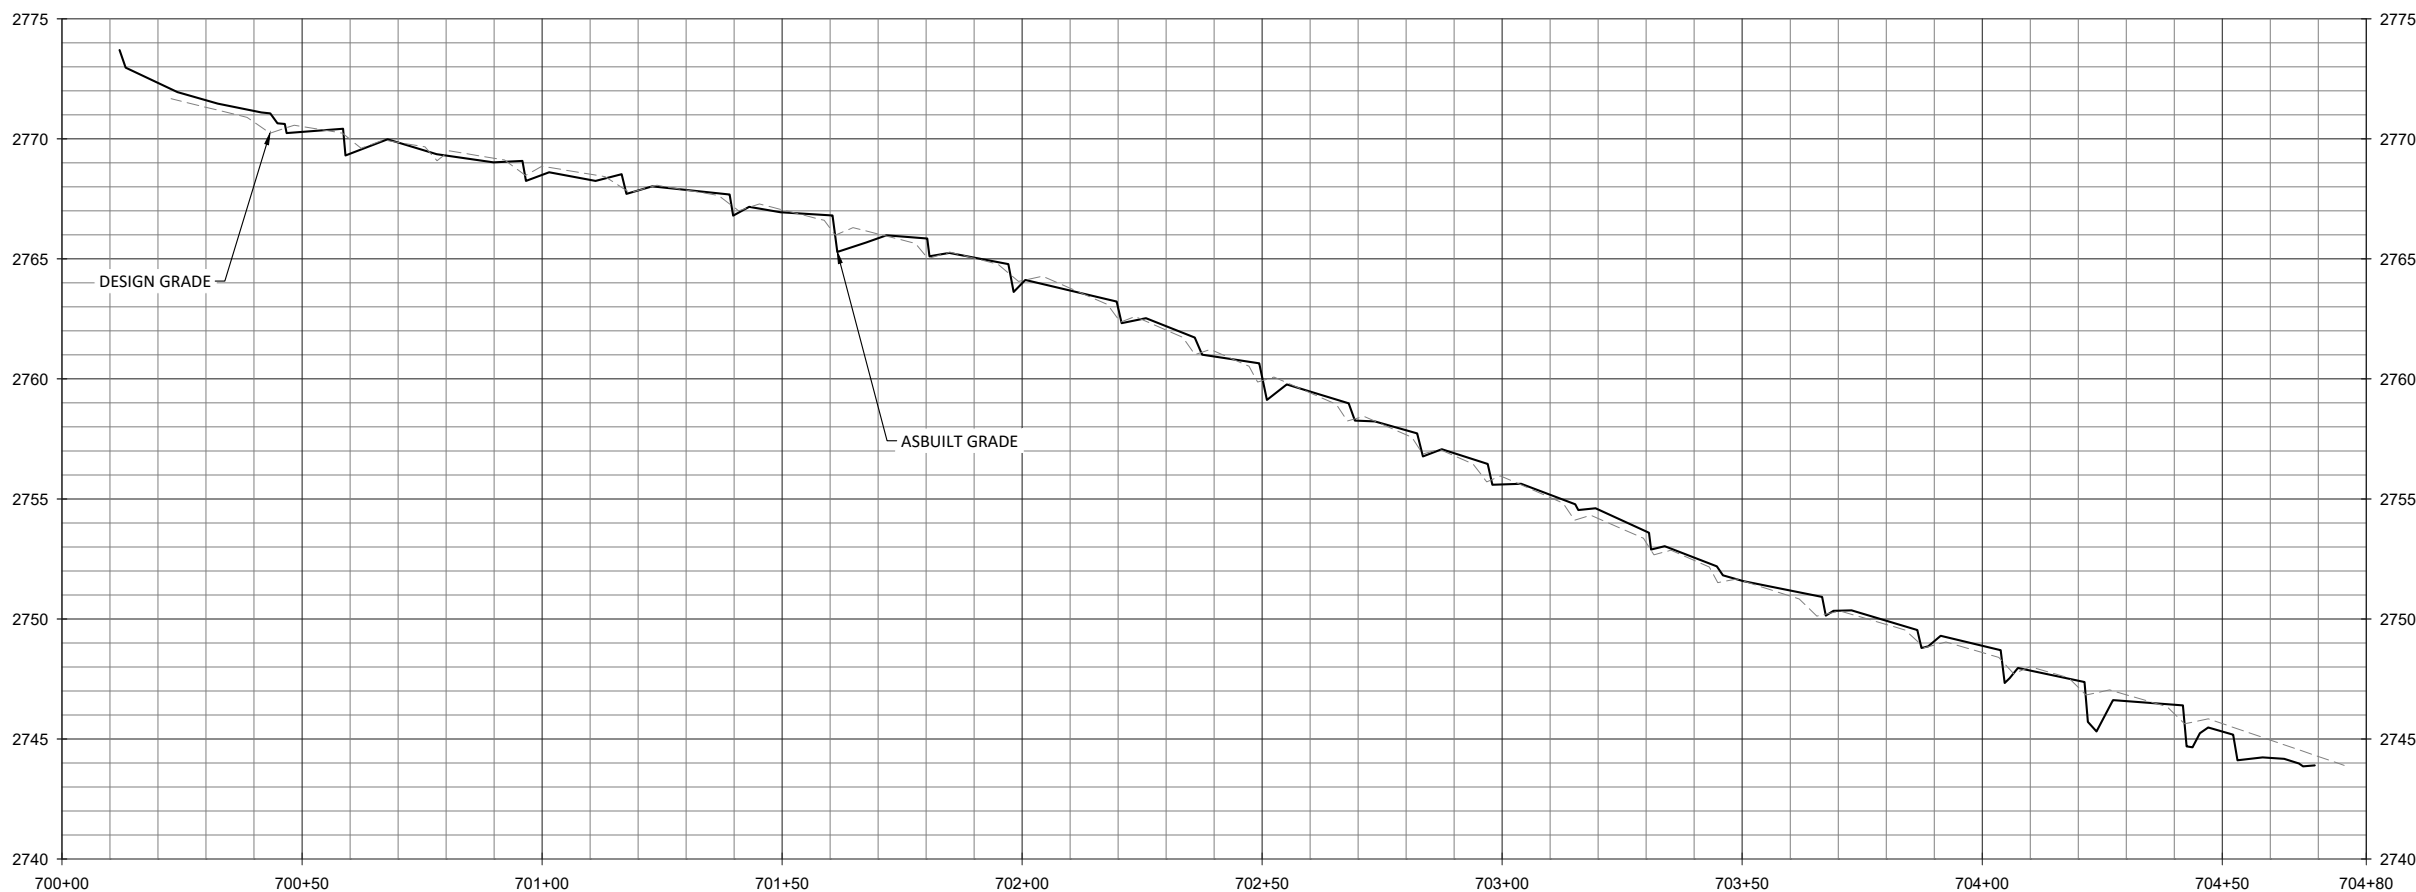
NOTE: SILLS ADDED AT THE RIFFLE TOE FOR STABILITY
 STA: 701+60, 701+80, 701+97, 702+20, 702+36, 702+49, 702+68,
 702+83, 702+97, 703+15, 703+30, 703+45, 703+67, 703+86,
 704+04, 704+21, 704+41
