# As-built Baseline Monitoring Report FINAL Blair Creek Mitigation Project

Clay County, North Carolina

DMS Project ID No. 100047

Baseline Data Collection Period: Dec. 2021 to Feb. 2022

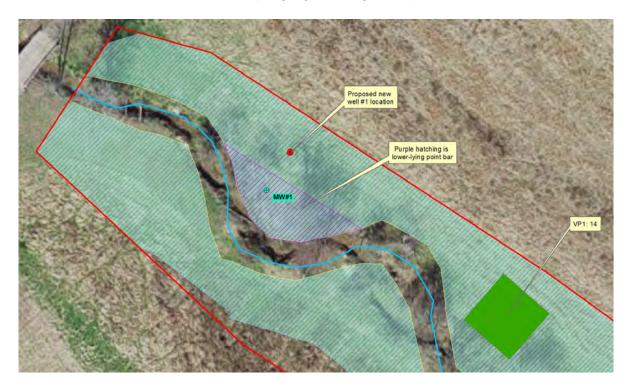
- Monitoring Well #1 is located in an area approximately 1' lower than surrounding wetland reestablishment area. Recommend adding an additional well to document hydrology throughout reestablishment area.

- Response: Well #1 was placed where it is simply because that's roughly where it was shown on the proposed monitoring figure in the mitigation plan. However, as noted, it is currently found within a lower-lying portion of a point bar, as compared to the rest of the left bank floodplain. As this portion of the point bar is much smaller (only about 1,500 ft² or 0.03 ac) and quite obviously wetter than the adjacent floodplain (and thus not truly representative of the restoration area as a whole), Baker would prefer to relocate this well about 15-20 ft farther away from the channel and into the middle of the floodplain where the bulk of the wetland reestablishment is found (see proposed map below).

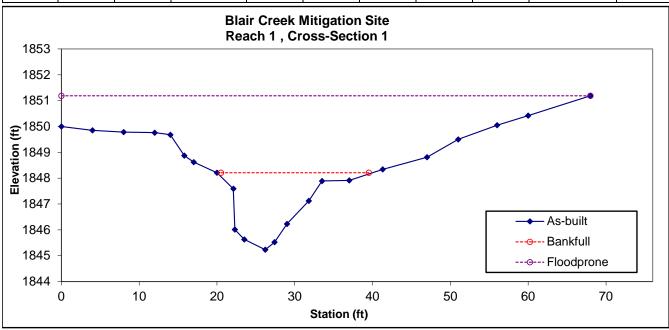
Looking at the Left Bank

Stream			BKF	Max BKF					
Feature	Type	BKF Area	BKF Width	Depth	Depth	W/D	BH Ratio	ER	BKF Elev	TOB Elev
Pool		25.48	20.00	1.27	2.98	15.75			1848.21	1848.21

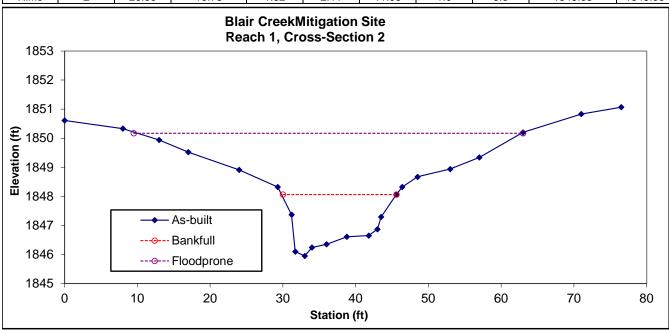
Looking at the Right Bank

Stream			BKF	Max BKF					
Feature	Type	BKF Area	BKF Width	Depth	Depth	W/D	BH Ratio	ER	BKF Elev	TOB Elev
Riffle	E	20.85	15.78	1.32	2.11	11.95	1.0	3.3	1848.06	1848.06

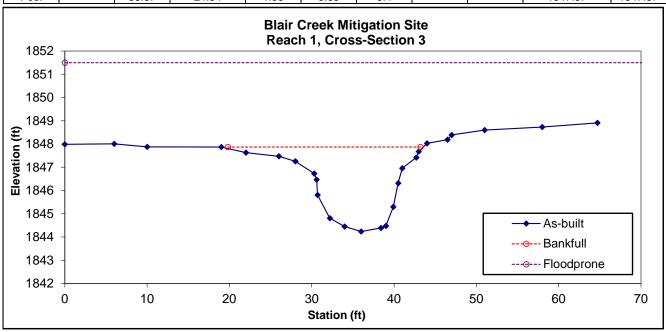
Looking at the Right Bank

Stream			BKF	Max BKF					
١	Feature	Type	BKF Area	BKF Width	Depth	Depth	W/D	BH Ratio	ER	BKF Elev	TOB Elev
Ī	Pool		38.37	24.54	1.56	3.63	9.4			1847.87	1847.87

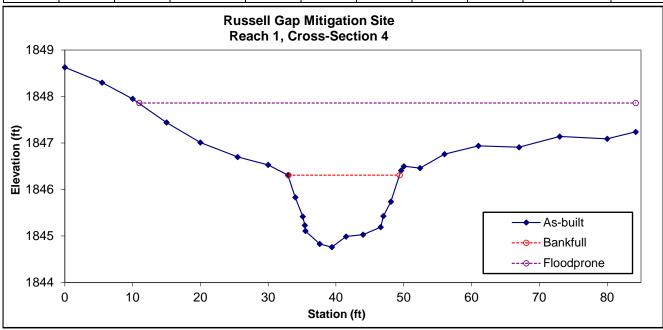
Looking at the Right Bank

Stream			BKF	Max BKF					
	Feature	Type	BKF Area	BKF Width	Depth	Depth	W/D	BH Ratio	ER	BKF Elev	TOB Elev
ſ	Riffle	С	17.9	16.5	1.1	1.6	15.1	1.0	4.5	1846.31	1846.31

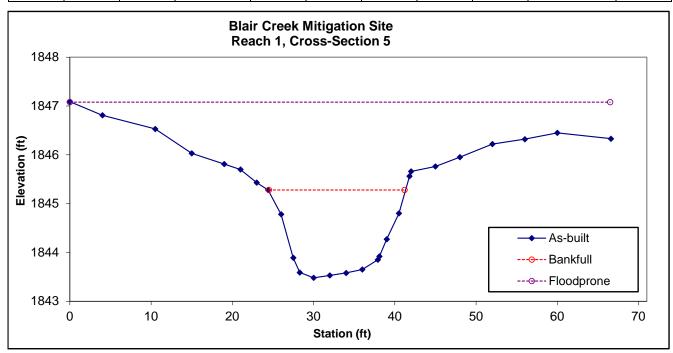
Looking at the Right Bank

Stream			BKF	Max BKF					
Feature	Type	BKF Area	BKF Width	Depth	Depth	W/D	BH Ratio	ER	BKF Elev	TOB Elev
Riffle	С	21.9	16.9	1.3	1.8	13.0	1.0	3.9	1845.28	1845.28

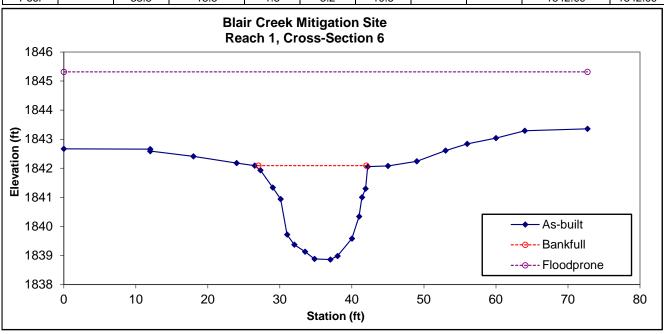
Looking at the Right Bank

Stream			BKF	Max BKF					
Feature	Type	BKF Area	BKF Width	Depth	Depth	W/D	BH Ratio	ER	BKF Elev	TOB Elev
Pool		33.5	18.8	1.8	3.2	10.5			1842.09	1842.09

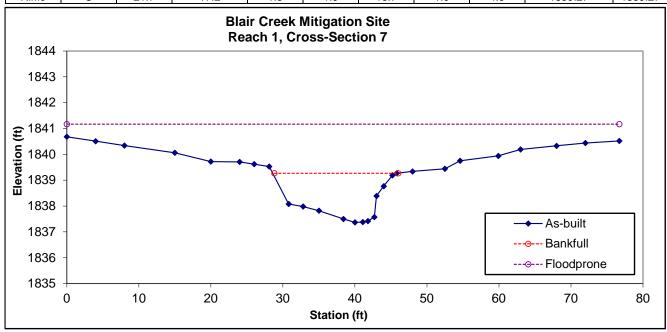
Looking at the Right Bank

Stream			BKF	Max BKF					
Feature	Type	BKF Area	BKF Width	Depth	Depth	W/D	BH Ratio	ER	BKF Elev	TOB Elev
Riffle	С	21.7	17.2	1.3	1.9	13.7	1.0	4.5	1839.27	1839.27

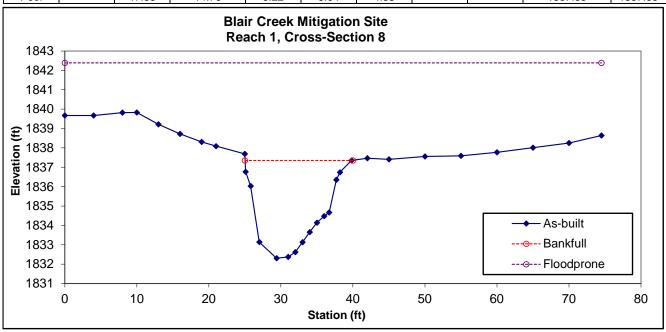
Looking at the Right Bank

Stream			BKF	Max BKF					
Feature	Type	BKF Area	BKF Width	Depth	Depth	W/D	BH Ratio	ER	BKF Elev	TOB Elev
Pool		47.58	14.76	3.22	5.04	4.58			1837.35	1837.35

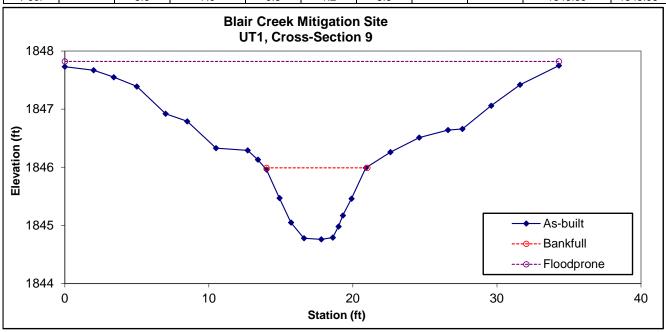
Looking at the Right Bank

Stream			BKF	Max BKF					
	Feature	Type	BKF Area	BKF Width	Depth	Depth	W/D	BH Ratio	ER	BKF Elev	TOB Elev
Γ	Pool		5.6	7.0	0.8	1.2	8.8			1845.99	1845.99

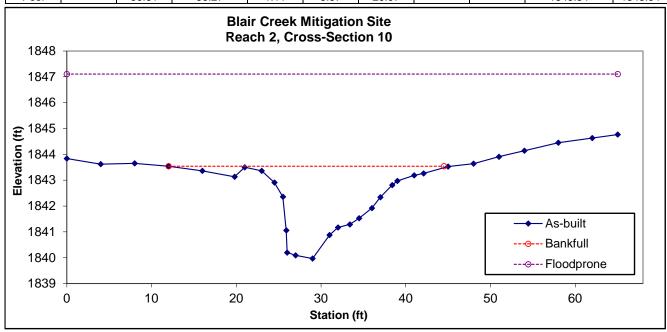
Looking at the Right Bank

Stream			BKF	Max BKF					
١	Feature	Type	BKF Area	BKF Width	Depth	Depth	W/D	BH Ratio	ER	BKF Elev	TOB Elev
Ī	Pool		36.81	33.27	1.11	3.57	29.97			1843.54	1843.54

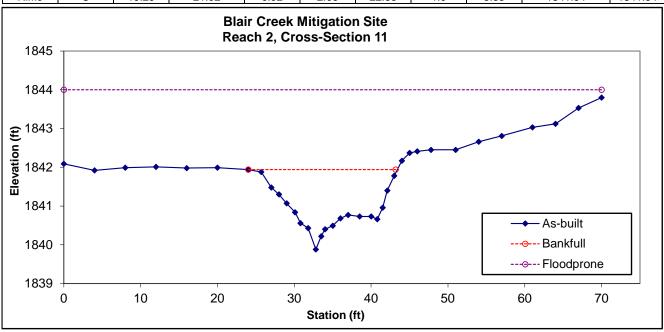
Looking at the Right Bank

Stream			BKF	Max BKF						ı
Feature	Type	BKF Area	BKF Width	Depth	Depth	W/D	BH Ratio	ER	BKF Elev	TOB Elev	ı
Riffle	С	19.29	21.02	0.92	2.06	22.85	1.0	3.33	1841.94	1841.94	l

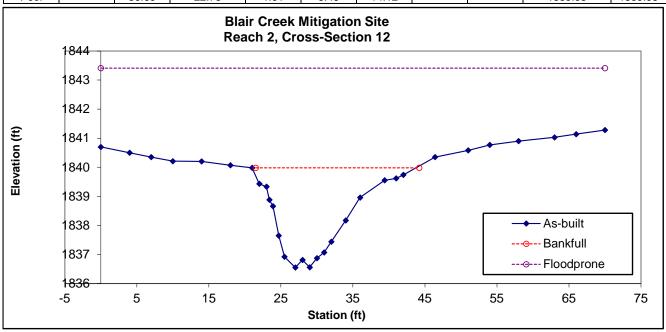
Looking at the Right Bank

Stream			BKF	Max BKF					
	Feature	Type	BKF Area	BKF Width	Depth	Depth	W/D	BH Ratio	ER	BKF Elev	TOB Elev
Ī	Pool		36.69	22.73	1.61	3.43	14.12			1839.98	1839.98

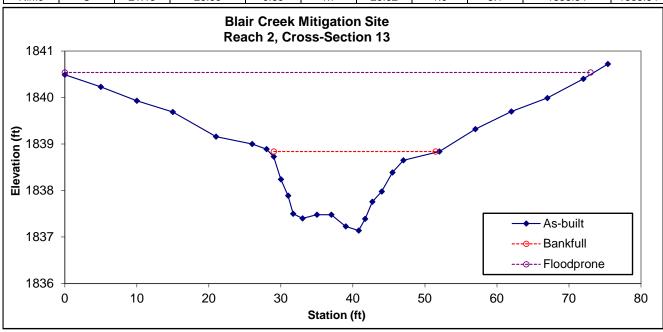
Looking at the Right Bank

Stream			BKF	Max BKF					
Feature	Type	BKF Area	BKF Width	Depth	Depth	W/D	BH Ratio	ER	BKF Elev	TOB Elev
Riffle	С	21.13	23.69	0.89	1.7	26.62	1.0	3.1	1838.84	1838.84

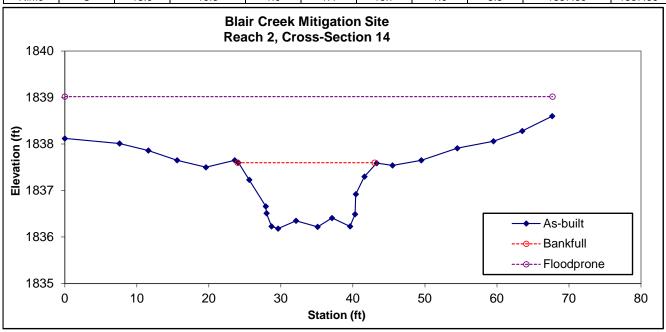
Looking at the Right Bank

١		Stream			BKF	Max BKF					
	Feature	Type	BKF Area	BKF Width	Depth	Depth	W/D	BH Ratio	ER	BKF Elev	TOB Elev
	Riffle	С	18.9	19.3	1.0	1.4	19.7	1.0	3.5	1837.60	1837.60

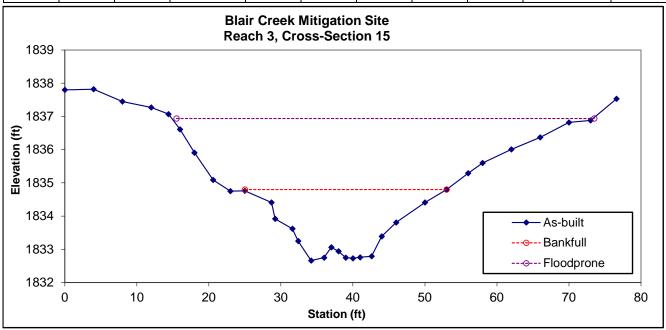
Looking at the Right Bank

Stream			BKF	Max BKF					
	Feature	Type	BKF Area	BKF Width	Depth	Depth	W/D	BH Ratio	ER	BKF Elev	TOB Elev
ſ	Riffle	В	33.01	30.4	1.1	2.14	27.8	1	1.93	1834.8	1834.8

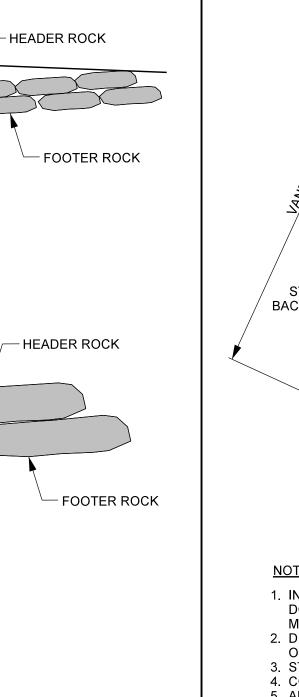
**SECTION A - A**

**NOTES FOR ALL VANE STRUCTURES:**

6. BOULDER SILL MUST BE A MINIMUM OF 6'.

4% TO 7% SLOPE

PROFILE VIEW

REACH 2 15' 2'x3'x4'
