MONITORING YEAR 0 ANNUAL REPORT FINAL

OAK HILL DAIRY MITIGATION SITE

Gaston County, NC
Catawba River basin
HUC 03050102

DMS Project No. 100120

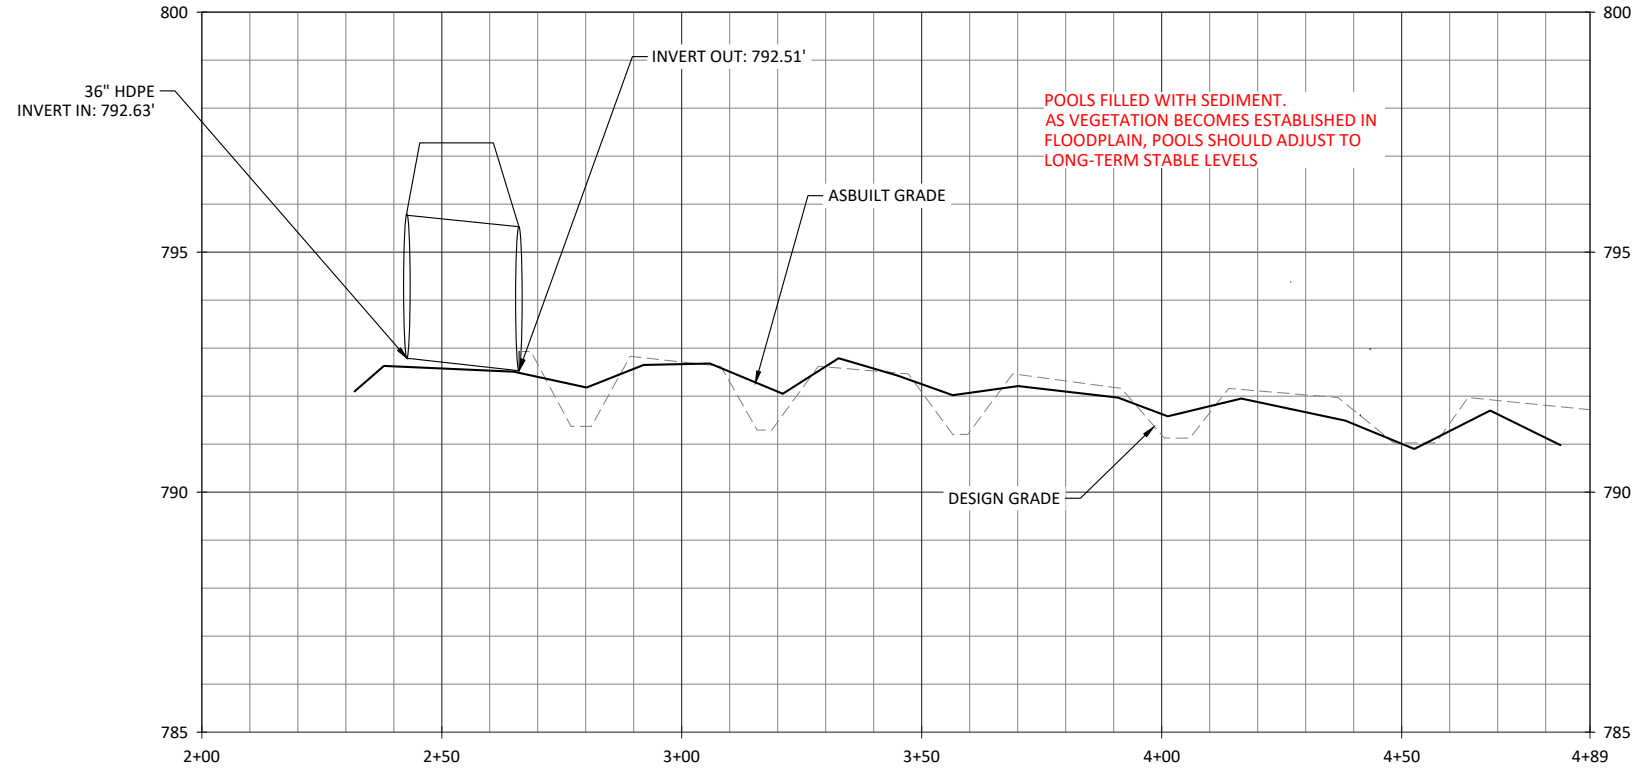
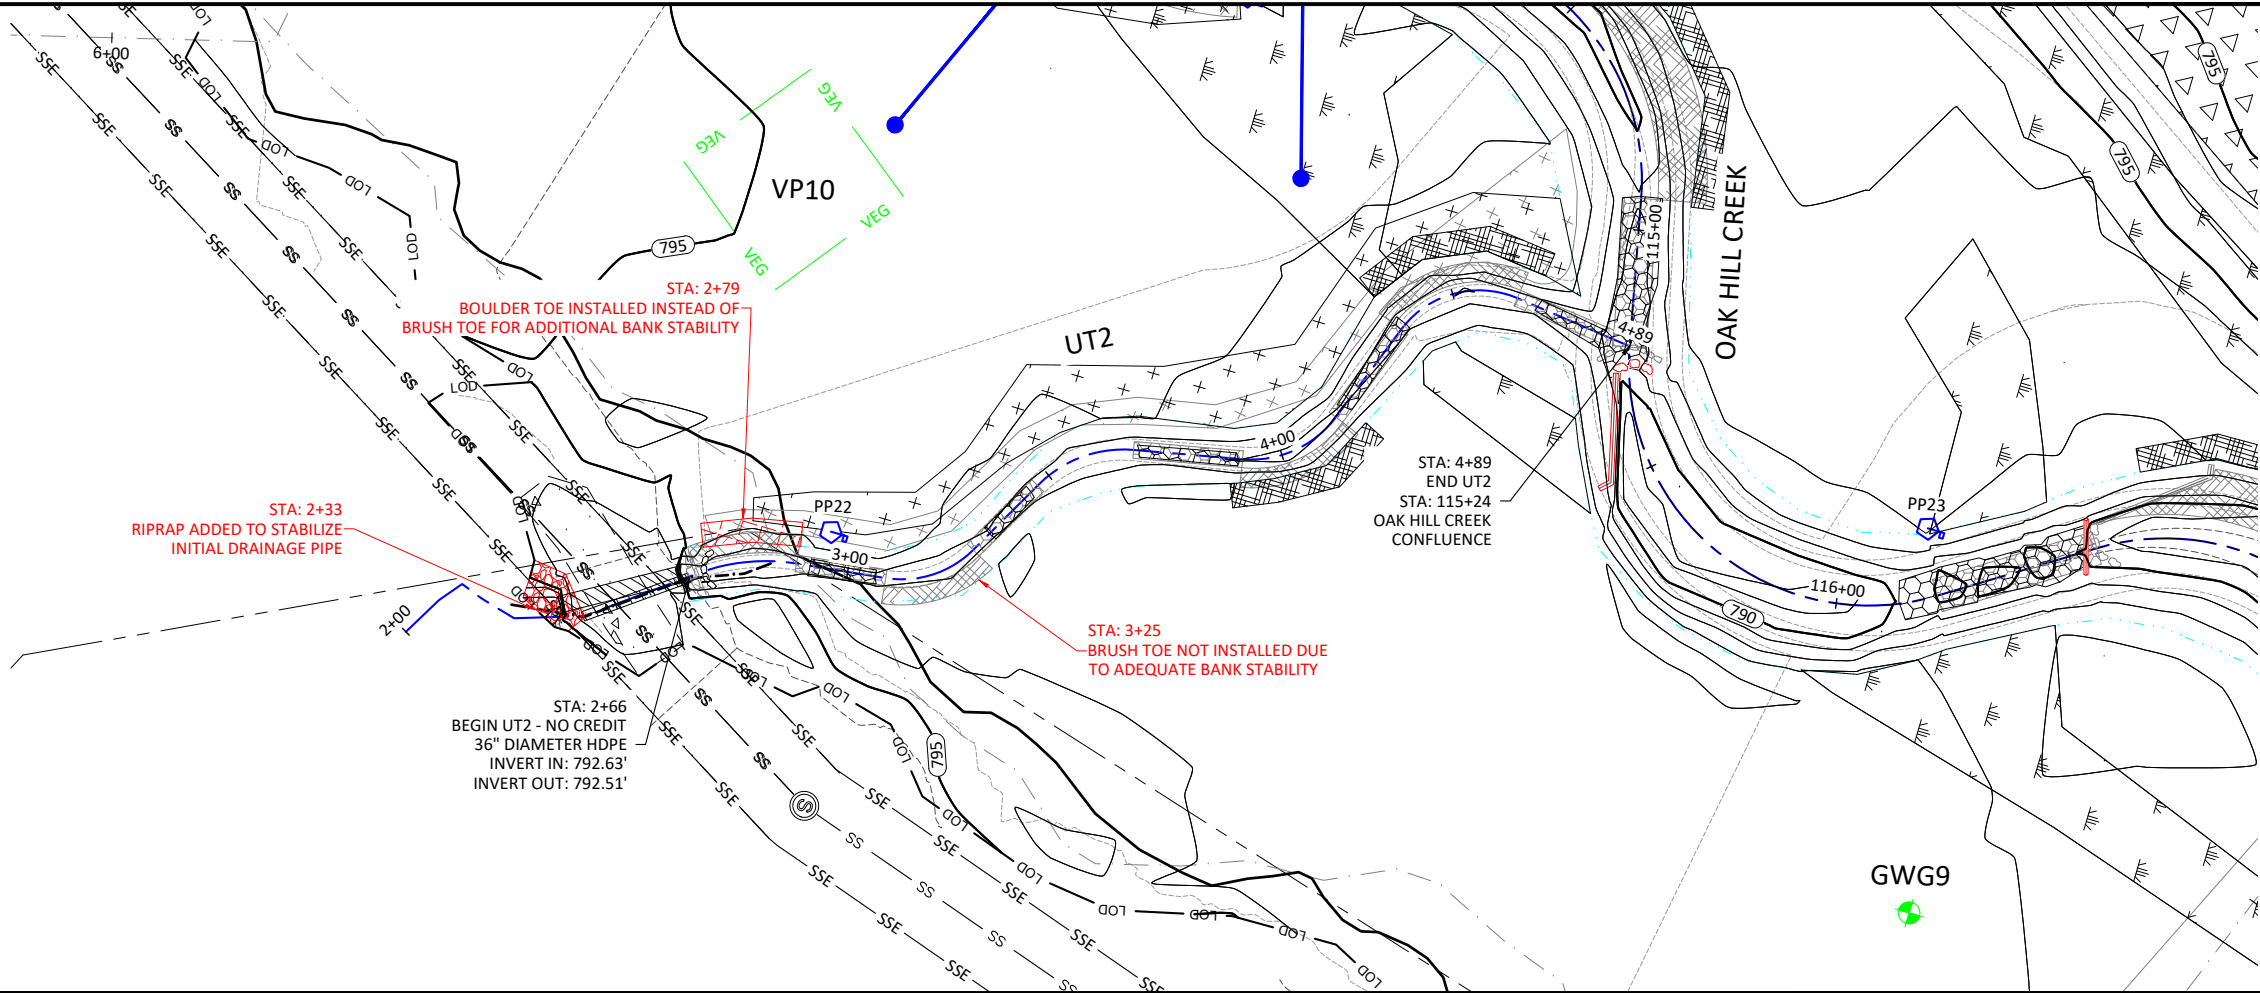
Uncredited-Tribs - UT2
Stream Plan and Profiles

7. *Sheet 1.14: Pools on UT2 profile are shown and noted as being filled with sediment. WEI expects the pools to adjust as vegetation becomes established. Please provide an update in MY1 regarding the UT2 stream conditions. Note that UT2 is not a credited reach.*

Wildlands Response: A brief summation of UT2 stream conditions will be included in MY1.
