Baseline Monitoring Report

Anderson Farm Mitigation Site

Wayne County, NC
NCDEQ Contract No. 0402-10
DMS ID No. 100180
DWR No. 2021-0023v2

Neuse River Basin
HUC 03020201

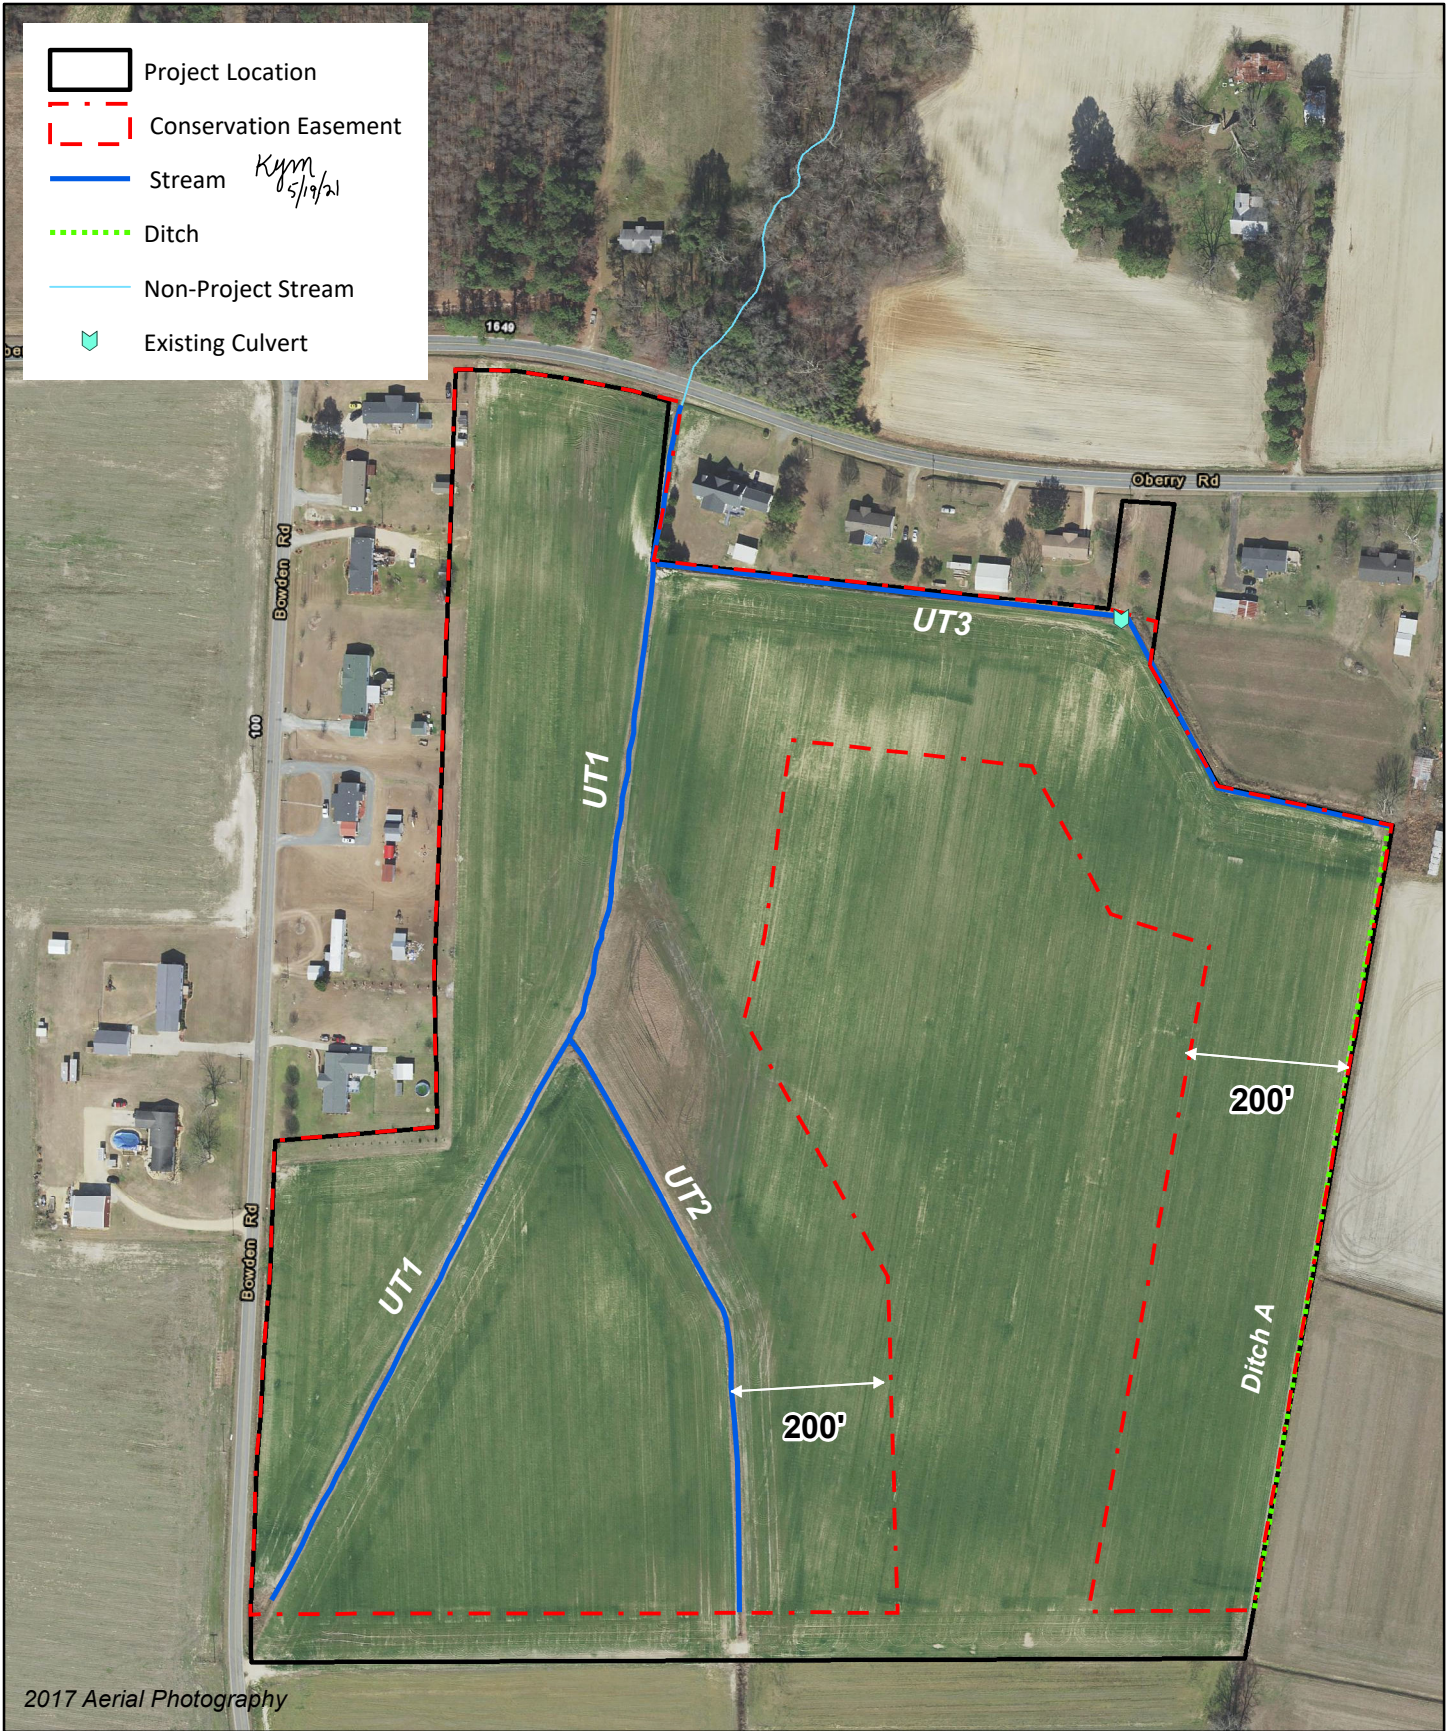
Figure 1 Site Map
Anderson Farm
Neuse River Basin (03020201)

Determinations provided in the table above were based on the proposed conservation easement boundaries depicted in Figure 1 for the site. The map representing the proposal for the site is attached to this letter and is initialed by Ms. Merritt on May 19, 2021. Substantial changes to the proposed easement boundaries could affect the site's potential to generate buffer mitigation and nutrient offset credits.

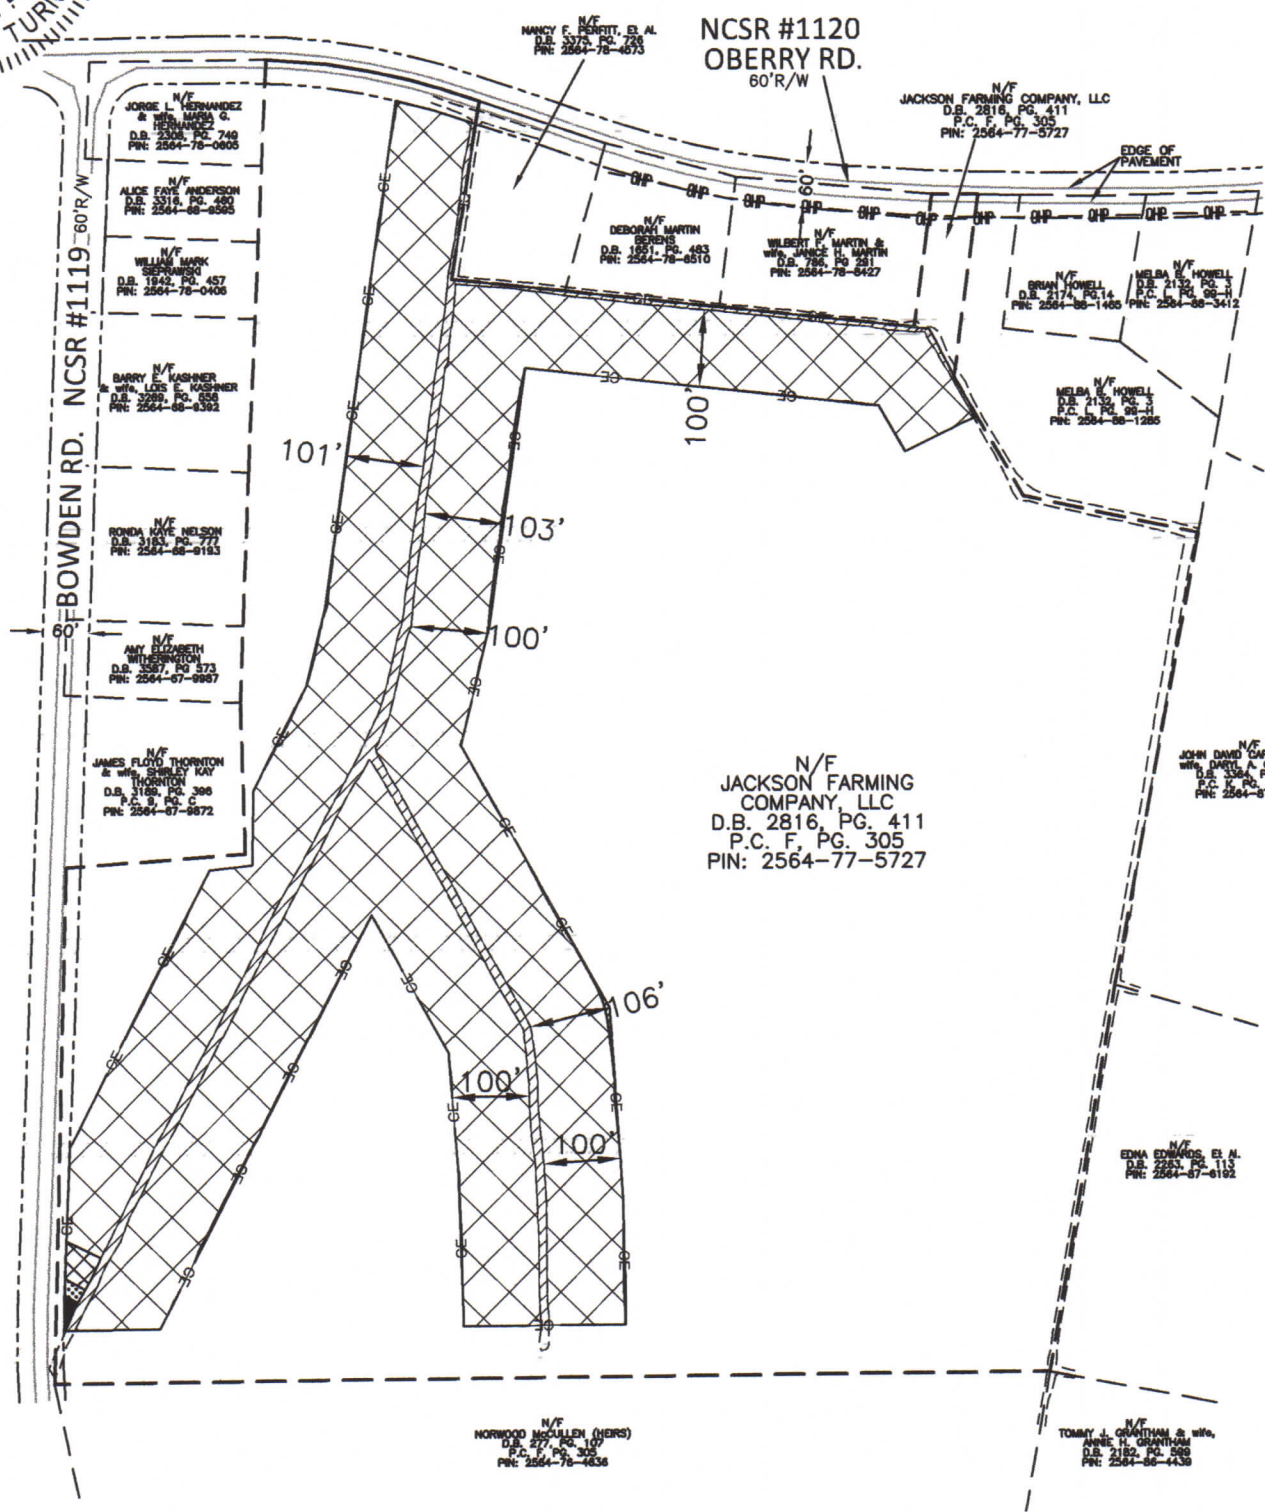
Riparian Buffer Credit:	SQ. FT.	Acres
Streams	31,994	0.73
Buffer Restoration 0'-29' (Min. 20')	475	0.01
Buffer Restoration 0'-49' (Min. 30')	1,816	0.04
Buffer Restoration 0'-100' (Min. 50')	491,294	11.28
Buffer Restoration 101'-200'	3,267	0.08
No Credit	452	0.01
Total CE Area	529,298	12.15

- THE AREA SHOWN HEREON WAS COMPUTED USING THE COORDINATE COMPUTATION METHOD.
- THE PURPOSE OF THIS PLAT IS TO SHOW THE AS-BUILT AREAS FOR RIPARIAN BUFFER CREDITS WITHIN THE CONSERVATION EASEMENT. THIS PLAT IS NOT A BOUNDARY SURVEY. THE LAND PARCELS AND THEIR BOUNDARIES AFFECTED BY THIS CONSERVATION EASEMENT ARE NOT CHANGED BY THIS PLAT.

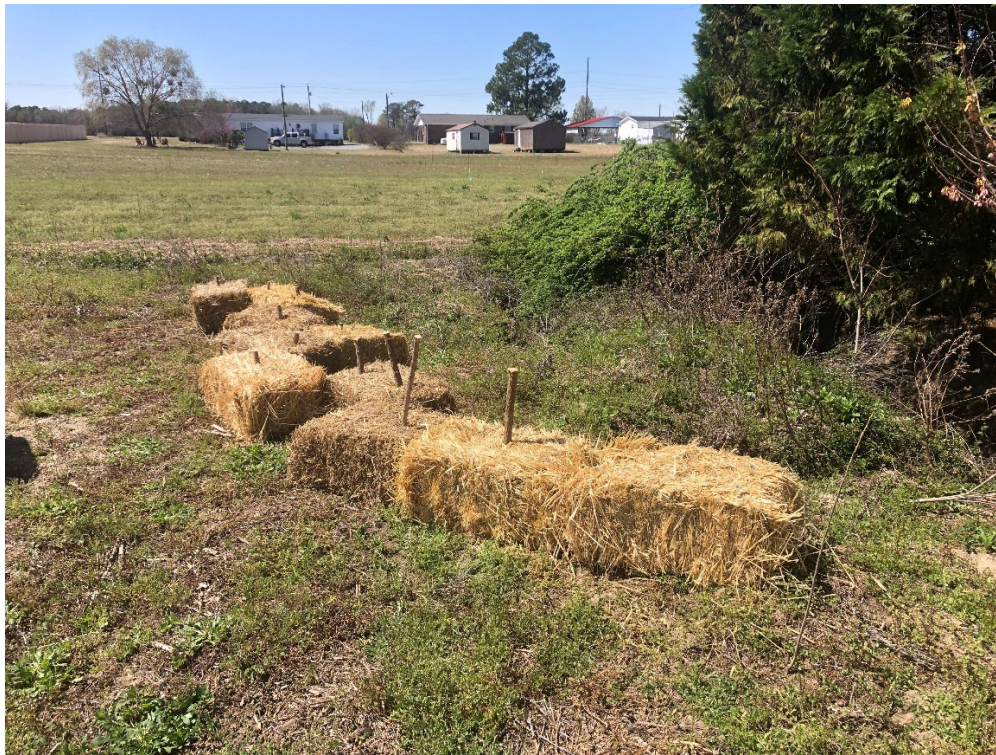
Erosion Control and Reduction Via Live Stakes and Sheet Flow Diversion
(3/29/2022)

Prior to planting, the buffer restoration area was occupied by agricultural fields, mainly used to produce corn or soybeans. A culvert on UT3 was removed prior to planting. The area was immediately seeded with a regionally appropriate seed mix and live stakes and coir matting were placed along banks to provide soil stabilization. An area of isolated erosion at the confluence of UT1 and UT3 was identified prior to planting which was stabilized by placing straw bales directly adjacent to the area to divert overland flow during rainfall events. Additionally, live stakes were planted and a regionally appropriate native seed mix was applied around the area to provide long term soil stabilization. Photographs taken following the culvert removal and erosion stabilization can be found in Appendix 5.

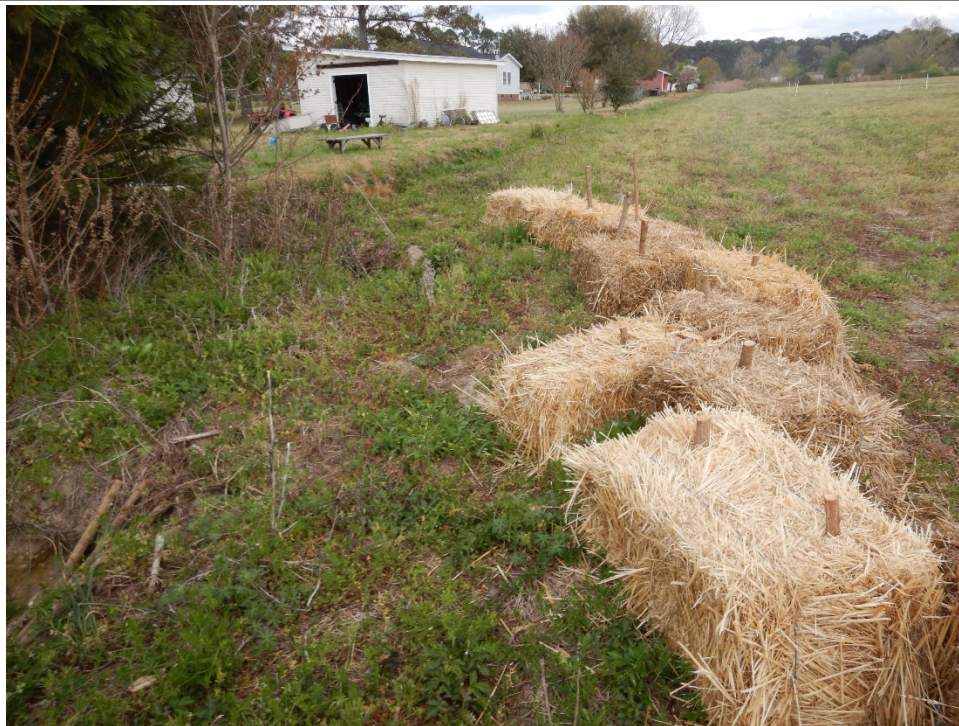
Erosion Control and Reduction Via Live Stakes and Sheet Flow Diversion
(4/5/2022)

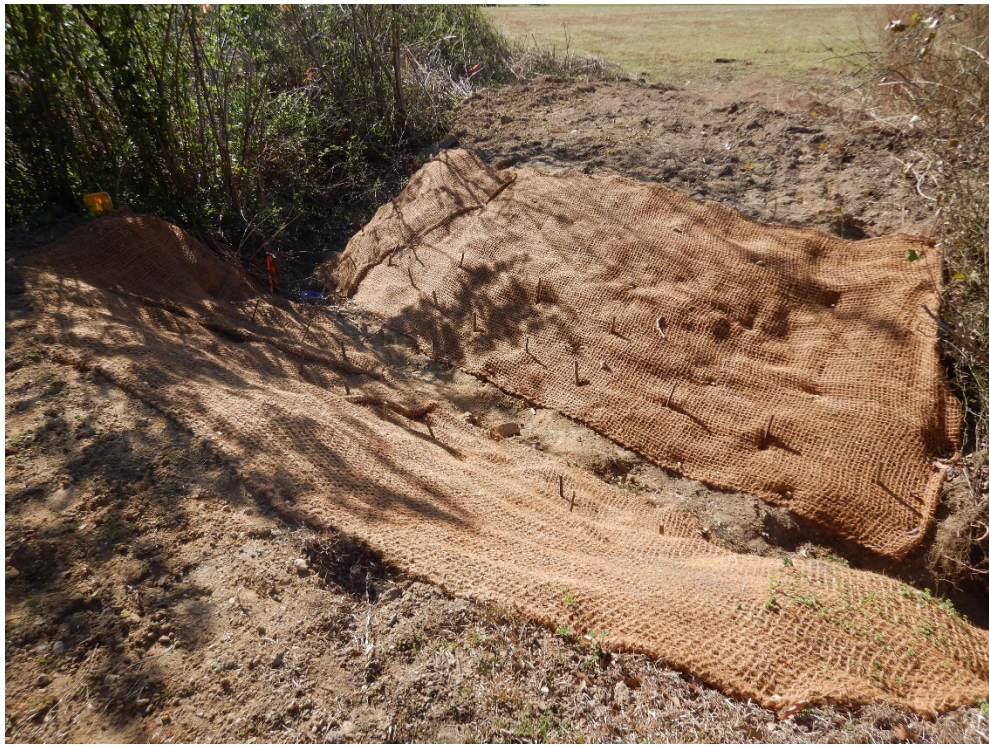
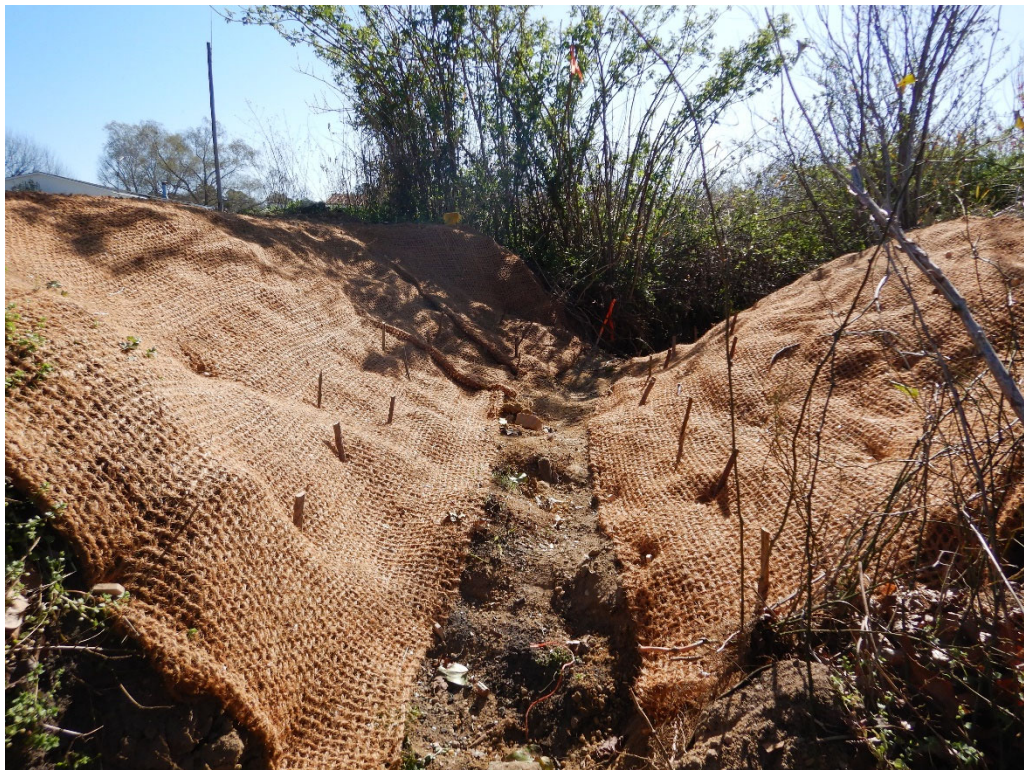
Culvert Removal (3/21/2022)
