COLONIAL FARMS WETLAND MITIGATION SITE FINAL ANNUAL MONITORING REPORT – YEAR 0

Edgecombe County, NC

August 2022

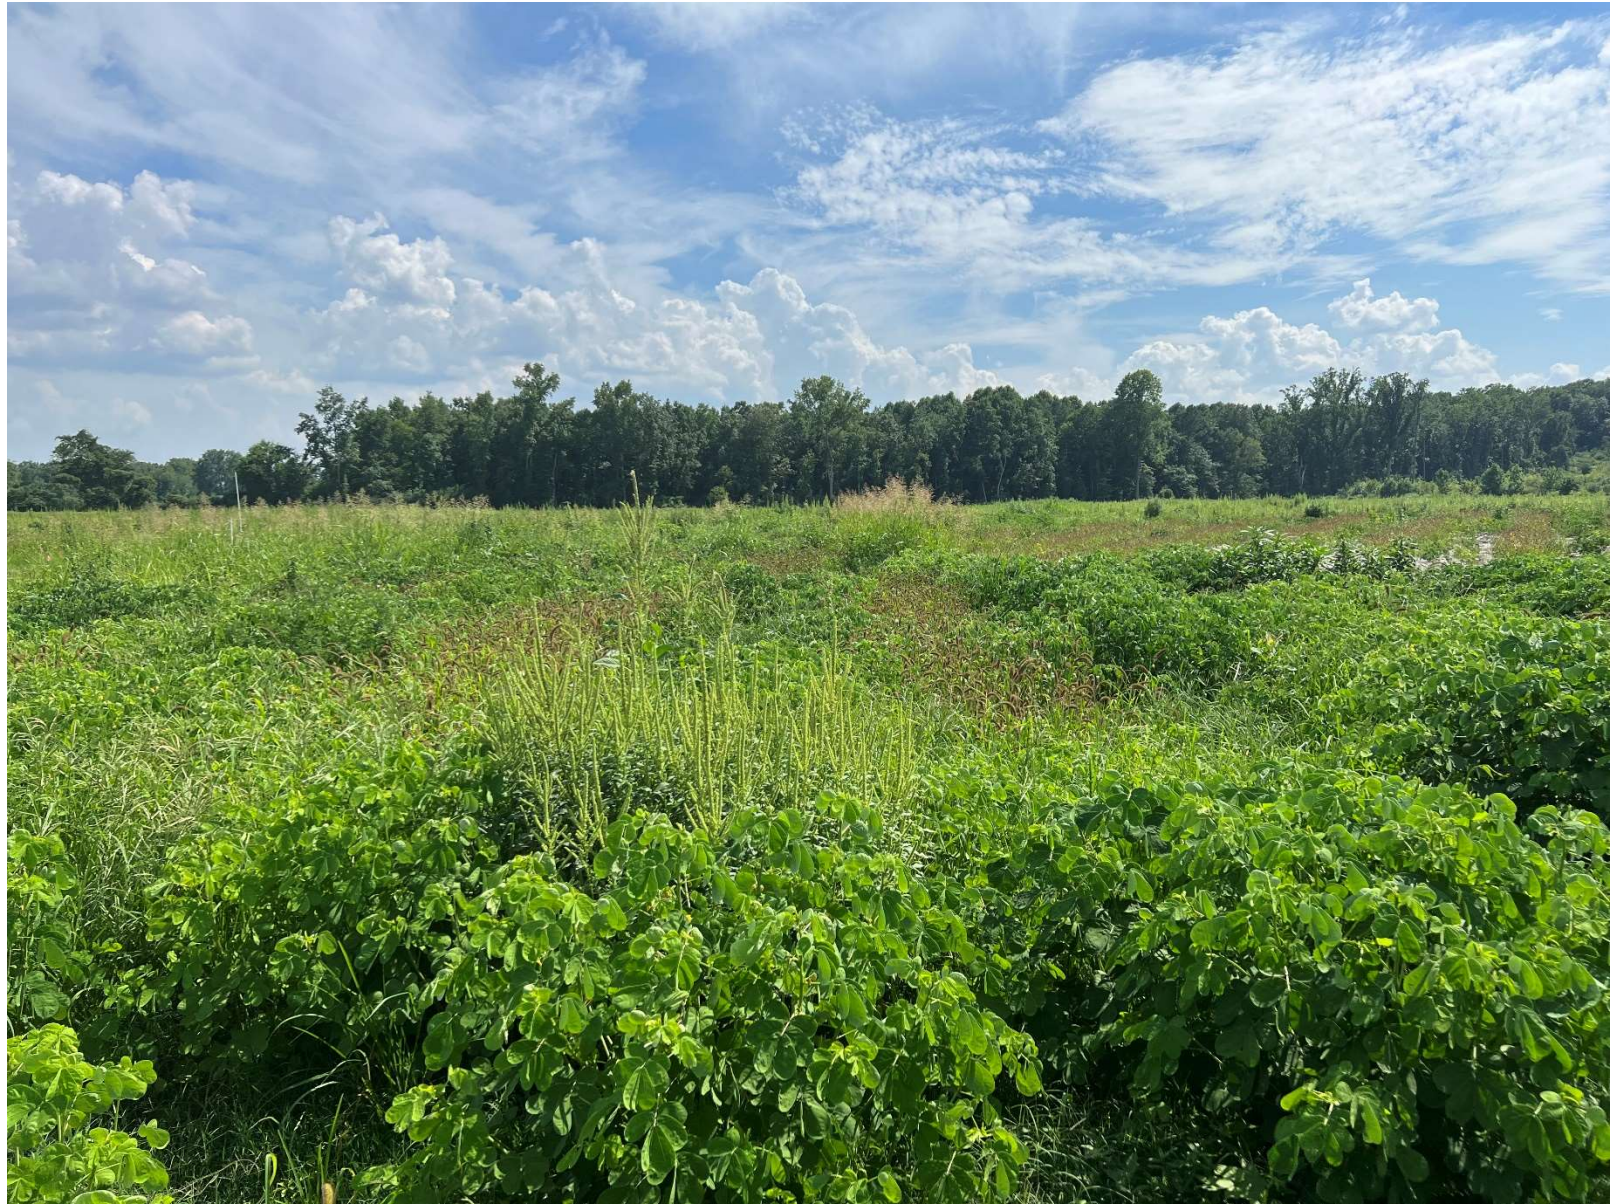
Established Vegetation (view south from farm road) – taken 7/26/2022

Additional photos showing near-current Site vegetation conditions have been added to Appendix A

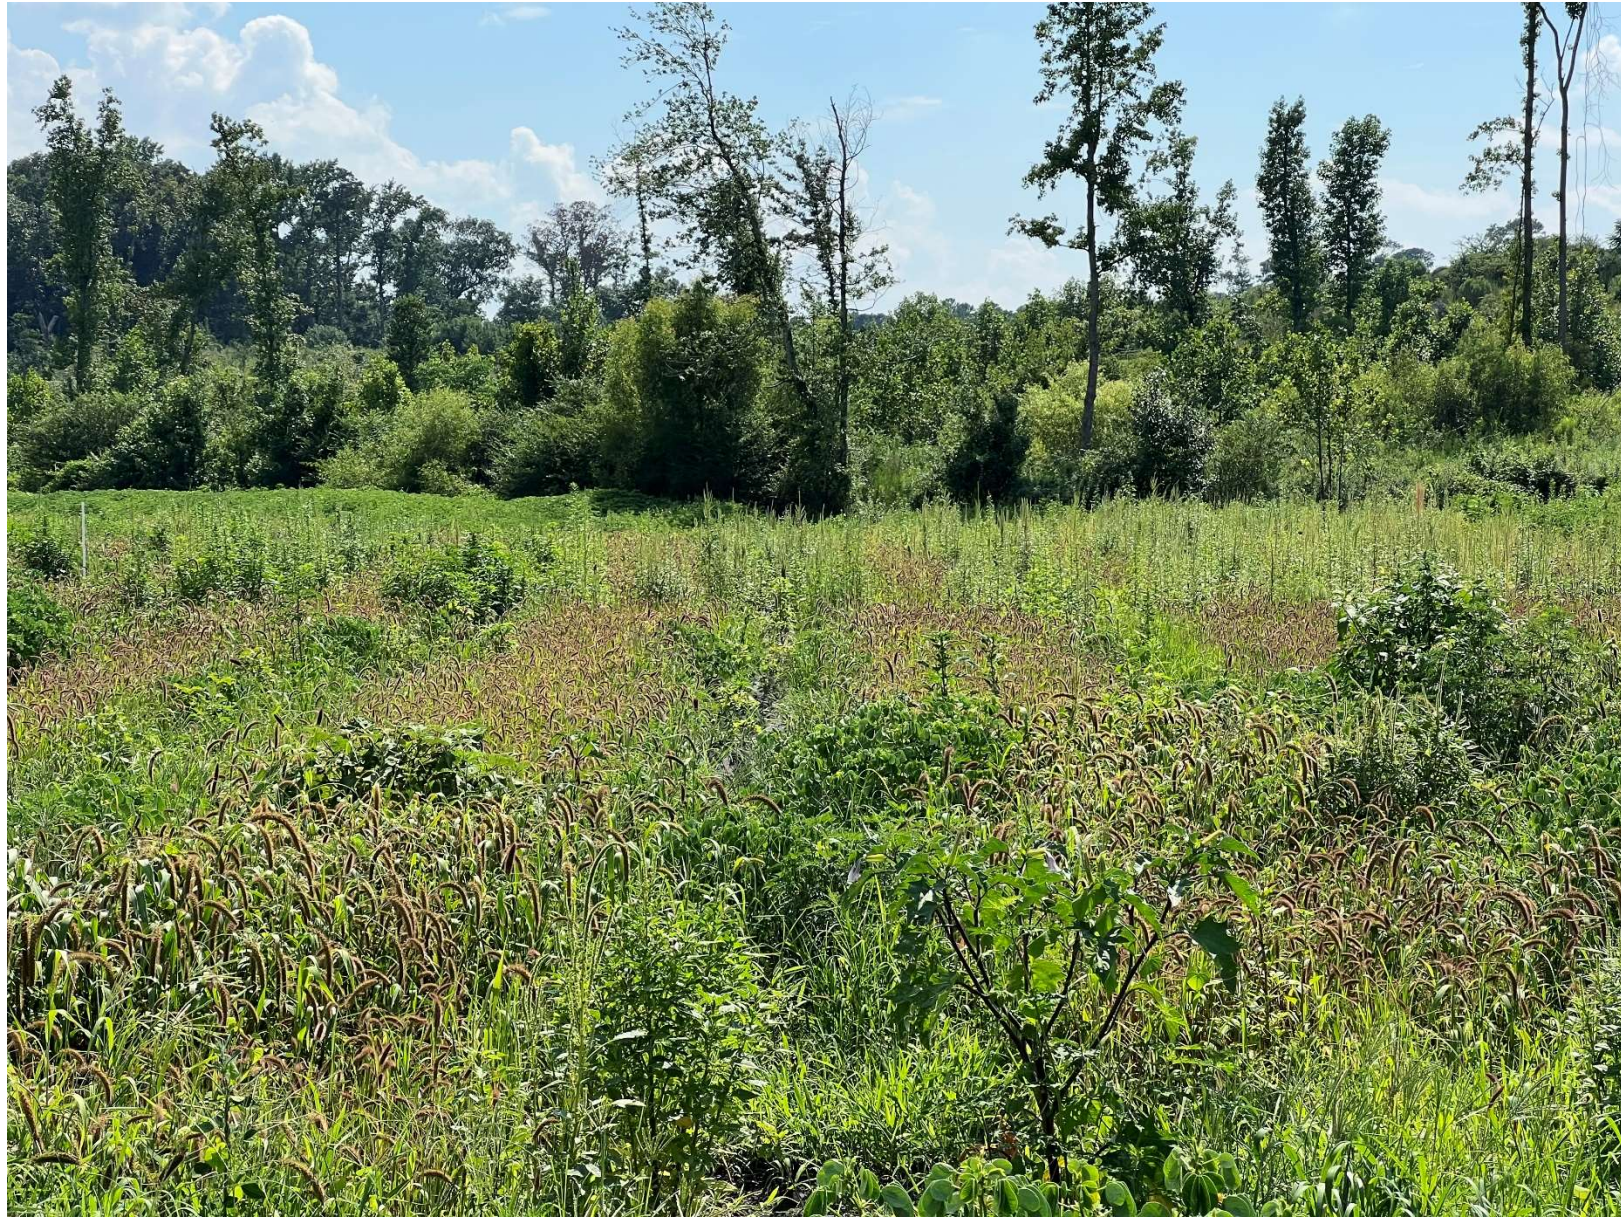
Established Vegetation (view southwest from farm road) – taken 7/26/2022

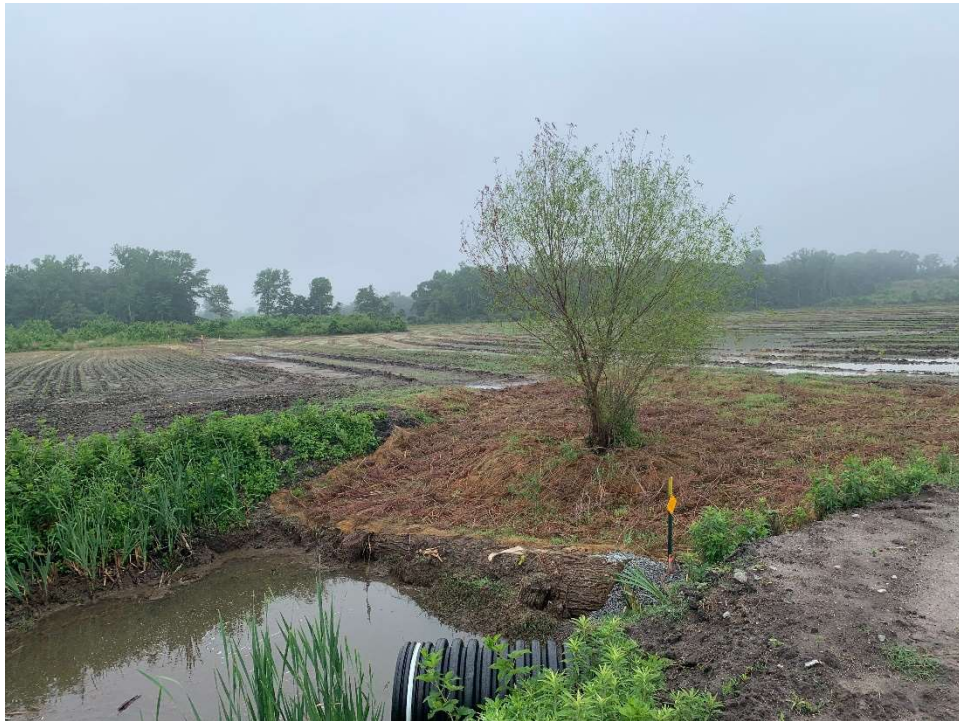
Ditch Plug Constructed at NE corner of the Site (view SW) – taken 5/25/2022

Visual assessment of the Site indicates that the Site is stable and planted vegetation is in good health with current weather patterns and baseflow hydrology supplied from the western escarpment. The constructed ditch plug at the northeast corner of the Site shows no sign of deterioration from overland runoff or scour beneath the perched culvert passing beneath the farm road. There are no signs of erosion or excessive deposition at the Site. The Site boundary has been well marked with signage and there is no evidence of encroachment. Photographs taken from the 11 established photo points are presented in Appendix A.

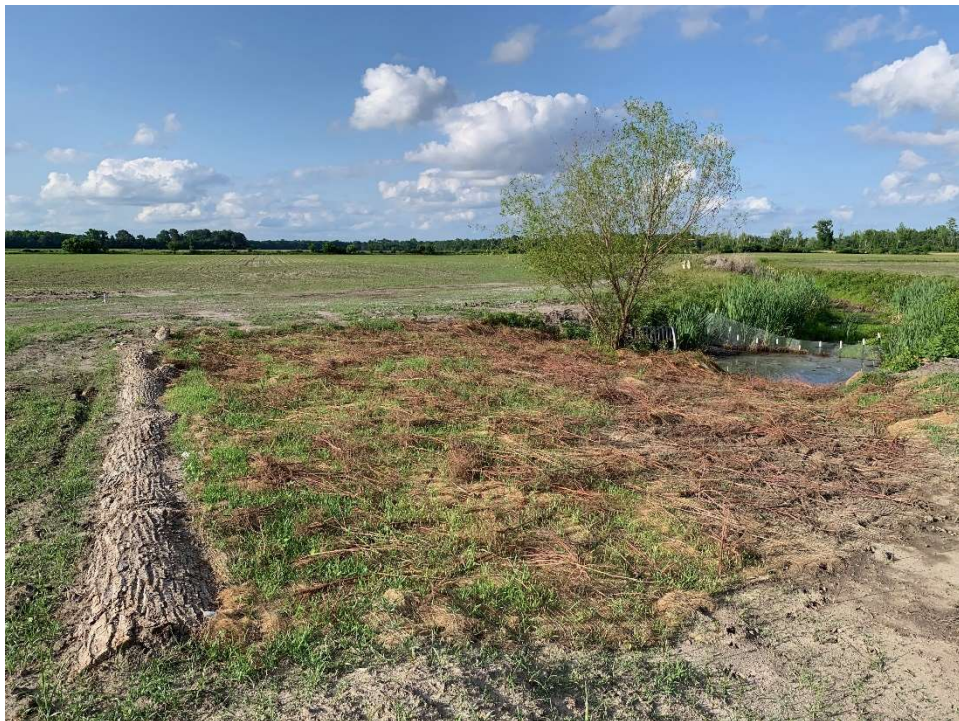
Ditch Plug Constructed at NE corner of the Site (view NE) – taken 5/25/2022

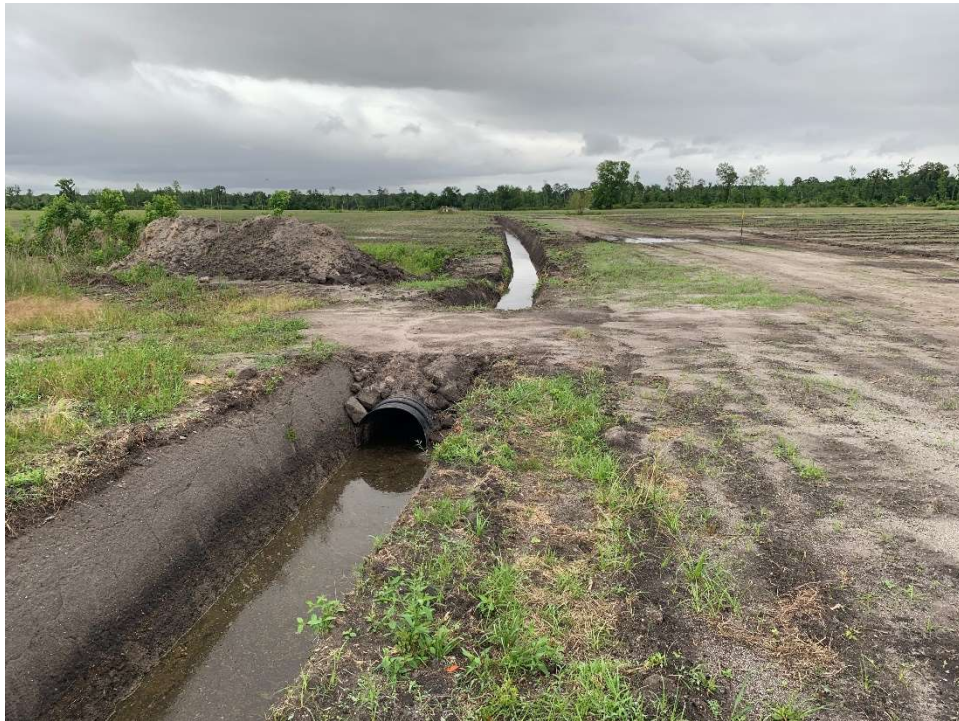
Constructed Drainage Ditch North of the Site (view east) – taken 5/25/2022

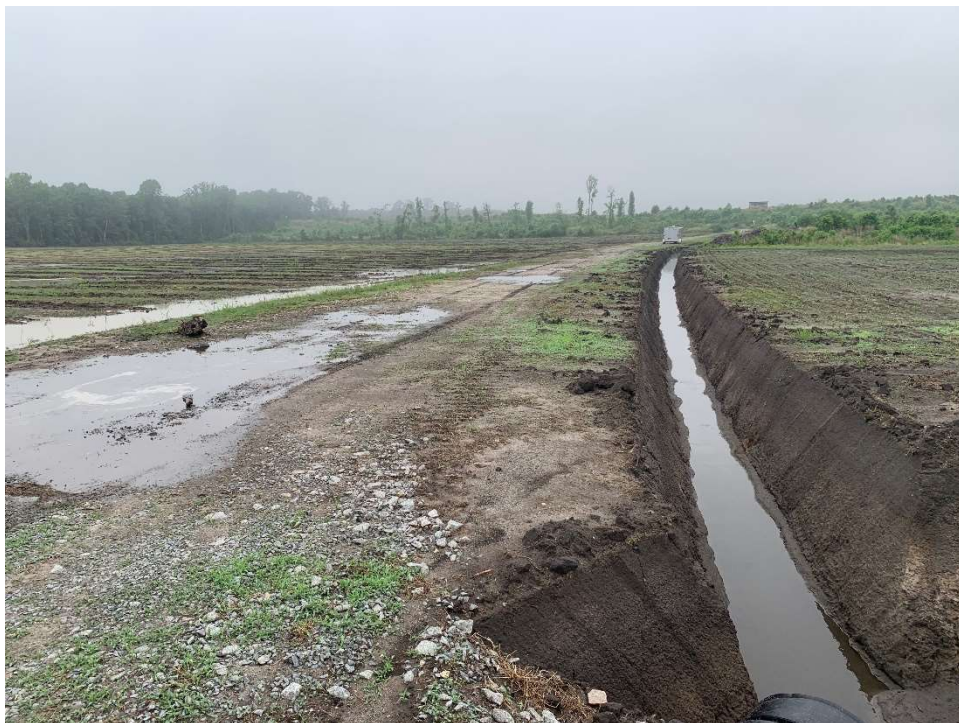
Constructed Drainage Ditch North of the Site (view west) – taken 5/25/2022
