MONITORING YEAR 0 ANNUAL REPORT

CROSS CREEK RANCH SITE

Montgomery County, NC
Yadkin River Basin
HUC 03040104

DMS Project No. 100138
NCDEQ Contract No. 7879-01
DMS RFP No. 16-007879 / Issued: May 6, 2019
USACE Action ID No. 2020-00051
DWR Project No. 2020-0016
Data Collection Dates: February 2022 – July 2022

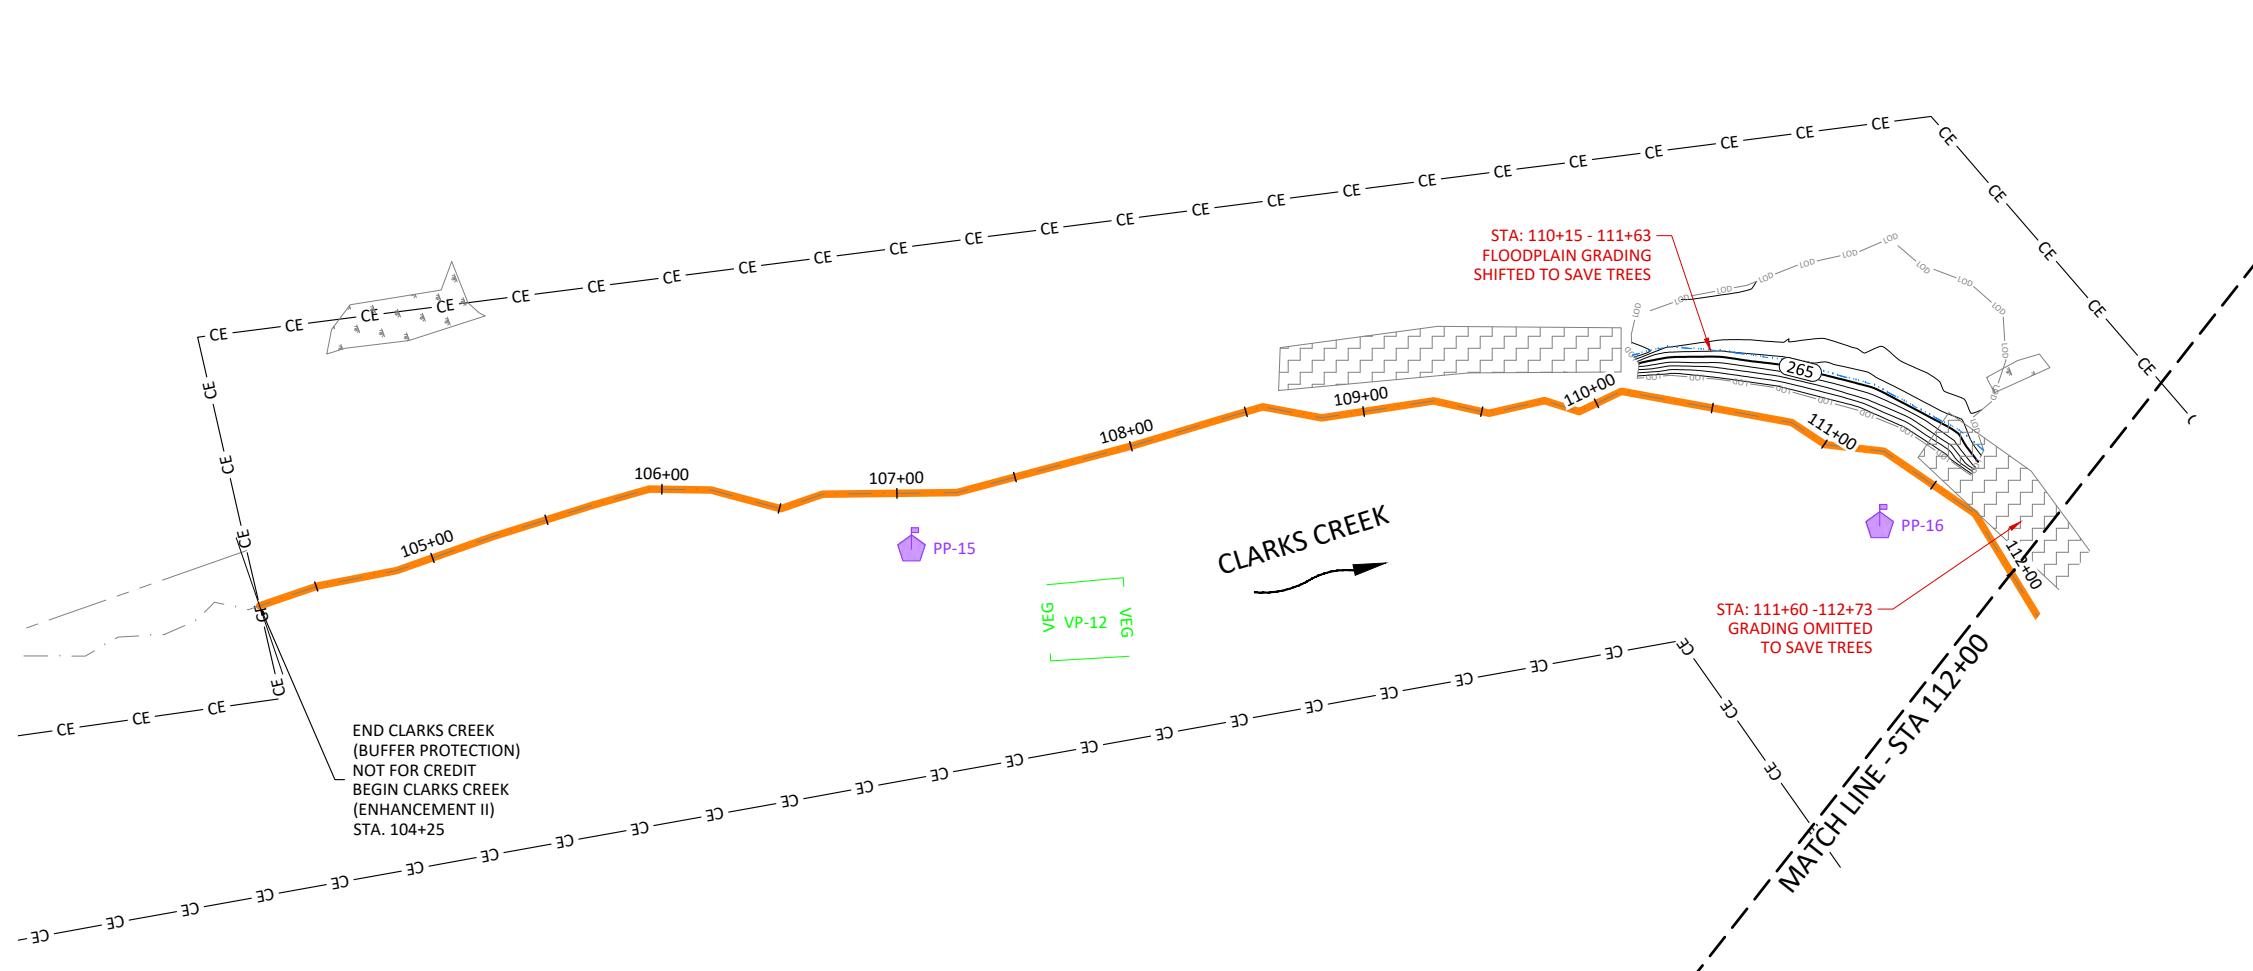
Date: 07/11/2022
Job Number: 005-02186
Project Engineer: ARV
Drawn By: FHM
Checked By: TWVV
Sheet: 1.1.1

NOTES:
1. DEVIATIONS FROM THE DESIGN ARE SHOWN IN RED.

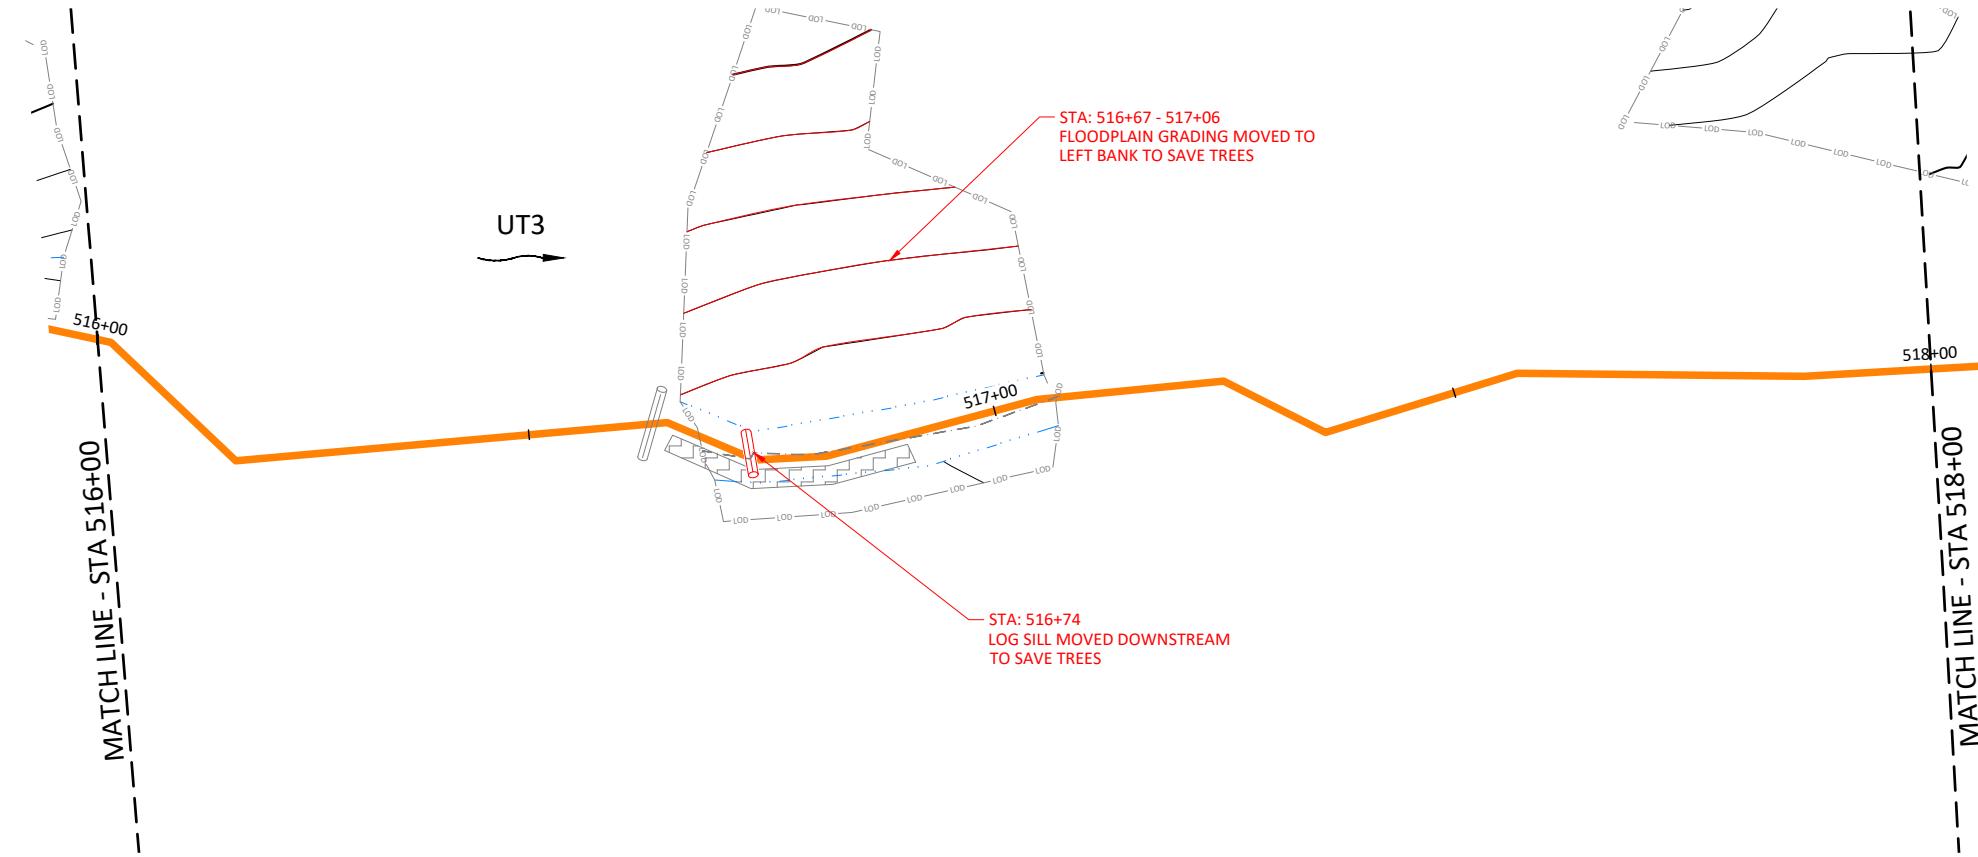
Date: 07/11/2022
Revision: _____
Job Number: 005-02186
Project Engineer: ARV
Firm: TWWW
Drawn By: _____
Checked By: _____
Sheet: 1.5.9

NOTES:
1. DEVIATIONS FROM THE DESIGN ARE SHOWN IN RED.

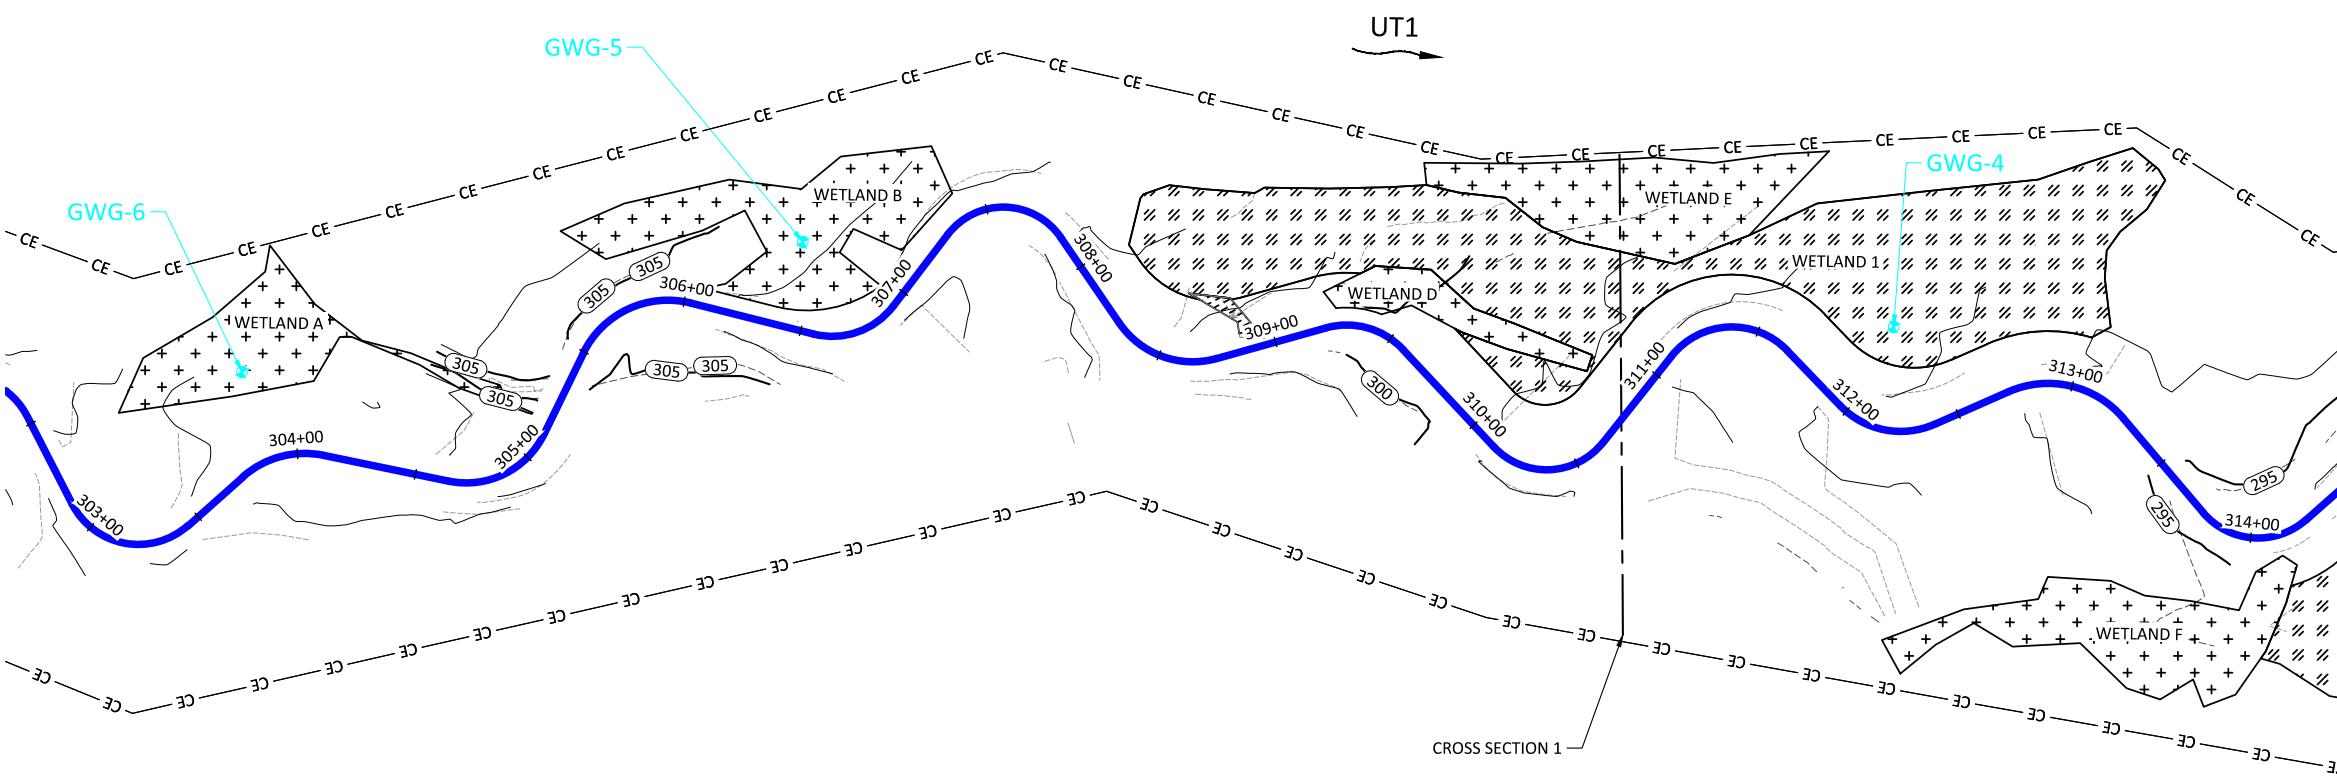
CROSS SECTION 1

NOTES:
1. DEVIATIONS FROM THE DESIGN ARE SHOWN IN RED.

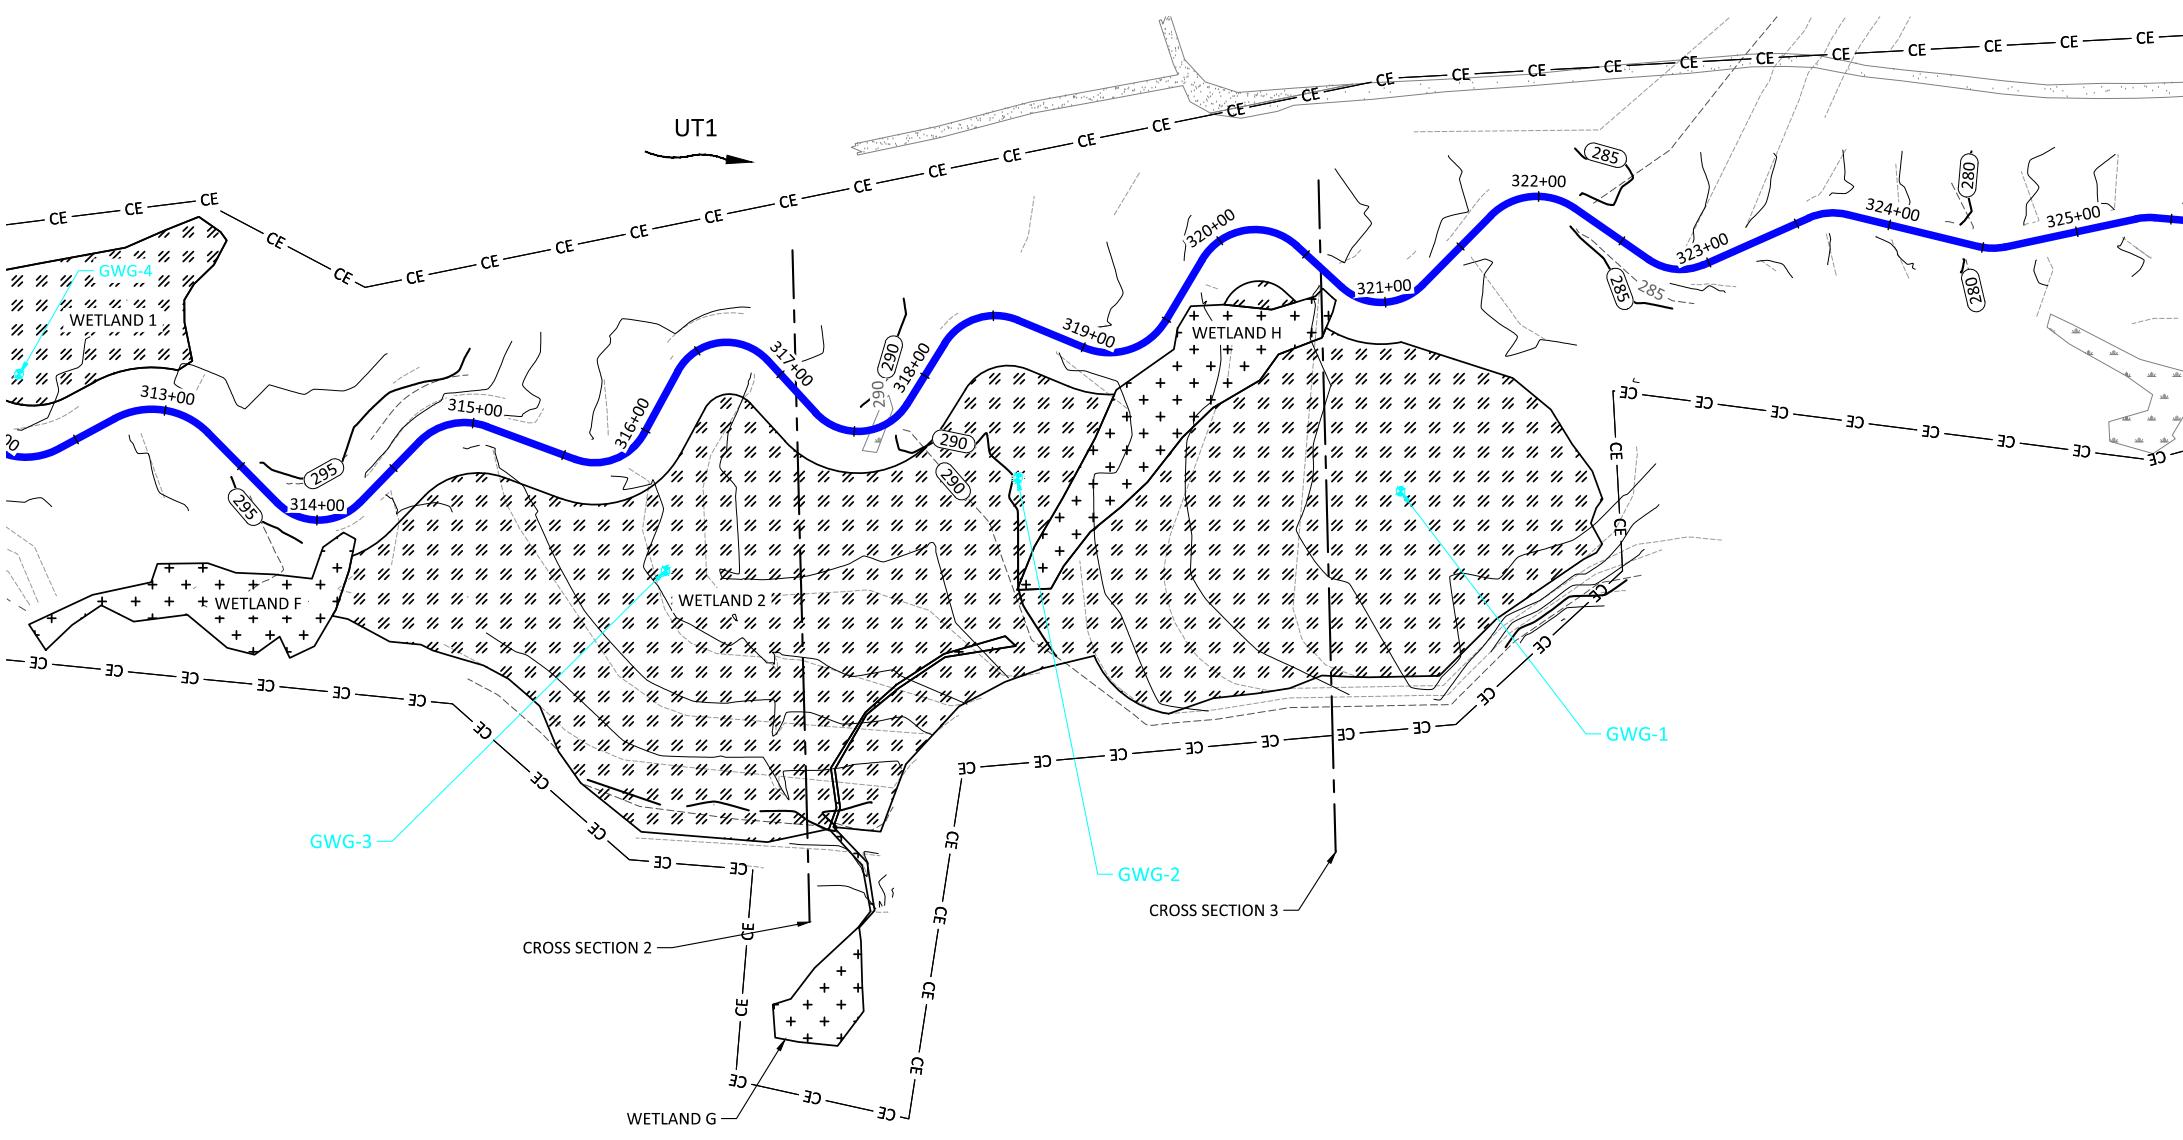
Cross Creek Ranch Site
Montgomery County, North Carolina
Cross Section 4
Wetlands

NOTES:
1. DEVIATIONS FROM THE DESIGN ARE SHOWN IN RED.
