Subject: Task 5 Draft As-Built Baseline Monitoring Report Comments – Kingfield Buffer Mitigation Project (DMS #100176)
Neuse River 03020204; Jones County, NC
Contract No. 0103-01

Baseline Monitoring Report

KINGFIELD BUFFER MITIGATION SITE

Jones County, NC

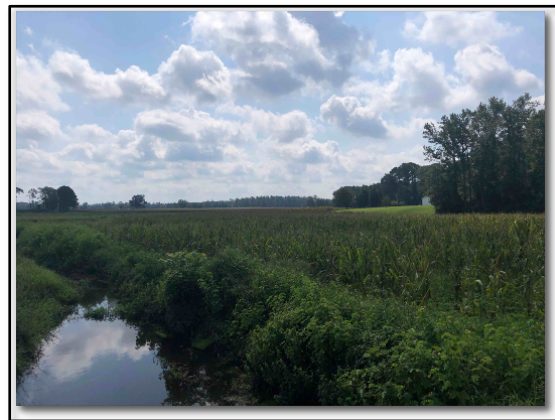
UT1 at Project origin (September 2020)

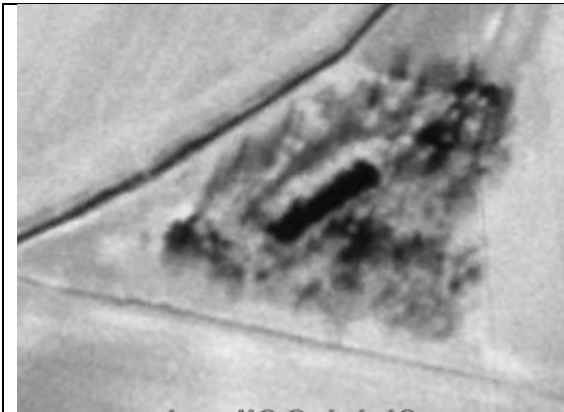
1999 Imagery showing pond riparian areas vegetated. Zone 1 & Zone 2 of riparian buffer in maintained ag

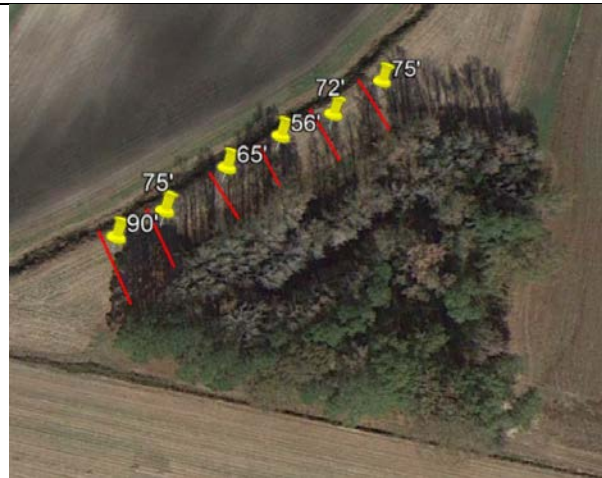
2014 imagery (fall) showing pond riparian areas vegetated & approximate measurements taken from top of bank along stream to edge of forest (not dripline). Zone 1 & Zone 2 of riparian buffer in maintained ag.

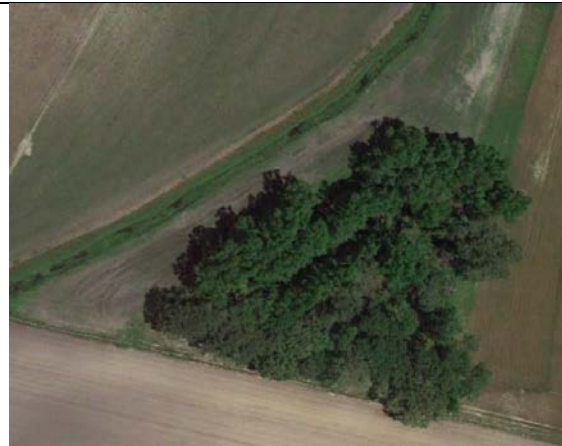
2016 Imagery showing pond riparian areas vegetated. Zone 1 & Zone 2 of riparian buffer in maintained ag

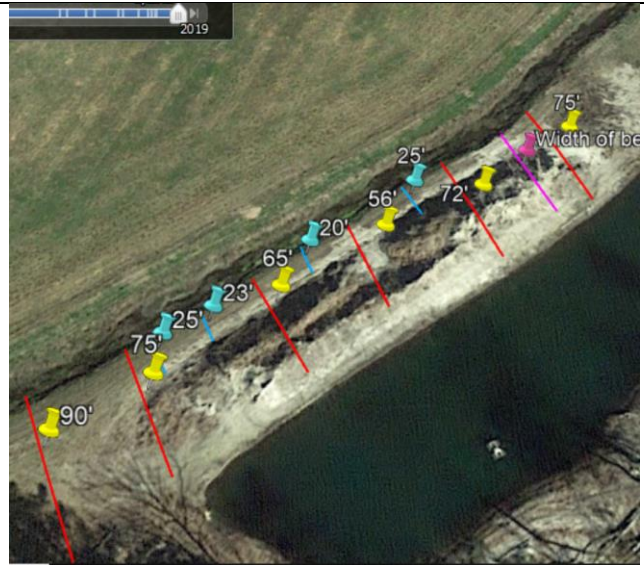
2019 imagery showing pond footprint, recent removal of trees, & excavated material/berm pile located in Zone 1 and some of Zone 2 of riparian buffer. Approximate measurements taken in feet from top of bank along stream to previous (before clearing) edge of forest (Red lines) & approximate measurements in feet taken from top of bank along stream to edge of berm pile (Blue lines).

DWR Central and Regional staff discussed the Kingfield Site associated with DWR ID# 2021-0020. It was determined that the overall existing use of the property is still agriculture and that there is currently no clear buffer violation on the site.

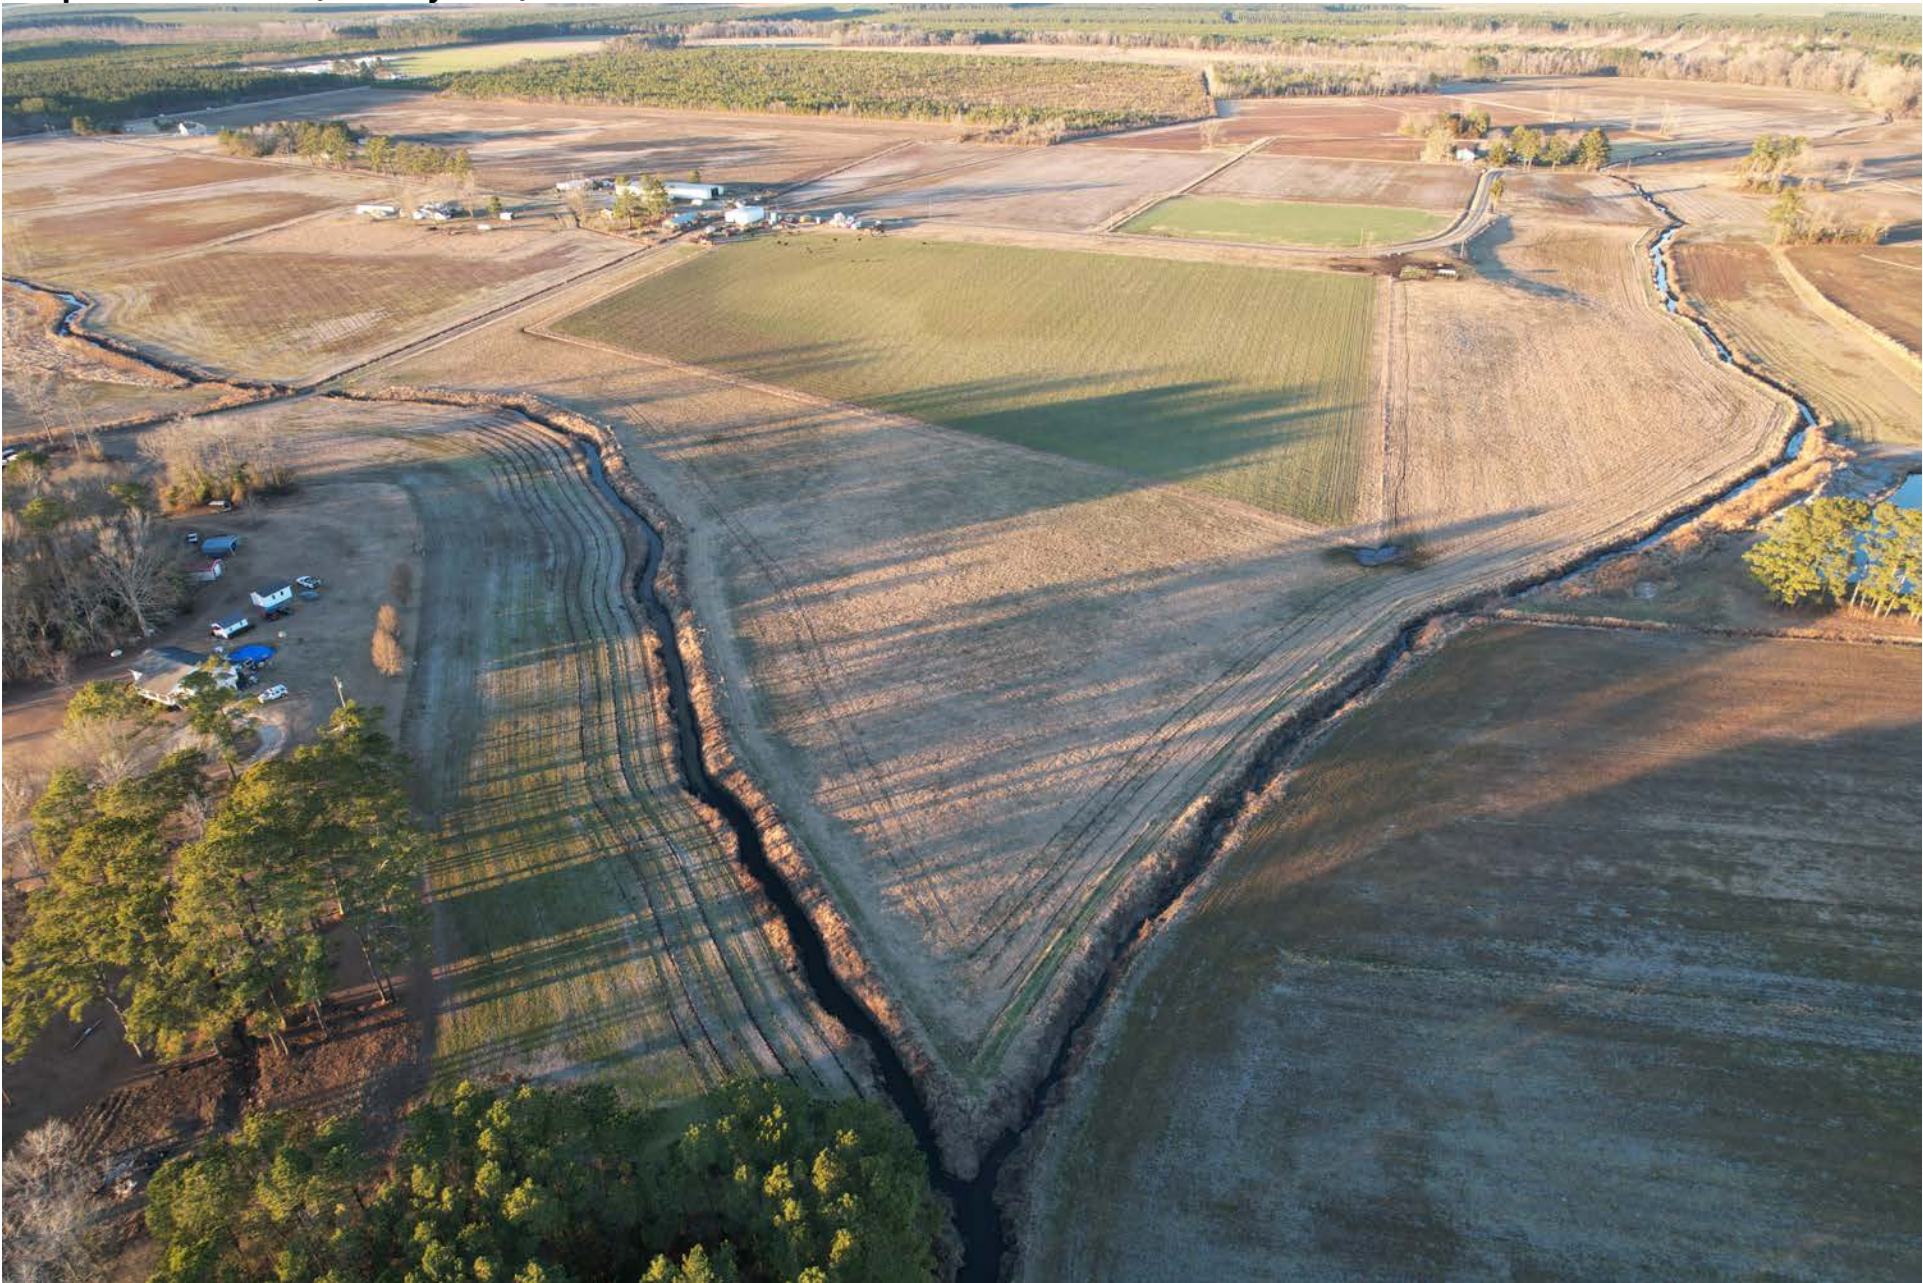
Site post construction (February 2022)
