**MAPLE SWAMP WETLAND MITIGATION SITE
FINAL ANNUAL MONITORING REPORT – YEAR 0**

Edgecombe County, NC

NCDMS ID No. 100190

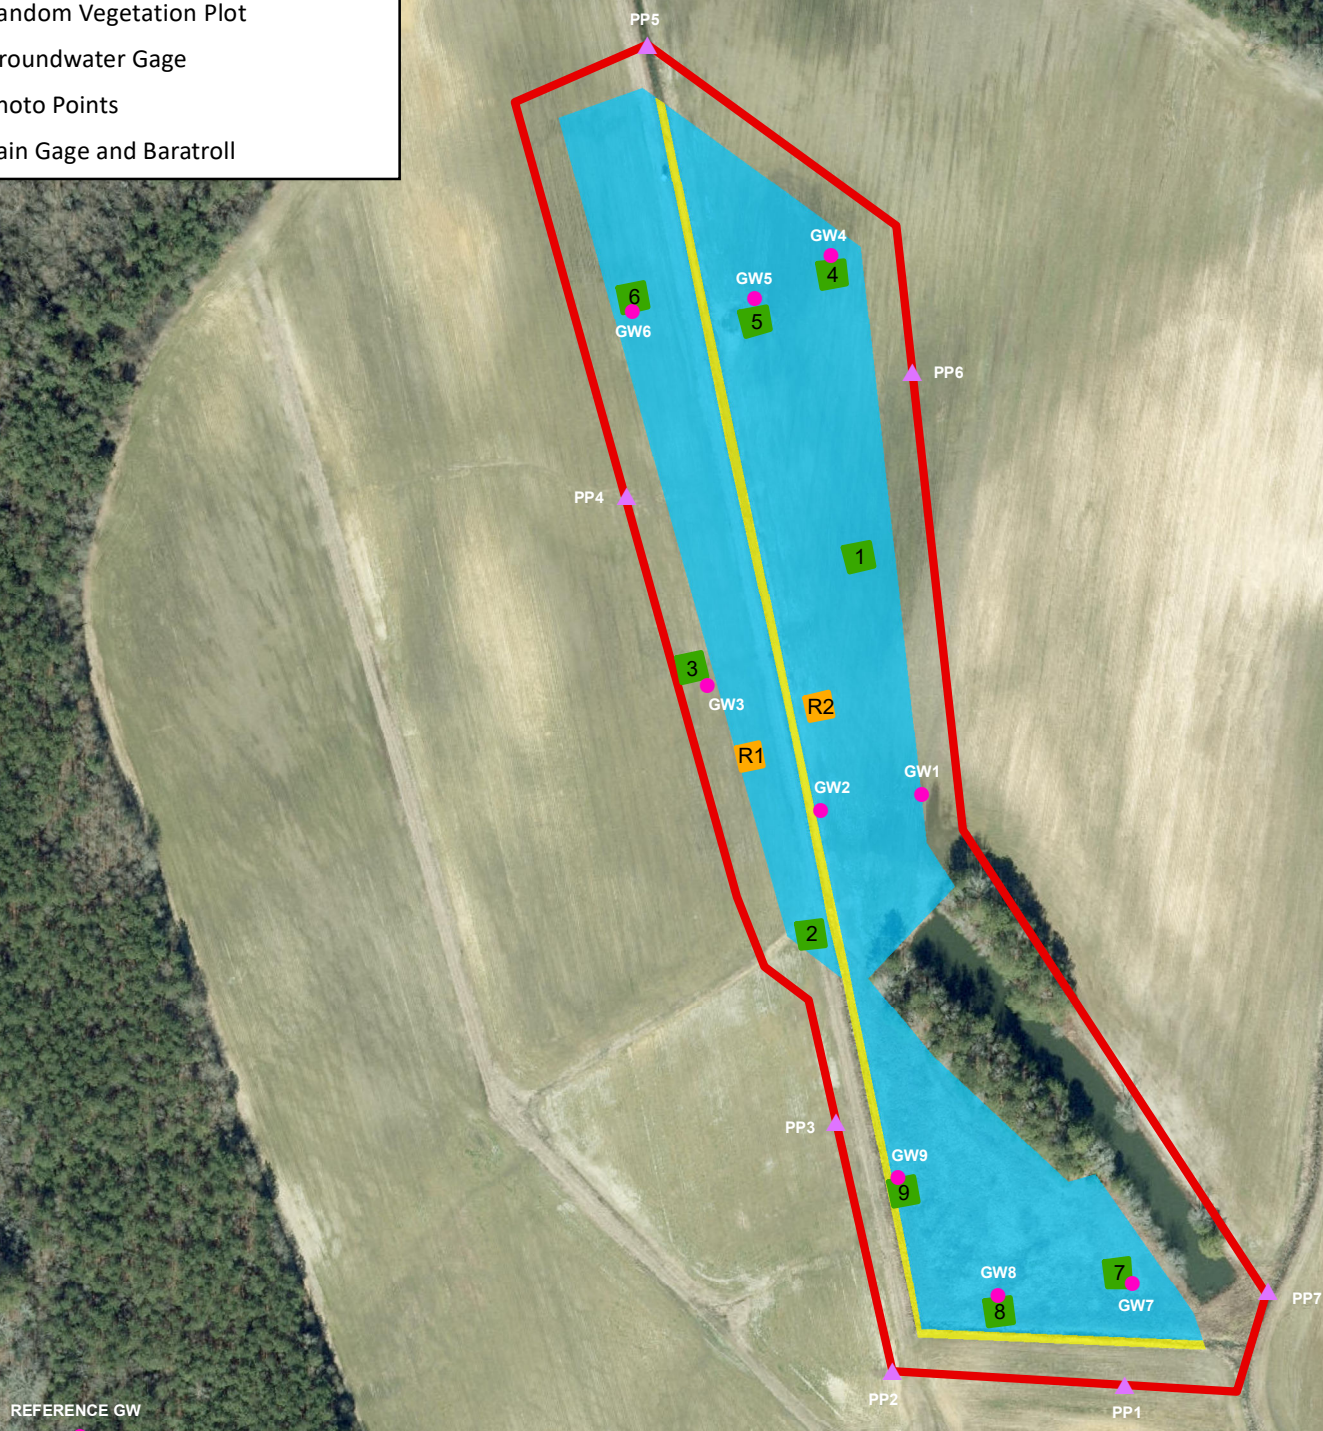
MAPLE SWAMP WETLAND MITIGATION SITE
CURRENT CONDITIONS SITE MAP
 Tar-Pamlico 03020102
 Edgecombe County, North Carolina

- Conservation Easement
- Wetland Re-establishment (8.635 ac)
- Wetland Rehabilitation (0.449 ac)
- Fixed Vegetation Plot
- Random Vegetation Plot
- Groundwater Gage
- ▲ Photo Points
- Rain Gage and Barotroll

Seven fixed photo points were located along the perimeter of the Site post-construction, two more than proposed in the Final Mitigation Plan (Figure 1). Two additional photo points were located to provide better clarity and overall improved visual assessment of the Site's condition in each annual monitoring report.

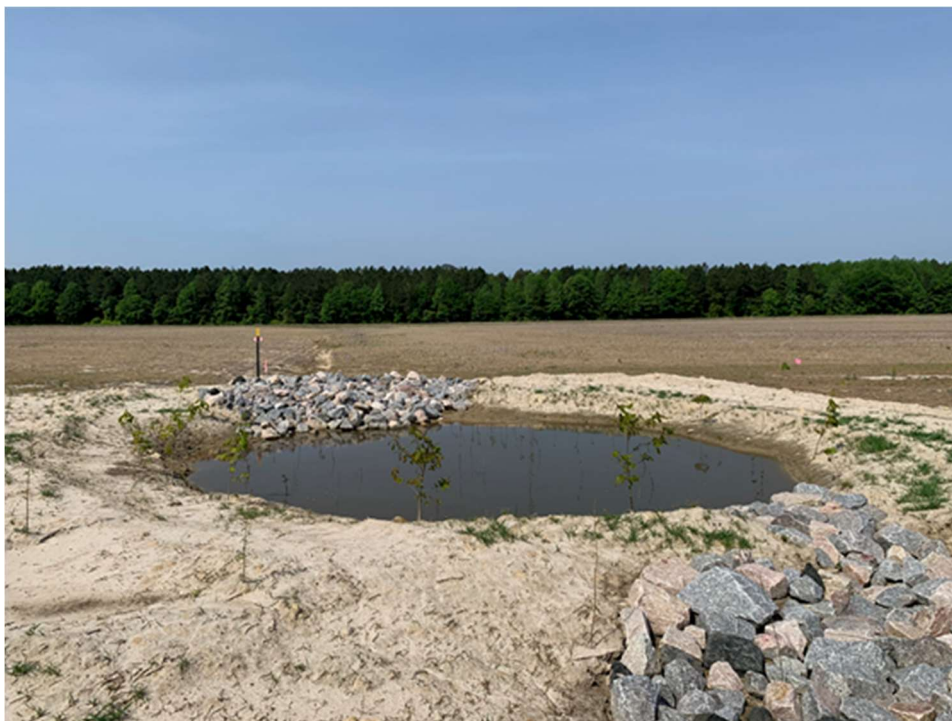
Northernmost Ditch Plug with Sediment Forebay on Western Site Boundary – view west

Three ditch plugs were constructed on Site to prevent potential future erosion of fill material placed in the previously existing ditches. The proposed ditch plugs were described in the Final Mitigation Plan and construction drawings to be minimum 100 feet long with the exposed face to be lined with biodegradable erosion control matting. Based on field conditions and observed runoff trends during construction, it was determined that 100-foot-long ditch plugs were not necessary to ensure long-term stability of fill material in the two ditches on the western side of the property. Short ditch plugs (10-20 feet in length) were constructed and sediment forebays, heavily planted with woody stems, were constructed downslope of the ditch plugs to dissipate concentrated flows and retain sediment from entering the wetland restoration area. The exposed face of the two ditch plugs were protected with riprap to ensure long-term stability of the plugs. The ditch plug constructed in the central ditch (Ditch A) in the southeast corner of the Site was constructed to be 100-feet long as proposed. The exposed face of this ditch plug was also protected with riprap. All ditch plugs were constructed of clay material and densely planted to ensure long-term stability. Photographs of the constructed ditch plugs are included in Appendix A.

Visual assessment of the Site indicates that the Site is stable and planted vegetation is in good health. Constructed ditch plugs show no signs of deterioration and there are signs of sediment deposition in the two constructed sediment forebays on the western side of the Site. The Site boundary has been well marked with signage and there is no evidence of encroachment. Photographs taken from the seven established photo points are presented in the Appendix A.

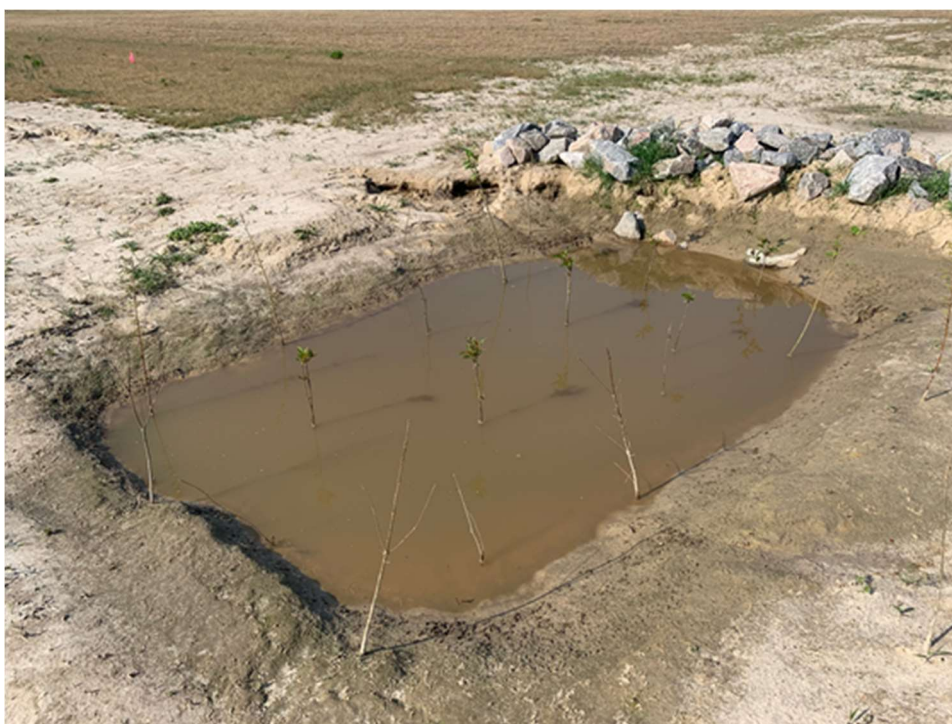
Southernmost Ditch Plug with Sediment Forebay on Western Site Boundary – view southwest

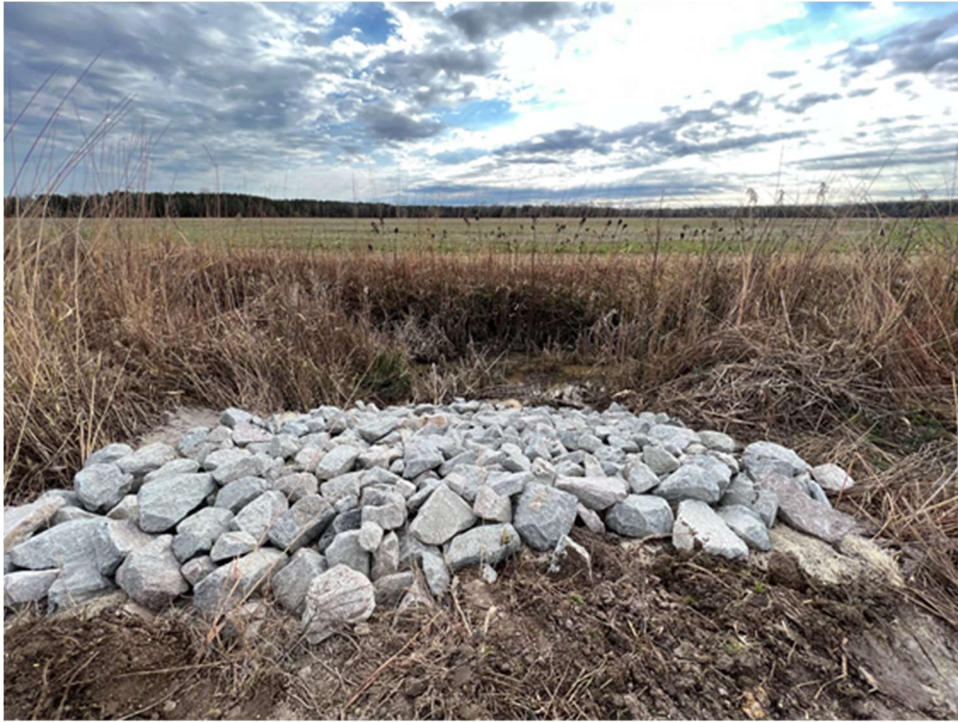
Ditch Plug at Southeastern Site Boundary (Ditch A) – view east

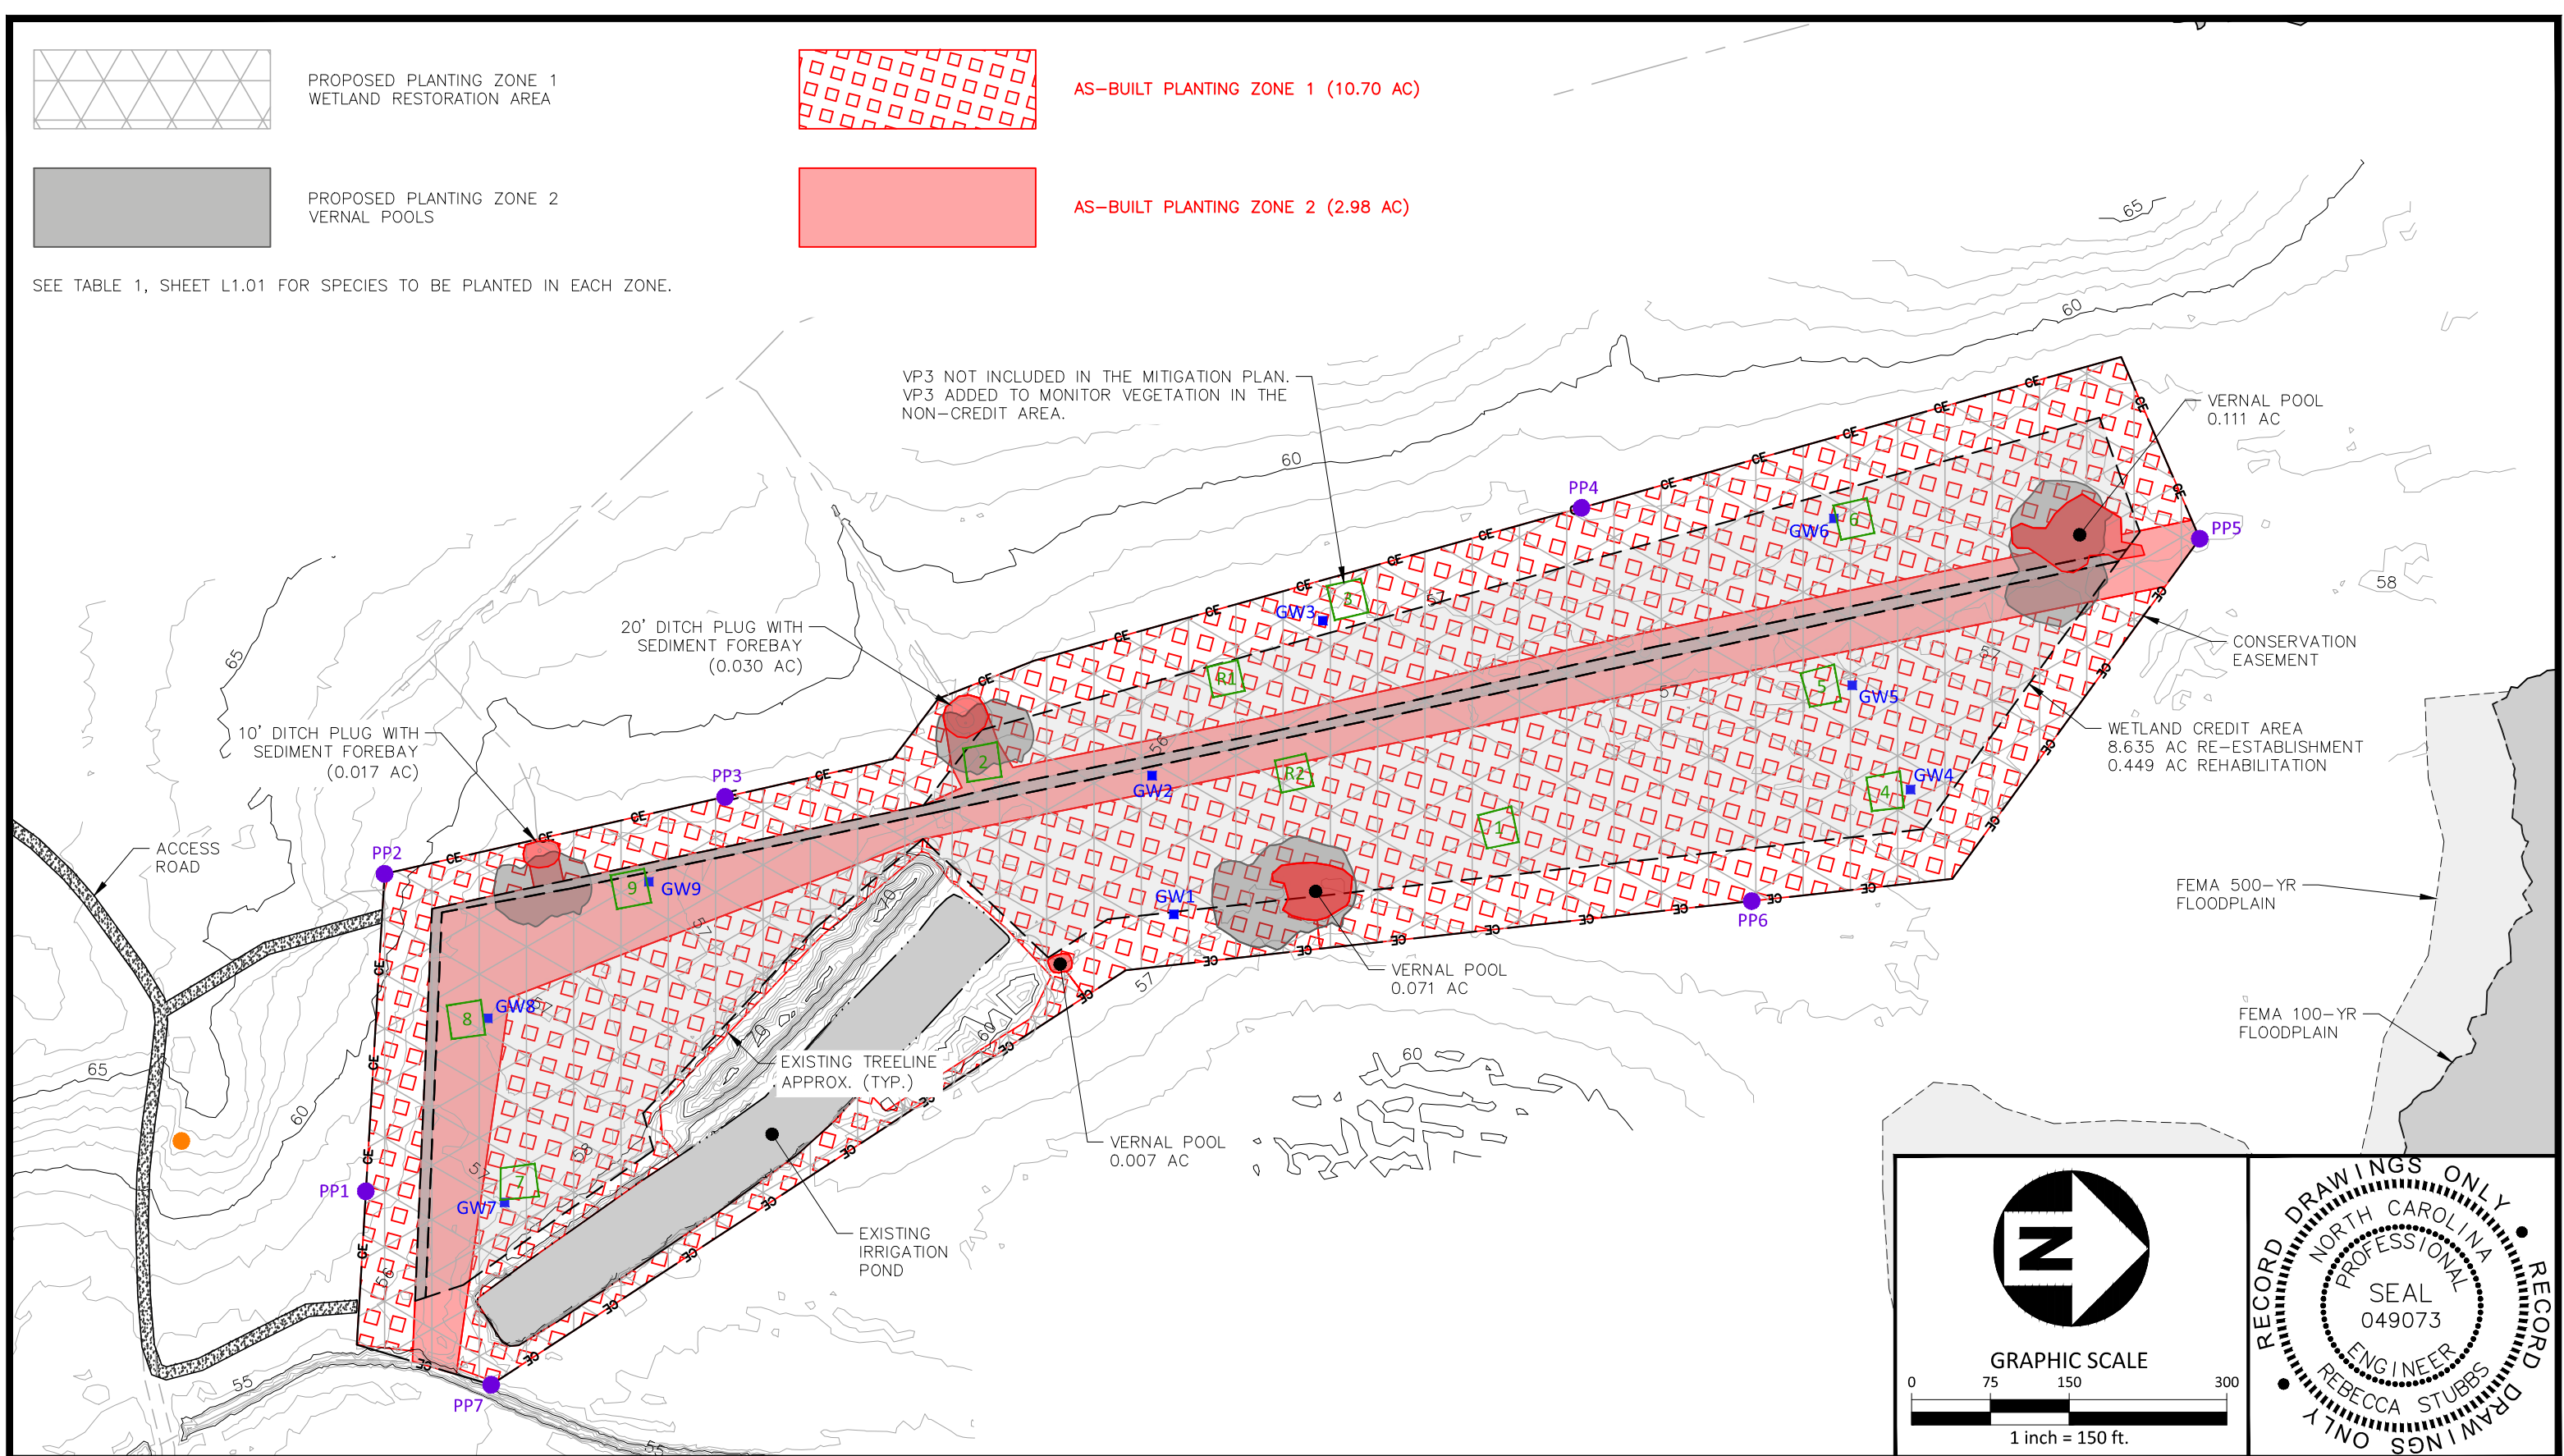
AS-BUILT PLANTING ZONE 2 (2.98 AC)

SEE TABLE 1, SHEET L1.01 FOR SPECIES TO BE PLANTED IN EACH ZONE.

The entire easement area was mechanically planted with woody tree and shrub plant material in two planting zones matching potential future hydrology conditions. Bare root planting zones proposed in the Final Mitigation Plan and construction drawings were modified based on field conditions and observed drainage patterns following Site grading. The wettest areas, including vernal pools, were planted with species tolerant of longer inundation times and designated as Zone 2. Zone 1 was designated as higher landscape position wetland areas and planted with appropriate tree species. The central ditch alignment of the Site exhibited prolonged inundation tendencies which likely would have resulted in mortality of several species designated for planting in the location in the Final Mitigation Plan. The location of planting zones described in the Final Mitigation were adjusted such that more hydrophytic species would be planted in the central part of the ditch alignment and vernal pool areas to ensure survival of planted stems. Species, quantity, and percent composition of bare root stems planted onsite are presented in Table 4 and the record drawings (Appendix D).
