Final Mitigation Plan Six Runs Stream and Wetland Mitigation Project

July 2022

DMS #: 100170 | Contract #: 0303-01 | RFP: 16-20190303
USACE Action ID: SAW-2020-01964 | DWR #: 20201798 v1
Cape Fear River Basin | HUC 03030006 | Sampson County, North Carolina

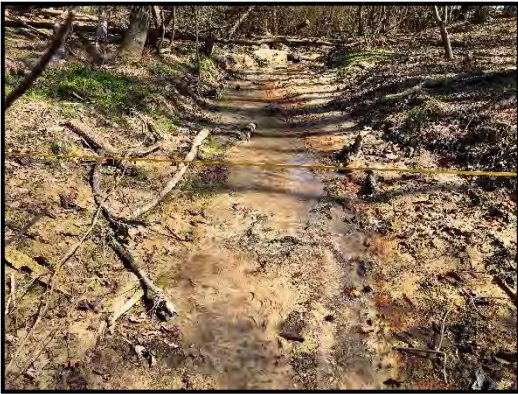
Looking upstream along reach BB-A, US of MT2

Brad's Branch is the primary tributary on the project and flows generally southwest to eventually confluence with Six Runs Creek. The portion of the stream above E Darden Road is split into BB-A and BB-B to be consistent with the Proposal reach names. However, there is no distinguishable difference in their existing conditions, so these reaches will be described together. This stream flows southwest from the Project property line, past Reach MT2, to Wetland A where it turns and flows south, parallel with E Darden Road, past Wetland B before turning sharply to enter the NCDOT culvert below E Darden Road. The channel and riparian corridor experiences regular cattle access, which has resulted in active downcutting, unstable and eroding banks, and lack of defined bedform. The riparian buffer is forested; however, cattle grazing has resulted in a lack of understory or herbaceous cover, and the soil structure has been highly manipulated from trampling and wallowing. The invasive Chinese privet is also prevalent throughout. Importantly, the buffer width off the right bank of BB-B is narrow and constrained by the NCDOT right-of-way. This reach is also bisected by an overhead power line and co-located water line that service an adjacent residence. The stream has a high sediment load, which is likely a result of upstream row crop farming and the cattle pressure onsite. As a result, the bed substrate is almost exclusively sand.

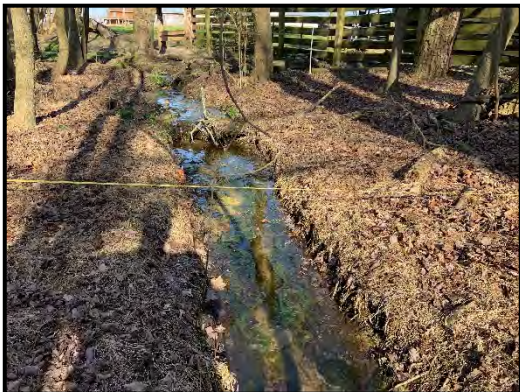
Looking upstream along reach DE2-A

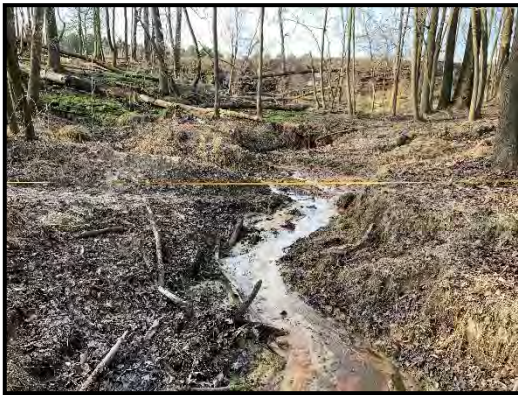
Looking upstream along reach DE8

Reach DE8 is the natural feature which was cut off from its watershed by the dam that currently outlets to DE3. This relic channel still receives enough seepage from the dam and surrounding hillslope to maintain intermittent status, but flow is severely inhibited. Despite this, the channel is cutting down to match Brad's Branch, leading to an incised and over-wide channel dimension with evidence of previous bank failures. Cattle access and the resulting hoof shear have accelerated the deterioration of the banks and negatively impacted the surrounding riparian zone. Bed substrate is fine sand. The riparian buffer is forested; however, cattle grazing has resulted in a lack of understory or herbaceous cover.

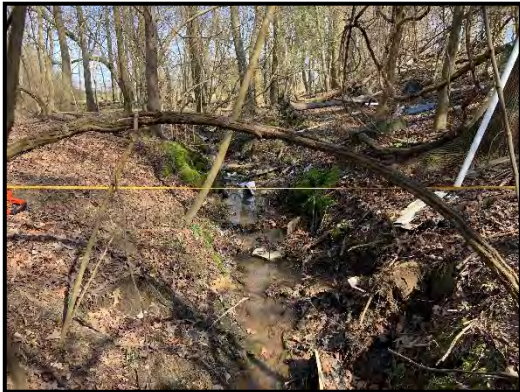
Looking upstream along reach DE7

degraded from cattle grazing. The bed substrate is silt and sand, and the reach is also littered with significant amounts of garbage and debris.

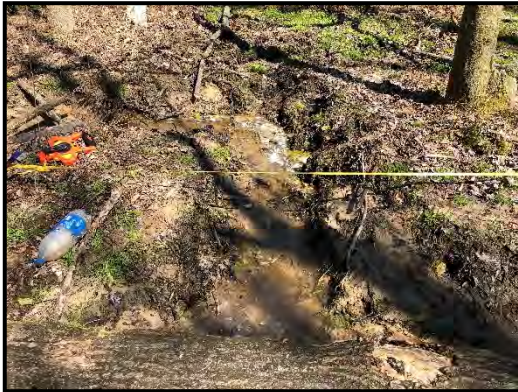
Looking upstream along reach MT2

that of reach BB-A, the riparian buffer is forested; however, cattle grazing has resulted in a lack of understory or herbaceous cover and soil structure has been highly manipulated from trampling. Chinese privet is also prevalent throughout.

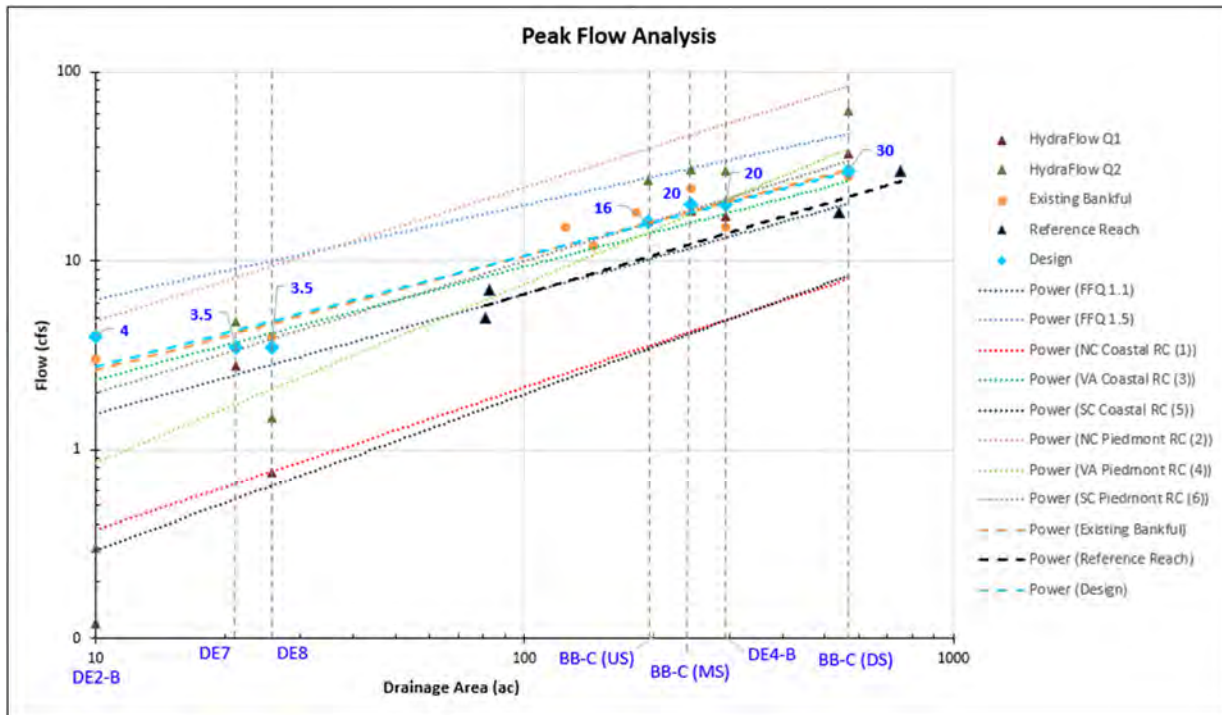
Chart 1. Peak Flow Analysis – Drainage areas were converted to acres for display on the chart. Existing bankfull estimates are based on observed and measured bankfull indicators and Manning’s equation. Nearby reference-reach discharges include the sites used for the Project design (UT to Buffalo Creek and UT to Hannah Creek) as well as two other, nearby sites in the Cape Fear River Basin (HUC 03030006) and Neuse River Basin (HUC 03020201). The data summarized in this chart can be found in **Appendix B**.

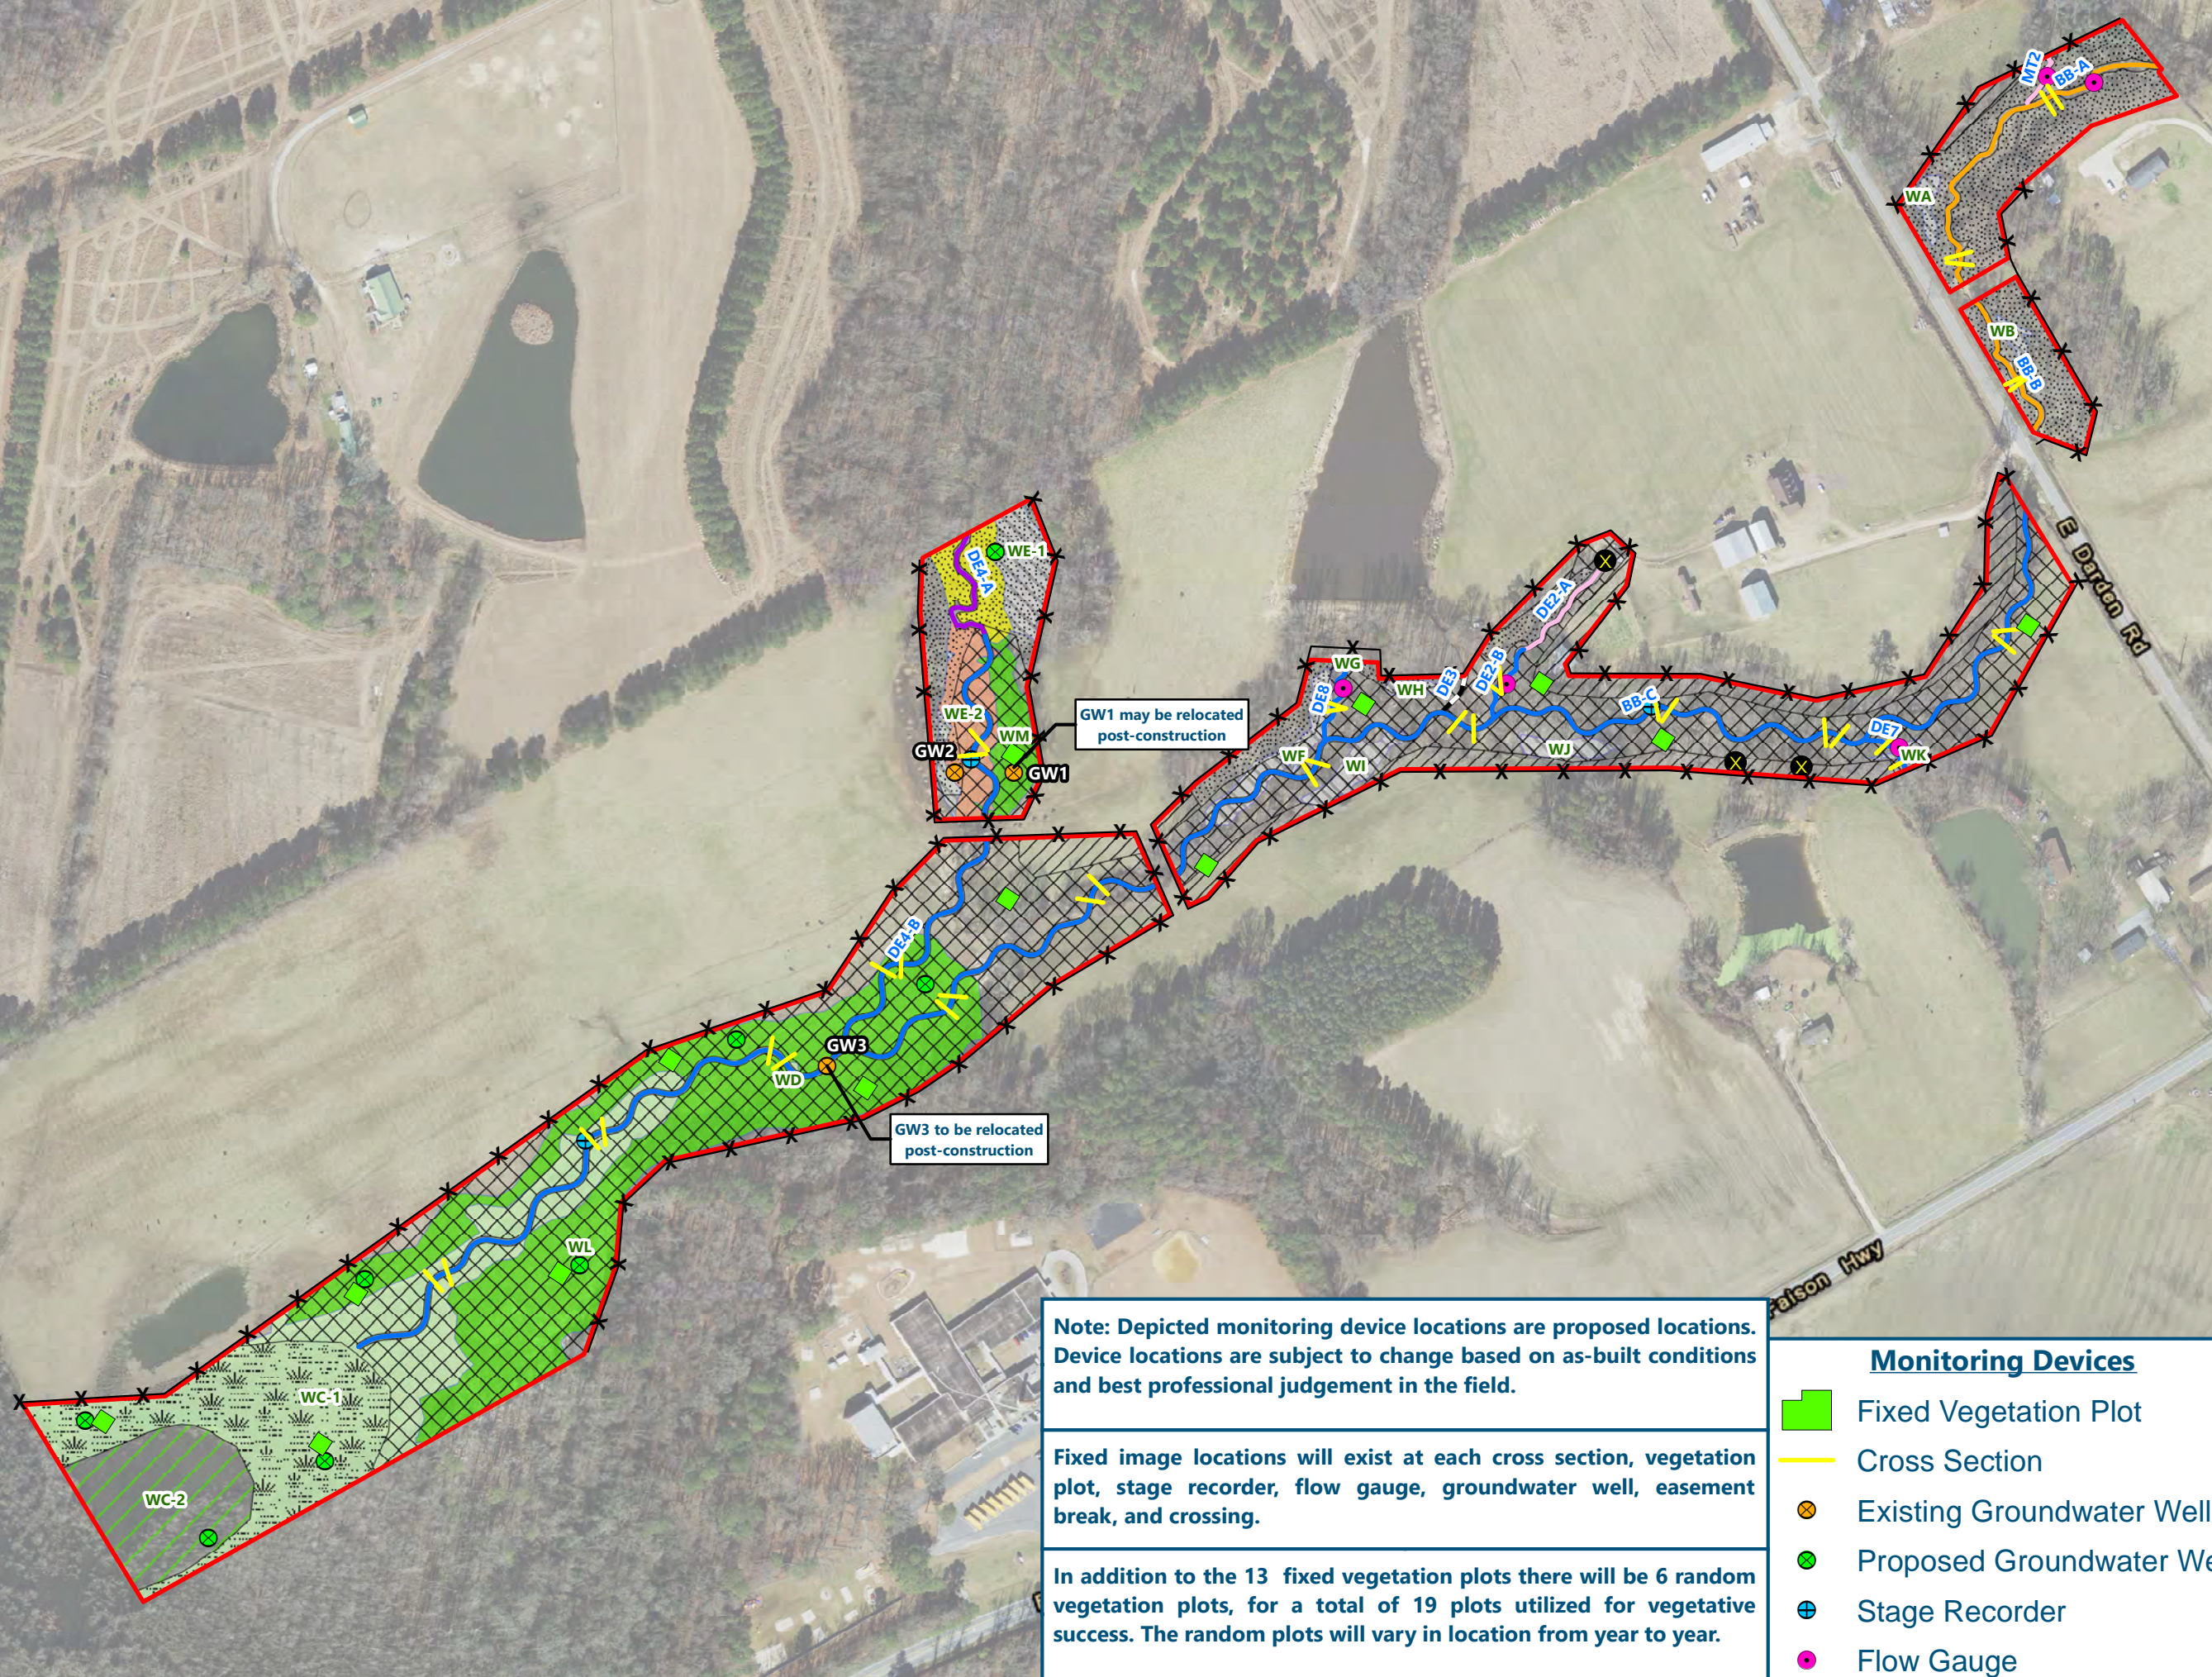
Note: Depicted monitoring device locations are proposed locations. Device locations are subject to change based on as-built conditions and best professional judgement in the field.

Fixed image locations will exist at each cross section, vegetation plot, stage recorder, flow gauge, groundwater well, easement break, and crossing.

17. Figure 12 Monitoring –
 - a. DWR requests that the groundwater gauge at southern edge of the reestablishment area be relocated near the south corner of the veg plot in the rehabilitation area (I can provide a map mark-up if requested). DWR also recommends considering adding a reference groundwater gauge in the preservation area.

- a. DWR requests that the groundwater gauge at southern edge of the reestablishment area be relocated near the south corner of the veg plot in the rehabilitation area (I can provide a map mark-up if requested). DWR also recommends considering adding a reference groundwater gauge in the preservation area.

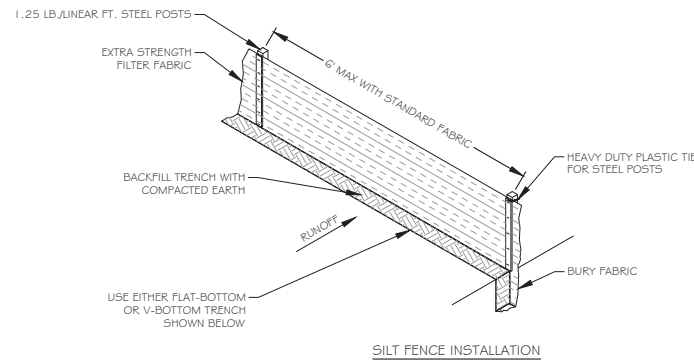
SILT FENCE INSTALLATION

- INSPECT SEDIMENT FENCES AT LEAST ONCE A WEEK AND AFTER EACH RAINFALL. MAKE ANY REQUIRED REPAIRS IMMEDIATELY.
- IF THE FABRIC OF A SEDIMENT FENCE COLLAPSE, TEAR, DECOMPOSE OR BECOME INEFFECTIVE, REPLACE IT PROMPTLY.
- REMOVE SEDIMENT DEPOSITS AS NECESSARY TO PROVIDE ADEQUATE STORAGE VOLUME FOR THE NEXT RAIN AND TO REDUCE PRESSURE ON THE FENCE. TAKE CARE TO AVOID UNDERMINING THE FENCE DURING CLEANOUT.
- REMOVE ALL FENCING MATERIALS AND UNSTABLE SEDIMENT DEPOSITS AND BRING THE AREA TO GRADE AND STABILIZE IT AFTER THE CONTRIBUTING DRAINAGE AREA HAS BEEN PROPERLY STABILIZED.

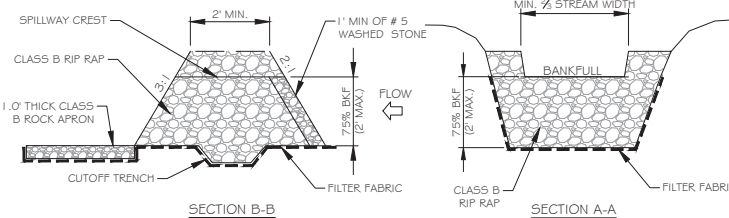
TEMPORARY ROCK CHECK DAM

- INSPECT CHECK DAM PERIODICALLY AND AFTER EACH SIGNIFICANT RAINFALL EVENT FOR DAMAGE AND SEDIMENT ACCUMULATION.
- AT A MINIMUM, REMOVE SEDIMENT WHEN ACCUMULATIONS REACH ONE-HALF THE HEIGHT OF THE SEDIMENT CONTROL STONE.
- REPLACE OR CLEAN SEDIMENT CONTROL STONE AS NEEDED TO ALLOW WATER TO DRAIN THROUGH THE DEVICE BETWEEN RAINFALL EVENTS.

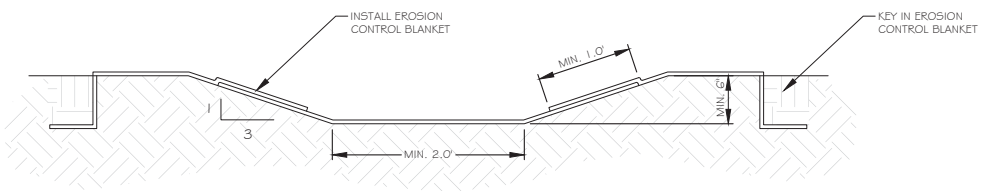
FLOODPLAIN SWALE
NTS

- INSTALL SWALE AT LOCATIONS SHOWN ON THE PLAN SHEETS. LOCATIONS MAY BE ADJUSTED OR ADDED TO BETTER HANDLE SITE DRAINAGE CONDITIONS DURING CONSTRUCTION ACTIVITIES.
- INSTALL EROSION CONTROL BLANKETS (ECB) ALONG ALL SWALES PER MANUFACTURER'S INSTRUCTIONS. APPLY BOTH TEMPORARY AND PERMANENT SEED MIX BEFORE ECB INSTALLATION.
- SWALES SHOULD BE CONSTRUCTED WITH SLOPES NO STEEPER THAN 5%.
- EROSION CONTROL BLANKET INSTALLATION MUST MEET OR EXCEED THE SPECIFICATIONS OF CURLEX II FIBRENET. COIR MATTING MAY BE USED IN PLACE OF CURLEX PER APPROVAL FROM ENGINEER.
- ALL SWALES MUST BE STABILIZED WITH SEED, MULCH & MATTING WITHIN 7 DAYS OF LAND DISTURBING ACTIVITIES.

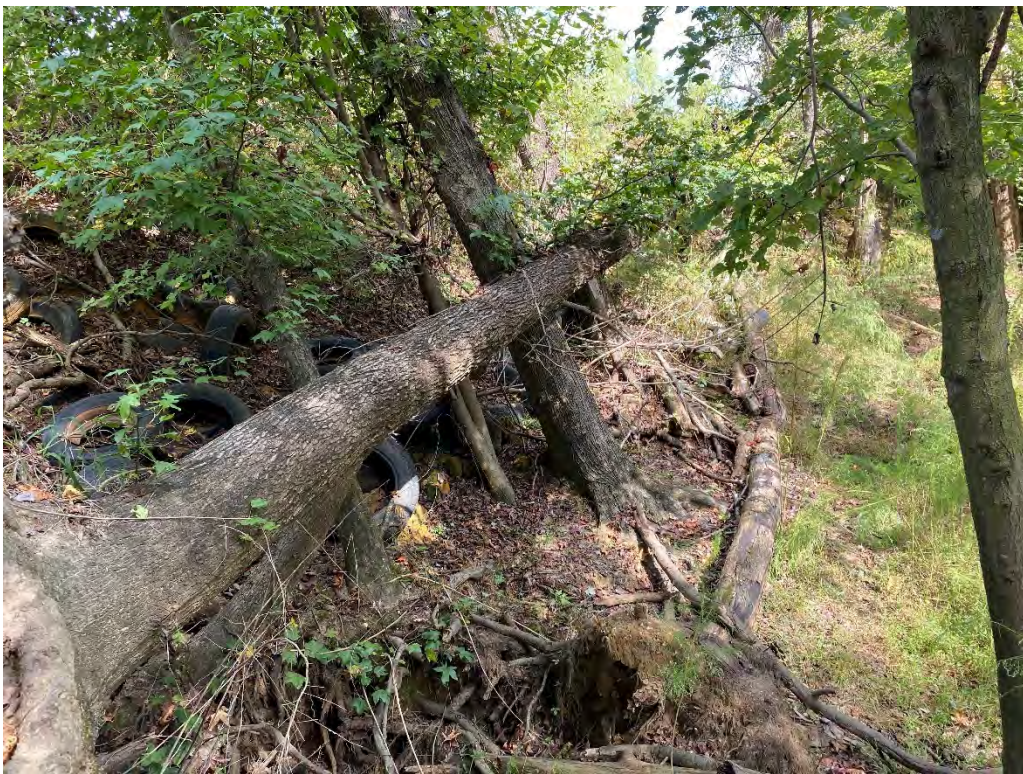
Photo 7: Uprooted tree on downstream face has removed portion of dam embankment.

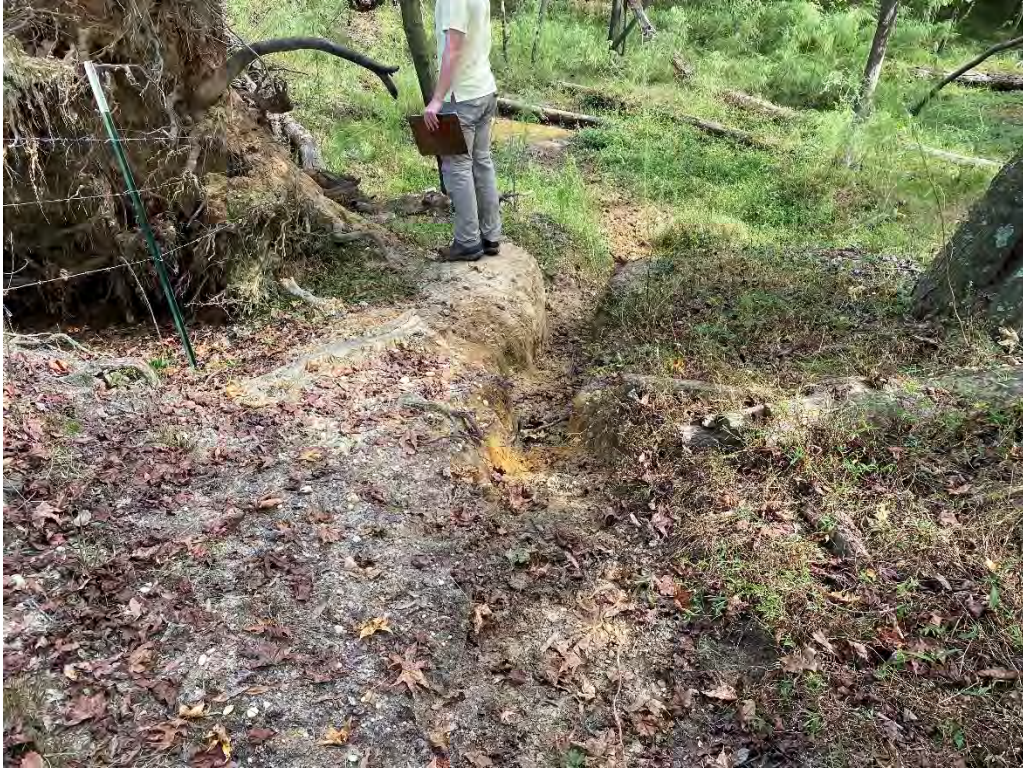
Photo 8: Uprooted tree on downstream face of dam in area of previous repair using tires and other refuse.

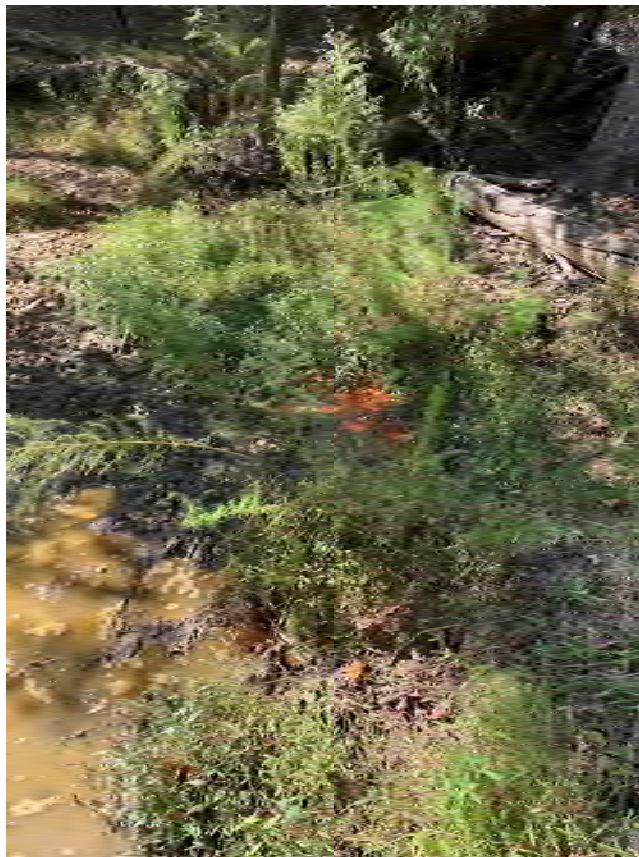
Photo 11: Rust-colored water ponding below downstream face due to seepage through dam embankment.
