(MY0) FINAL MONITORING REPORT - *Stream Mitigation*

STRAWBERRY HILL MITIGATION PROJECT

Johnston County, North Carolina

NCDMS Project #100094

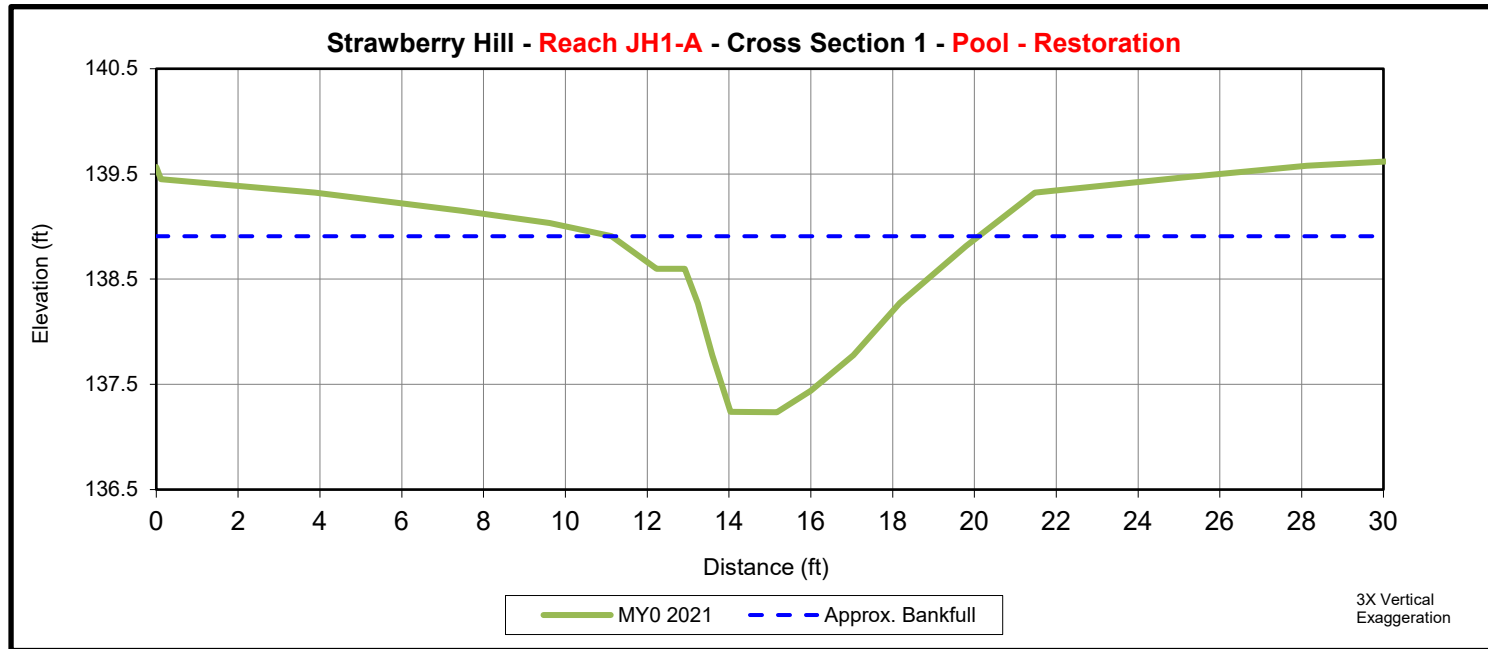
Cross Section 1 (Pool - JH1-A)						
	MY0	MY1	MY2	MY3	MY5	MY7	MY+
Bankfull Elevation (ft) - Based on AB-Bankfull ¹ Area	---						
Bank Height Ratio_Based on AB Bankfull ¹ Area	---						
Thalweg Elevation	137.24						
LTOB ² Elevation	138.91						
LTOB ² Max Depth (ft)	1.7						
LTOB ² Cross Sectional Area (ft ²)	7.60

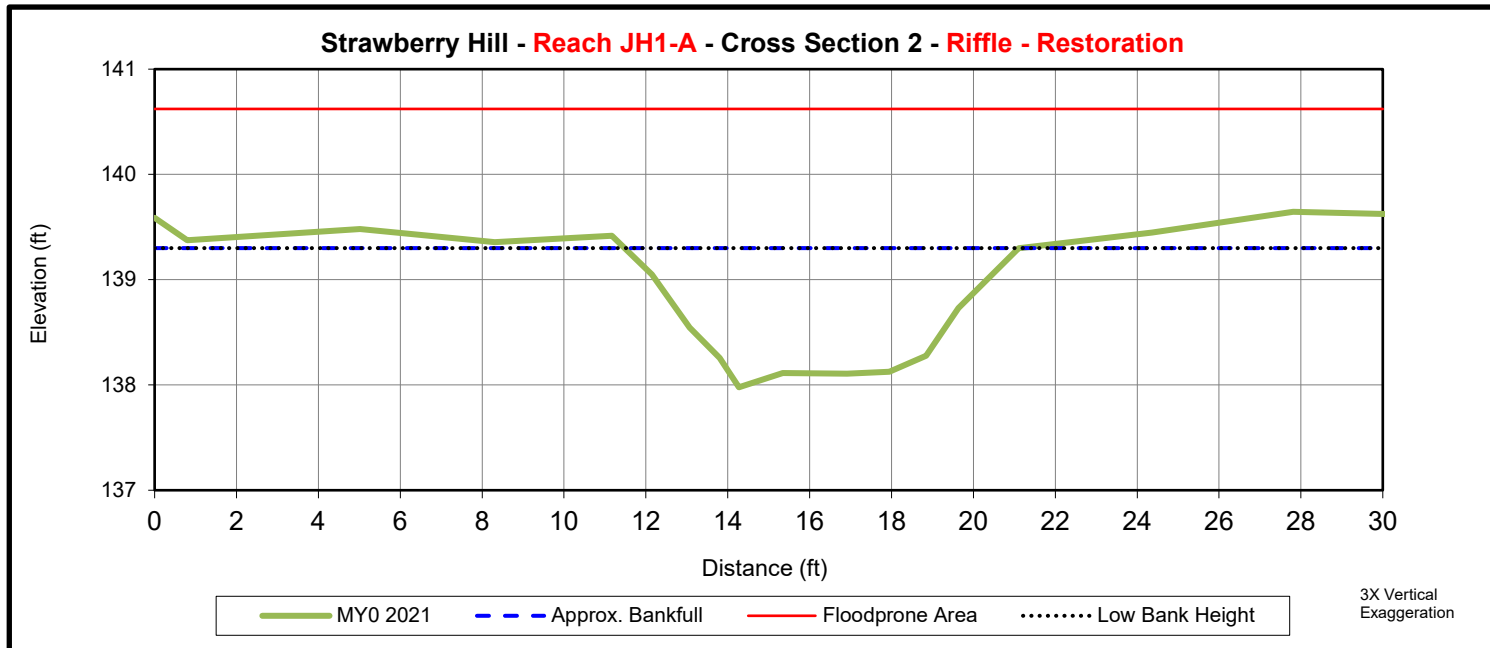
Cross Section 2 (Riffle - JH1-A)						
	MY0	MY1	MY2	MY3	MY5	MY7	MY+
Bankfull Elevation (ft) - Based on AB-Bankfull ¹ Area	139.30						
Bank Height Ratio_ Based on AB Bankfull ¹ Area	1.00						
Thalweg Elevation	137.98						
LTOB ² Elevation	139.30						
LTOB ² Max Depth (ft)	1.3						
LTOB ² Cross Sectional Area (ft ²)	8.20

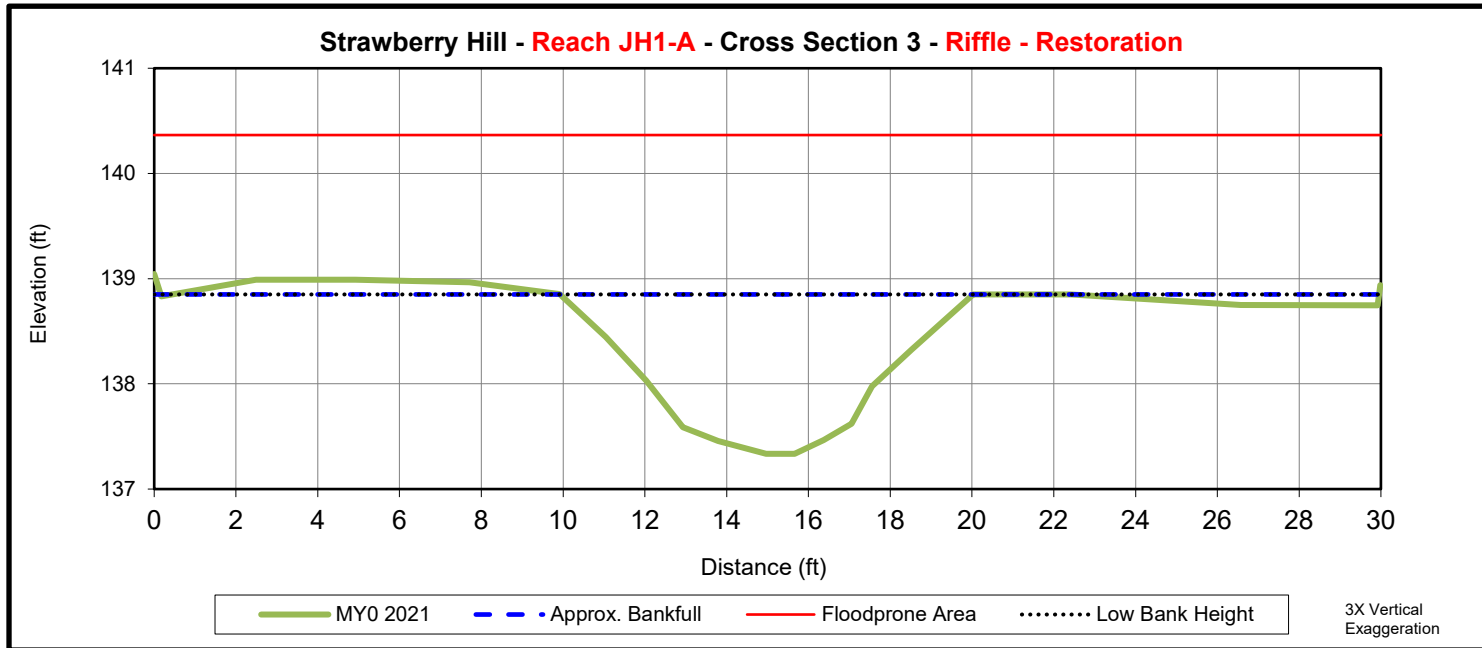
Cross Section 3 (Riffle - JH1-A)						
	MY0	MY1	MY2	MY3	MY5	MY7	MY+
Bankfull Elevation (ft) - Based on AB-Bankfull ¹ Area	138.85						
Bank Height Ratio - Based on AB Bankfull ¹ Area	1.00						
Thalweg Elevation	137.34						
LTOB ² Elevation	138.85						
LTOB ² Max Depth (ft)	1.5						
LTOB ² Cross Sectional Area (ft ²)	9.20

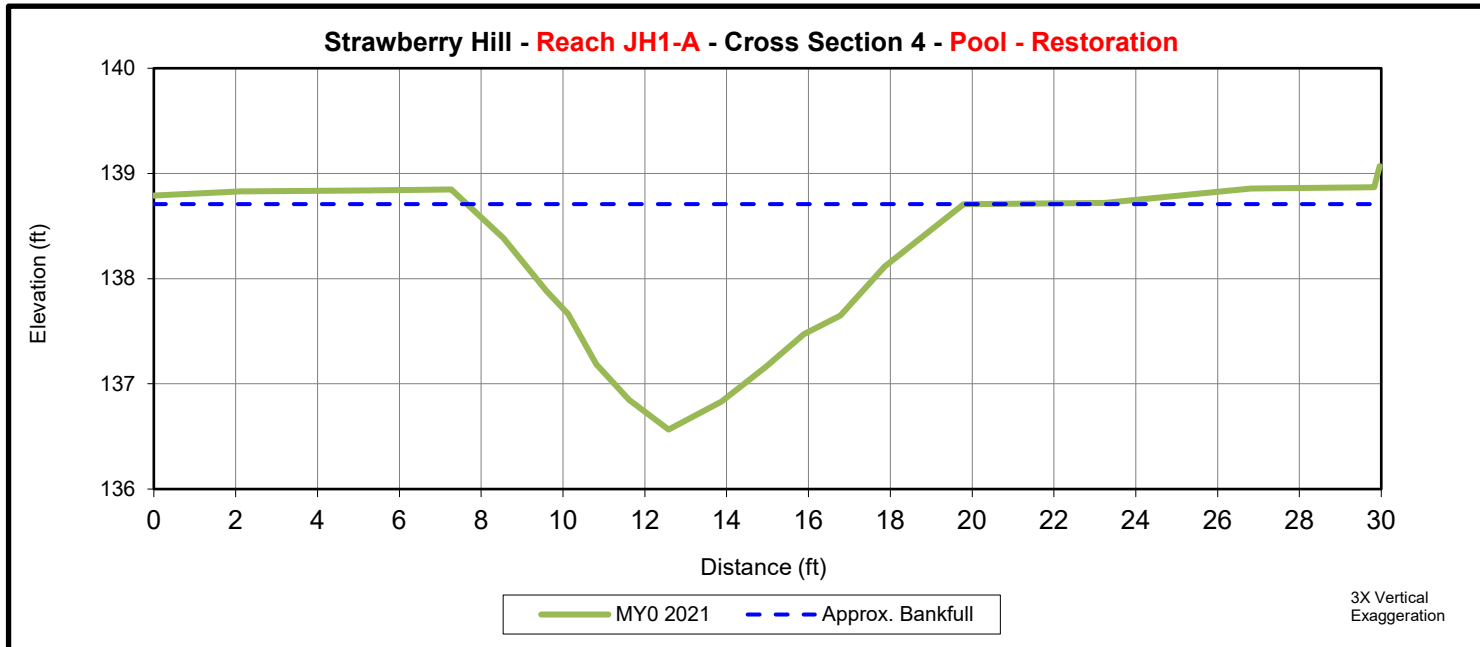
Cross Section 4 (Pool - JH1-A)						
	MY0	MY1	MY2	MY3	MY5	MY7	MY+
Bankfull Elevation (ft) - Based on AB-Bankfull ¹ Area	---						
Bank Height Ratio_Based on AB Bankfull ¹ Area	---						
Thalweg Elevation	136.57						
LTOB ² Elevation	138.71						
LTOB ² Max Depth (ft)	2.1						
LTOB ² Cross Sectional Area (ft ²)	13.70

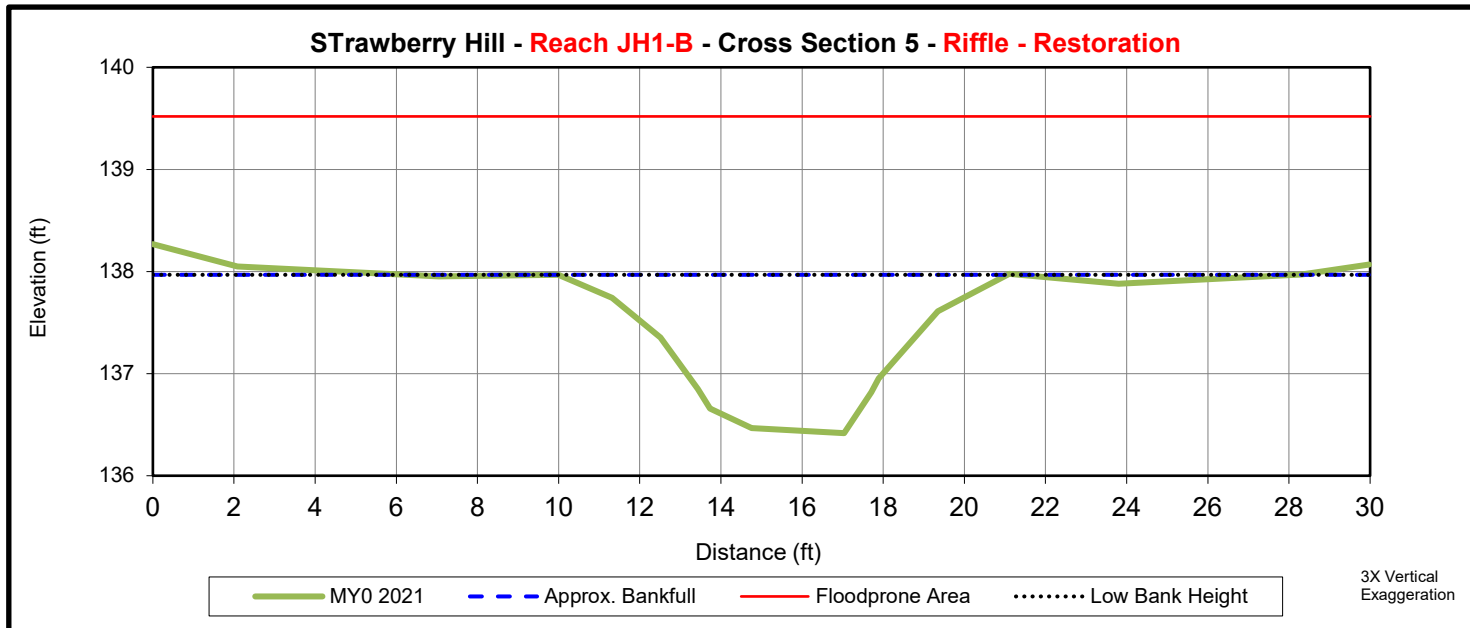
Cross Section 5 (Riffle - JH1-B)						
	MY0	MY1	MY2	MY3	MY5	MY7	MY+
Bankfull Elevation (ft) - Based on AB-Bankfull ¹ Area	137.97						
Bank Height Ratio - Based on AB Bankfull ¹ Area	1.00						
Thalweg Elevation	136.42						
LTOB ² Elevation	137.97						
LTOB ² Max Depth (ft)	1.6						
LTOB ² Cross Sectional Area (ft ²)	9.10

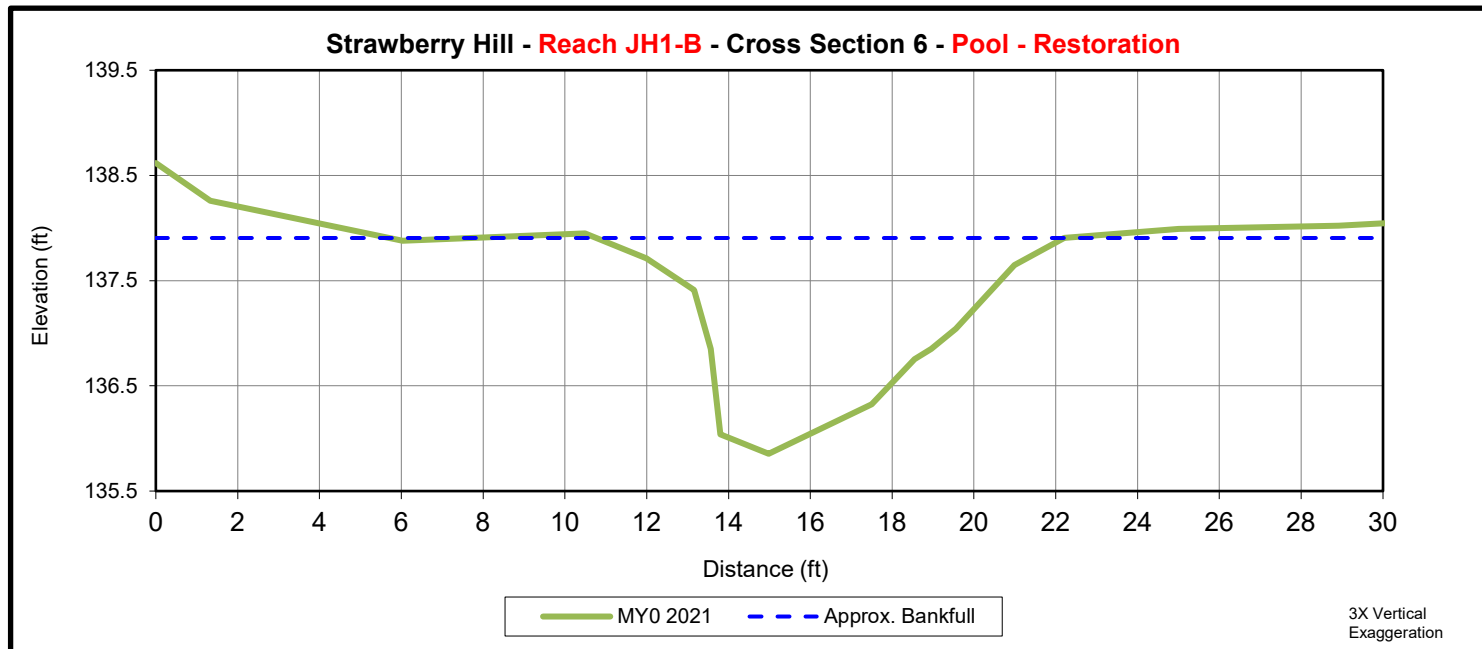
Cross Section 6 (Pool - JH1-B)						
	MY0	MY1	MY2	MY3	MY5	MY7	MY+
Bankfull Elevation (ft) - Based on AB-Bankfull ¹ Area	---						
Bank Height Ratio_Based on AB Bankfull ¹ Area	---						
Thalweg Elevation	135.85						
LTOB ² Elevation	137.91						
LTOB ² Max Depth (ft)	2.1						
LTOB ² Cross Sectional Area (ft ²)	11.50

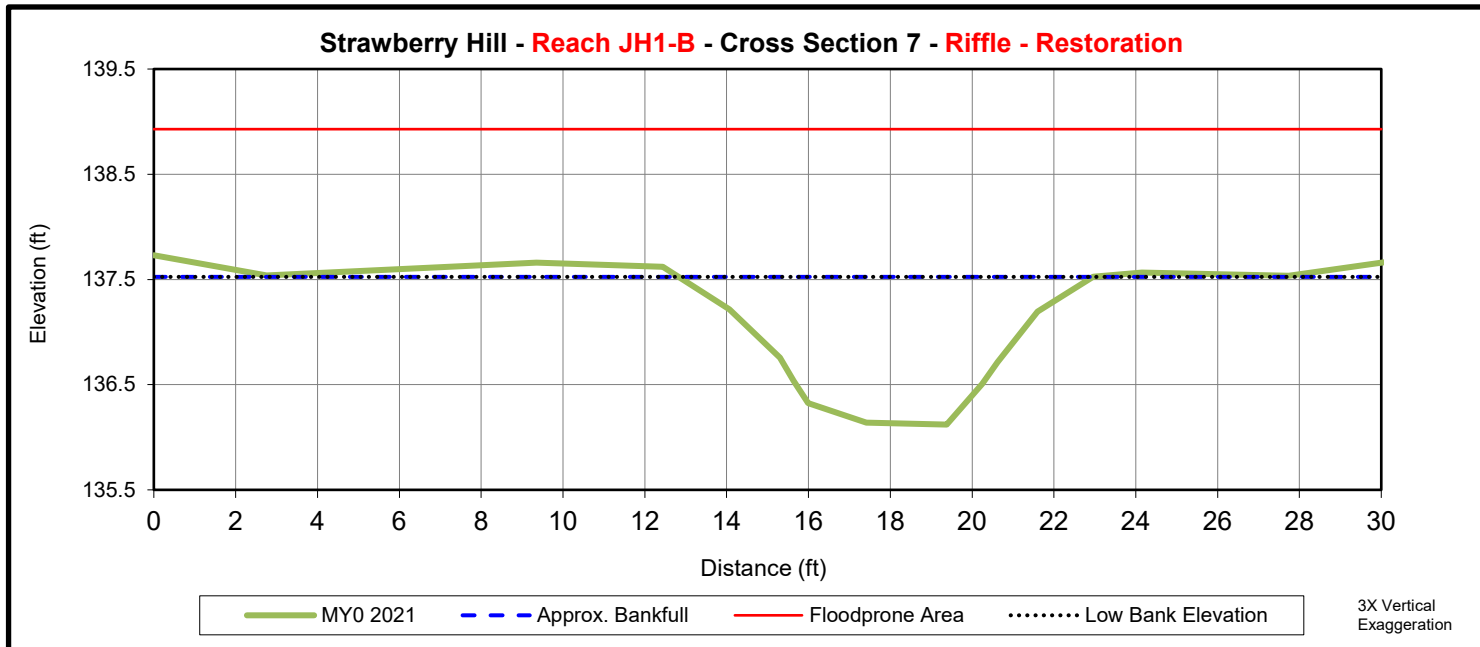
Cross Section 7 (Riffle - JH1-B)						
	MY0	MY1	MY2	MY3	MY5	MY7	MY+
Bankfull Elevation (ft) - Based on AB-Bankfull ¹ Area	137.52						
Bank Height Ratio - Based on AB Bankfull ¹ Area	1.00						
Thalweg Elevation	136.12						
LTOB ² Elevation	137.52						
LTOB ² Max Depth (ft)	1.4						
LTOB ² Cross Sectional Area (ft ²)	8.30

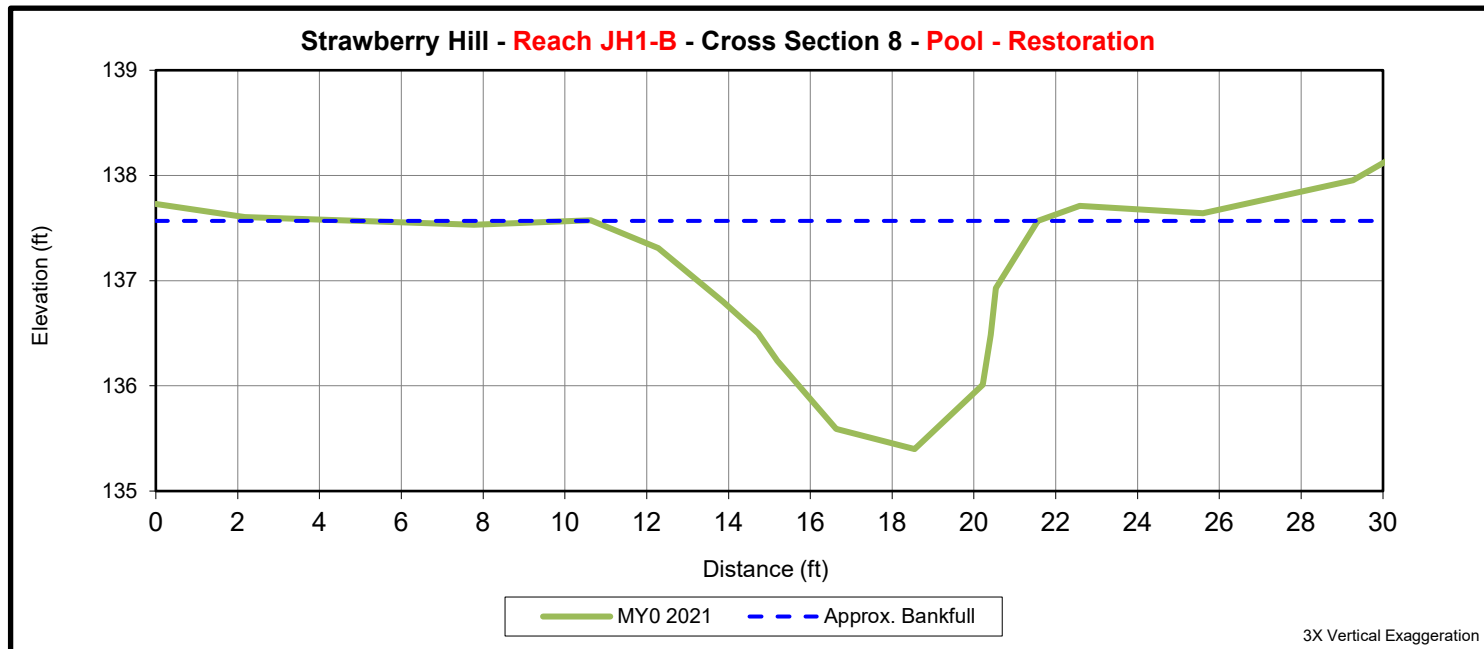
Cross Section 8 (Pool - JH1-B)						
	MY0	MY1	MY2	MY3	MY5	MY7	MY+
Bankfull Elevation (ft) - Based on AB-Bankfull ¹ Area	---						
Bank Height Ratio Based on AB Bankfull ¹ Area	---						
Thalweg Elevation	135.40						
LTOB ² Elevation	137.57						
LTOB ² Max Depth (ft)	2.2						
LTOB ² Cross Sectional Area (ft ²)	12.50

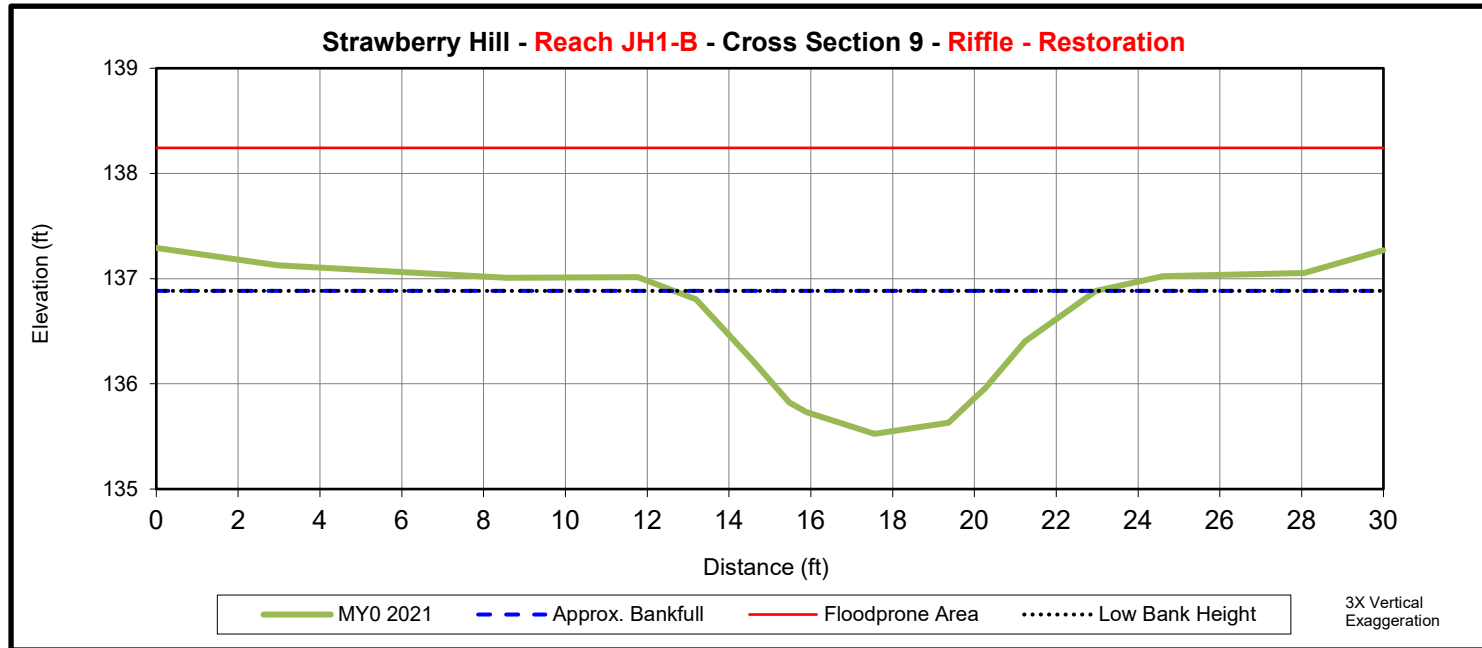
Cross Section 9 (Riffle - JH1-B)						
	MY0	MY1	MY2	MY3	MY5	MY7	MY+
Bankfull Elevation (ft) - Based on AB-Bankfull ¹ Area	136.88						
Bank Height Ratio - Based on AB Bankfull ¹ Area	1.00						
Thalweg Elevation	135.53						
LTOB ² Elevation	136.88						
LTOB ² Max Depth (ft)	1.4						
LTOB ² Cross Sectional Area (ft ²)	8.30

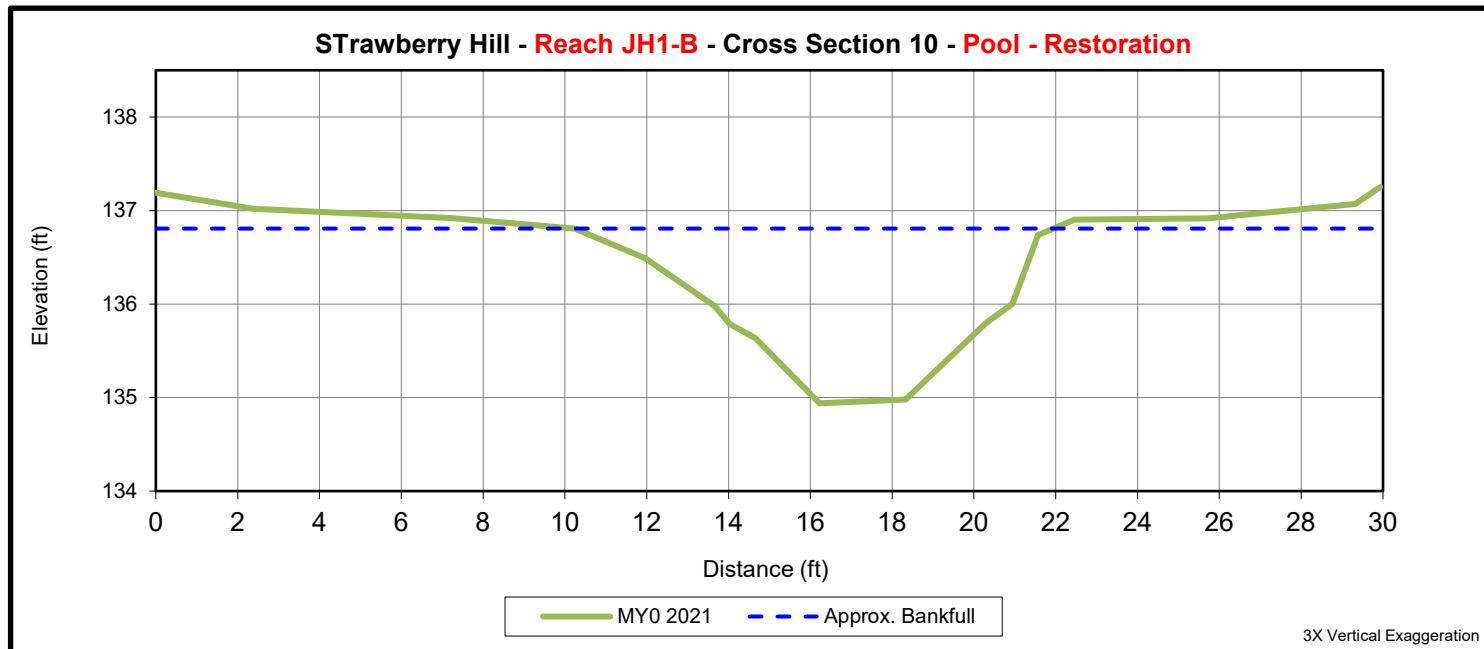
Cross Section 10 (Pool - JH1-B)						
	MY0	MY1	MY2	MY3	MY5	MY7	MY+
Bankfull Elevation (ft) - Based on AB-Bankfull ¹ Area	---						
Bank Height Ratio - Based on AB Bankfull ¹ Area	---						
Thalweg Elevation	134.94						
LTOB ² Elevation	136.81						
LTOB ² Max Depth (ft)	1.9						
LTOB ² Cross Sectional Area (ft ²)	12.20

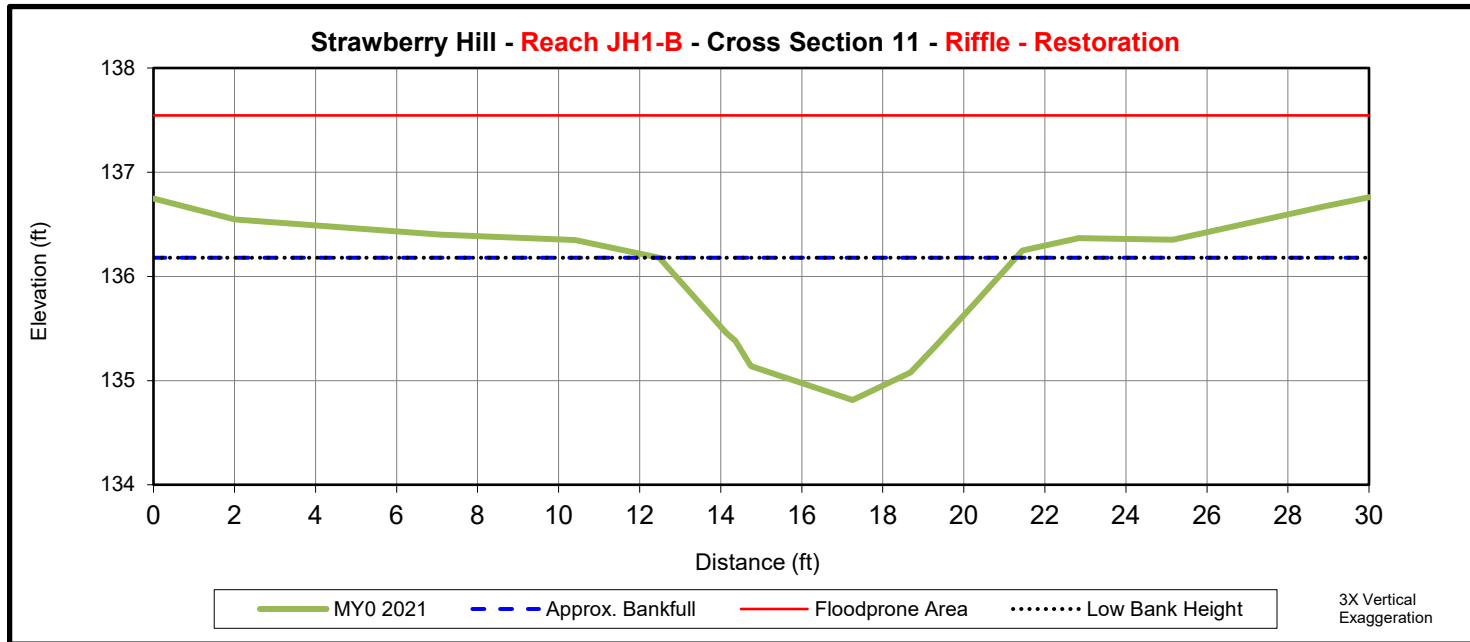
Cross Section 11 (Riffle - JH1-B)						
	MY0	MY1	MY2	MY3	MY5	MY7	MY+
Bankfull Elevation (ft) - Based on AB-Bankfull ¹ Area	136.18						
Bank Height Ratio_Based on AB Bankfull ¹ Area	1.00						
Thalweg Elevation	134.81						
LTOB ² Elevation	136.18						
LTOB ² Max Depth (ft)	1.4						
LTOB ² Cross Sectional Area (ft ²)	7.30

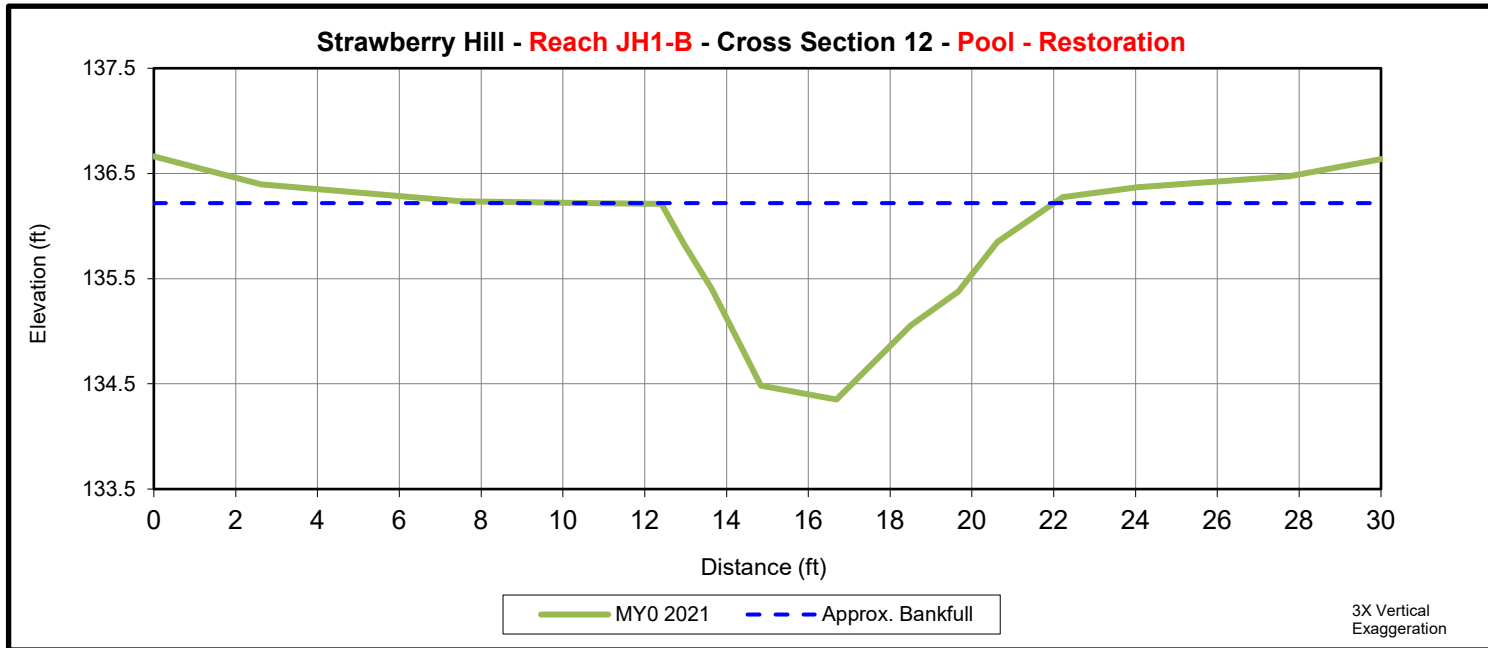
Cross Section 12 (Pool - JH1-B)						
	MY0	MY1	MY2	MY3	MY5	MY7	MY+
Bankfull Elevation (ft) - Based on AB-Bankfull ¹ Area	---						
Bank Height Ratio Based on AB Bankfull ¹ Area	---						
Thalweg Elevation	134.35						
LTOB ² Elevation	136.22						
LTOB ² Max Depth (ft)	1.9						
LTOB ² Cross Sectional Area (ft ²)	10.10

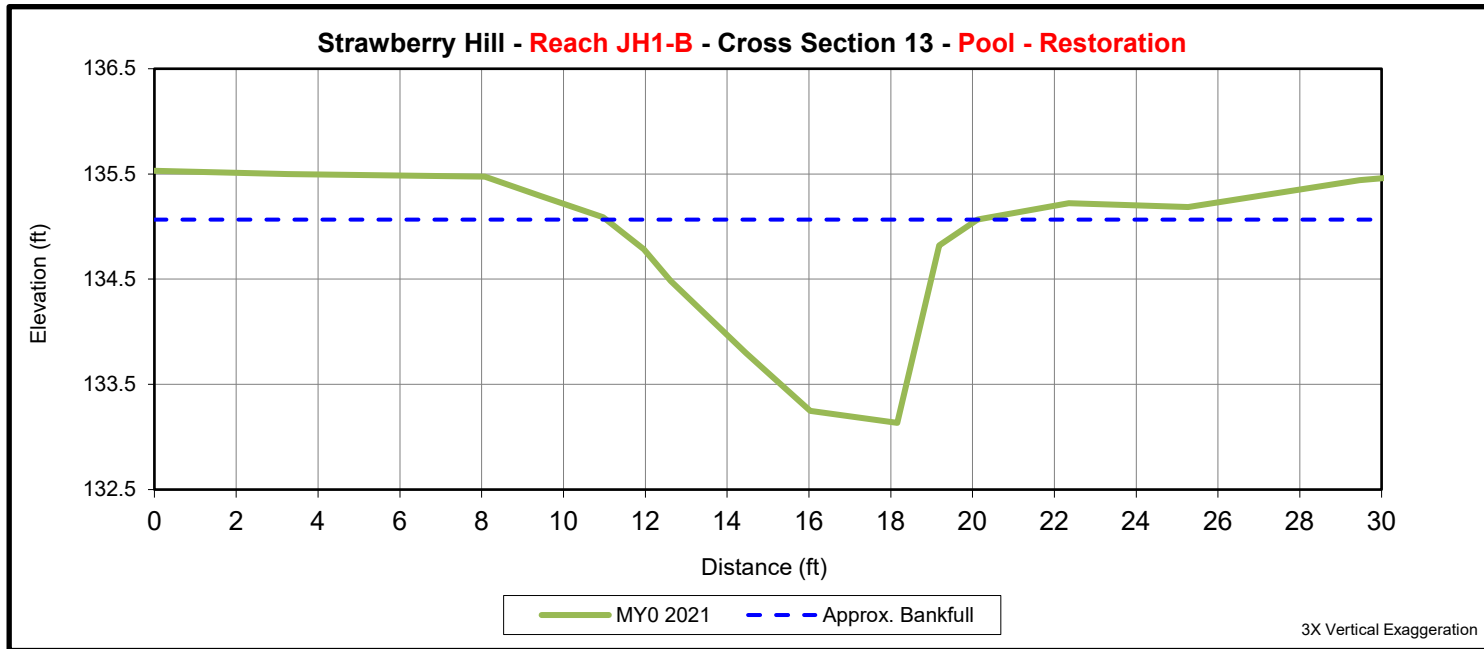
Cross Section 13 (Pool - JH1-B)						
	MY0	MY1	MY2	MY3	MY5	MY7	MY+
Bankfull Elevation (ft) - Based on AB-Bankfull ¹ Area	---						
Bank Height Ratio_Based on AB Bankfull ¹ Area	---						
Thalweg Elevation	133.13						
LTOB ² Elevation	135.07						
LTOB ² Max Depth (ft)	1.9						
LTOB ² Cross Sectional Area (ft ²)	9.70

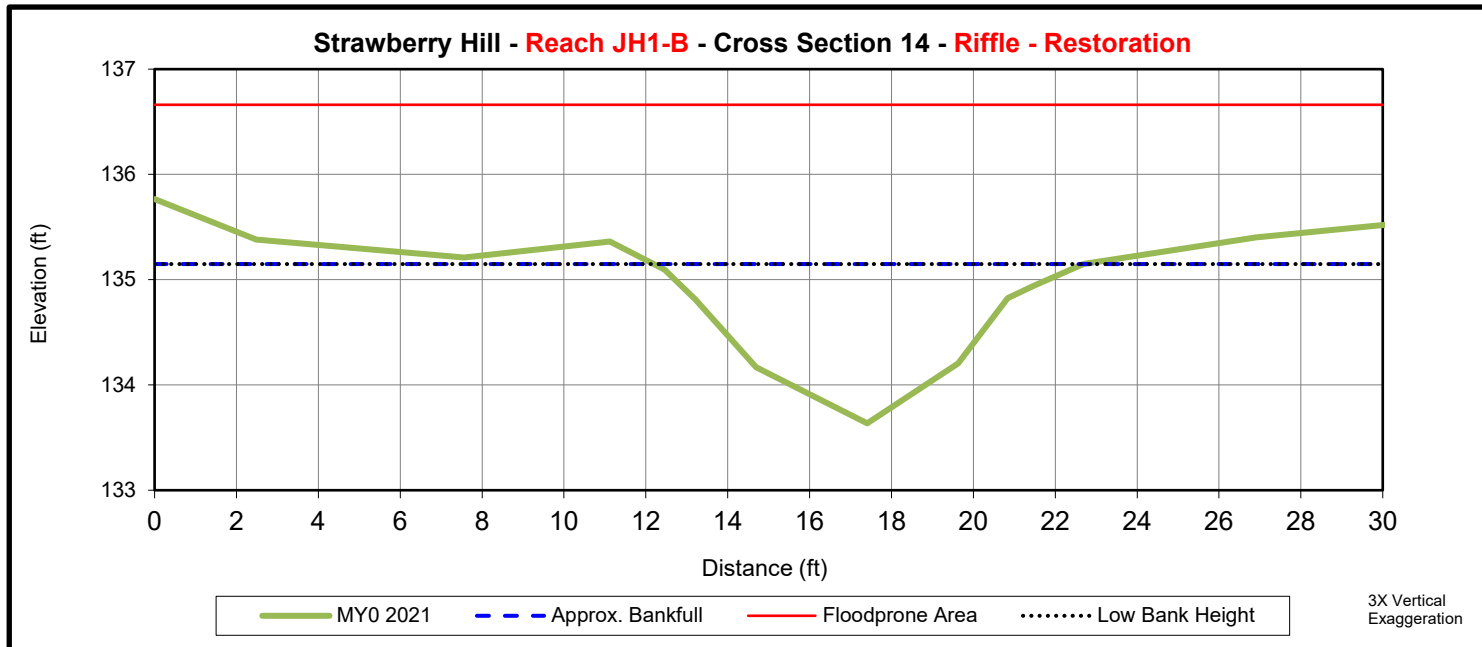
Cross Section 14 (Riffle - JH1-B)						
	MY0	MY1	MY2	MY3	MY5	MY7	MY+
Bankfull Elevation (ft) - Based on AB-Bankfull ¹ Area	135.15						
Bank Height Ratio_Based on AB Bankfull ¹ Area	1.00						
Thalweg Elevation	133.64						
LTOB ² Elevation	135.15						
LTOB ² Max Depth (ft)	1.5						
LTOB ² Cross Sectional Area (ft ²)	8.30

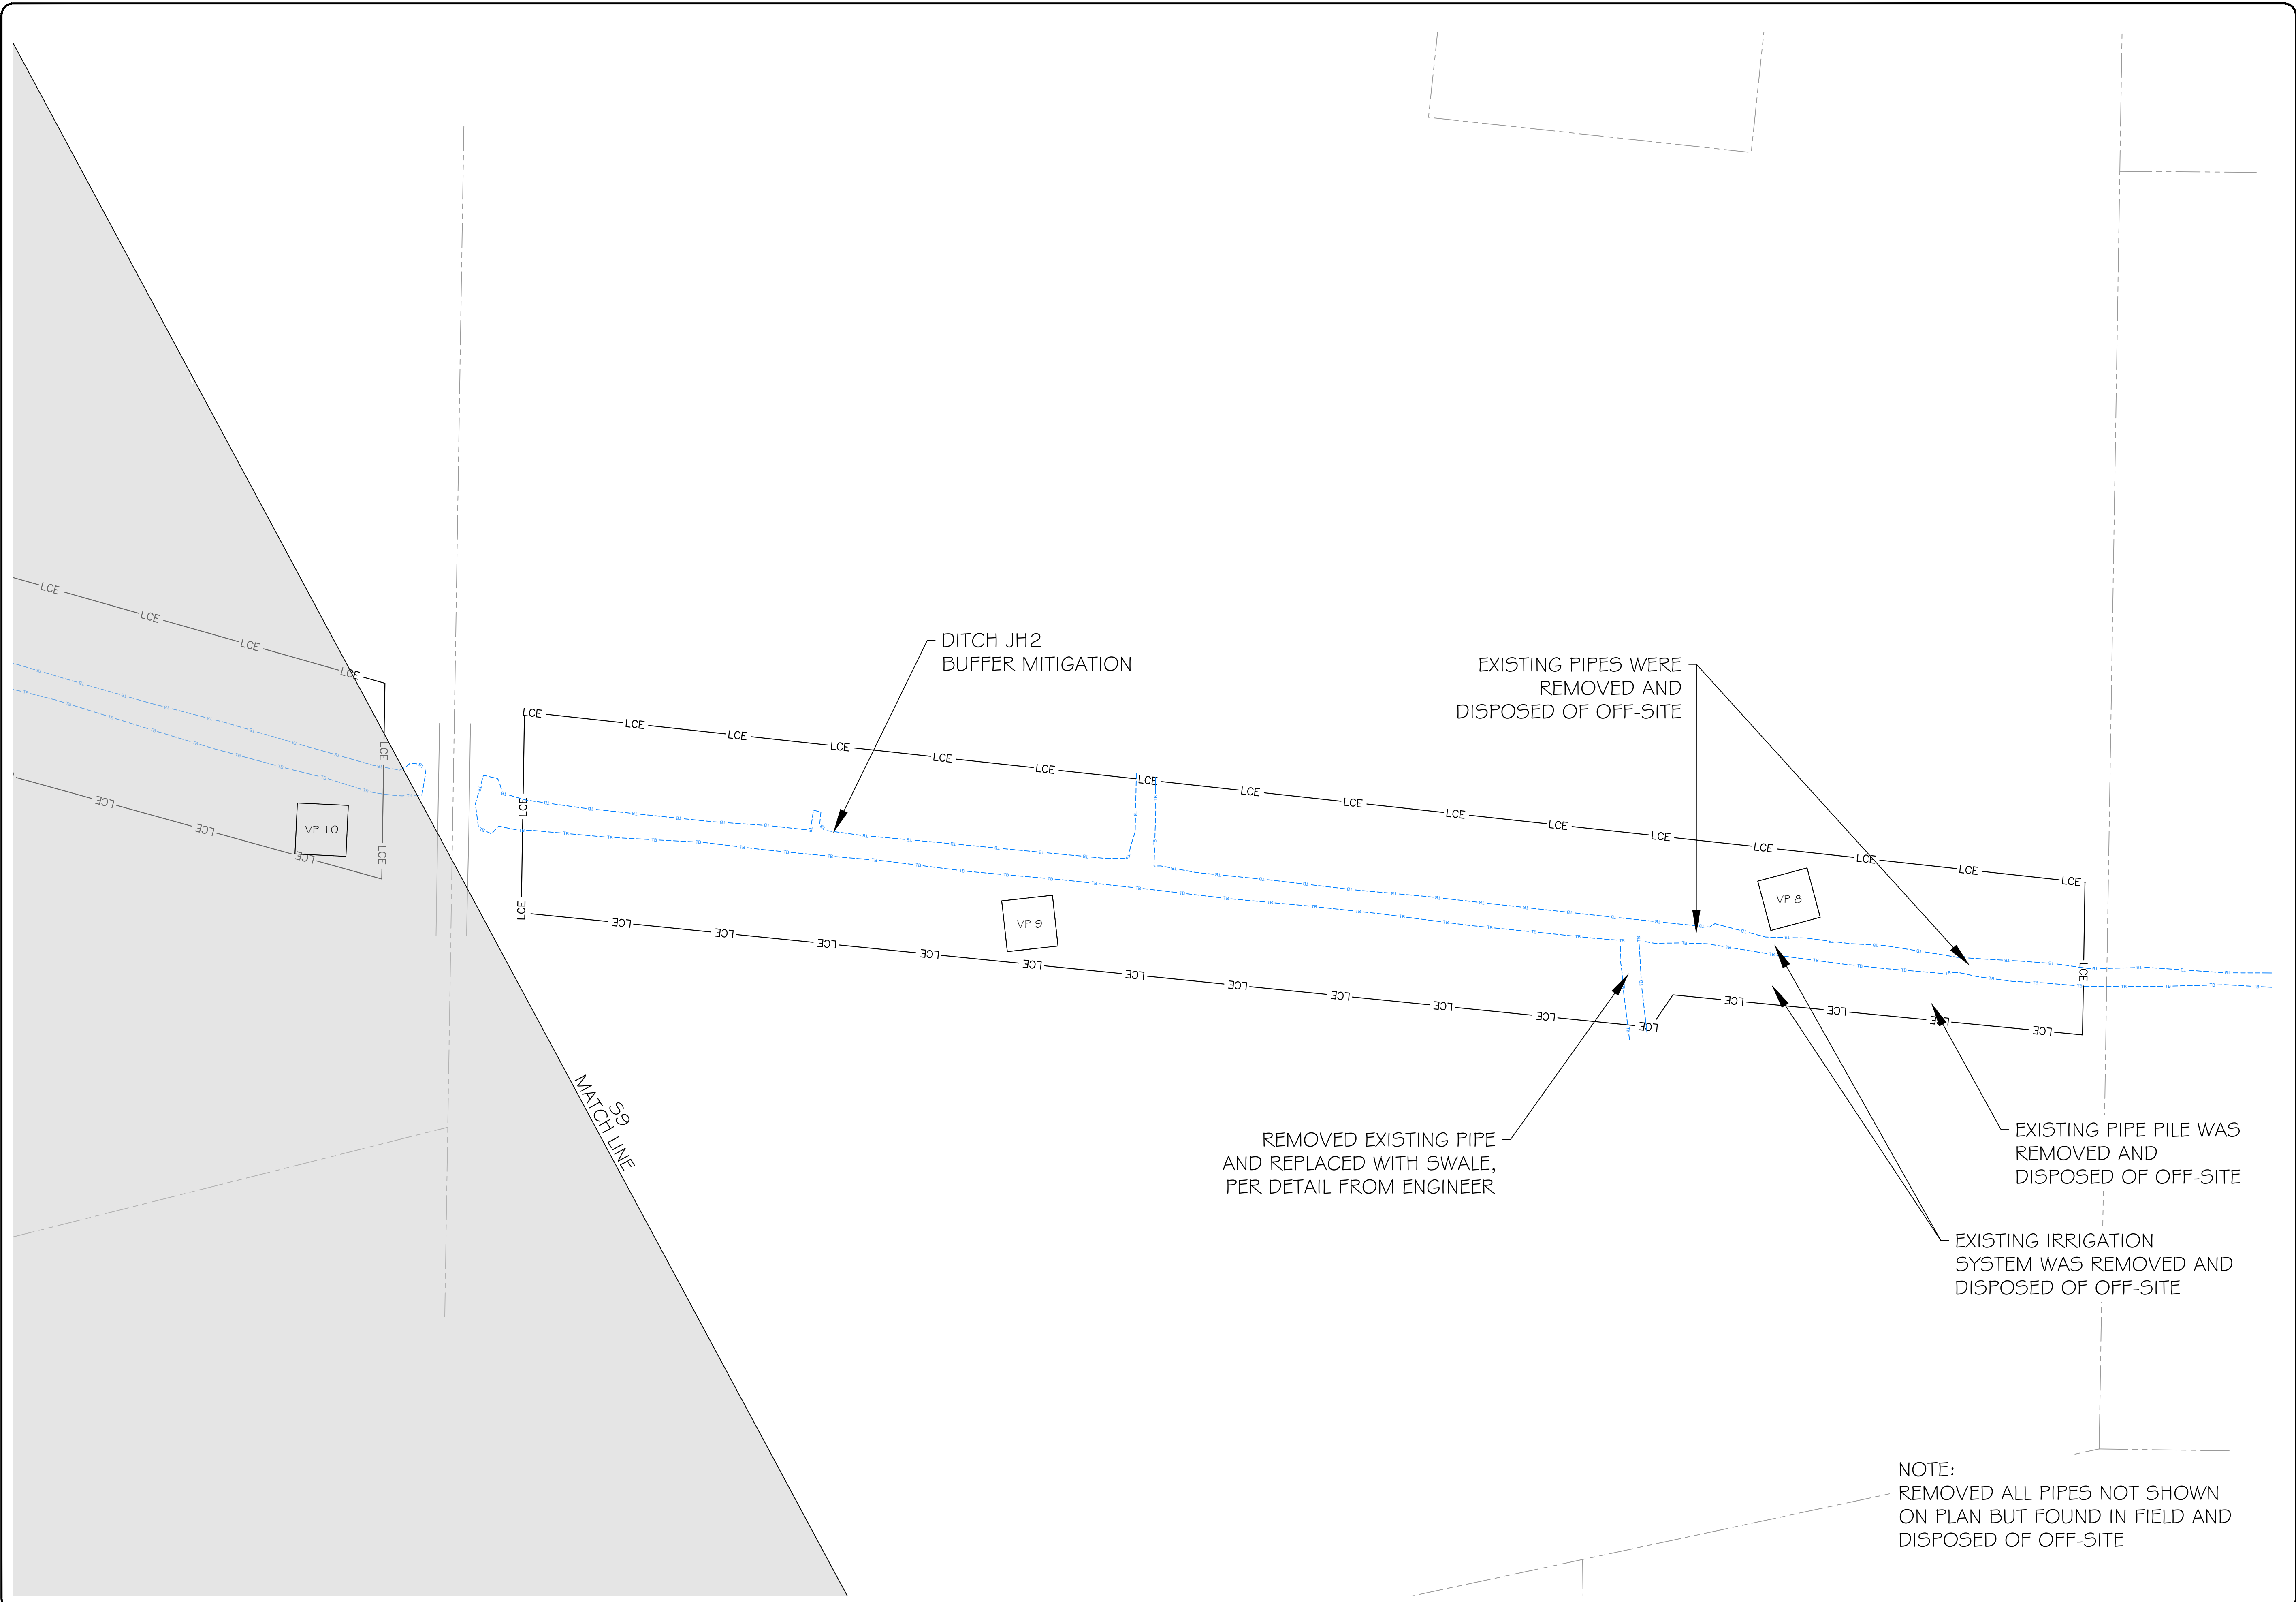
NOTE:
REMOVED ALL PIPES NOT SHOWN
ON PLAN BUT FOUND IN FIELD AND
DISPOSED OF OFF-SITE

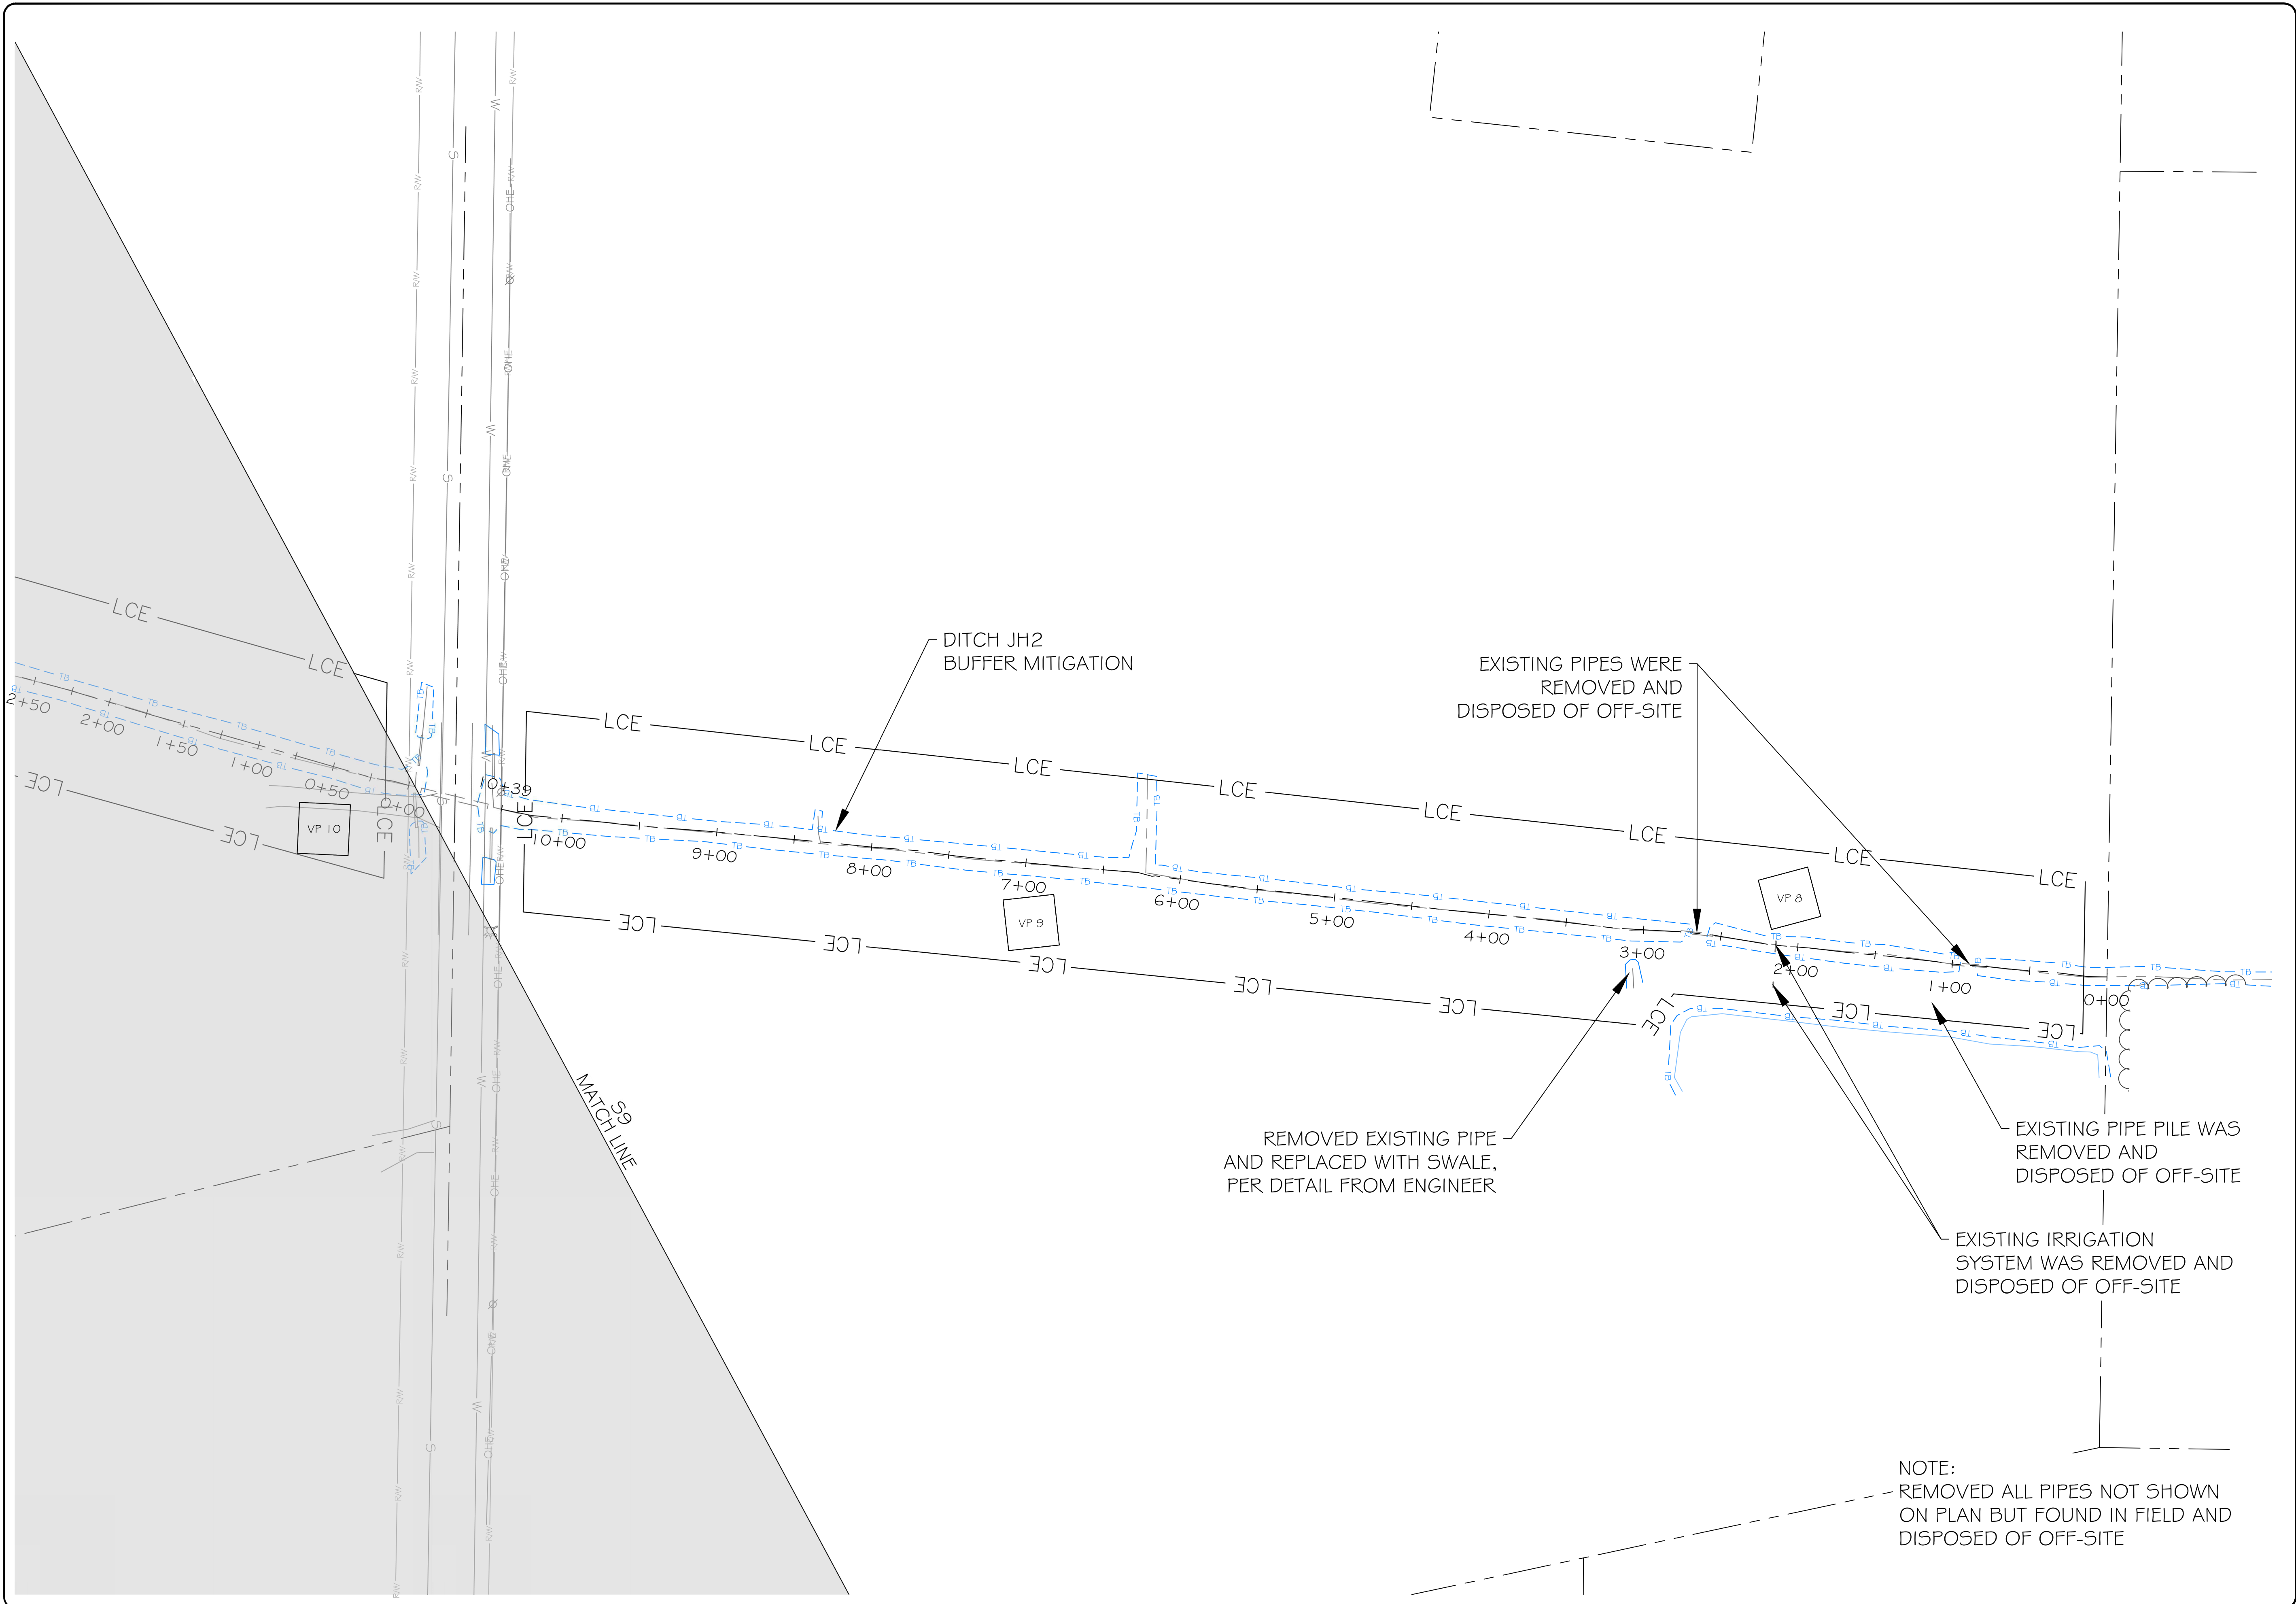
NOTE:
REMOVED ALL PIPES NOT SHOWN
ON PLAN BUT FOUND IN FIELD AND
DISPOSED OF OFF-SITE
