Re: Hatley Bank Site

Remarks: On behalf of the Environmental Banc & Exchange, LLC (EBX), EcoEngineering is submitting 1  
hardcopies of the Hatley Site Bank Parcel Development Package

- Figure 1: Vicinity Map
- Figure 2: Overall Proposed Neuse Buffer & Nutrient Offset Restoration Areas
- Figure 3: Geographic Service Area
- Figure 4: USGS Site Map
- Figure 5: Soil Survey Map
- Figure 6: FEMA Floodplain / Floodway Map

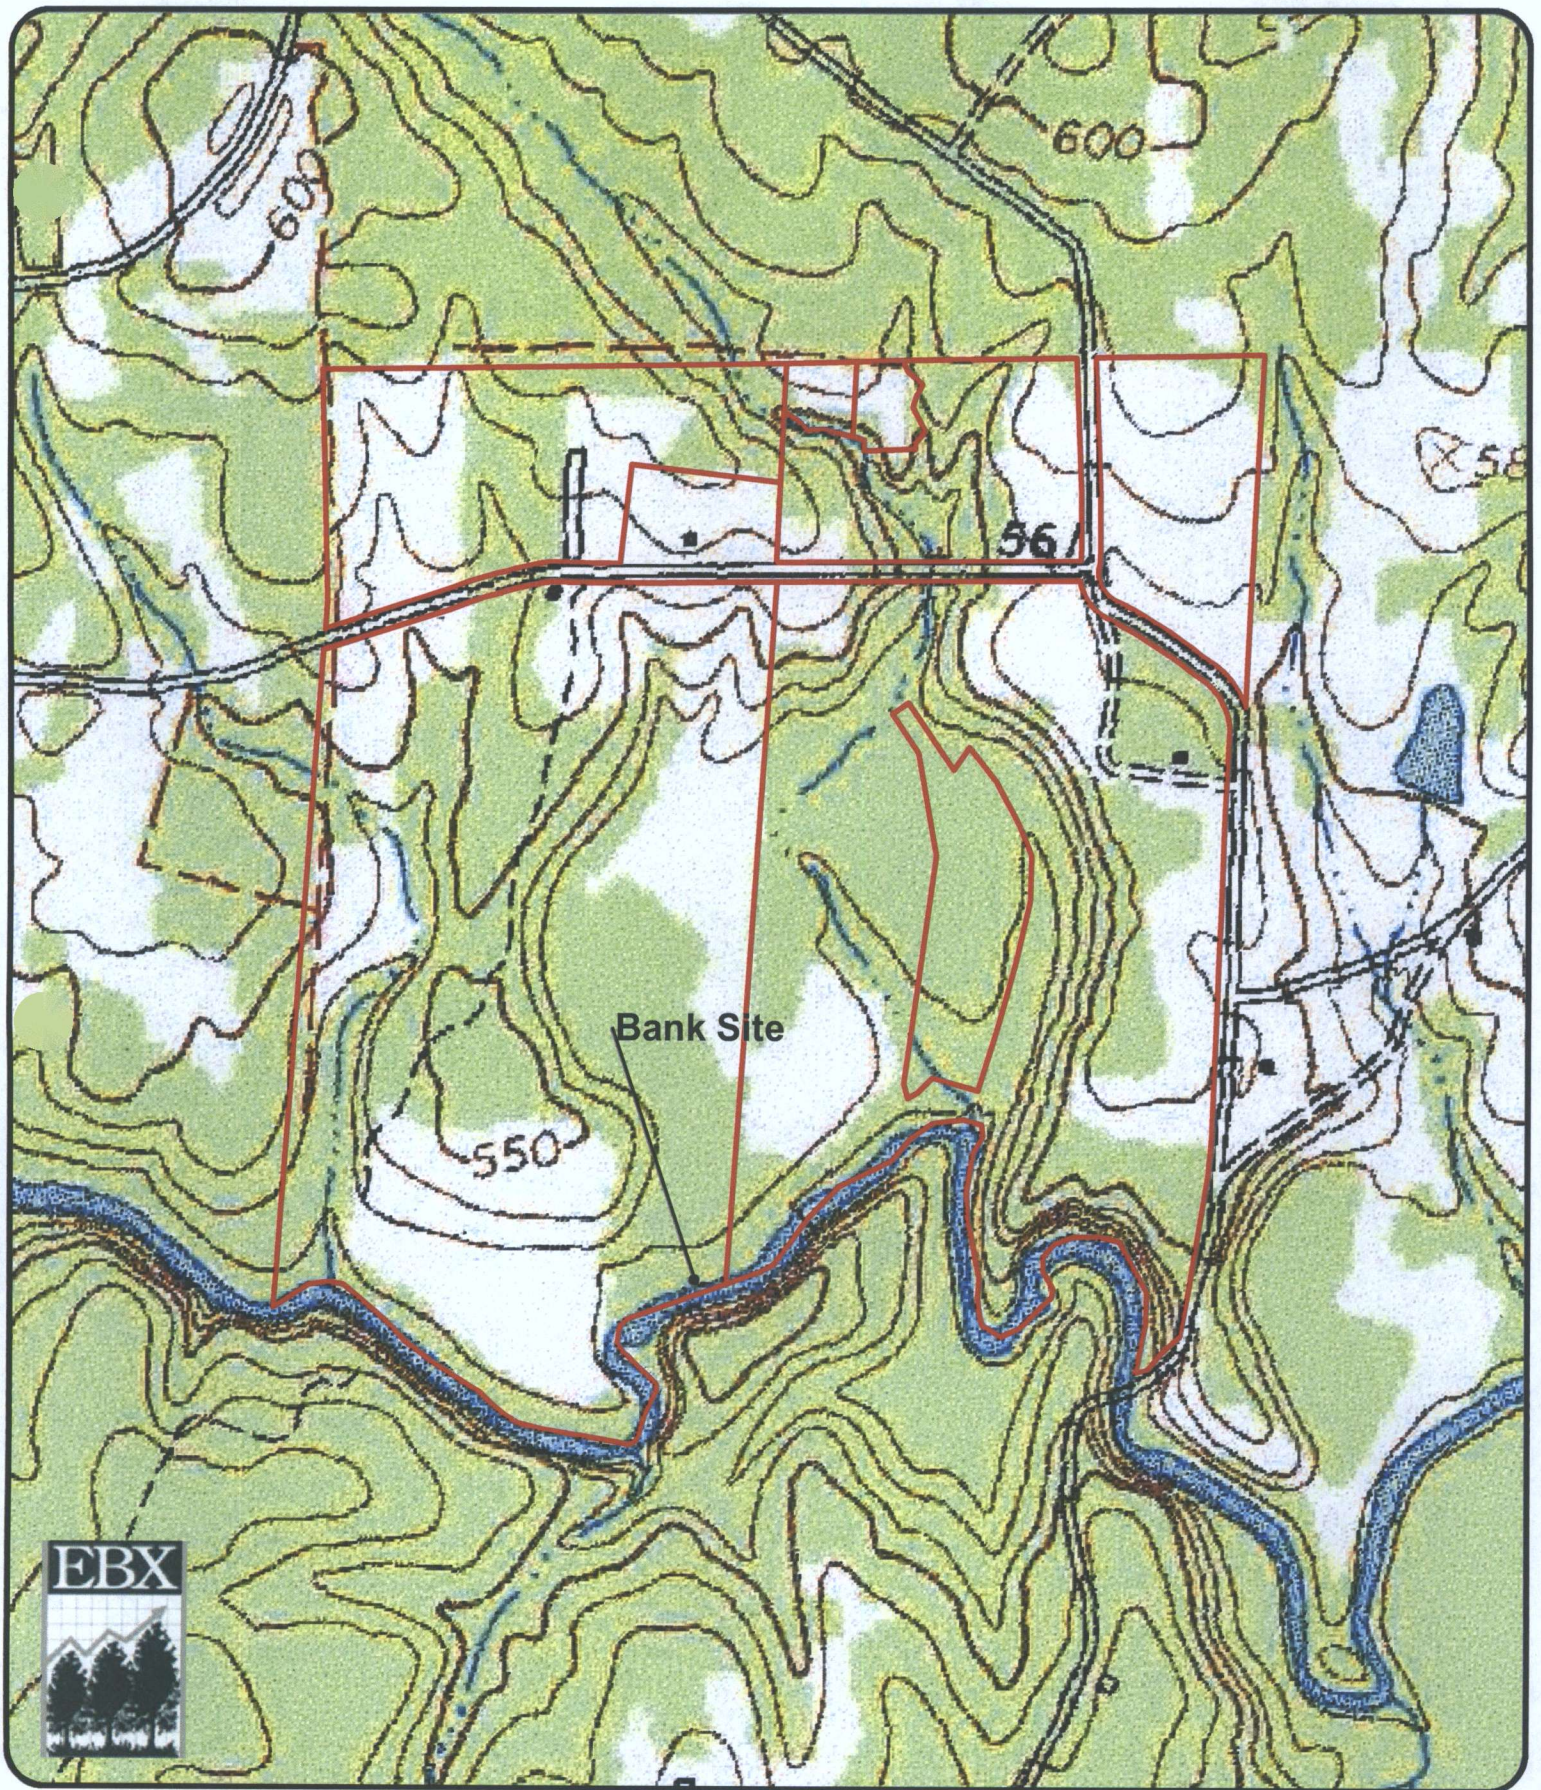
**Figure 4**

**HATLEY BANK SITE  
USGS SITE MAP**

Based upon review of the United States Geological Survey (USGS) Hurdle Mills, North Carolina Quadrangle, the Site contains low to moderate relief with elevations ranging from  $\pm$  520 feet to  $\pm$  550 feet. The Site has a topographic gradient that generally slopes south towards the South Flat River. Surface drainage is generally directed into the South Flat River and into 2 of its unnamed tributaries (**Figure 4**).

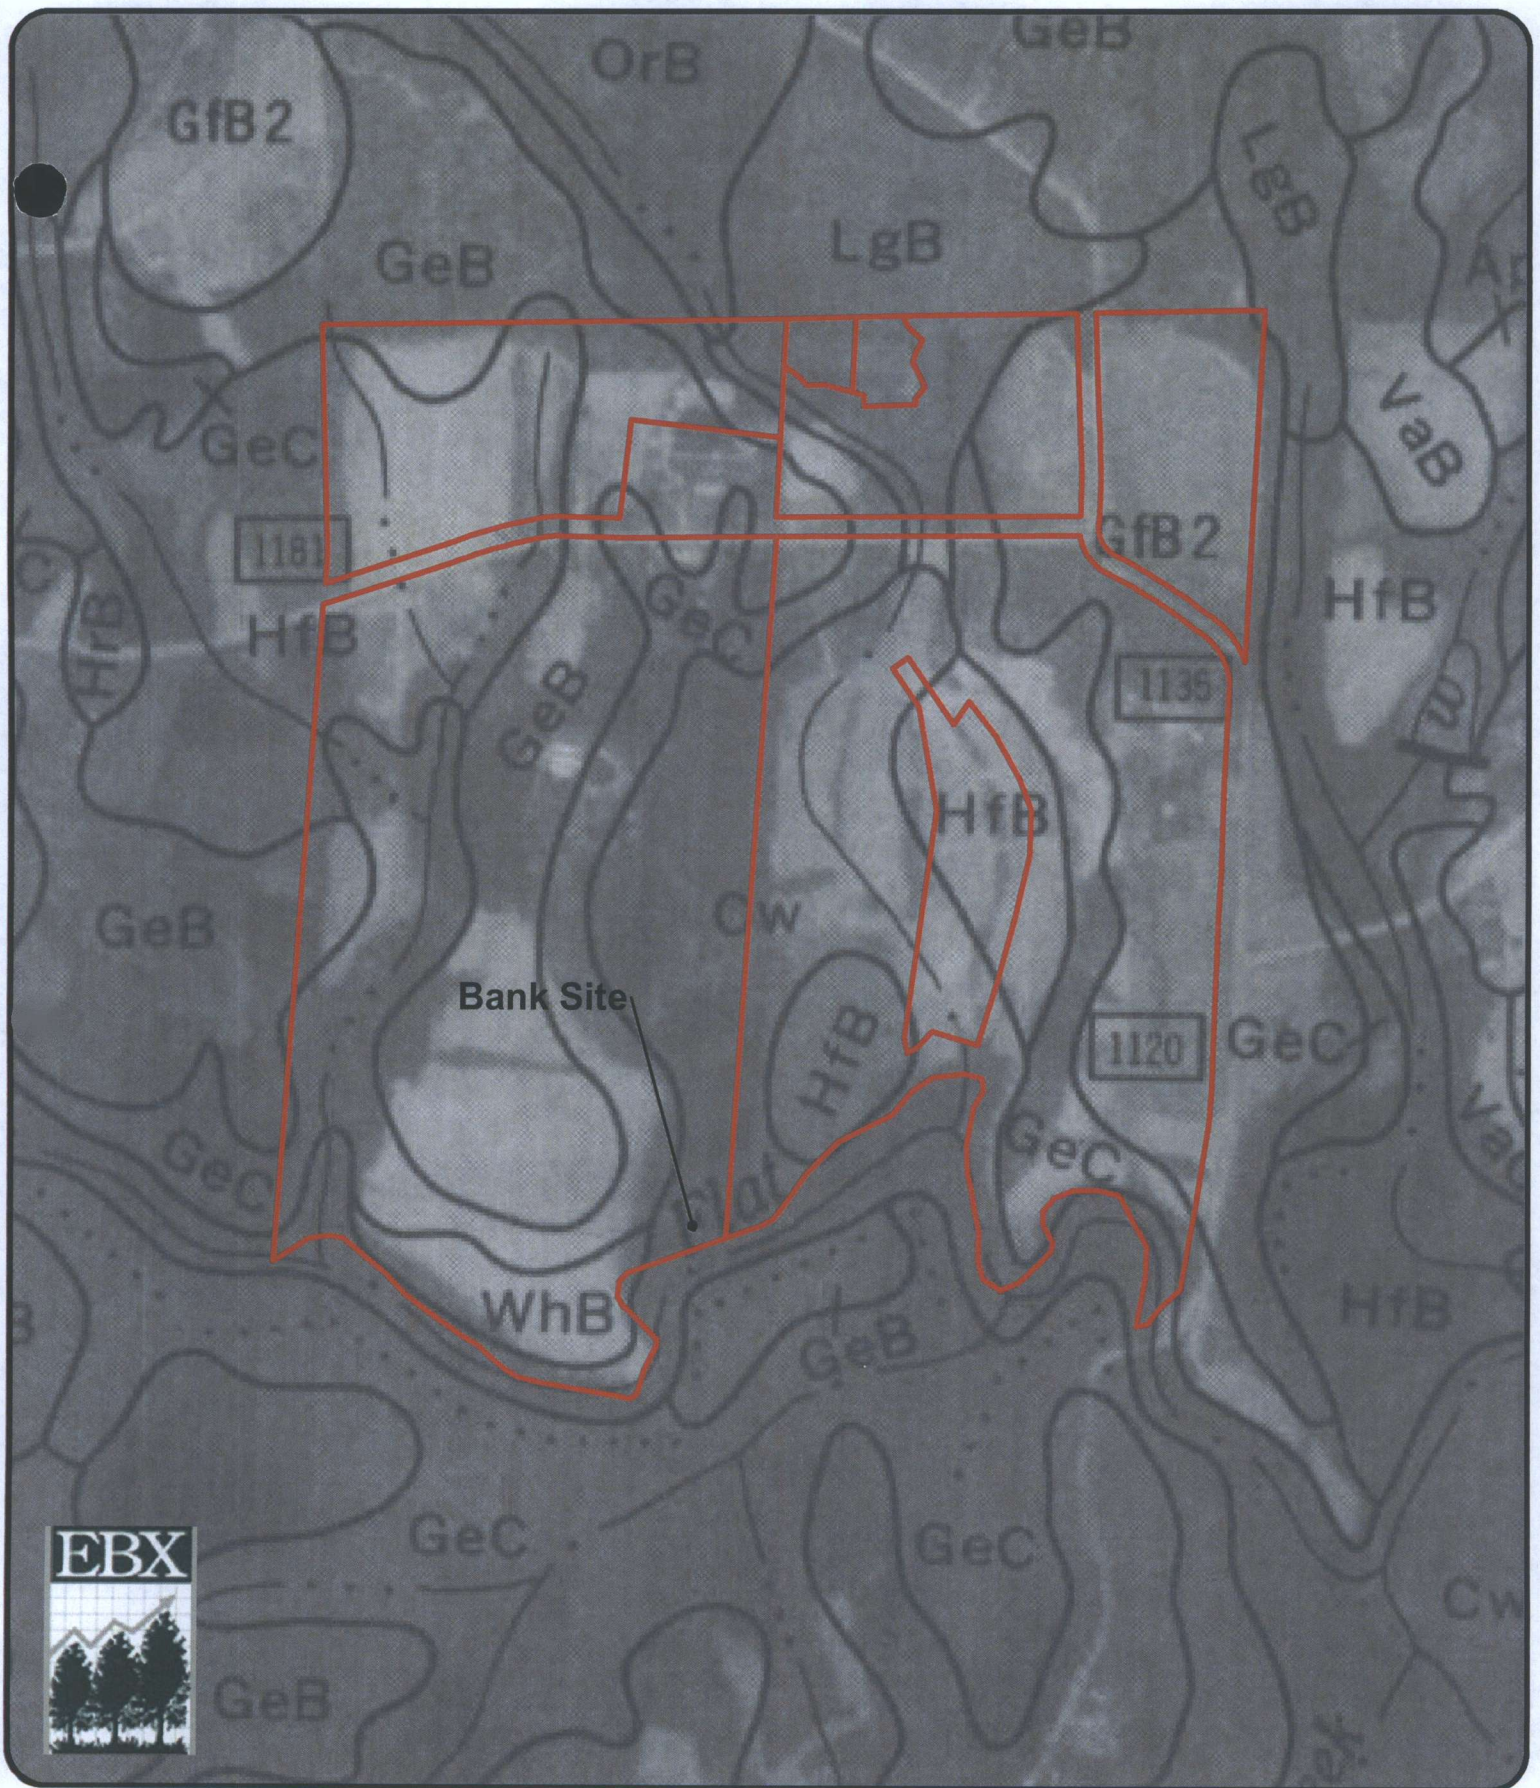
**HATLEY BANK SITE  
SOIL SURVEY MAP**

The Soil Survey of Person County, North Carolina (Soil Conservation Service, 1995) lists the soils within the Site as from the Cecil Association. As stated in the soil survey, these soils can be generally classified as gently sloping or moderately sloping well drained soils that have a loamy surface layer and a clayey subsoil. As described by the online USDA NRCS Official Soil Series Descriptions (OSD), the specific soils within the Site are shown on **Figure 5** and are listed, below, in **Table 1**:

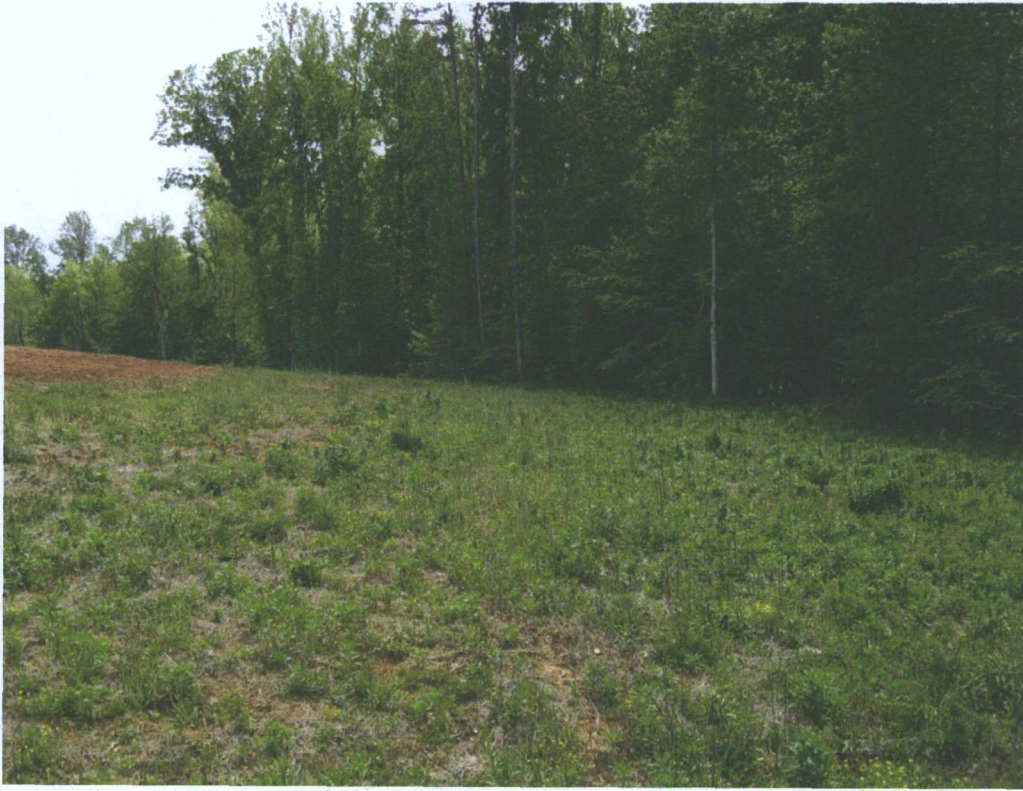
Picture 1: Located along the western section of Bank Site facing south.

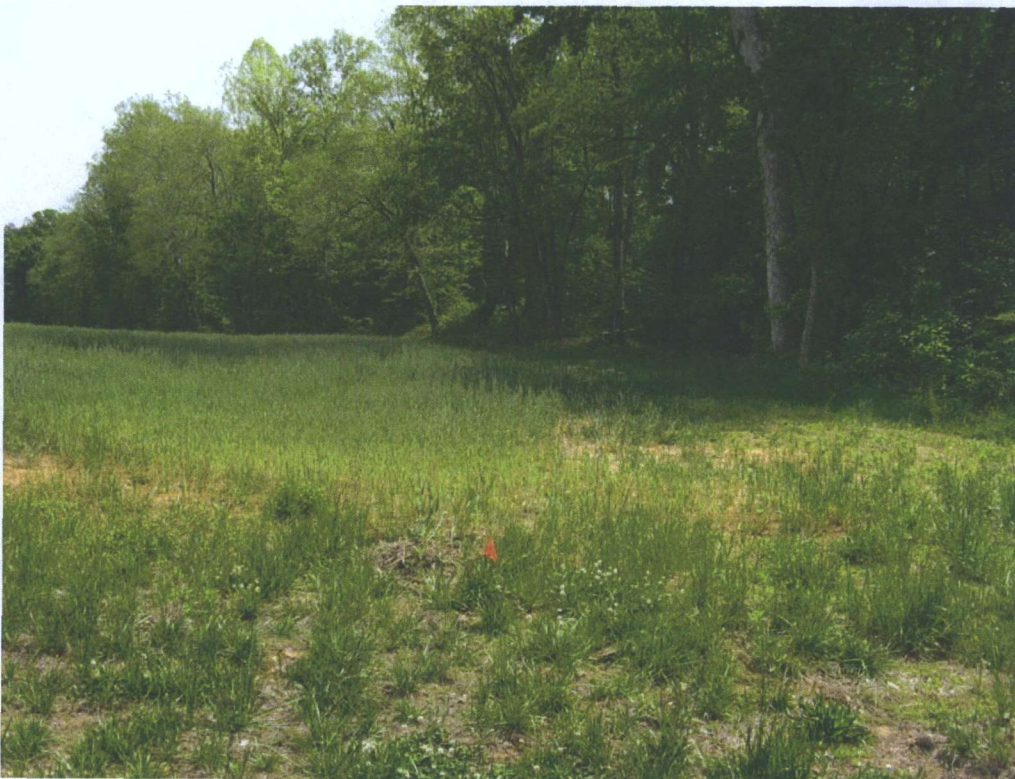
Picture 2: Located in southern section of Bank Site facing west.

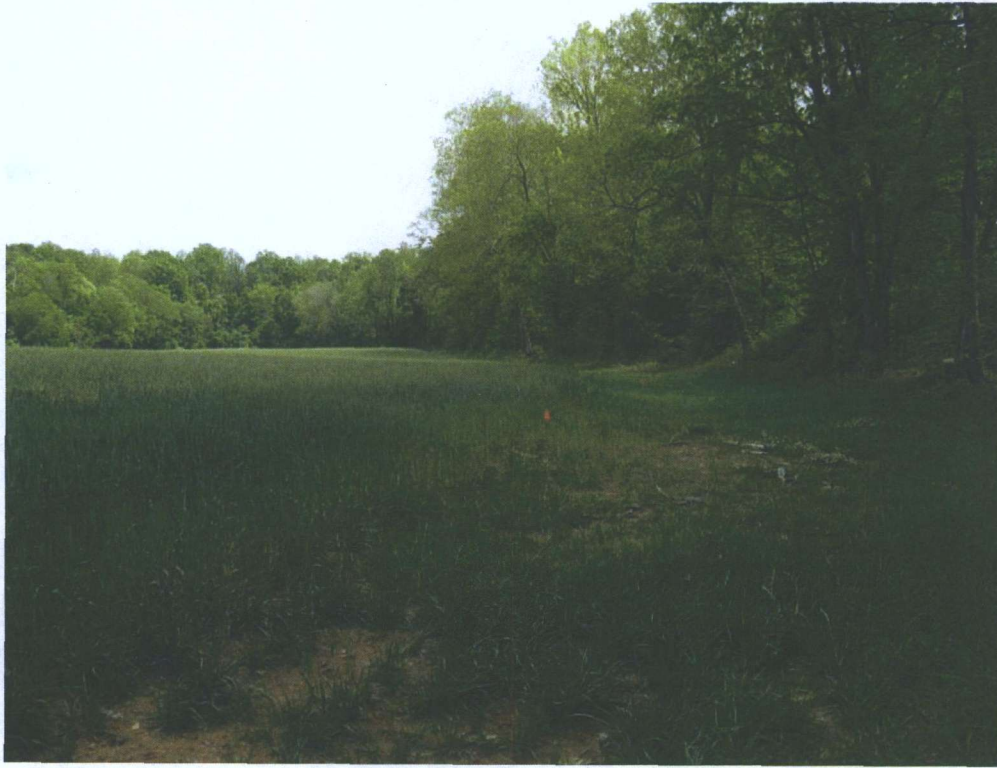
Picture 3: Located in southern section of Bank Site facing northwest..

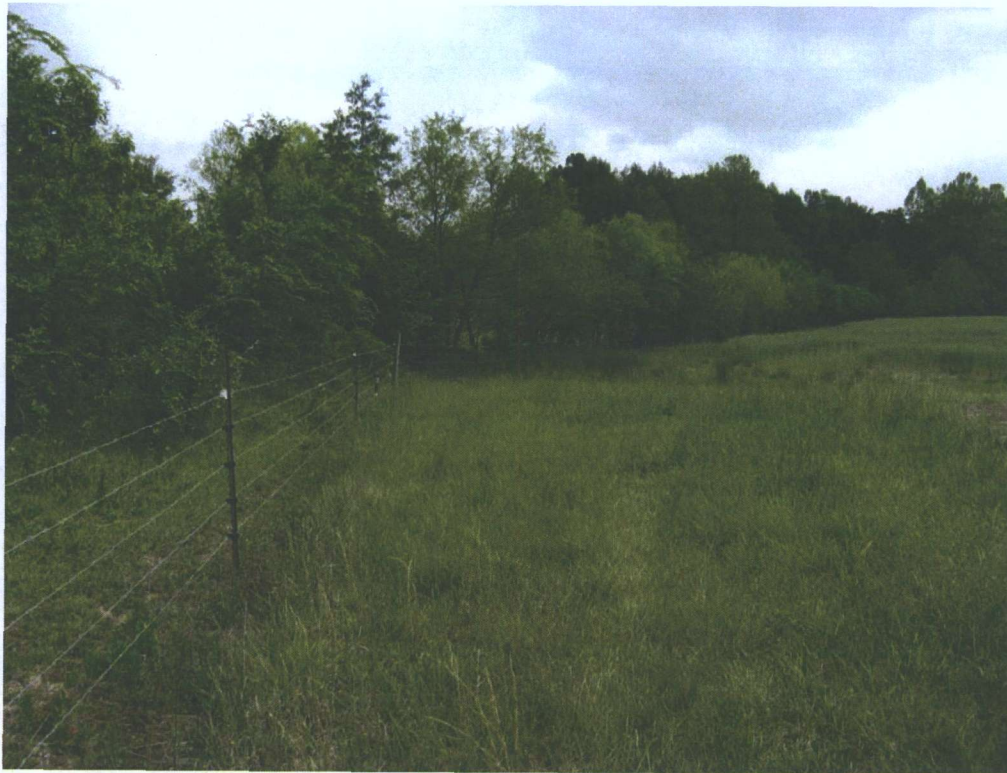
Picture 4: Located along the eastern section of Bank Site facing south.

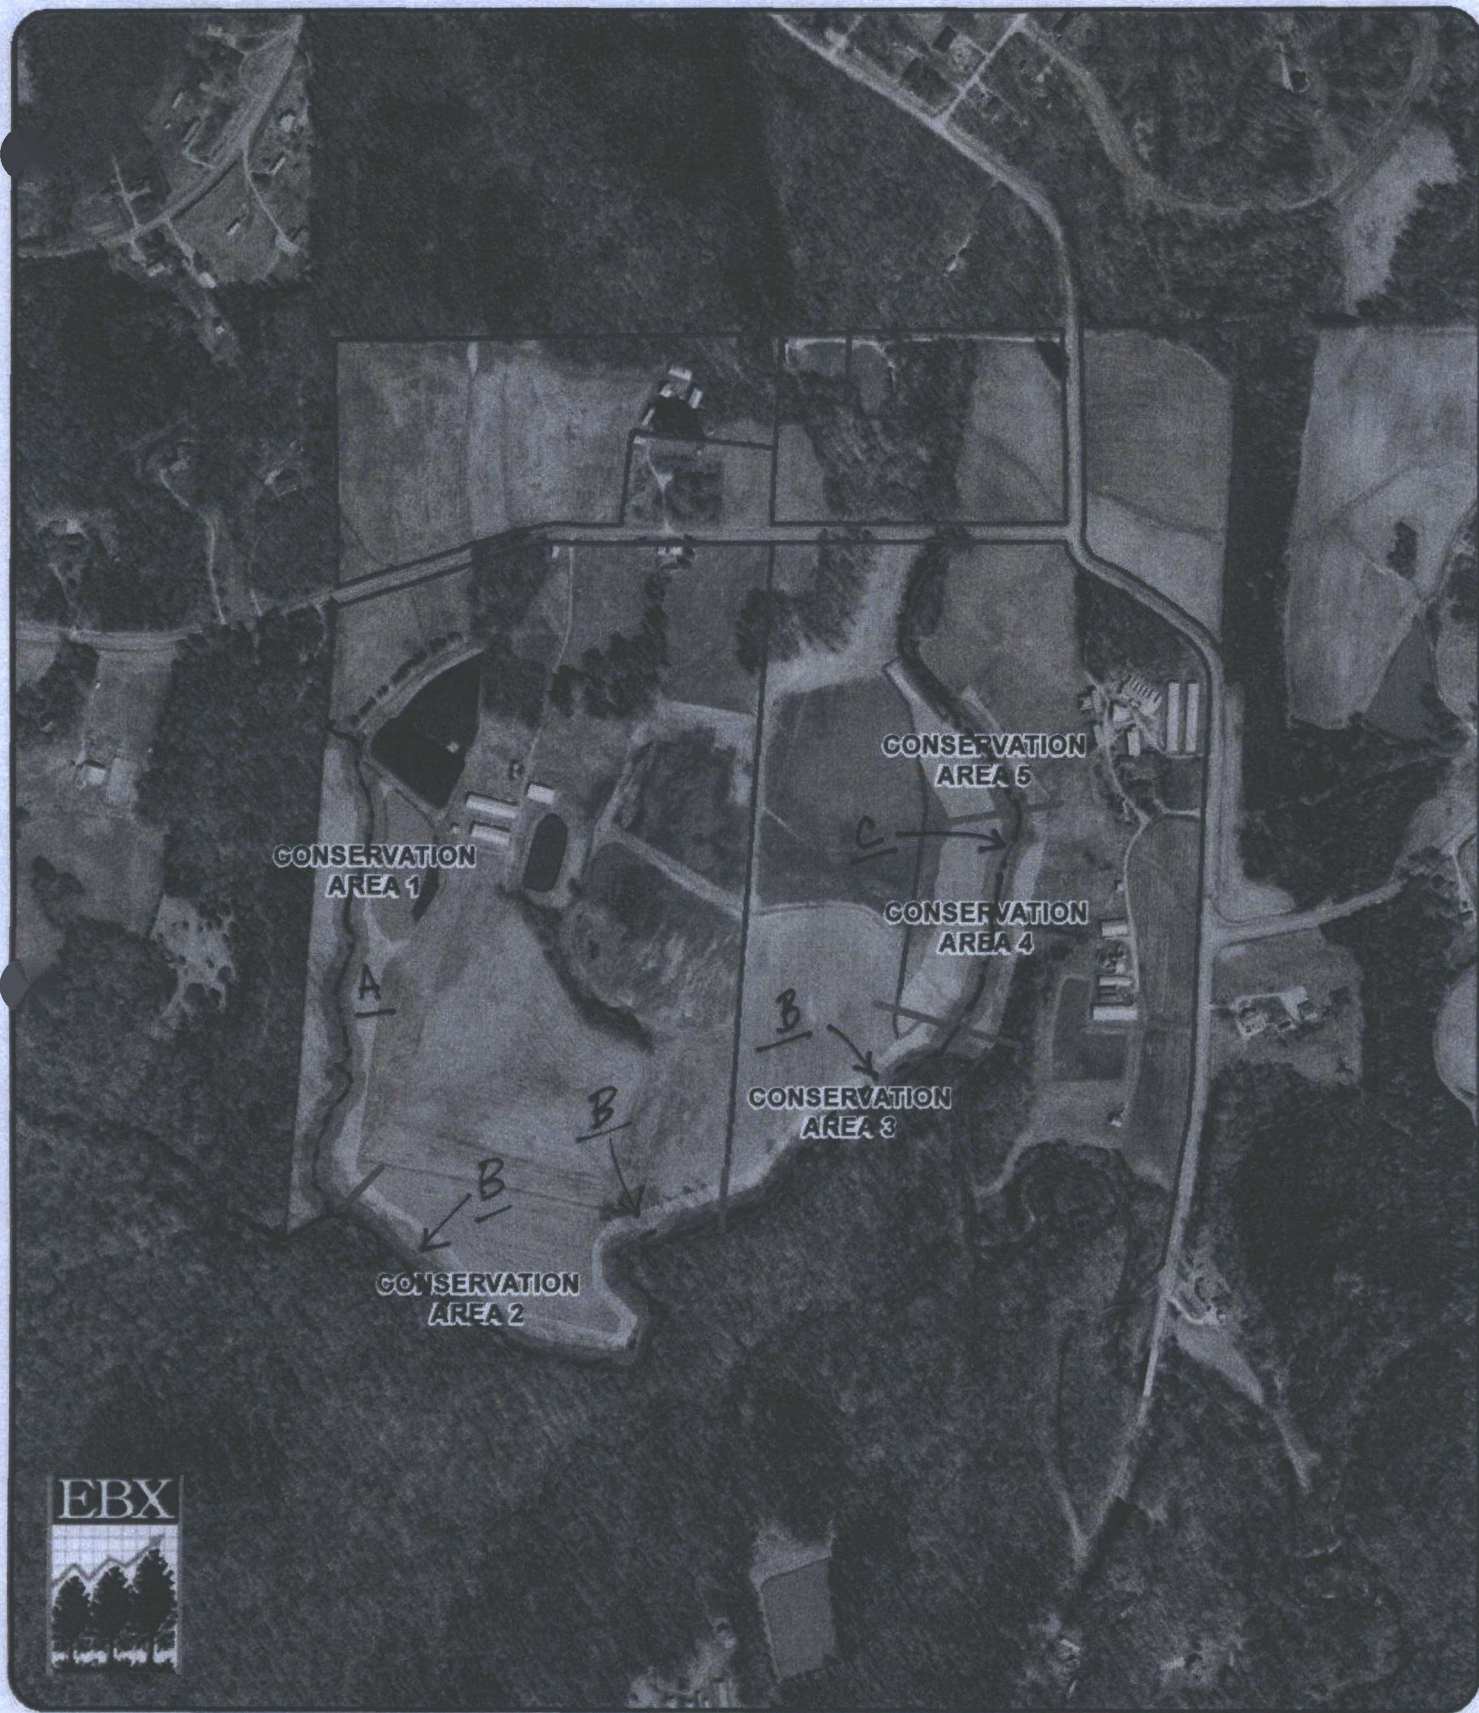
**Figure 2A**

**HATLEY BANK SITE**  
**OVERALL PROPOSED NEUSE BUFFER &**  
**NUTRIENT OFFSET RESTORATION AREA**

As mentioned in Section 2.2, natural forested areas are limited within many areas of the Site. These forested areas have been selectively timbered with much of the secondary understory cleared. Neuse buffer enhancement will be considered for those forested areas that are within 50 feet of the stream, but lacking adequate stem counts. Neuse buffer enhancement is defined as the process of converting a sparsely woody vegetated area (greater than or equal to 100 trees per acre but less than 200 trees per acre that are greater than or equal to 5 inches dbh for trees (15A NCAC 02B .0233 (2)(m)) and greater than two feet in height for shrubs) to a forested riparian buffer area (15A NCAC 02B .0242). Nuisance and exotic vegetation are not included in the stem count. The areas proposed for enhancement are shown on **Figure 2**. As noted in 15A NCAC 02B .0242, enhancement areas are credited at a ratio of 3:1 (i.e. for every 3 acres of enhancement, 1 acre of credit is generated). The existing trees and shrubs within the proposed enhancement areas within the Site have been surveyed by EcoEngineering and the tree locations, along with densities, are shown in **Figure 2**.

enhancement in **Figure 2**, the planting plan will include a minimum of at least two native hardwood trees species. In both instances, restoration and enhancement, planting is required such that a density sufficient to provide an average of 320 trees per acre following five years of successful monitoring at the Site.
