Mitigation Plan

Cow Tail Mitigation Project

Columbus County, North Carolina

FINAL VERSION

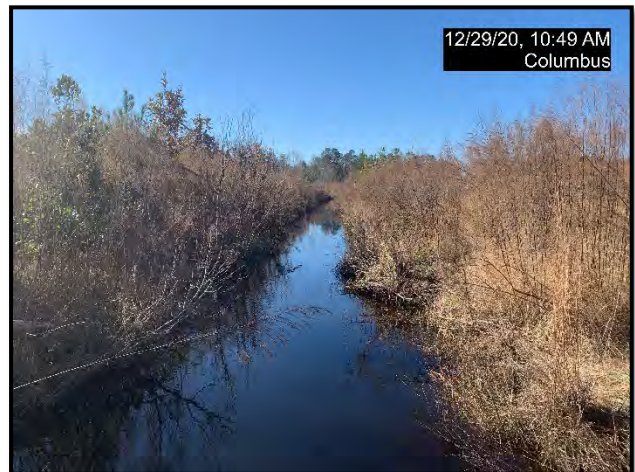
Looking upstream along Cow Branch showing channelized conditions.

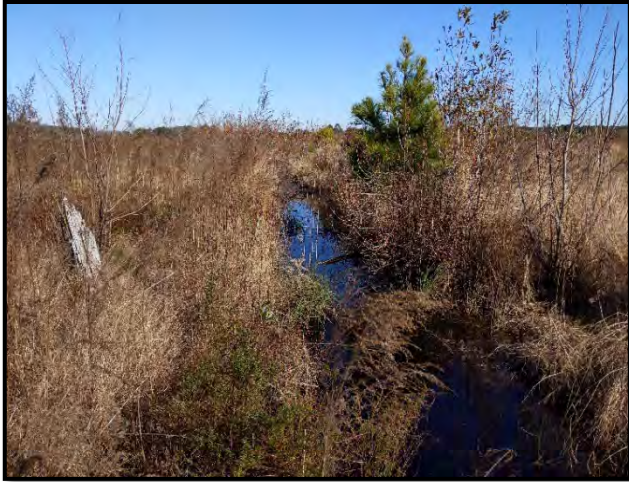
Looking upstream along S100 showing channelized stream conditions.

S100: S100 is a small tributary that has been channelized and straightened along its entire length. The valley slope is approximately 0.25 percent and the drainage area is 95 acres. The entire drainage area for this reach is within active agricultural fields. The channel is fed by an extensive ditch network at its upstream end and the natural valley was difficult to determine during site assessment.

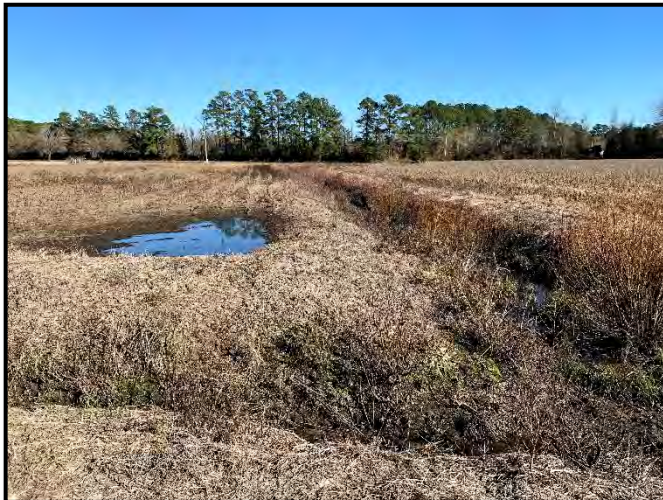
Looking upstream at S200 and channelized conditions lacking riparian buffer vegetation.

S200: S200 flows southwest under the Old Lumberton Road culvert crossing for approximately 2,347 feet before it's confluence with Cow Branch. The drainage area is approximately 288 acres and the upper area is located mostly within mixed forest and managed pine timber. The stream is fed by an extensive drainage network at its upstream end and this area appears to be heavily modified and/or a remnant Carolina bay.

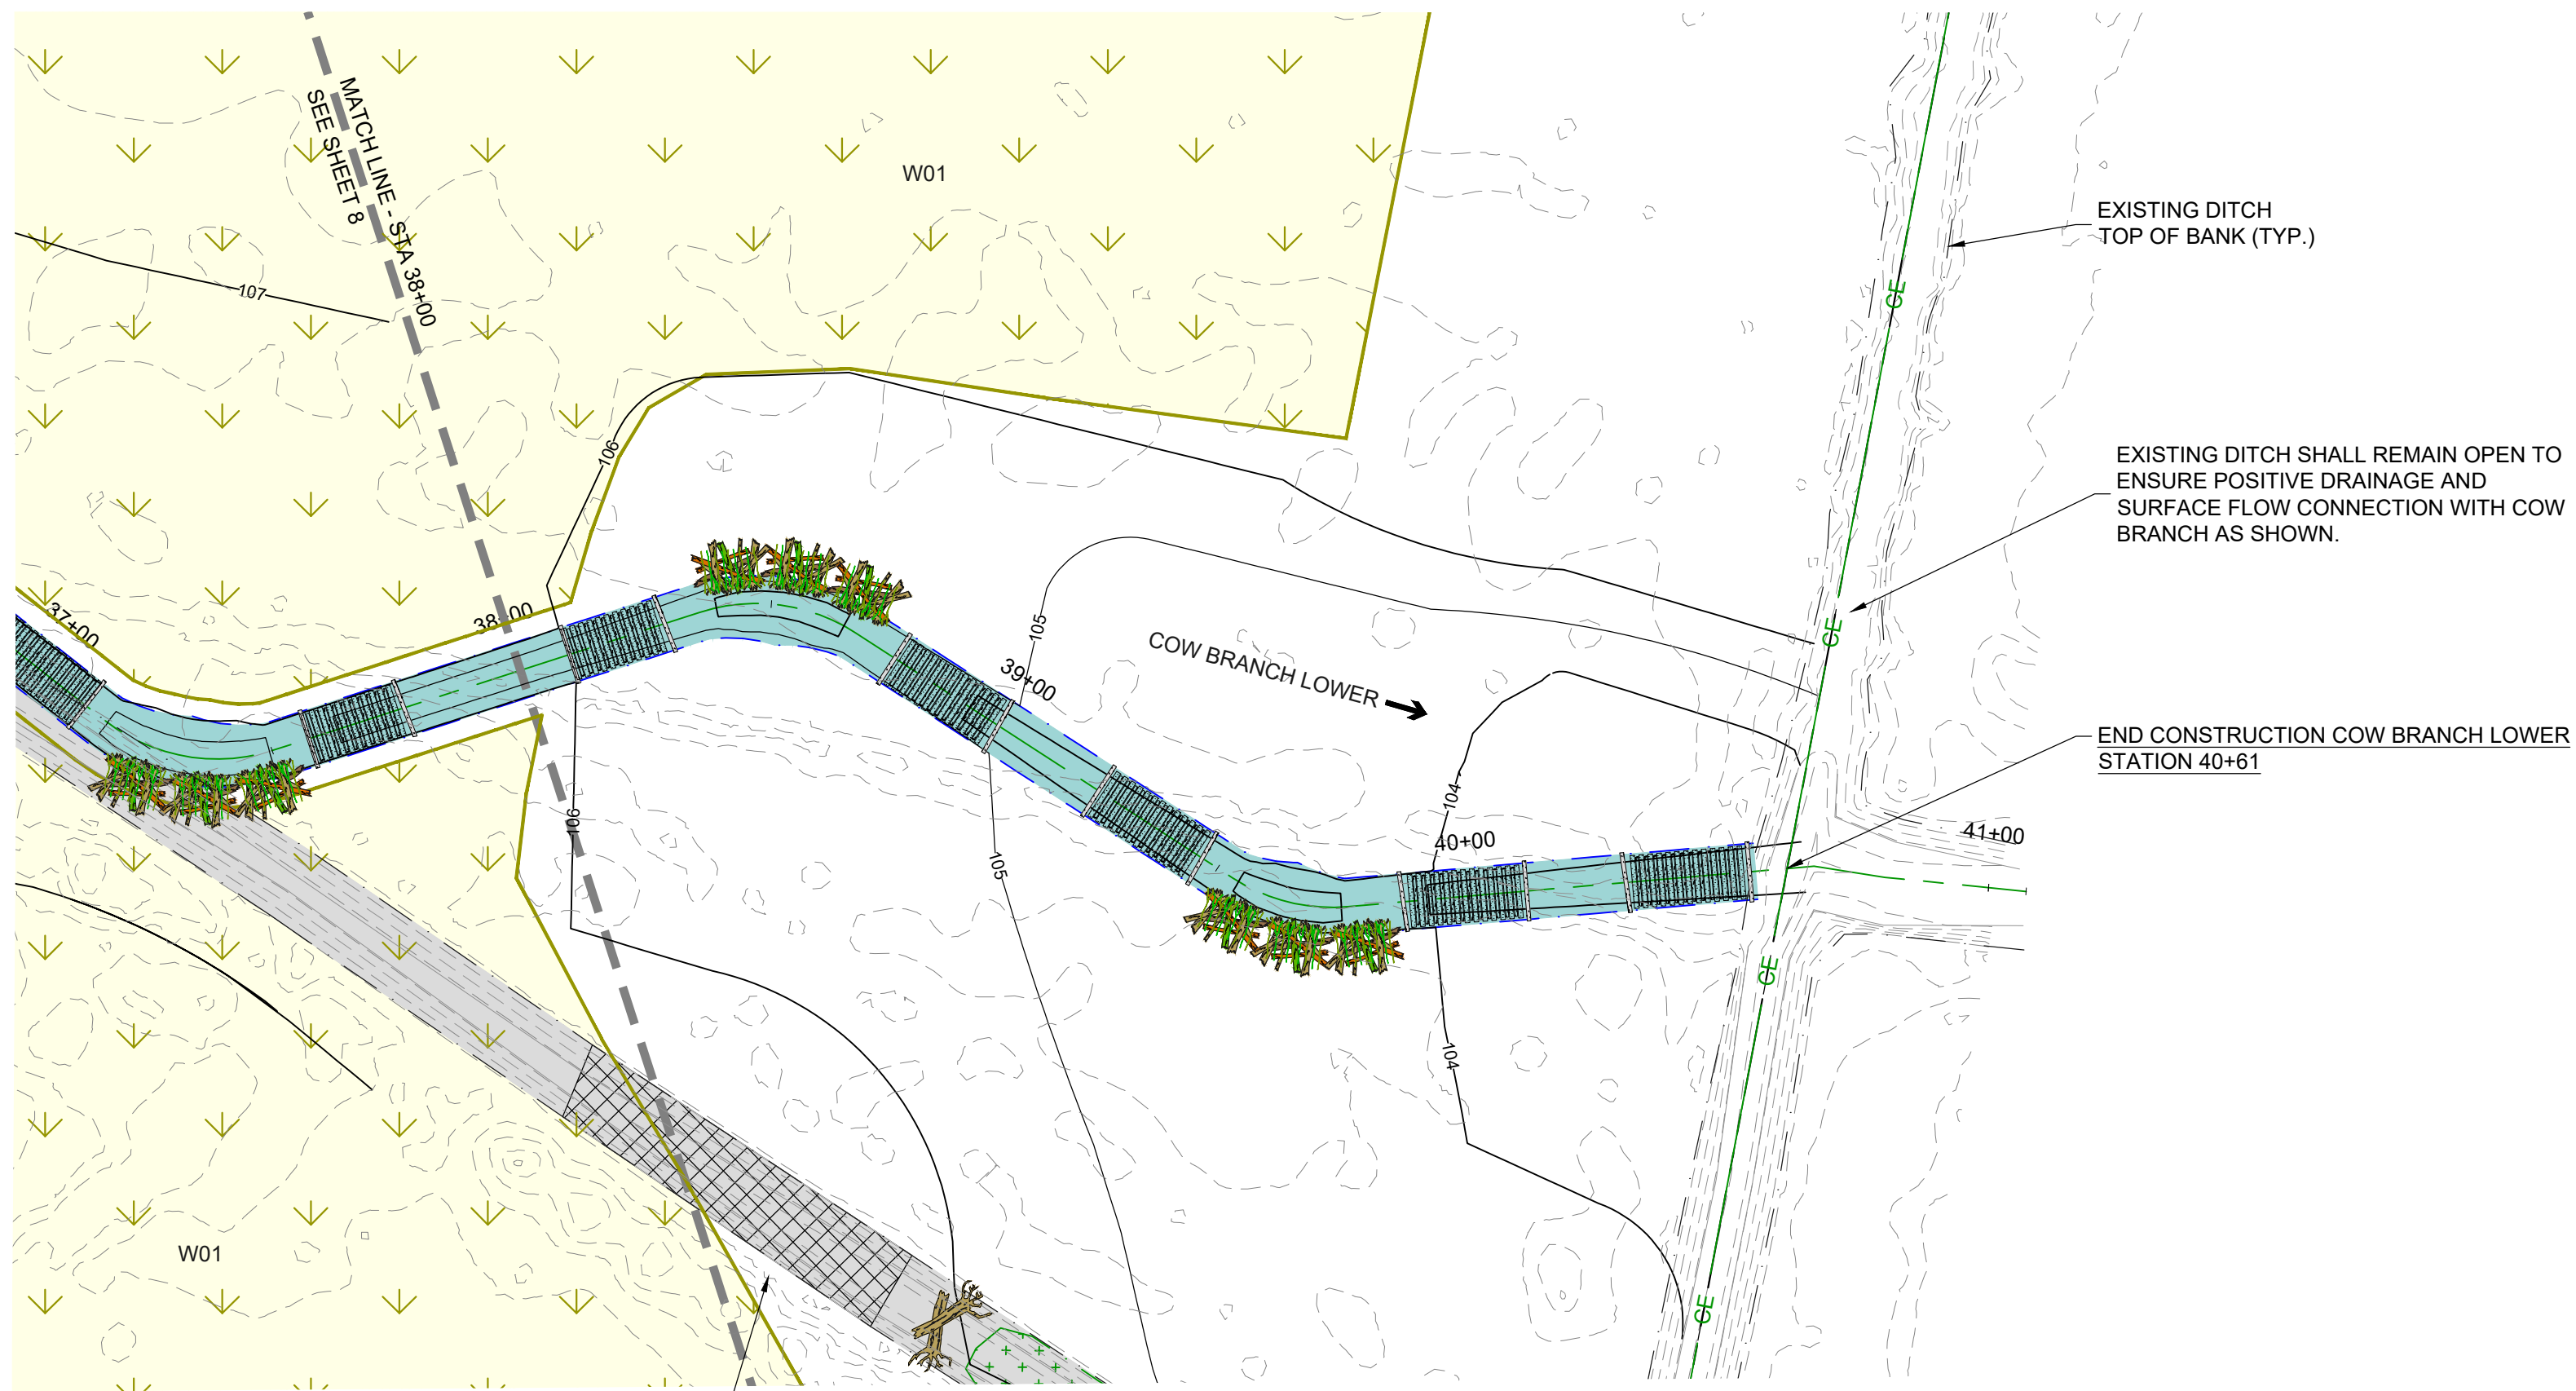
COW BRANCH LOWER PLAN

REMOVE SPOIL AND FILL EXISTING DITCH. REGRADE TO EXISTING GROUND ELEVATION. USE HARVESTED WOODY MATERIAL FOR IN-STREAM STRUCTURE INSTALLATION.

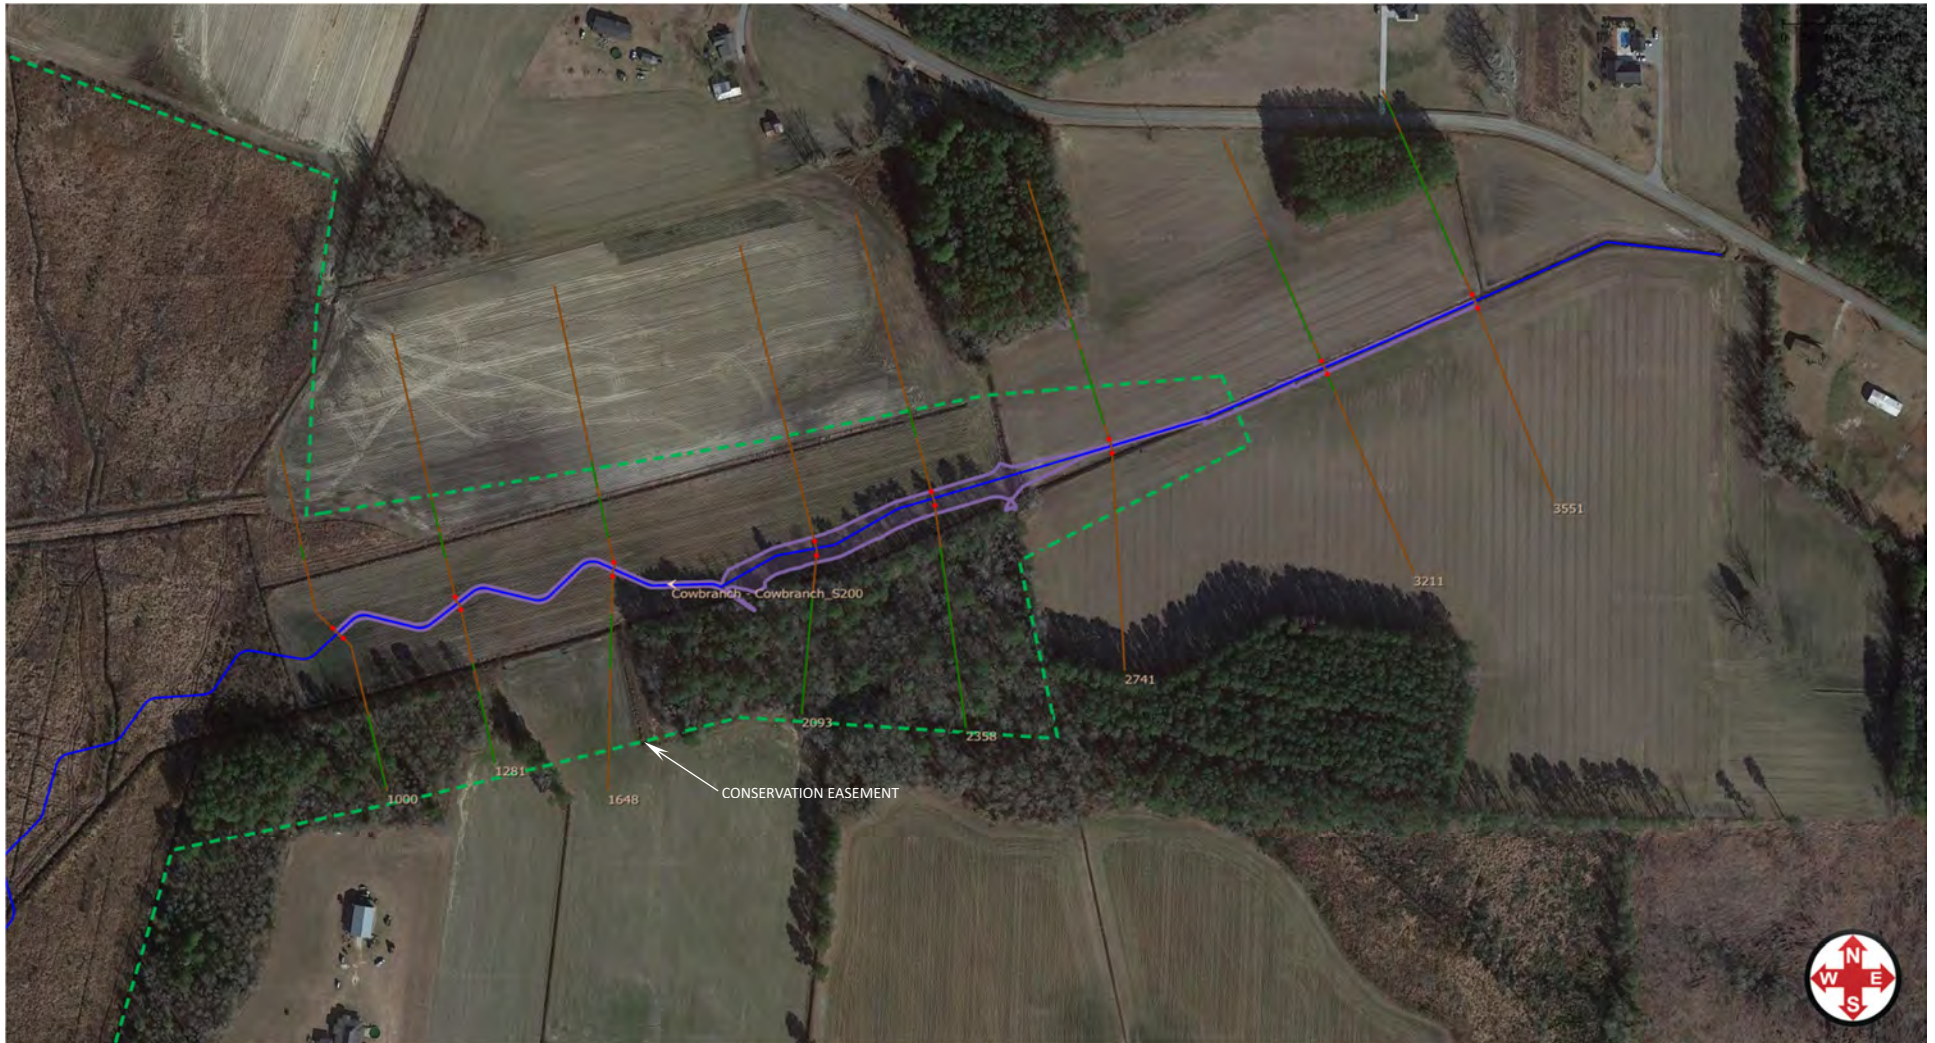
BANKFULL DISCHARGE = 7.8 CFS
WSF ELEV @ XSECT 3551 = 110.44'
48" DIA. CULVERT INV. @ LUMBERTON RD. = 110.35'
LUMBERTON RD. TOP OF ROAD ELEV = 116.16'

COW TAIL FLOOD MODEL ANALYSIS PROPOSED CONDITIONS

Response: The conservation easement area considers the proposed restoration limits and creditable areas to minimize flood extents and prevent hydrologic trespass. As described in Sections 3.7.4, 3.7.5 and 6.6.4, a flood inundation model was calculated for the bankfull, 10-yr, 25 yr-storm events to ensure post-restoration flooding will be contained within the project properties. We have added a hydraulic model in the appendix to show the 100-yr storm event for both the post-restoration conditions and if a hypothetical 2.0' tall beaver dam is built along upper Cow Branch after project regulatory closeout. Additional language has been added in Section 3.7.4 describing the model results.

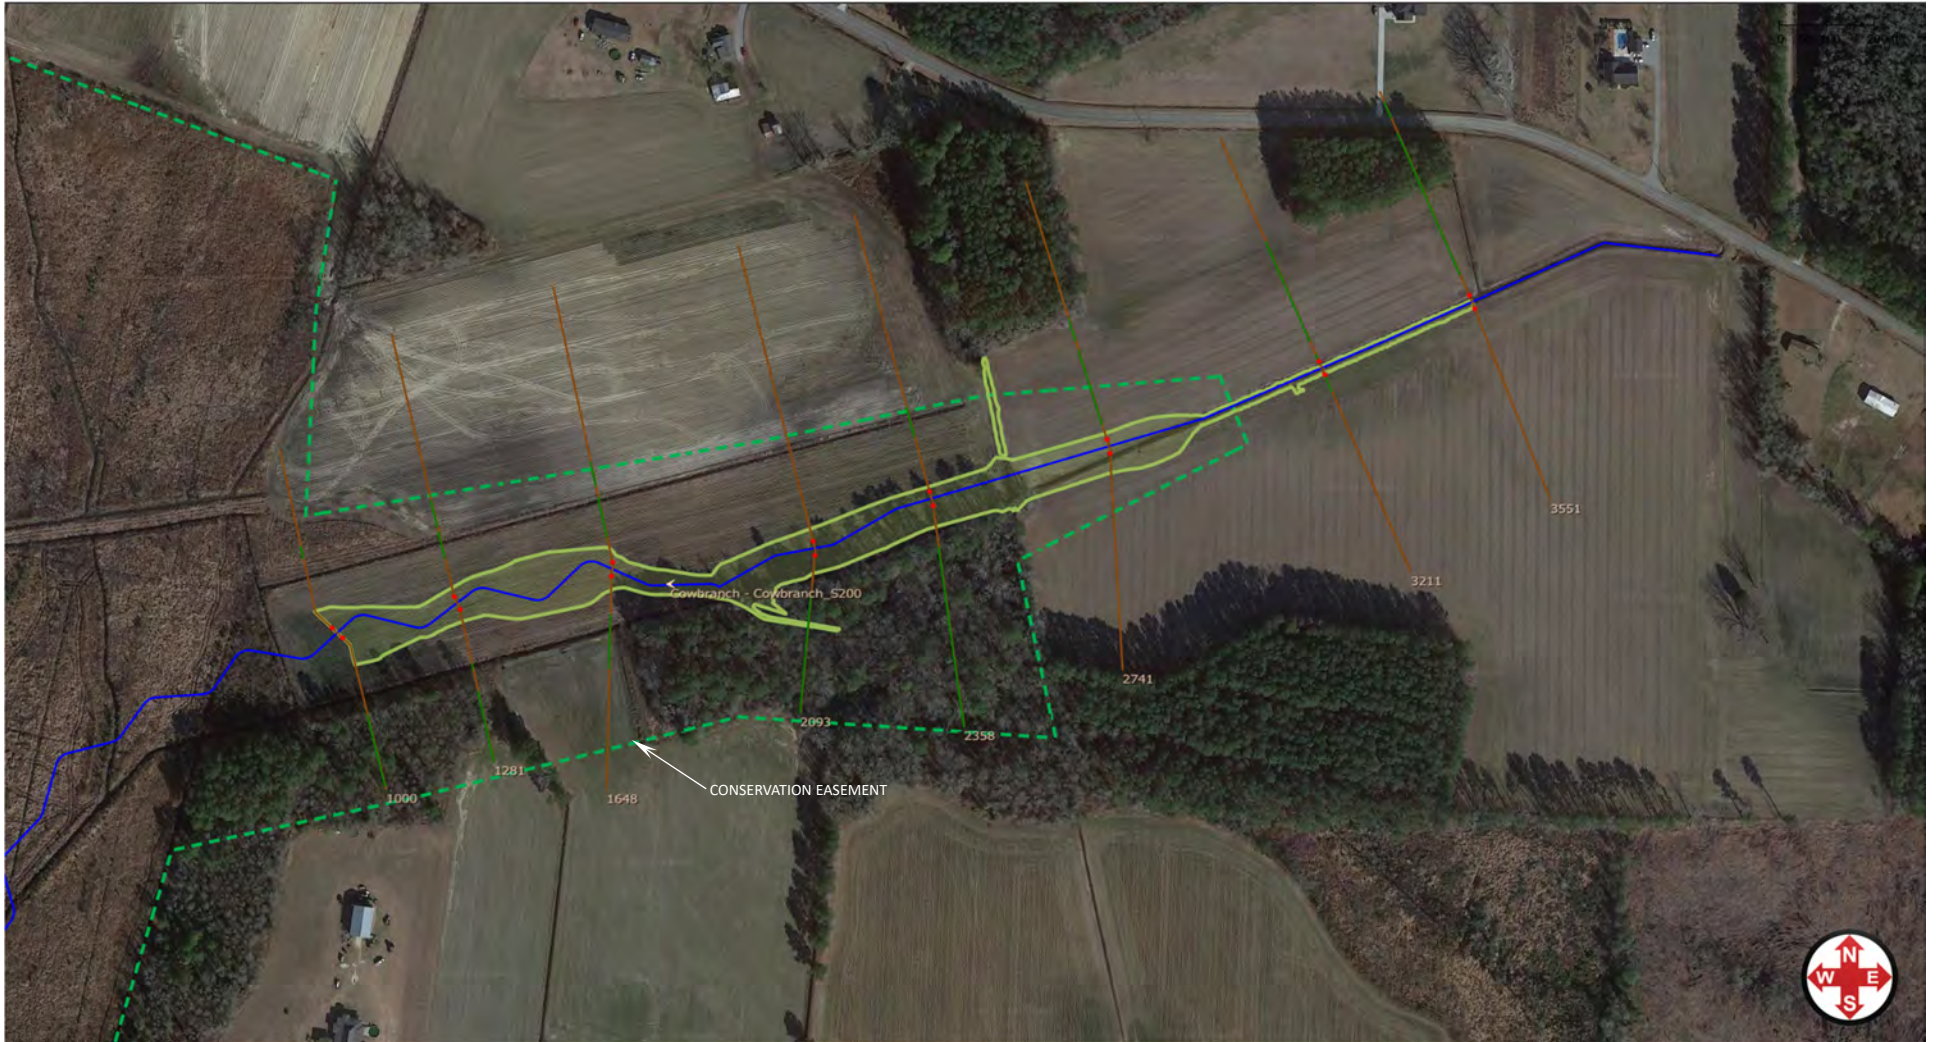
10 YR DISCHARGE = 26.2 CFS
WSF ELEV @ XSECT 3551 = 111.18"
48" DIA. CULVERT INV. @ LUMBERTON RD. = 110.35'
LUMBERTON RD. TOP OF ROAD ELEV = 116.16'

COW TAIL FLOOD MODEL ANALYSIS PROPOSED CONDITIONS

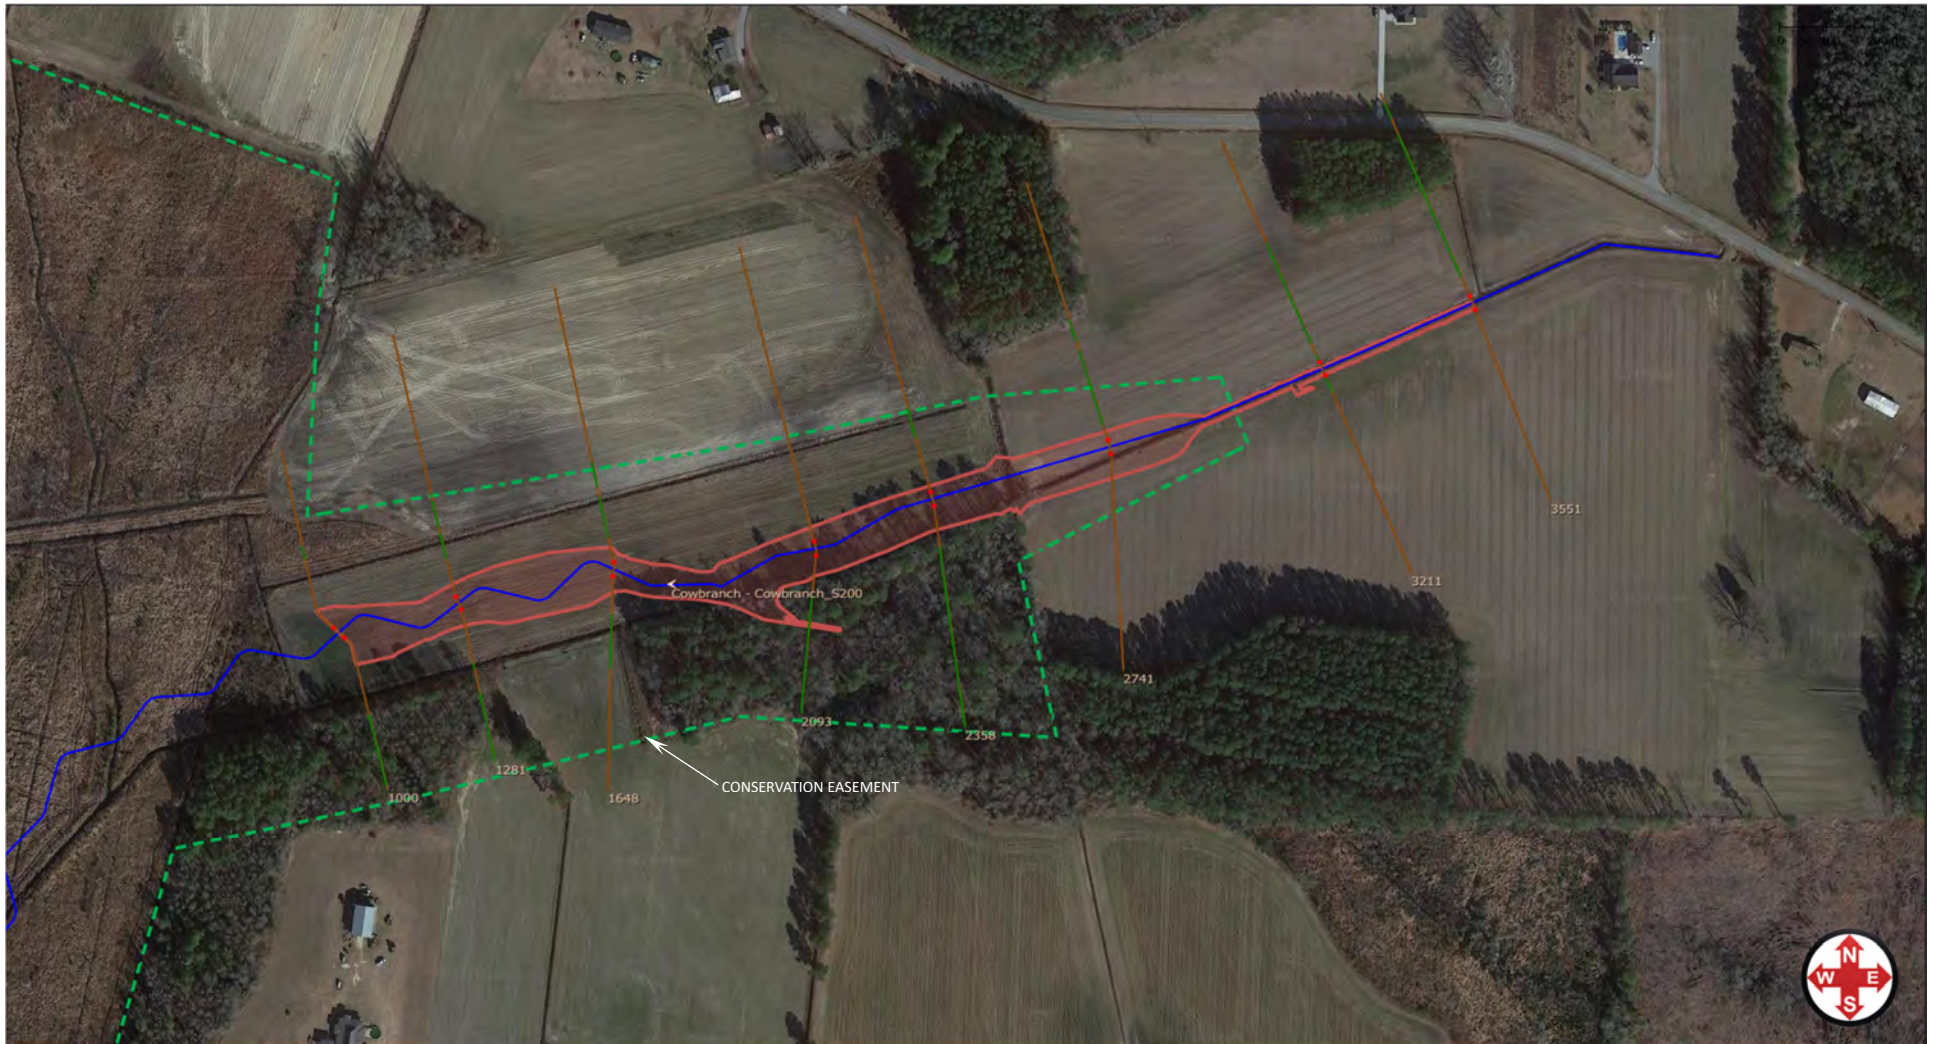
25 YR DISCHARGE = 33.6 CFS
WSF ELEV @ XSECT 3551 = 111.36"
48" DIA. CULVERT INV. @ LUMBERTON RD. = 110.35'
LUMBERTON RD. TOP OF ROAD ELEV = 116.16'

COW TAIL FLOOD MODEL ANALYSIS PROPOSED CONDITIONS

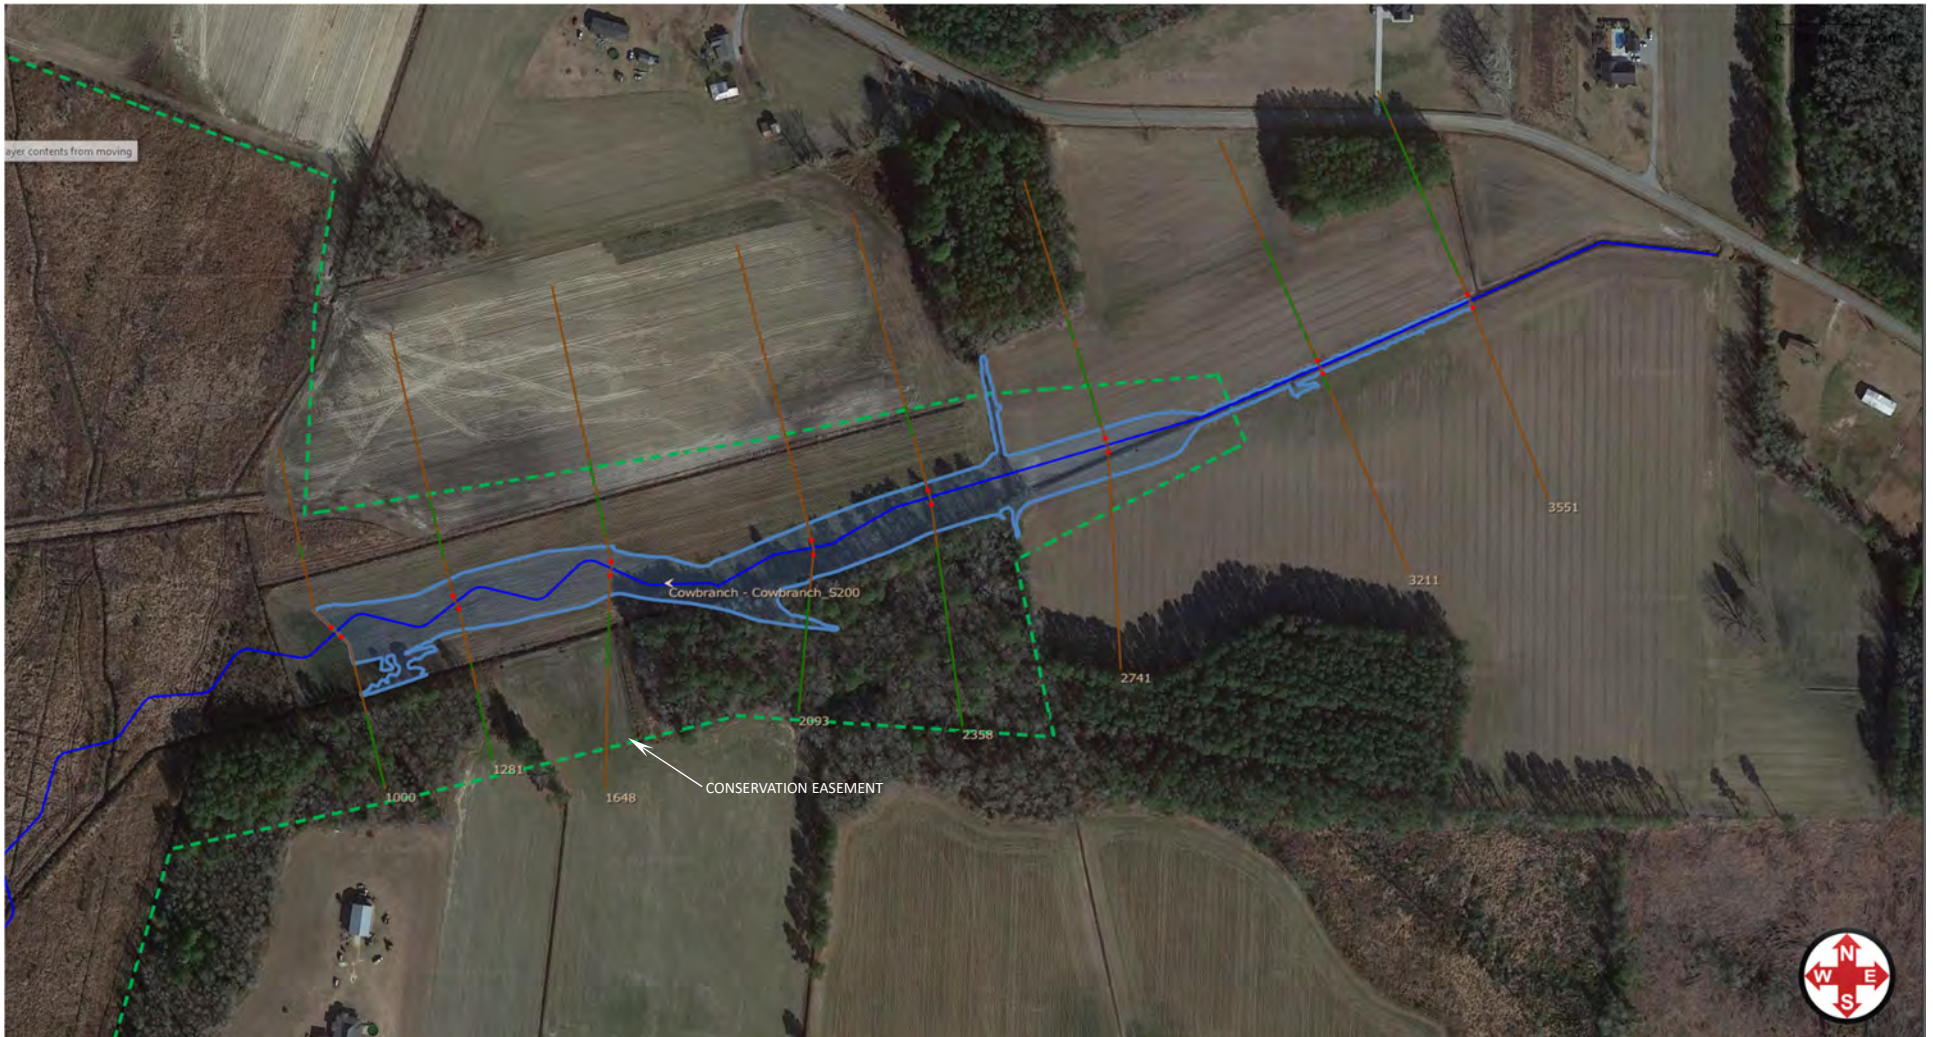
100 YR DISCHARGE = 44.9 CFS
WSF ELEV @ XSECT 3551 = 111.59''
48" DIA. CULVERT INV. @ LUMBERTON RD. = 110.35'
LUMBERTON RD. TOP OF ROAD ELEV = 116.16'

COW TAIL FLOOD MODEL ANALYSIS PROPOSED CONDITIONS

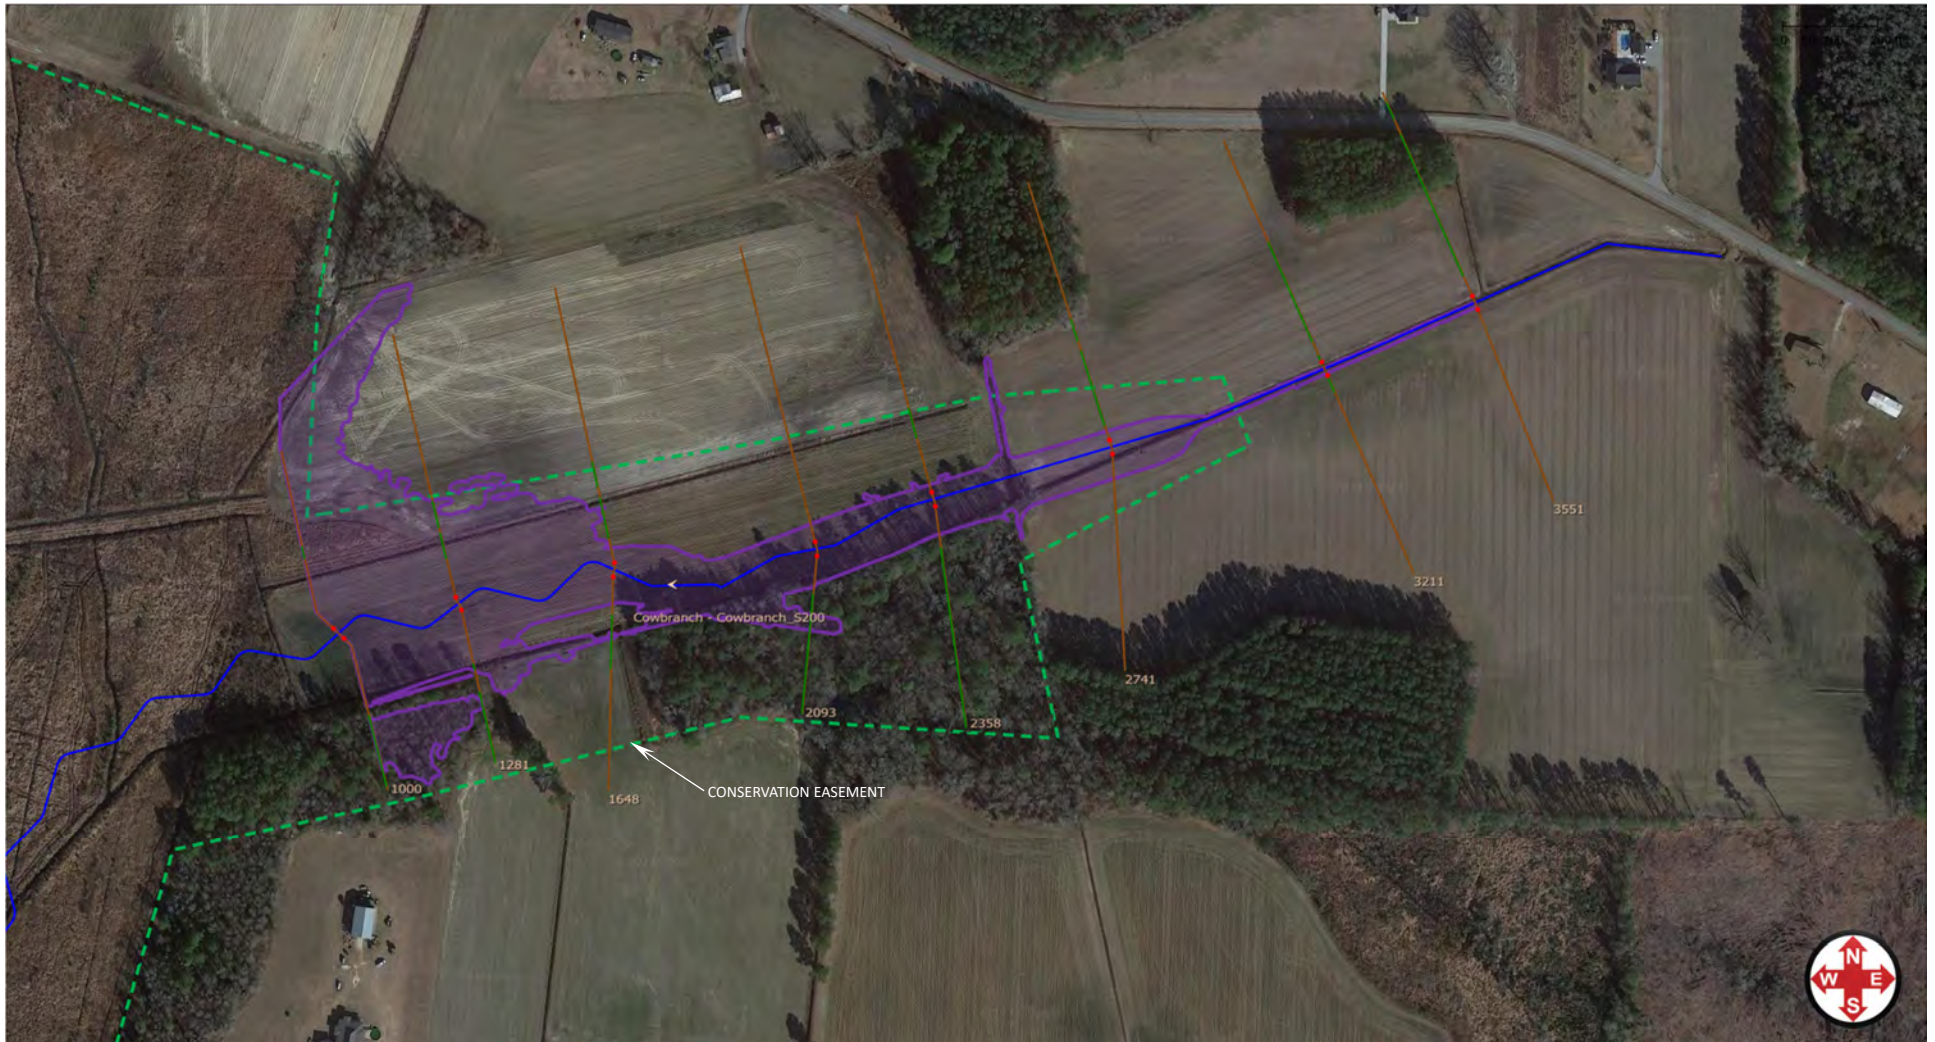
BANKFULL DISCHARGE = 7.8 CFS
WSF ELEV @ XSECT 3551 = 110.44'
48" DIA. CULVERT INV. @ LUMBERTON RD. = 110.35'
LUMBERTON RD. TOP OF ROAD ELEV = 116.16'

COW TAIL FLOOD MODEL ANALYSIS PROPOSED CONDITIONS
WITH HYPOTHETICAL 2' TALL BEAVERDAM @ XSECT 1000

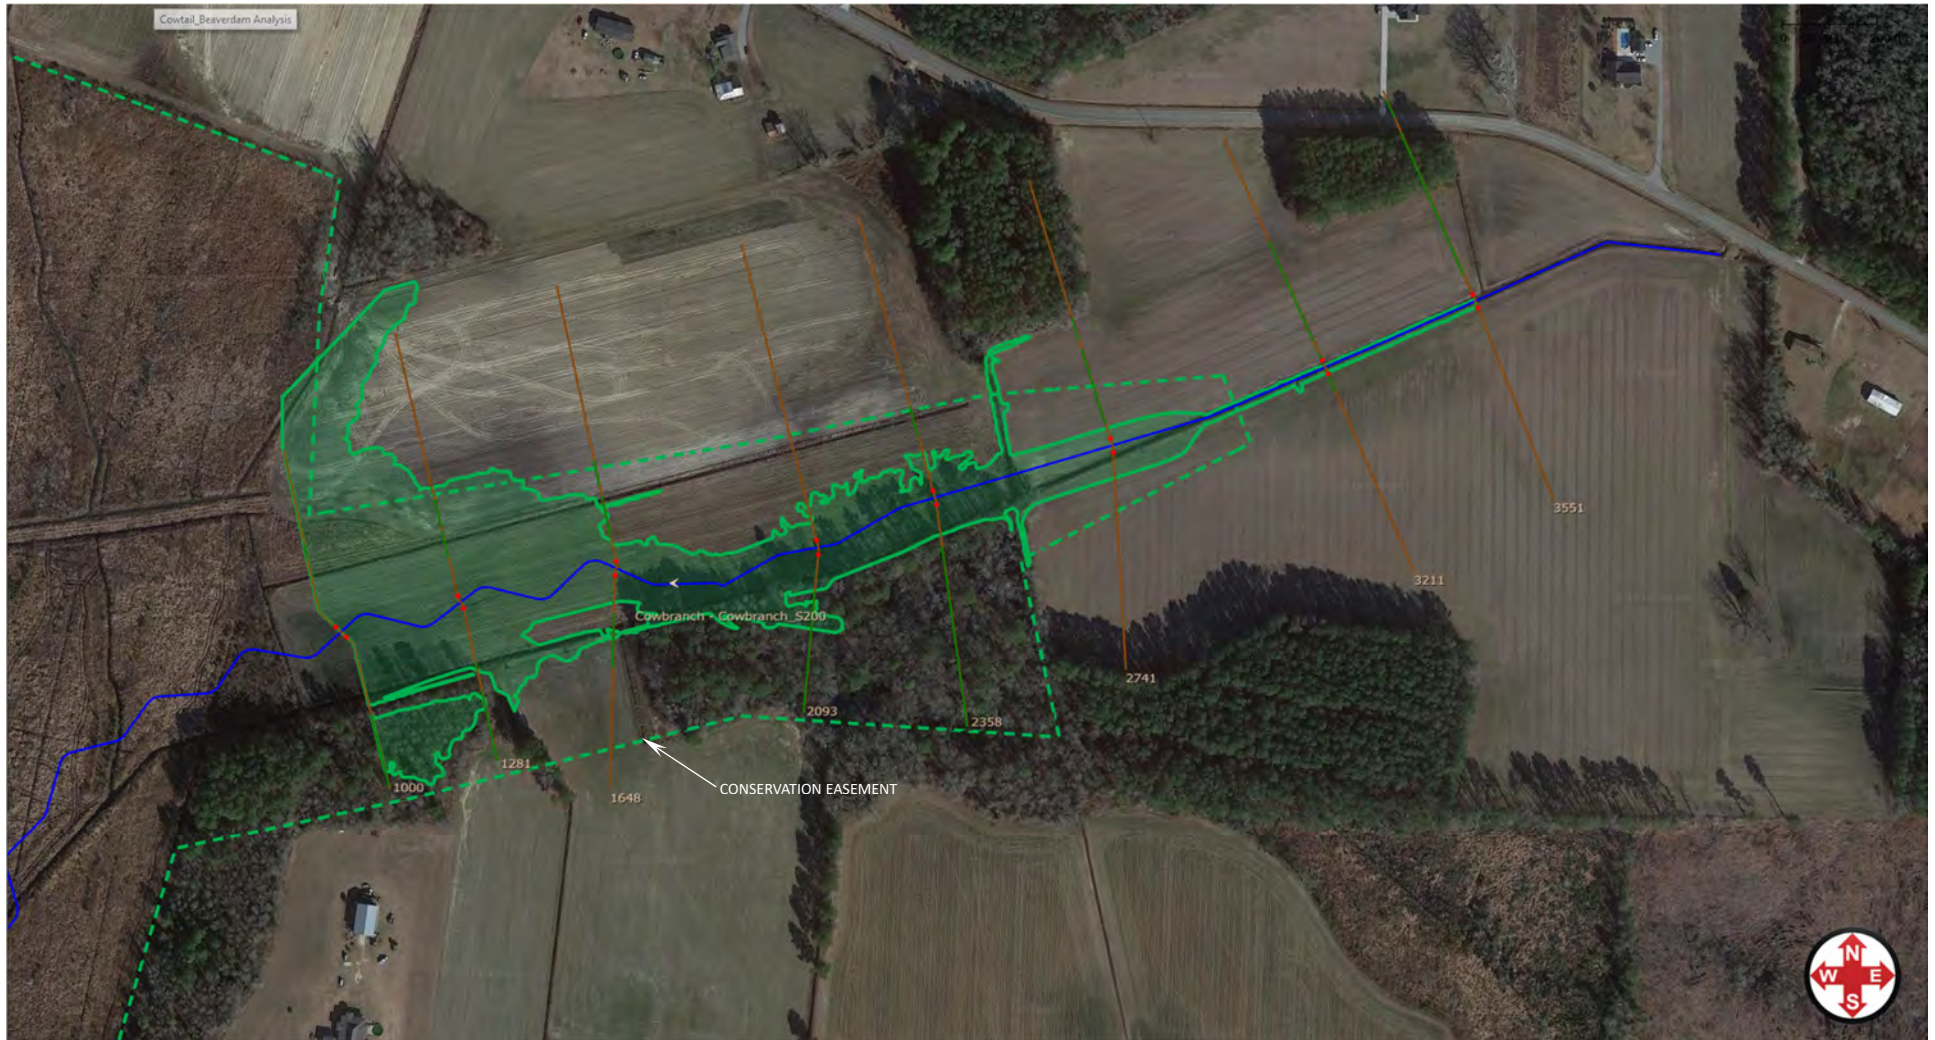
10 YR DISCHARGE = 26.2 CFS
WSF ELEV @ XSECT 3551 = 111.15"
48" DIA. CULVERT INV. @ LUMBERTON RD. = 110.35'
LUMBERTON RD. TOP OF ROAD ELEV = 116.16'

COW TAIL FLOOD MODEL ANALYSIS PROPOSED CONDITIONS
WITH HYPOTHETICAL 2' TALL BEAVERDAM @ XSECT 1000

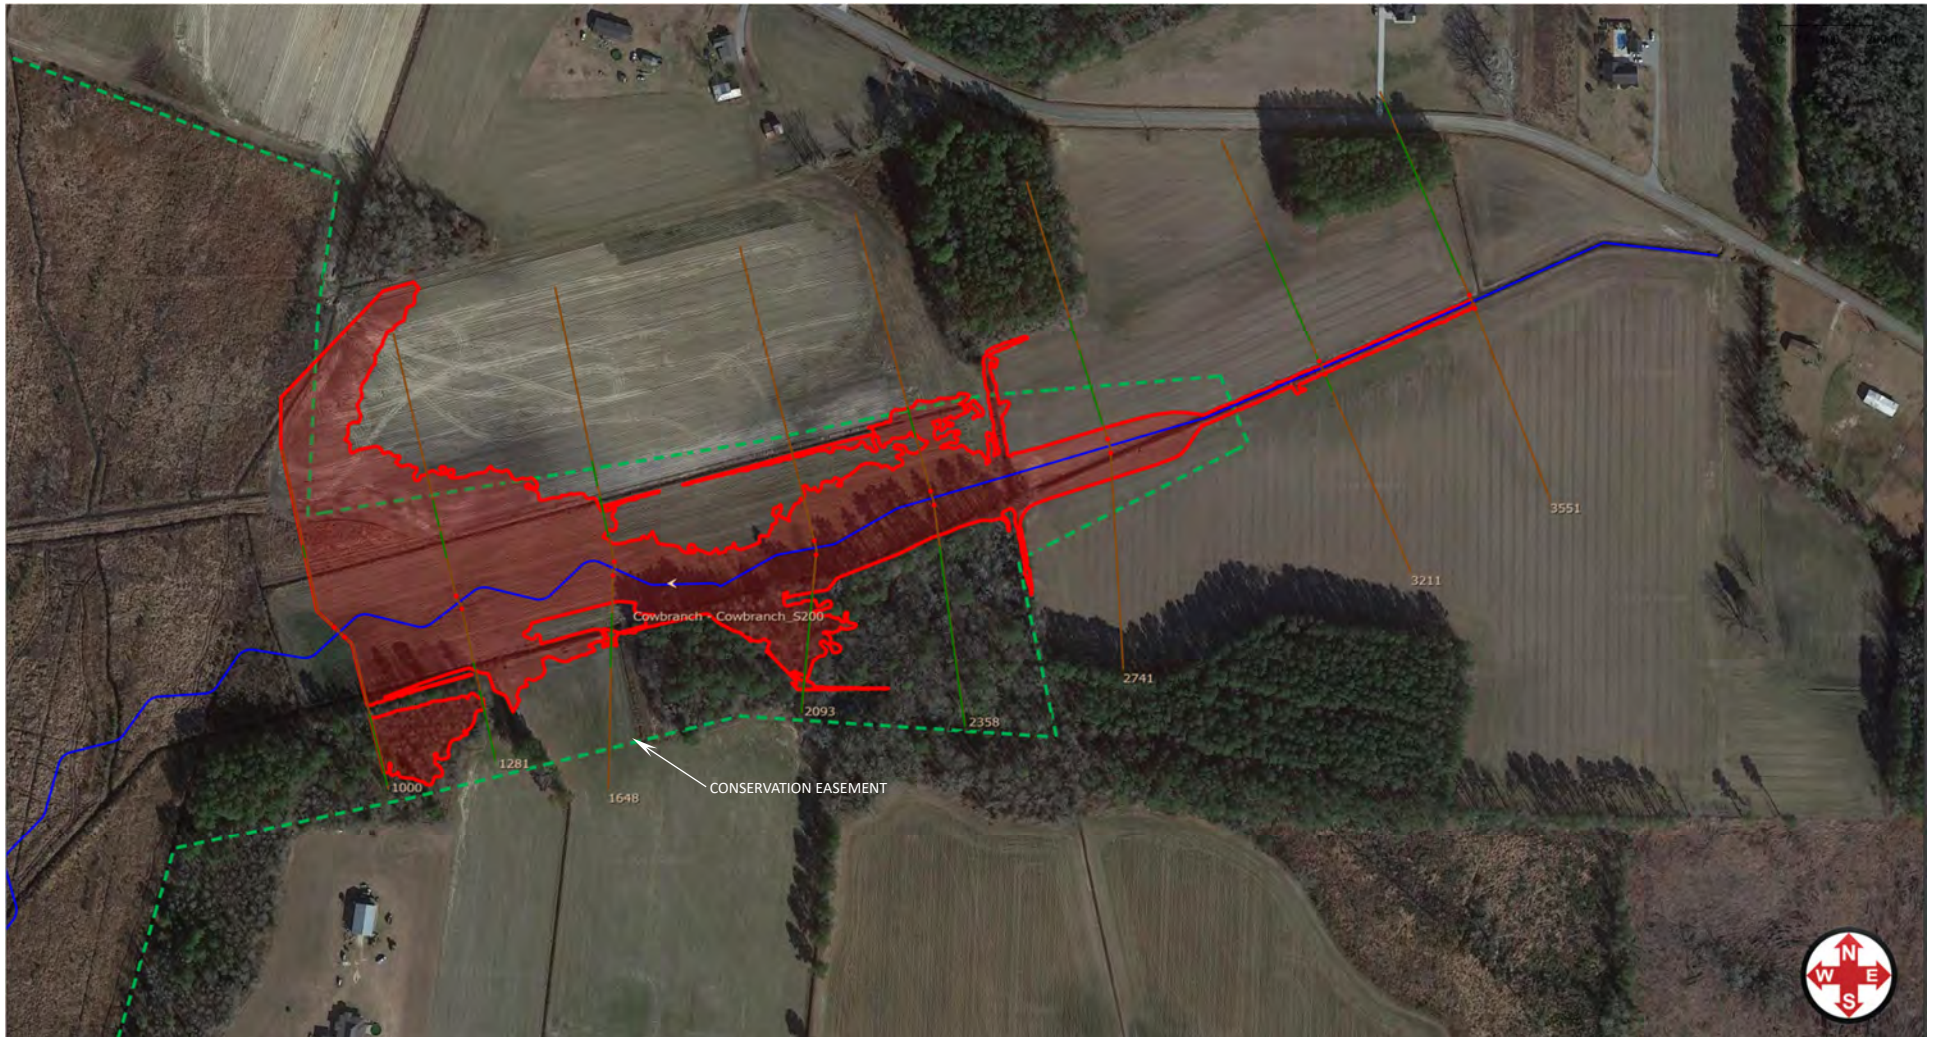
25 YR DISCHARGE = 33.6 CFS
WSF ELEV @ XSECT 3551 = 111.33"
48" DIA. CULVERT INV. @ LUMBERTON RD. = 110.35'
LUMBERTON RD. TOP OF ROAD ELEV = 116.16'

COW TAIL FLOOD MODEL ANALYSIS PROPOSED CONDITIONS
WITH HYPOTHETICAL 2' TALL BEAVERDAM @ XSECT 1000

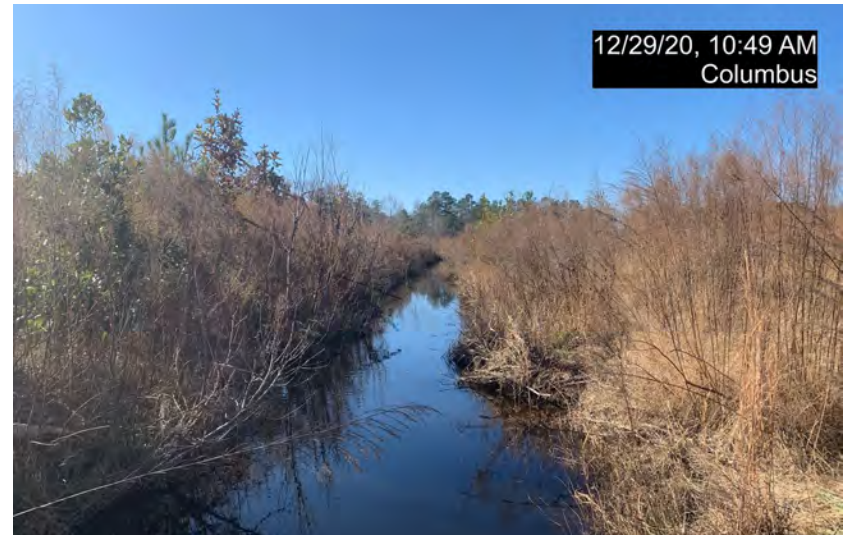
Cow Branch (lower) - Looking upstream showing channelized conditions

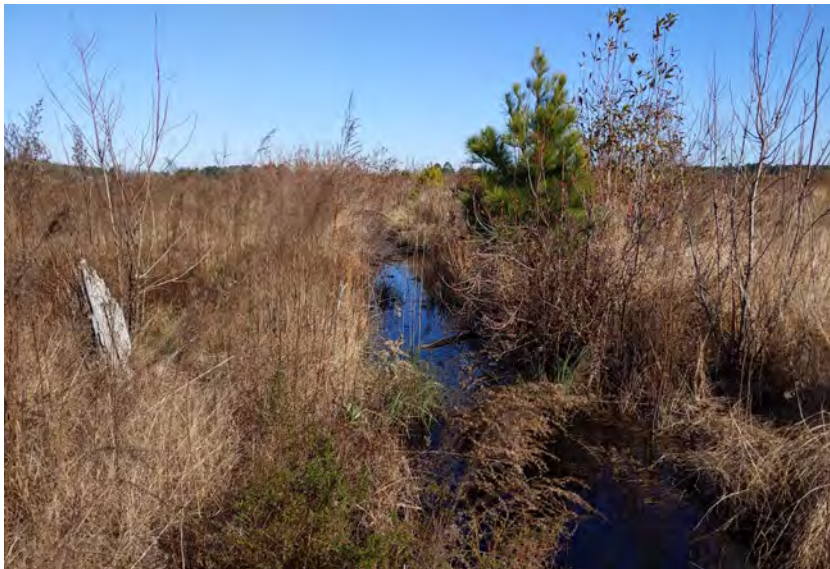
S100 - Looking upstream showing channelized stream conditions

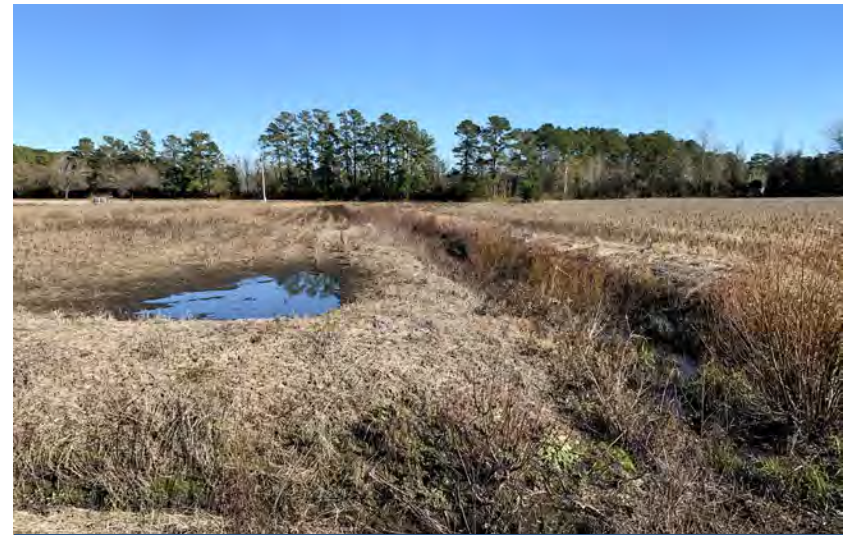
S200 - Looking upstream showing channelized conditions and lack of riparian buffer vegetation

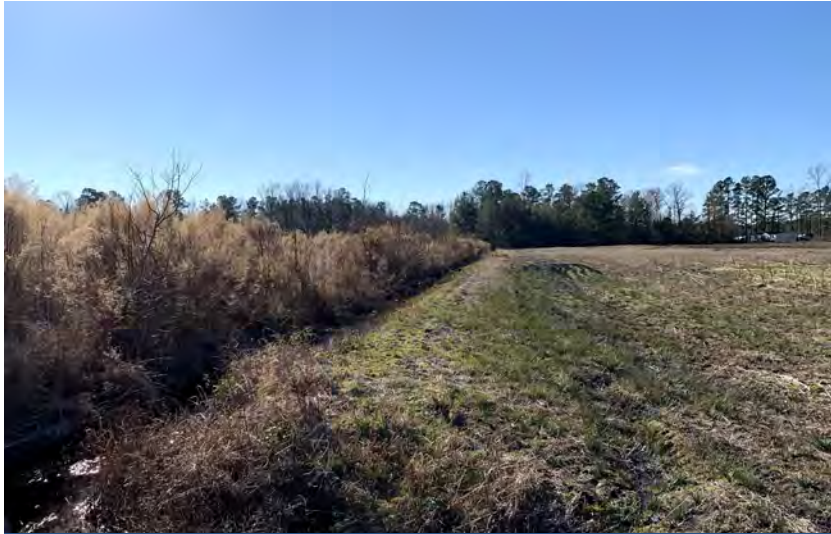
W01 - Typical channelized ditch conditions and drained wetland hydrology near edge of agricultural field area
