MITIGATION PLAN
ABBEY LAMM
STREAM AND WETLAND MITIGATION SITE
Alamance County, North Carolina
Full Delivery Contract No. 5790

Cape Fear River Basin
Cataloging Unit 03030002

December 2014

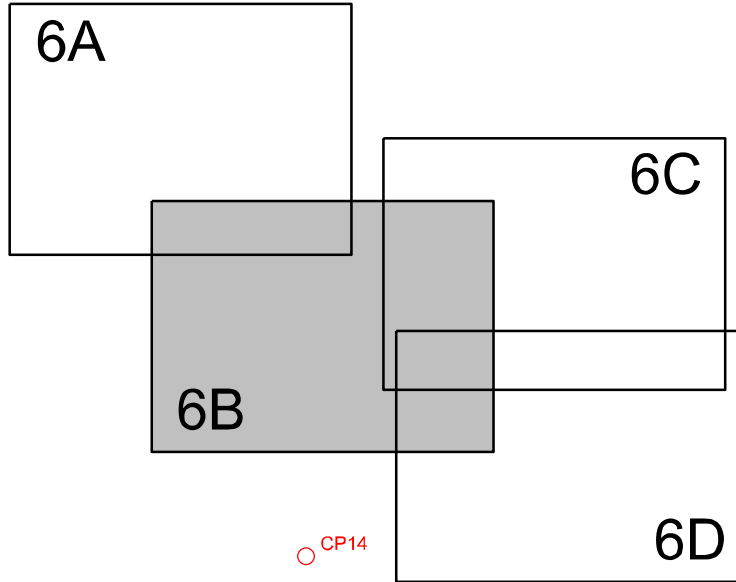
6B

MAIN CHANNEL
END ENHANCEMENT II
START RESTORATION
STA 20+59
ELEV 539.15
○ CP8

MAIN CHANNEL
END RESTORATION
START ENHANCEMENT II
STA 16+31
ELEV 547.11

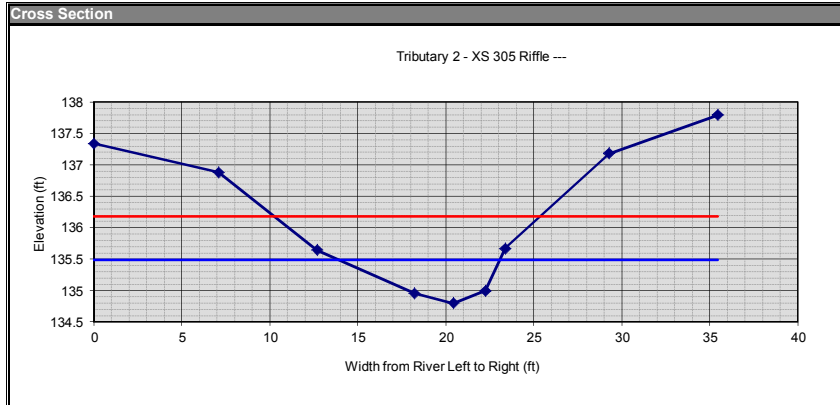
section: Tributary 2 - XS 305
 Riffle

description: Tributary 2 - XS 305
 height of instrument (ft): 100.00

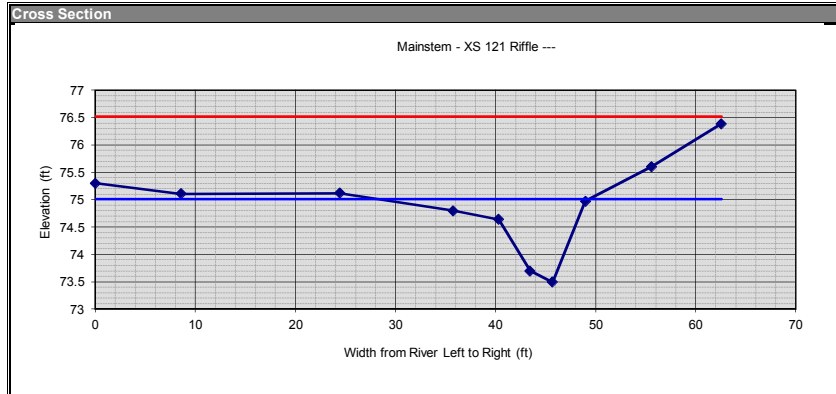
section: Mainstem - XS 121
Riffle

description: Mainstem - XS 121
height of instrument (ft): 100.00
