STREAM RESTORATION PLAN

ABBOTT PROPERTY Wake County, North Carolina

State Project No. 8.1402601
TIP Project No. R-2541

North Carolina Department of Transportation
Project Development and Environmental Analysis Branch

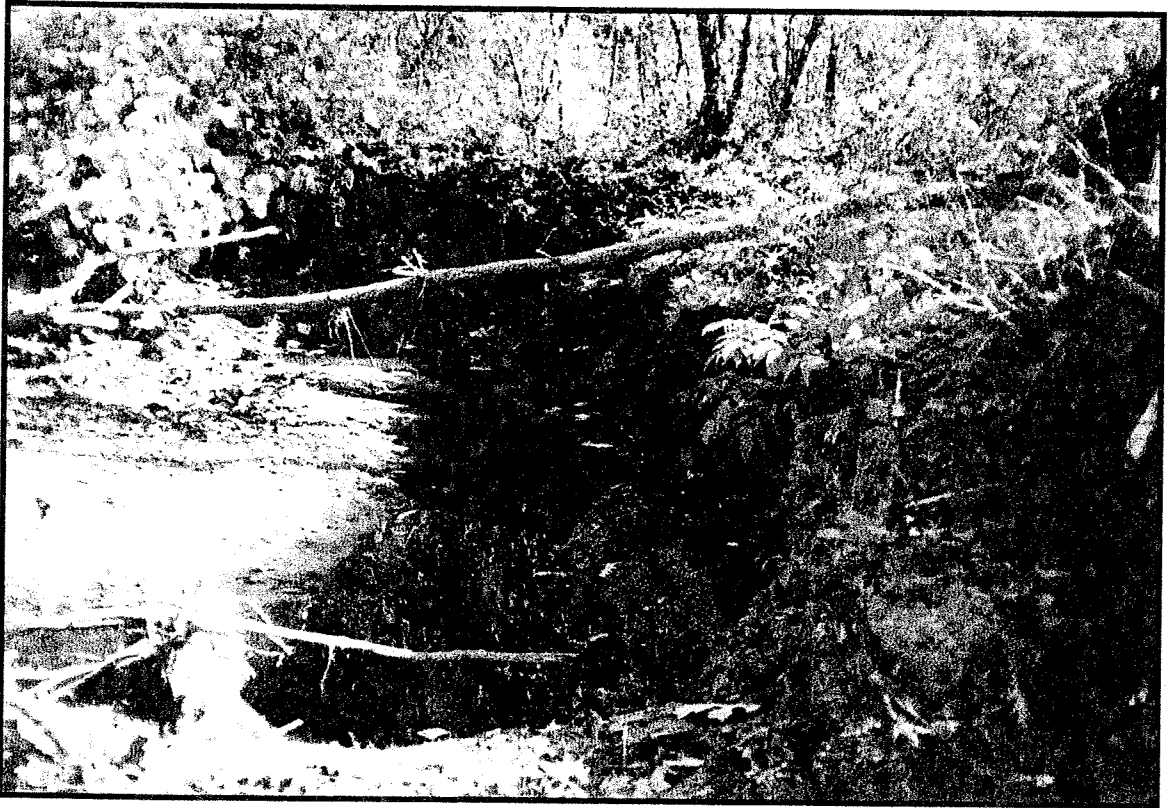
3. Mass wasting of stream bank.

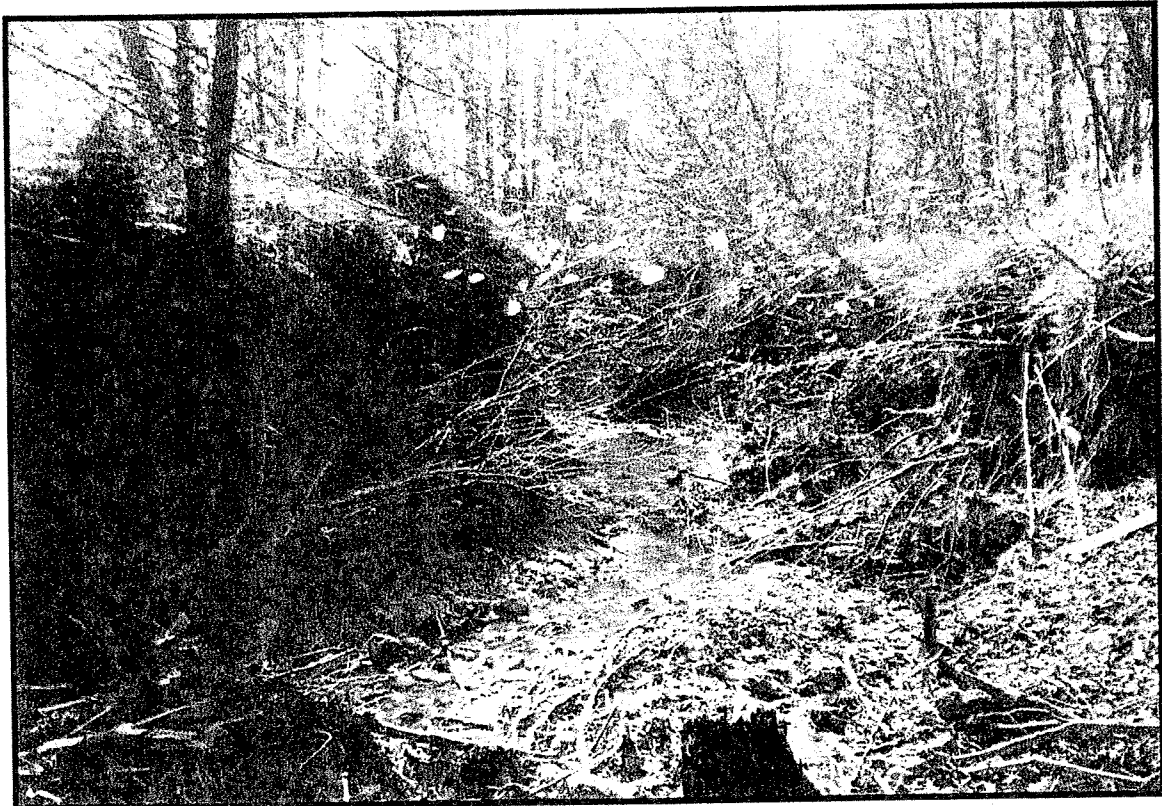
6. Severe down cut, resulting in vertical banks and loss of bank vegetation.

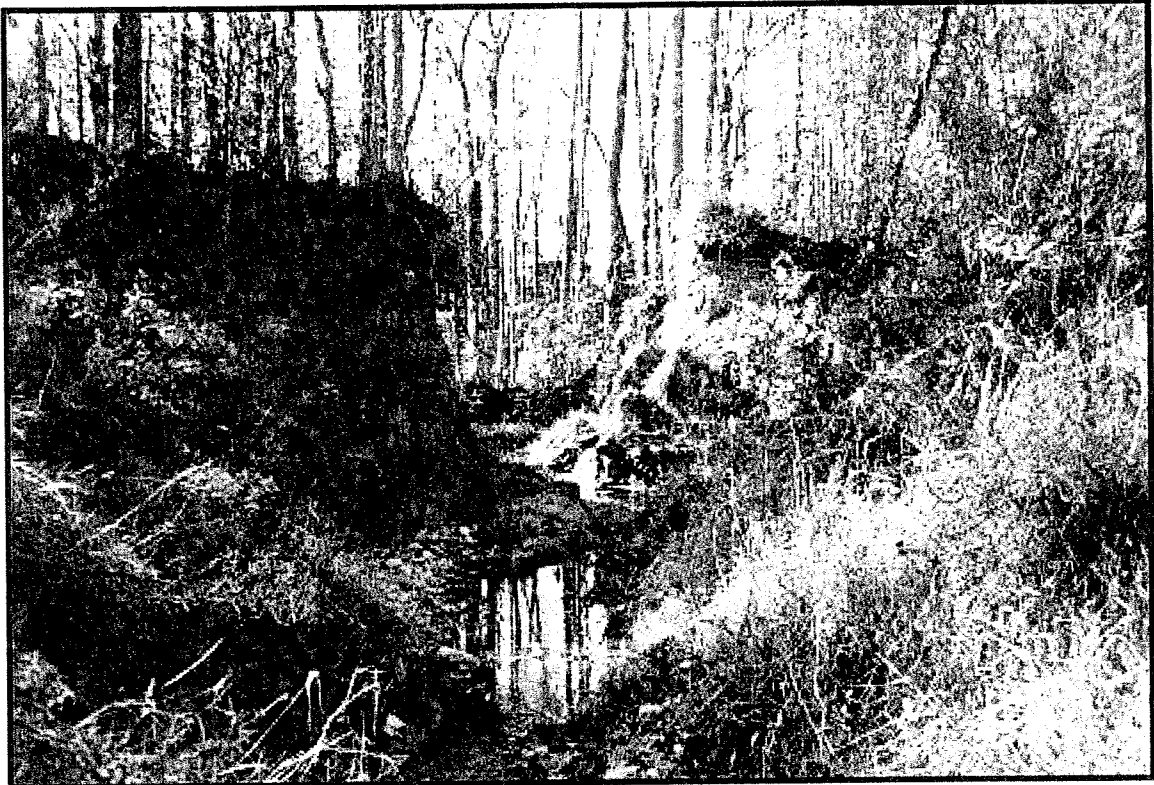
7. Breached center of dam wall. (Downstream View)

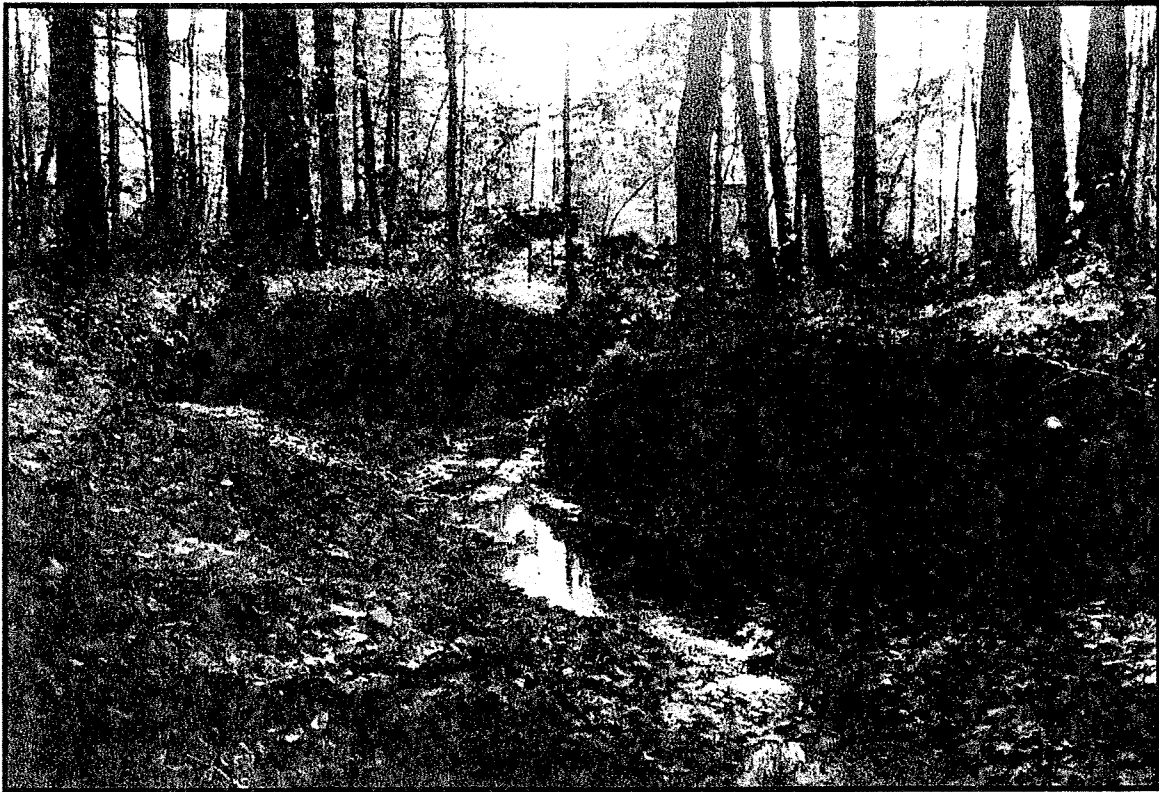
9. Bank erosion downstream of dam.
