AS-BUILT WETLAND CONSTRUCTION REPORT

ABC SITE
BEAUFORT COUNTY, NORTH CAROLINA

THE NORTH CAROLINA DEPARTMENT OF TRANSPORTATION
RALEIGH, NORTH CAROLINA

TIP#: R-2510WM
Project #: 8.T221801

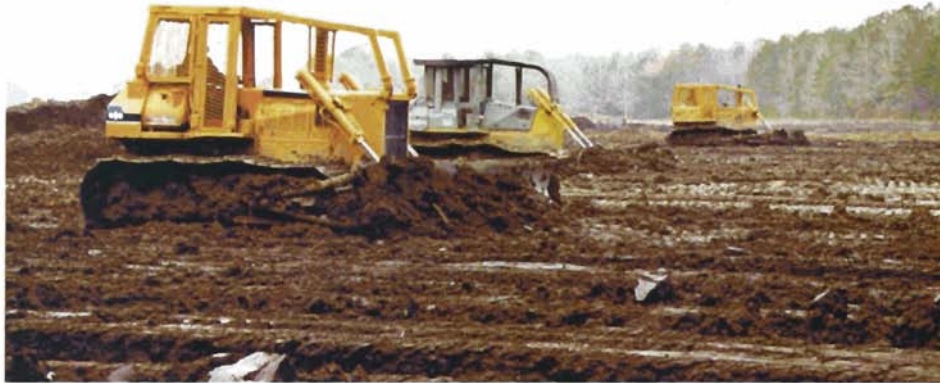
Dozer

- Topsoil removal and stockpiling
- Depression contouring
- Ditch backfill and compaction
- Topsoil redistribution
- Microrelief creation
- Sub-soiling

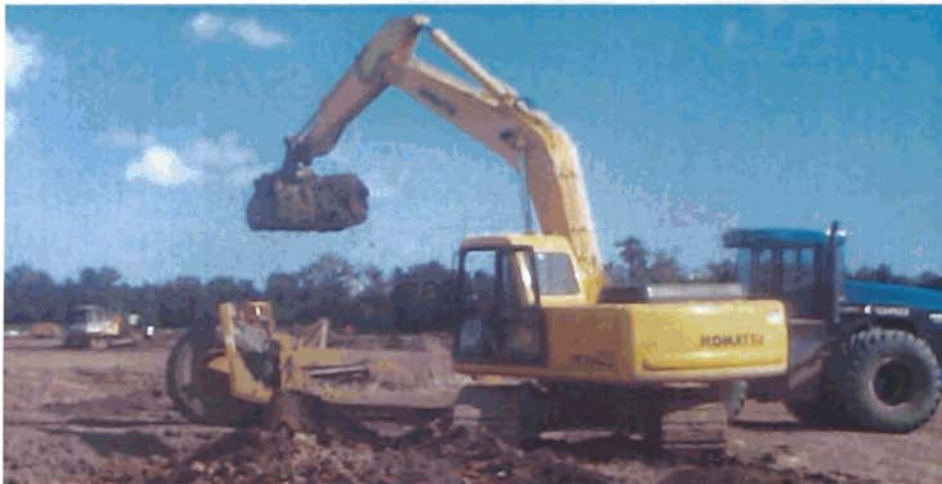
Excavator

- Ditch clean-out
- Embedded ditch plug excavation
- B-horizon contouring (Depression construction)
- Barrow material excavation
- Tip mound construction

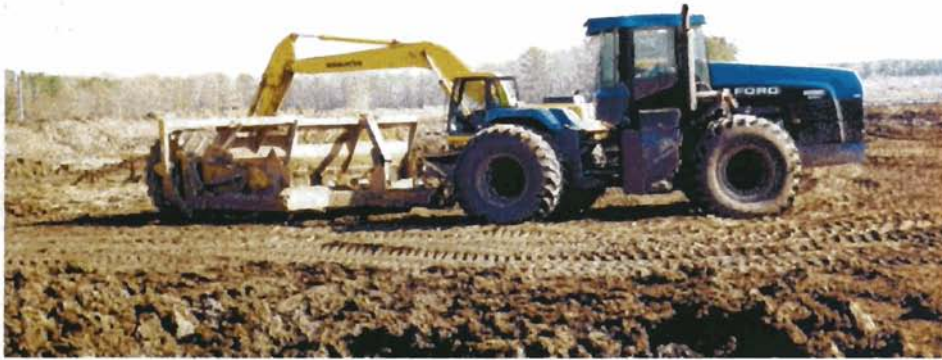
Tractor and Pan combination (Scraper)

- B-horizon excavation and hauling
- Ditch Backfilling

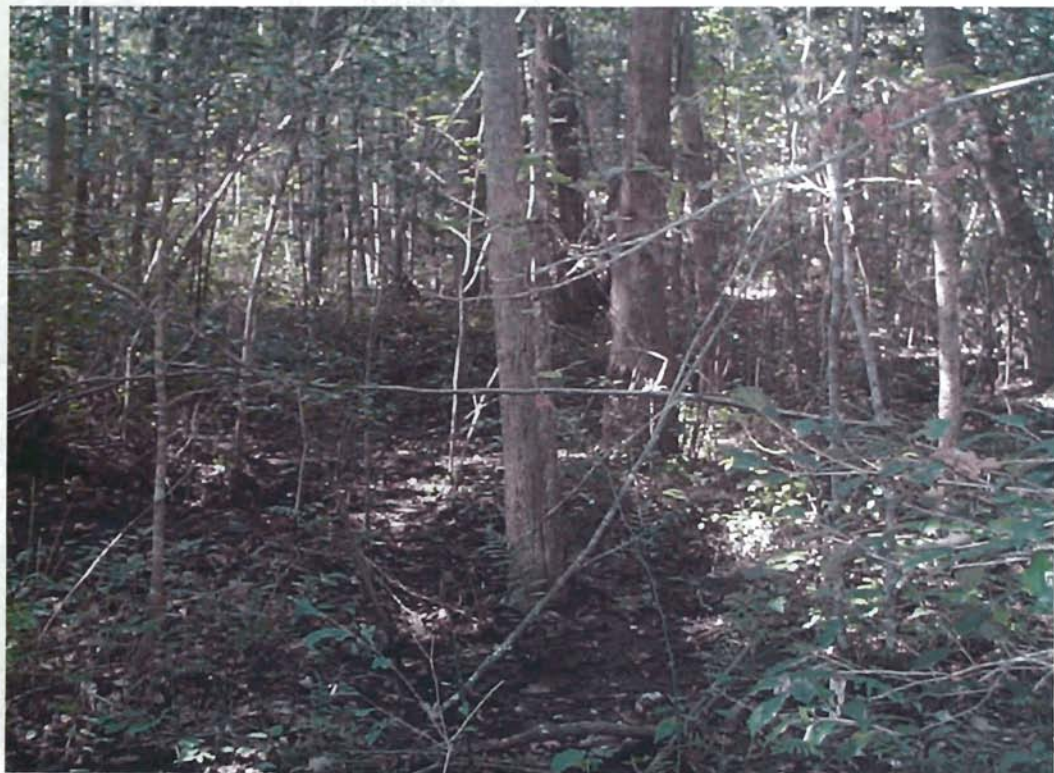
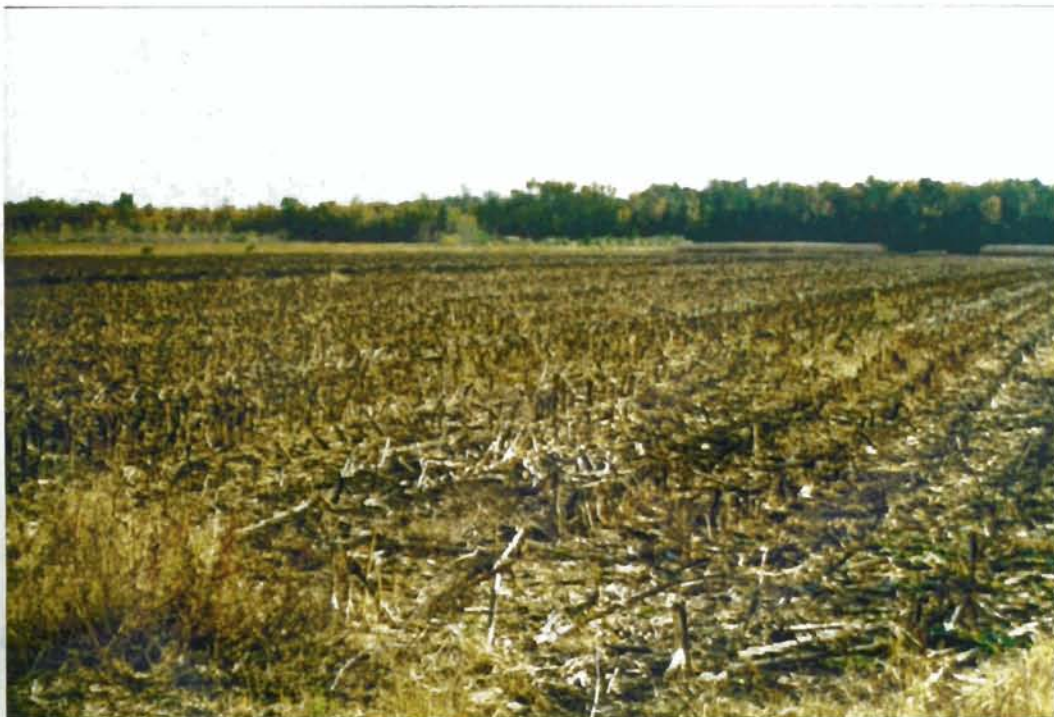
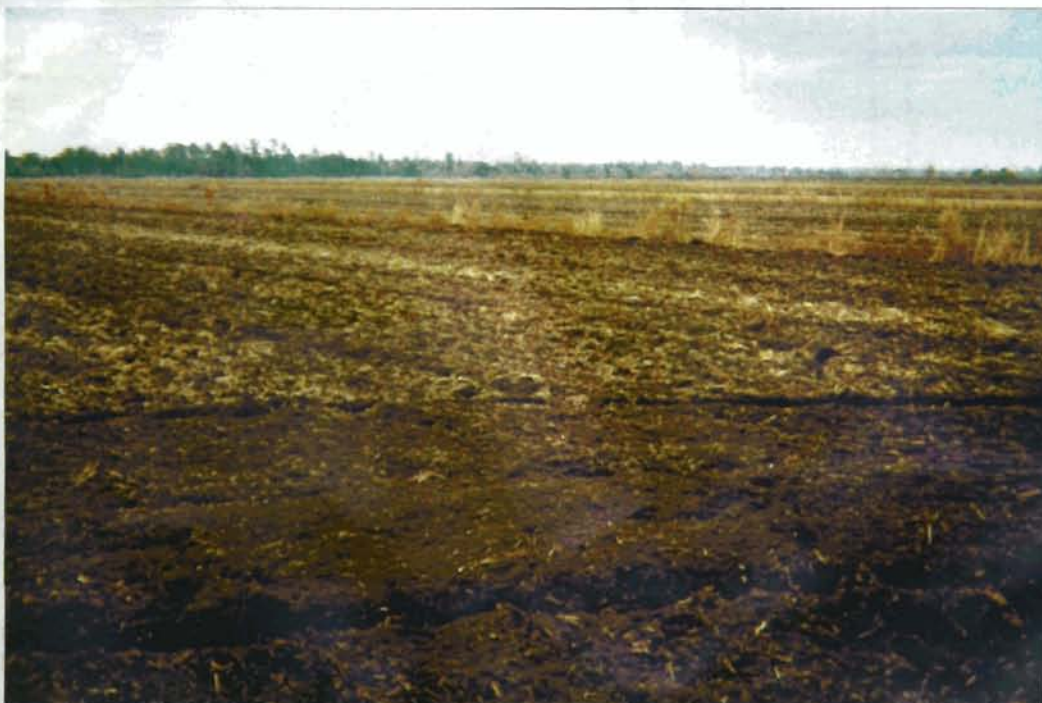
Features which establish hydrodynamic wetland functions, such as surface microtopography, ephemeral ponding, forest vegetation, and characteristic wetland soil properties have been eliminated from agricultural use. On-site reference conditions which represent conditions prior to land clearing and farming activity are shown in Photo 1. Under agricultural land uses, much of the Site exhibits negligible wetland functions. Hydrodynamic functions had been effectively eliminated from the site due to removal of forest vegetation, construction of a drainage network, crown construction, and compaction (plow pan). The pre-construction conditions showing crop land and lack of wetland functions are shown in photo 2 and 3. A diagrammatic depiction of pre-construction conditions is shown in Figure 3.

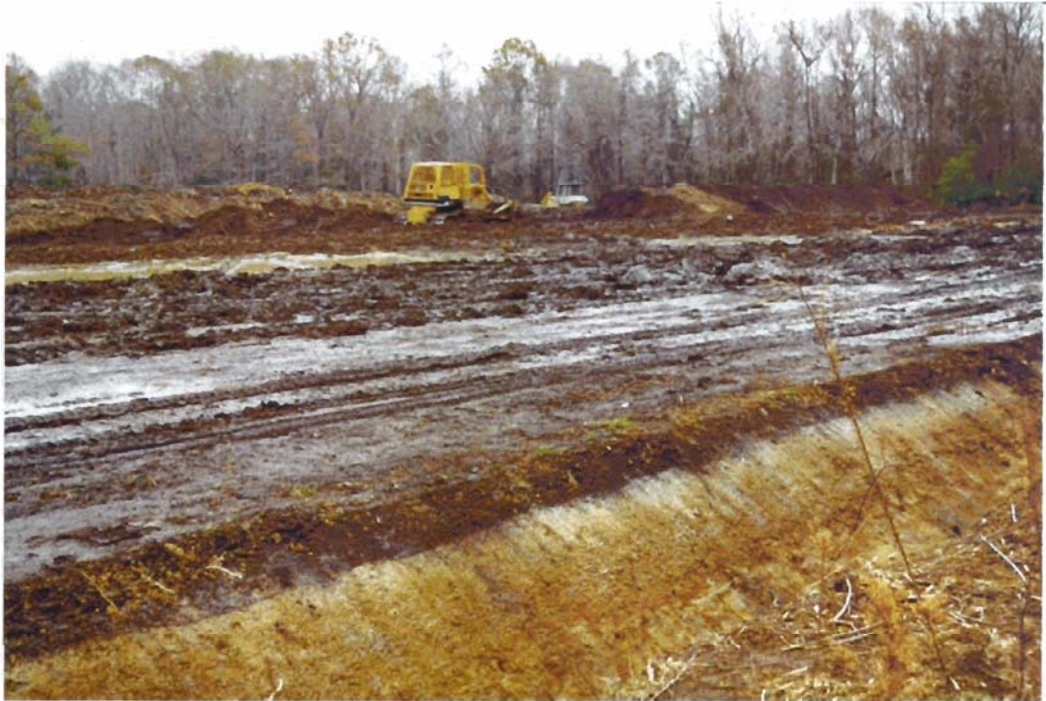
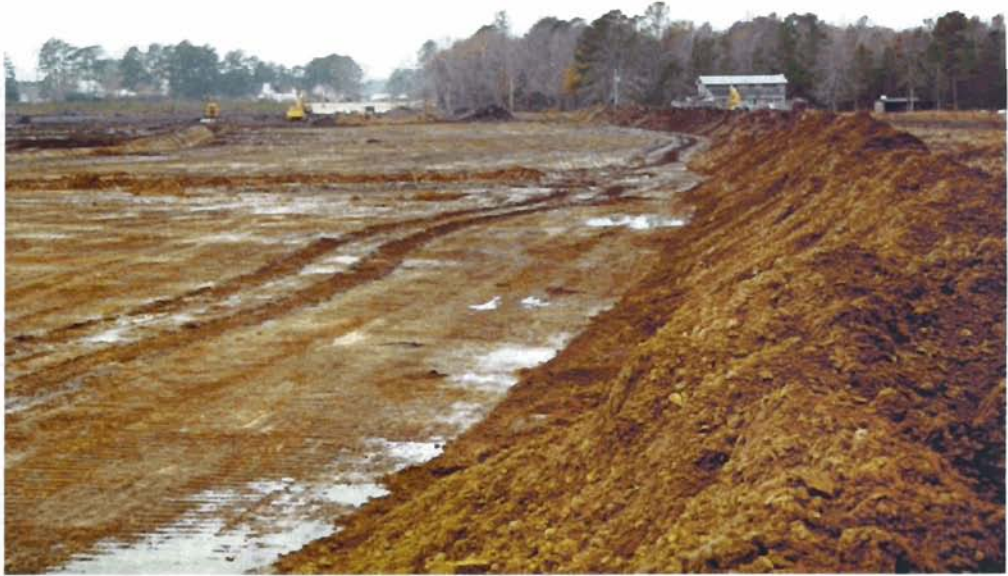
Topsoil excavation and stockpiling commenced as soon as the first ditches were cleaned. The topsoil, measuring approximately 1 foot in depth, was pushed to the center of each field. (i.e. the area between two parallel ditches). Topsoil excavation required the use of several large bulldozers to stay ahead of the ensuing sequence of activities. Several fields were excavated concurrently to expedite backfill operations and subsequent soil redistribution. Topsoil excavation and stockpiling is shown in photo 7 and 8 and depicted in Figure 5.

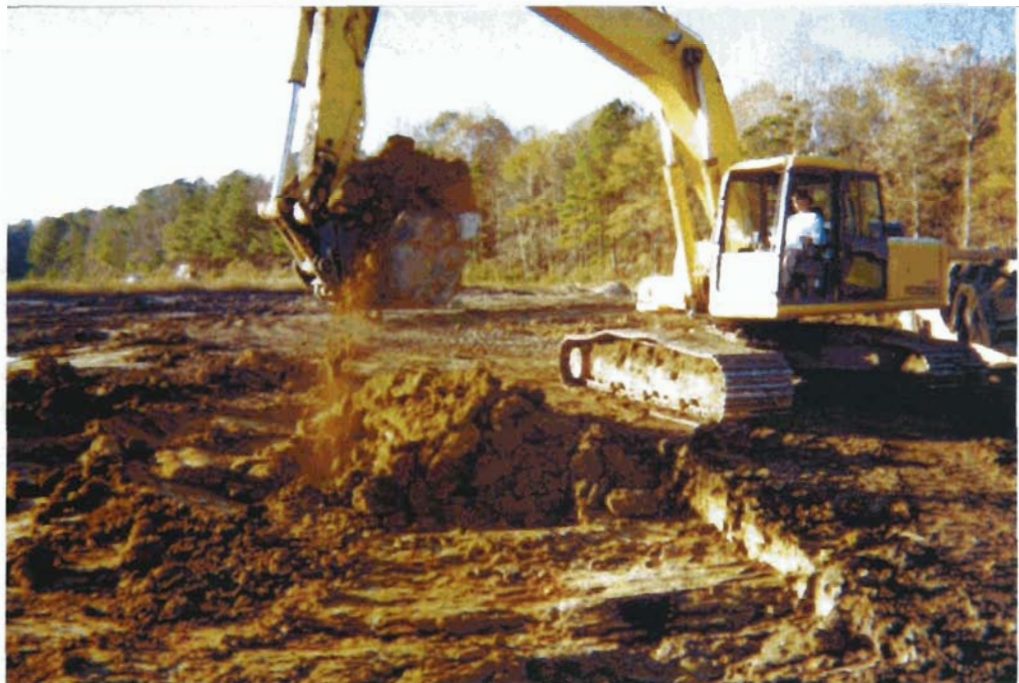
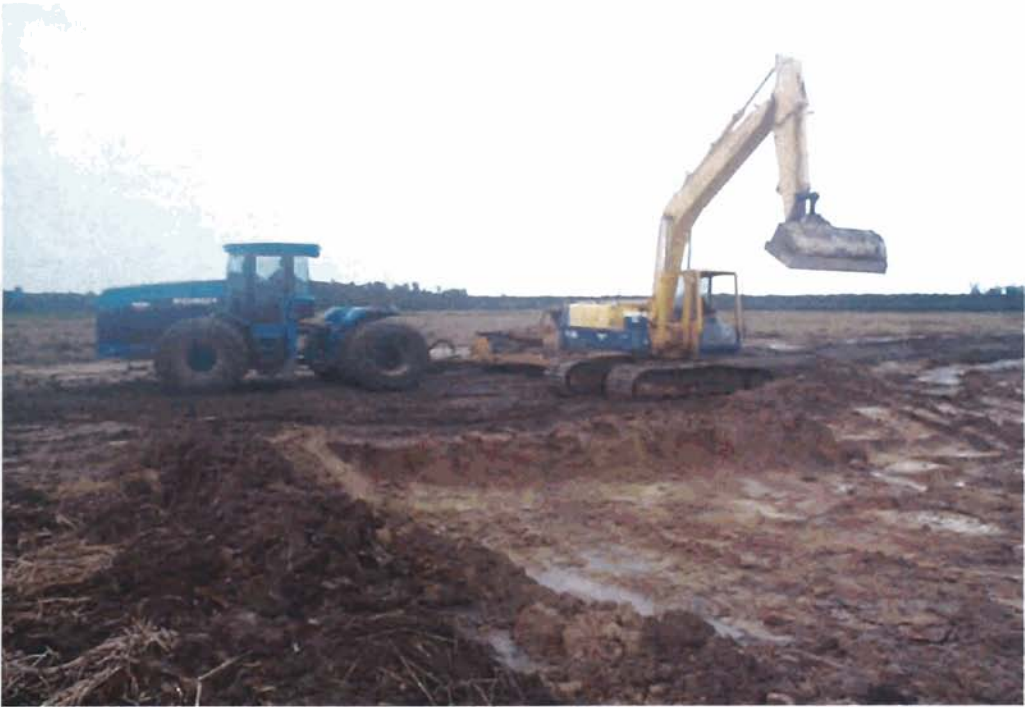
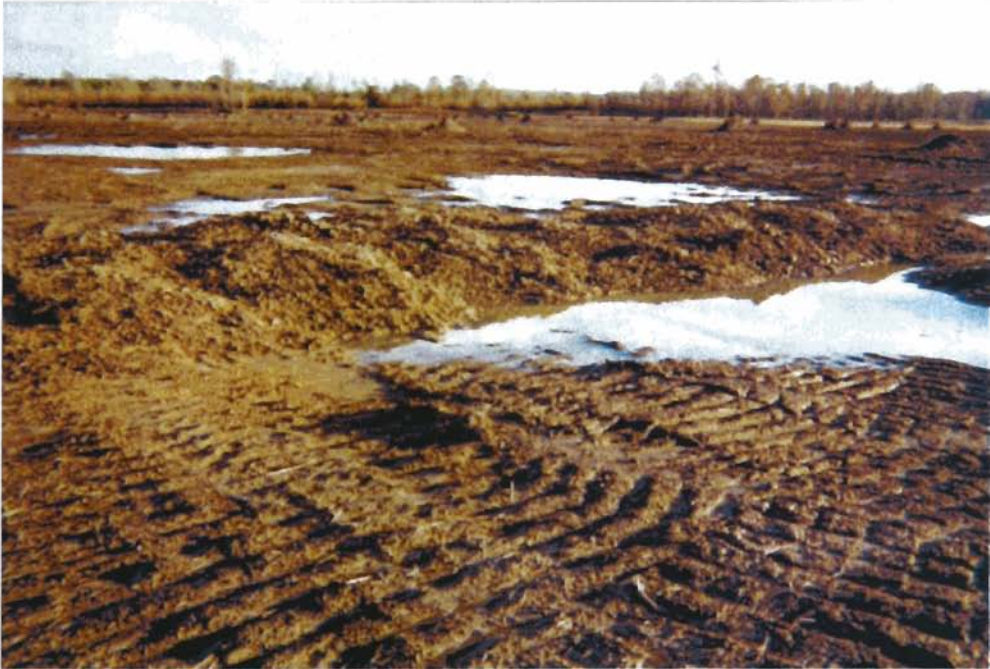
Depression construction always began at the top end (highest elevation) of the field to minimize hauling distances to coincide with ditch backfill activities. The area covered by each depression ranges from 0.02 ac to 0.1 ac in size. The clay material was excavated to a depth of approximately 1 to 2 feet below the surface and utilized as backfill material on adjacent ditch sections. A tracked excavator was used to construct and remove material from the depression. Precaution was taken not to dig through the clayey B-horizon into the sandy soil layer below. A scraper (pan) attached to a large farm tractor was used to haul and deliver the material to where it was needed. Subsequently, the depression were contoured with a bulldozer to provide for approximate 8:1 slopes. Photos 9-11 show the work in progress. Figure 6 depicts the B-horizon contouring.

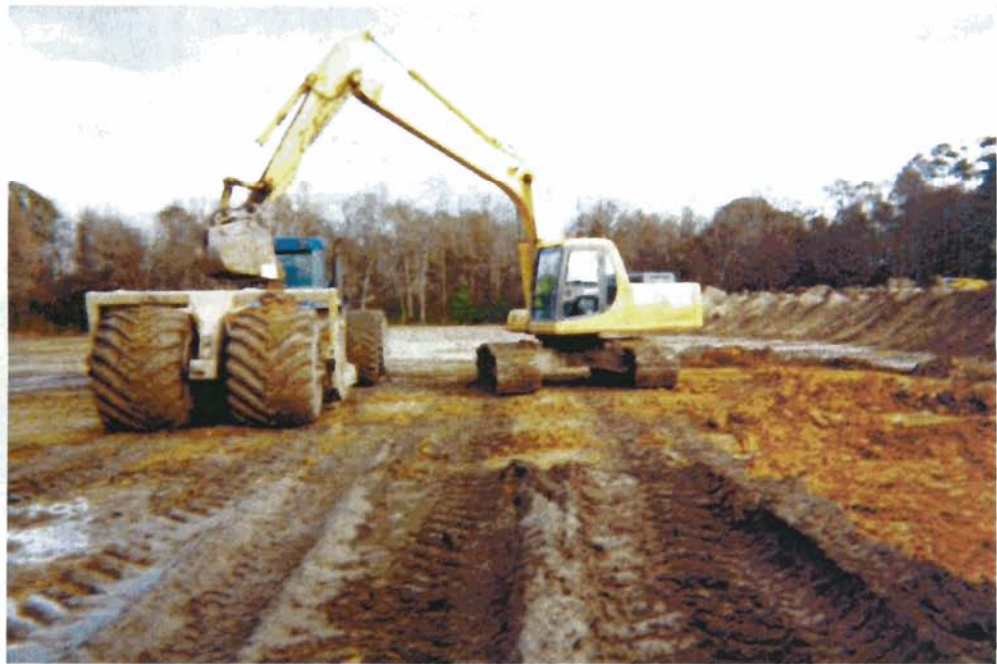
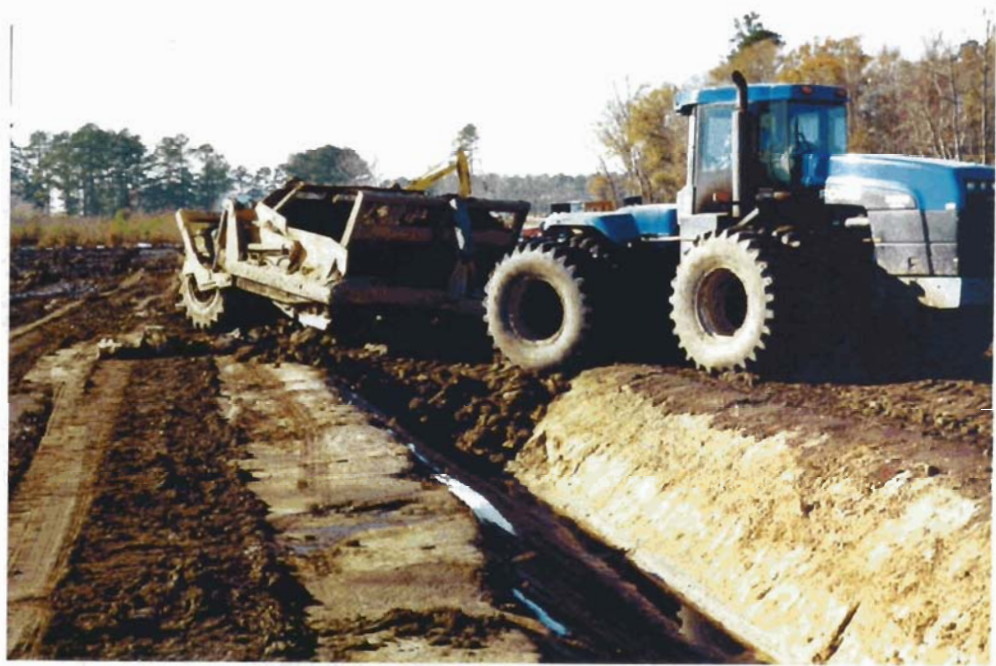
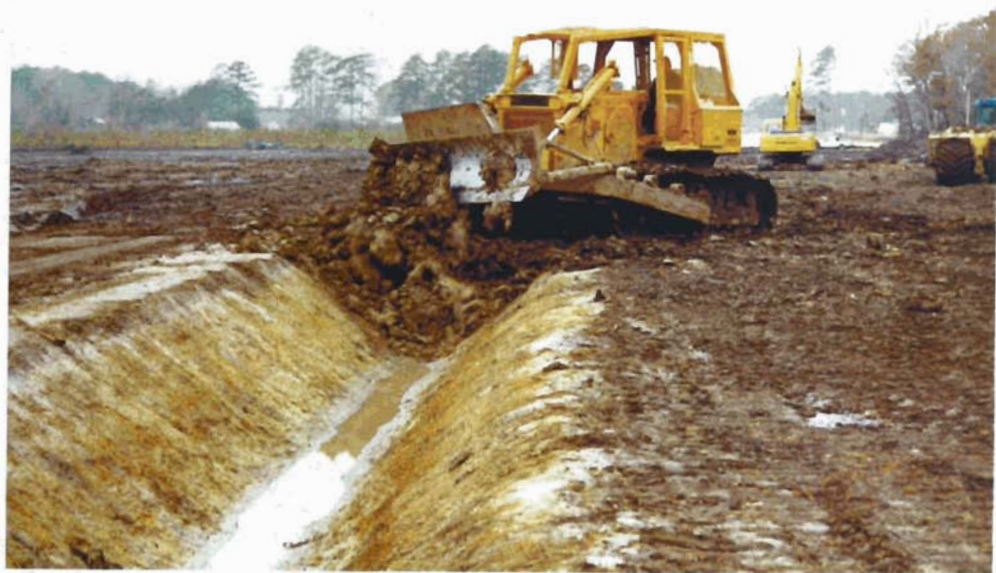
Ditches and ditch plugs located adjacent to the constructed depressions were back-filled with clay-based material excavated from the depressions. The ditch backfill operation always began from the highest ditch elevation to avoid flooding problems. An excavator working with the tractor and pan combination was used for this construction activity. Approximately 7,280 m (23,886 ft) of ditches were filled, compacted, and graded approximately 0.5 -0.8 foot above the elevation of the adjacent B-horizon surface. The additional fill material was added to allow for any future settling. Ditch and plug backfilling operations are shown in photo 12 and 13 and depicted in Figure 7. A bulldozer was used to both move the material into the ditch and for compaction (photo 14).

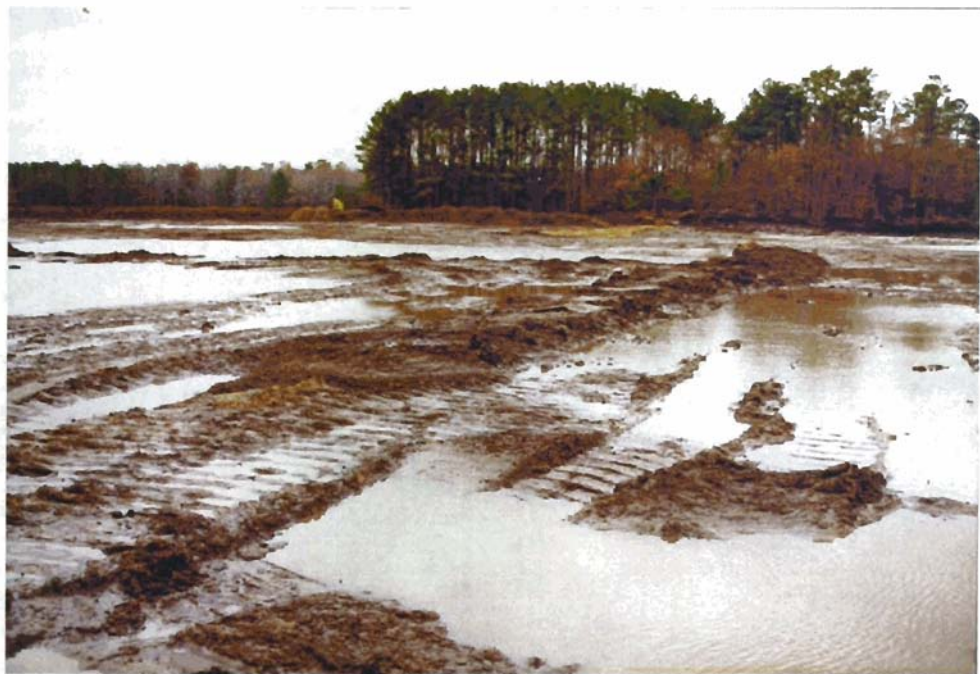
The water bars were placed directly on the B-horizon to both sides of the ditch and constructed from the low permeable materials excavated from the adjacent depressions. The water bars were compacted and graded to form a long mound approximately 50 feet in length by 10 feet in depth by 1 to 1.5 feet in height. Photo 15 shows a completed water bar.

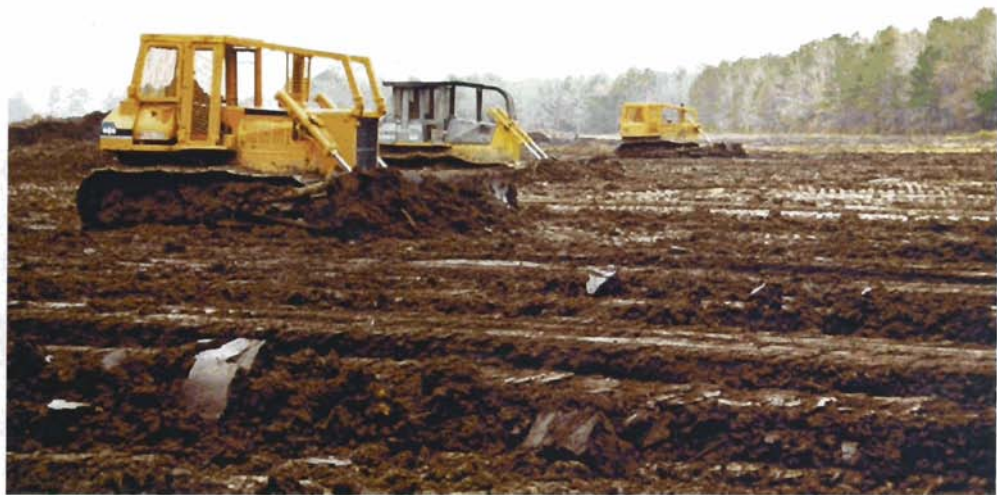
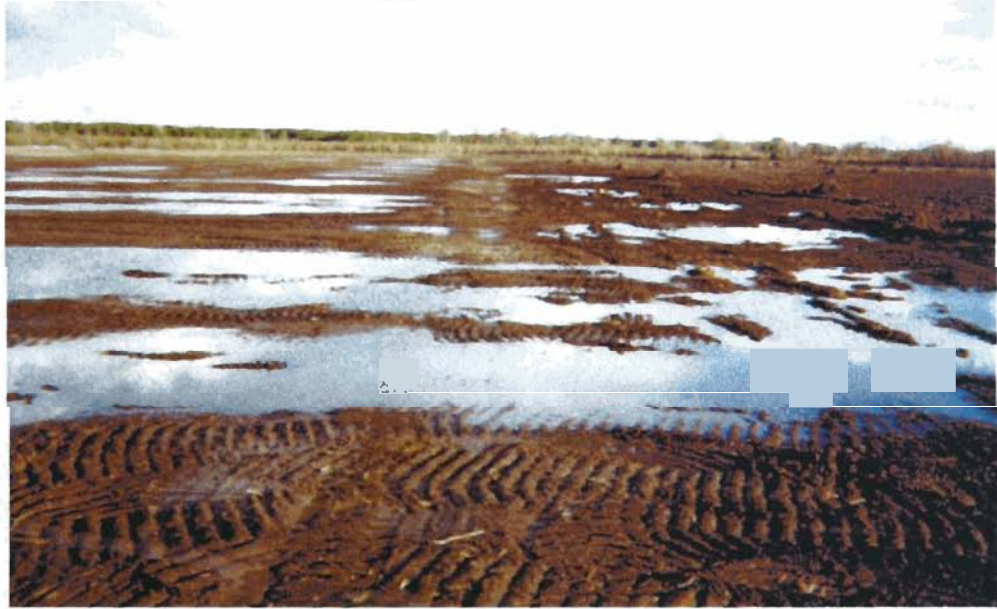
Upon completion of the B-horizon contouring, ditch backfilling, and water bar construction the topsoil was redistributed over the entire area at a nominal depth of one foot. Several dozers were employed for a majority of this task. Care was taken to redistribute topsoil evenly throughout, including areas within constructed depressions. During construction, depressional areas often filled with water from groundwater or precipitation events, making topsoil redistribution in these areas difficult. An excavator was used to place topsoil within depressional areas when conditions warranted. The excavator was also used to distribute topsoil on the water bars. With regular monitoring of topsoil depths and elevations the redistribution of the topsoil effectively eliminated the field crown. Photos 16 and 17 show the topsoil being redistributed. Figure 8 depicts completed site construction activities including: topsoil redistribution, crown removal, and microrelief modifications.

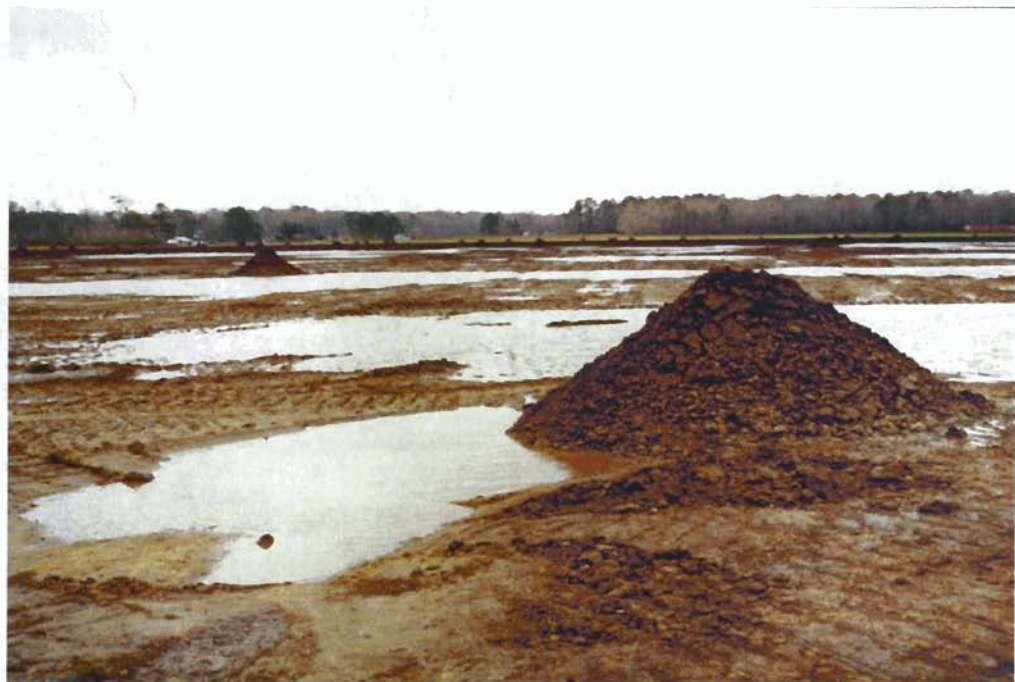
Mounds were constructed with an excavator using barrow material from an adjacent pit. The soil for the mounds were loosely piled approximately 4-5 feet in height, with a base diameter of approximately 8 feet. The adjacent pit was not excavated greater than one foot deep, with a diameter of approximately 10 feet. The mounds were spaced randomly around the site at a density of approximately one per acre. Approximately 0.15 acres is covered by mounds. Photo 18 shows an example of a completed mound and pit.

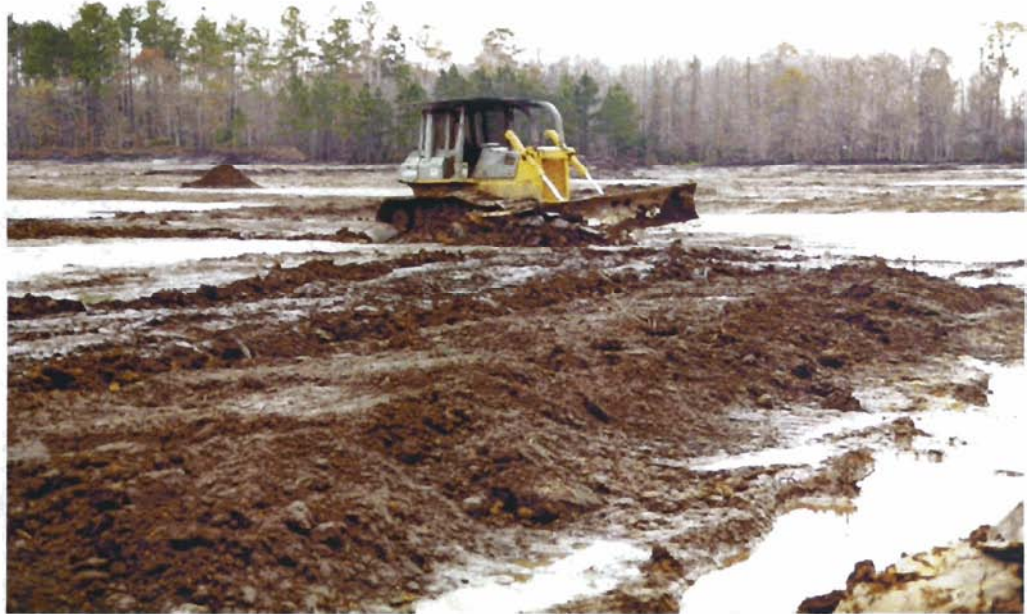
Photo 19

The second stage in microrelief development required a contouring treatment. The contouring treatment was created by use of a dozer with a tilted blade (photo 19). Topsoil was scraped out of one location and piled off to the side in a randomized ridge and trough pattern. The resultant surface ranged in approximately 2 foot vertical asymmetry across reaches of the landscape.
