ANNUAL REPORT FOR 2002

**ABC WETLAND MITIGATION SITE
BEAUFORT COUNTY
PROJECT NO. 8.T221801
TIP No. R-2510WM**

Prepared By:
Office of Natural Environment & Roadside Environmental Unit
North Carolina Department of Transportation
December 2002

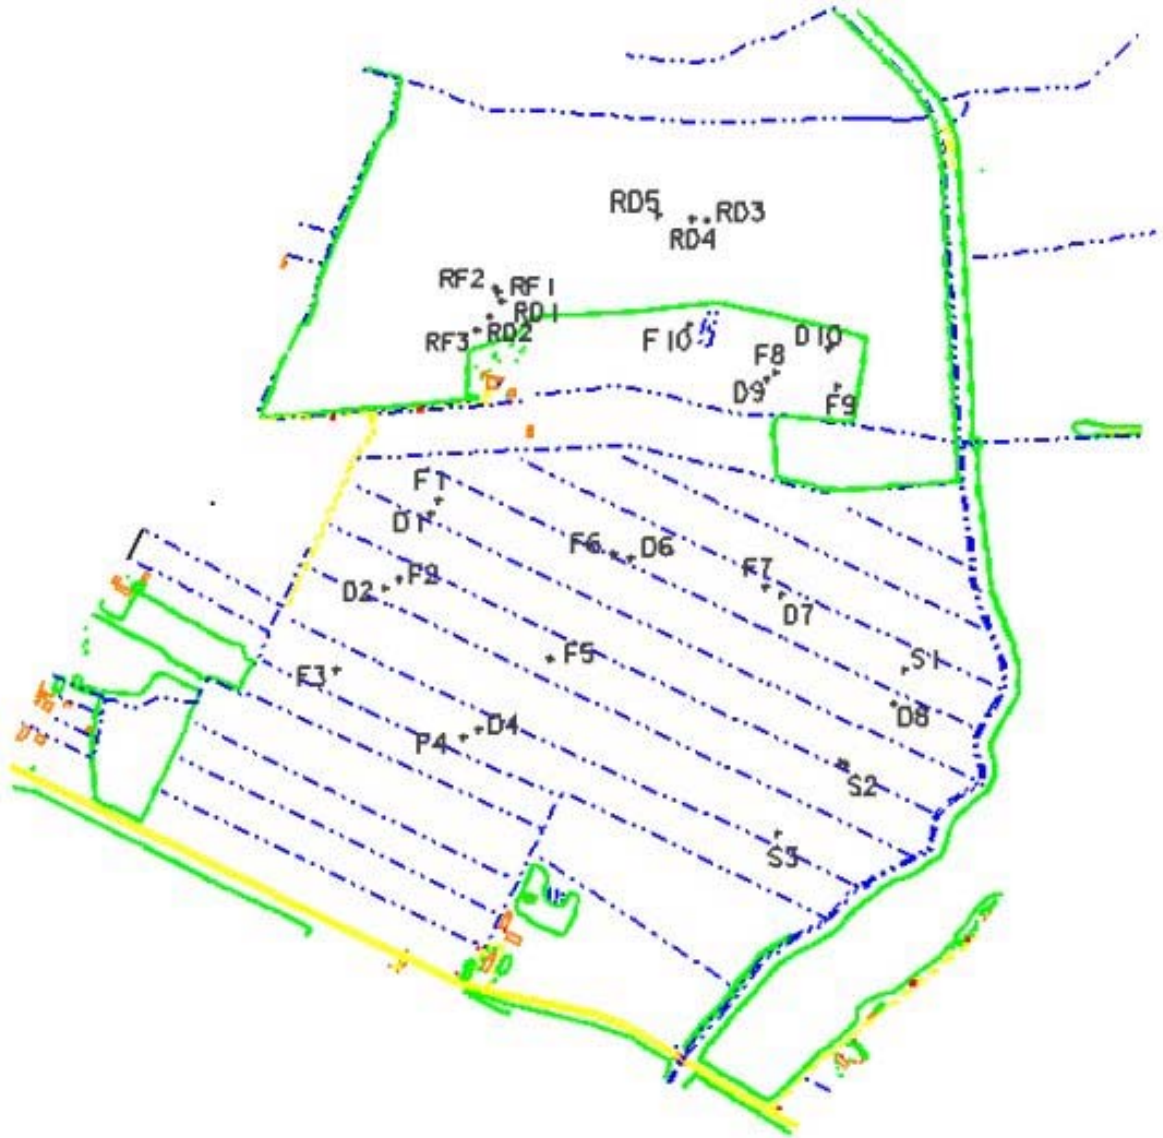
Figure 2: Monitoring Gauge Location Map

Following construction, 21 continuously monitored, groundwater gauges were placed in accordance with specifications in U.S. Corps of Engineers', Installing Monitoring Recorders/Piezometers in Wetlands (WRP Technical Note HY-IA-3.1, August 1993). Sixteen monitoring gauges were installed to provide representative coverage within each of the wetland physiographic landscape areas on the Site. In March and April 2002, 8 additional groundwater gauges were installed on site, 3 of those gauges were installed in the reference site. In addition, five monitoring gauges were placed within the reference wetland community located approximately 0.20 mile north of the Site. (Figure 2)

Micro-topographical features, such as semi-permanently inundated/saturated depressions and swales of various sizes, were created for the purpose of water storage as well as habitat diversity. Eleven gauges (D1, D2, D4, D6, D7, D8, D9, D10, S1, S2, and S3,) were placed within saturated depressions, while nine gauges (F1, F2, F3, F4, F5, F6, F7, F8, and F9) were placed in non-depressional areas throughout the Site at base elevation. Eight gauges were placed in similar landscape positions within the reference community.

Gauges RD1, RD2, RD3, RD4, and RD5 were placed in depressions while gauges RF1, RF2, and RF3 were placed at base elevation.

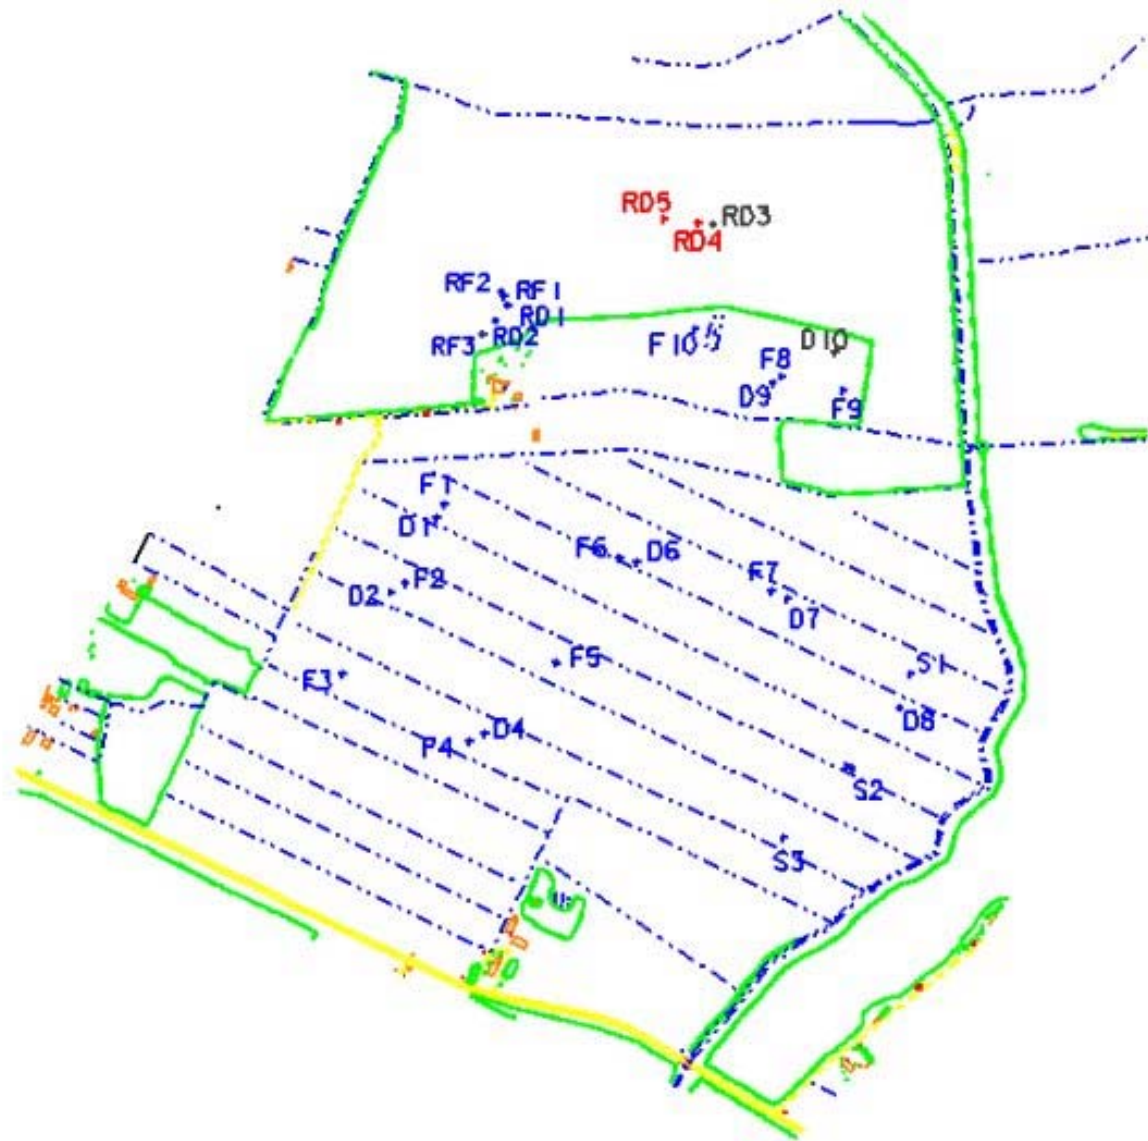
Figure 3: 2002 Hydrologic Monitoring Results

For the 2002 monitoring year, groundwater data indicates that the average wetland hydroperiod (for consecutive days) 25 of the 29 gauges (on-site and reference) exceeds the success criteria of 12.5%. Of these 29 gauges, 21 on-site groundwater gauges indicate that wetland hydroperiod exceeded the 12.5% jurisdictional threshold. Five of the 8 reference groundwater gauges exceeded the success criteria of 12.5%. Overall, on-site gauges exhibited similar results or exceed saturation periods with gauges in the reference community.

Hydrologic data indicate that the Site met or exceeded wetland jurisdictional status for the 2002-monitoring year. Twenty-five of the 29 gauges (both on-site and reference) exceeded 12.5% of the growing season. Gauges RD4 and RD5 exceeded the forecast 8% of the growing season and gauges D10 and RD3 fell below the 5% saturation. In addition, rainfall amounts were below average for the 2002-growing season. A good indication that the Site should be considered successful is that wetland hydroperiod for the Site is similar or exceeds that of reference wetland.

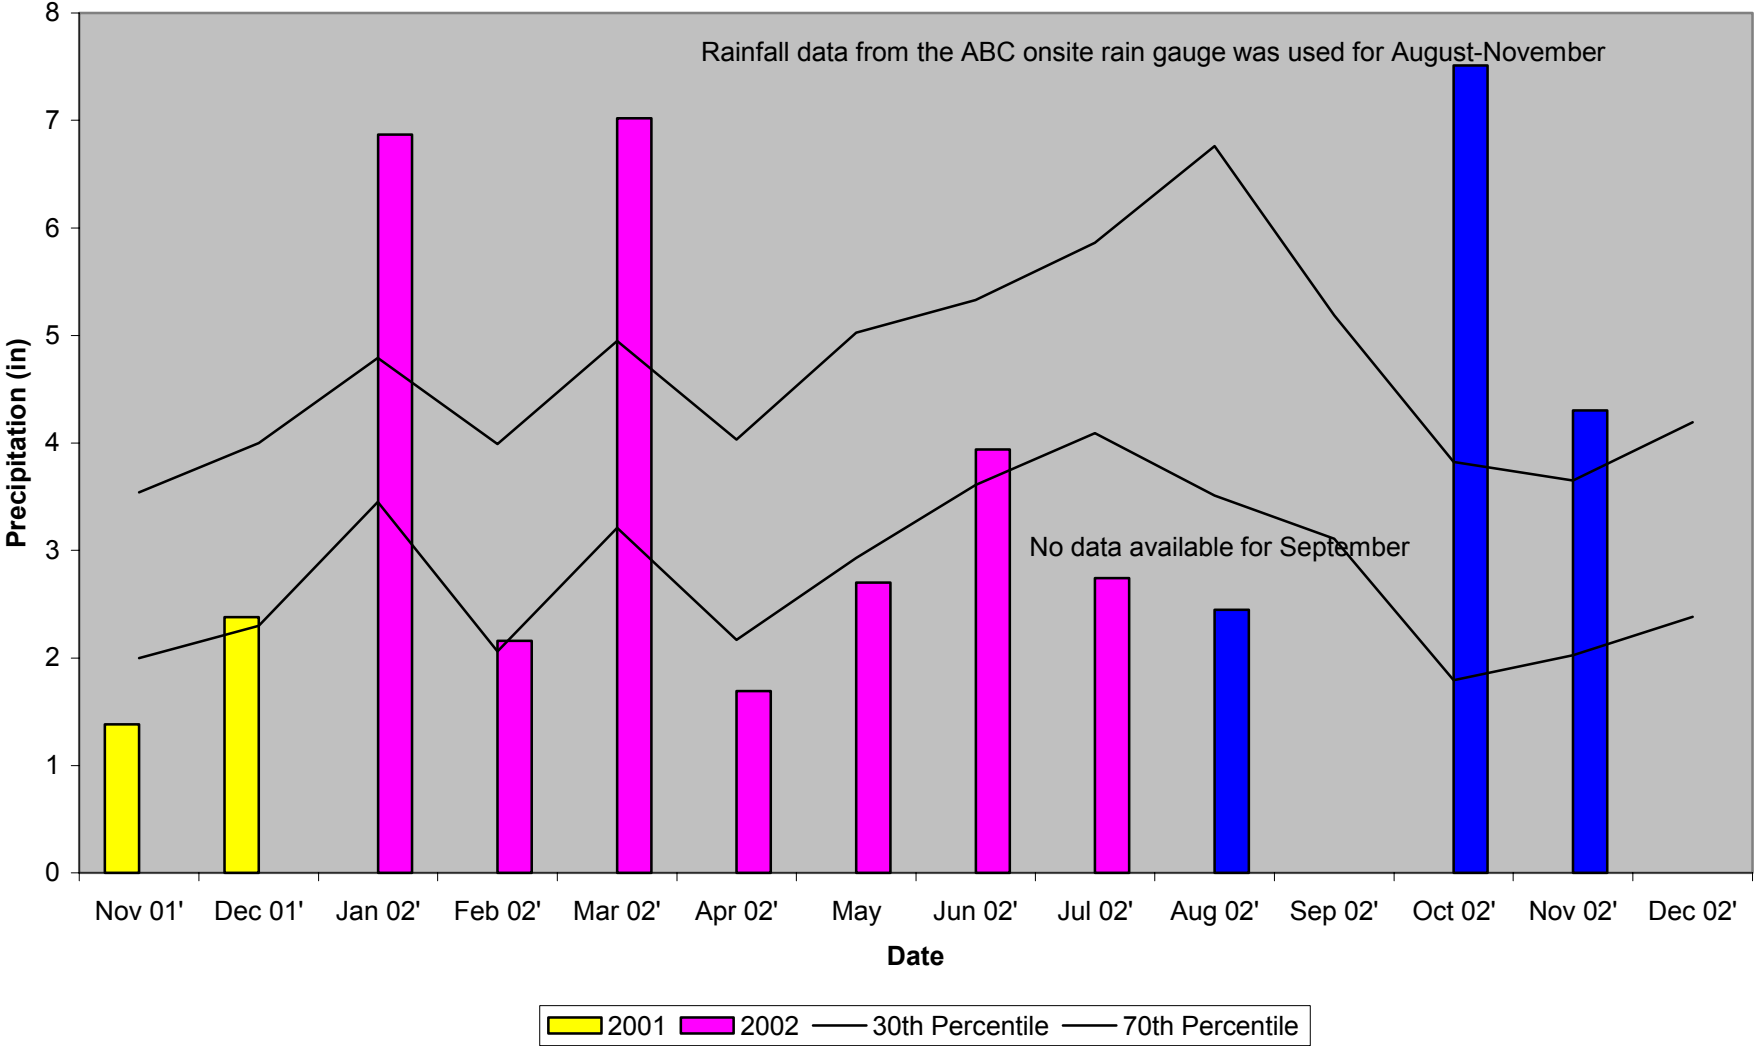
Figure 4: 30-70 Percentile Graph

The majority of this Site is characterized as a precipitation driven system and wetland hydroperiod is completely dependent upon local weather patterns. Figure 4 is a comparison of monthly rainfall for the period of November 2001 through November 2002 to historical precipitation (collected between 1971 and 2002) for Washington, North Carolina. Rainfall data from the Washington rain gauge was not available for months of August-November. For these particular months, the onsite rain gauge at ABC site was used for the monthly rainfall. This comparison gives an indication of how 2002 relates to historical data in terms of climate conditions. The NC State Climate Office provided all off-site data.

For the 2002-year, November 01, February, April, May, July, and August experienced below average rainfall. The months of December 01 and June all recorded average rainfall for the site. January, March, October, and November experienced above average rainfall. No data is available for the month of September. Overall, 2002 experienced a below average rainfall year.

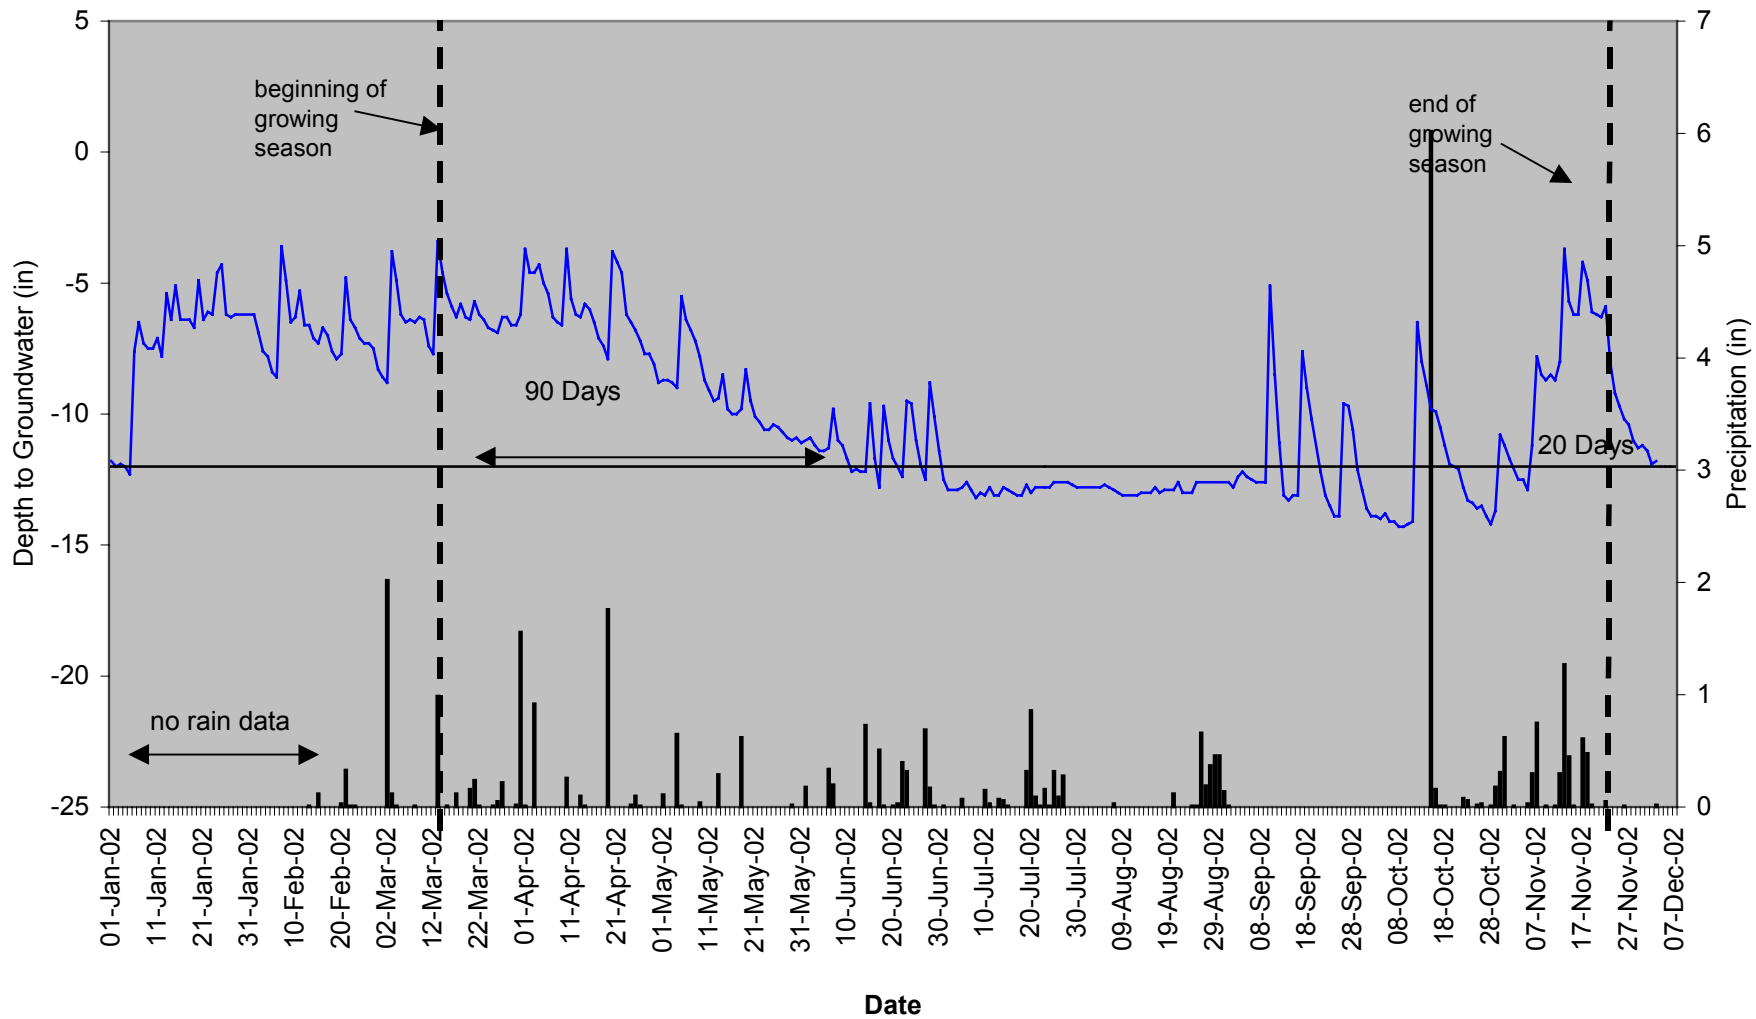
ABC S1

Appendix A contains a plot of the groundwater depth for each monitoring gauge. The maximum number of consecutive days that the gauge met success above this 12-inch depth is noted on each graph. Data determined to be erroneous was omitted; therefore, some gaps appear in the plots.

Precipitation events are included on each graph as bars. The rainfall plotted was obtained from the on-site Infinity rain gauge.

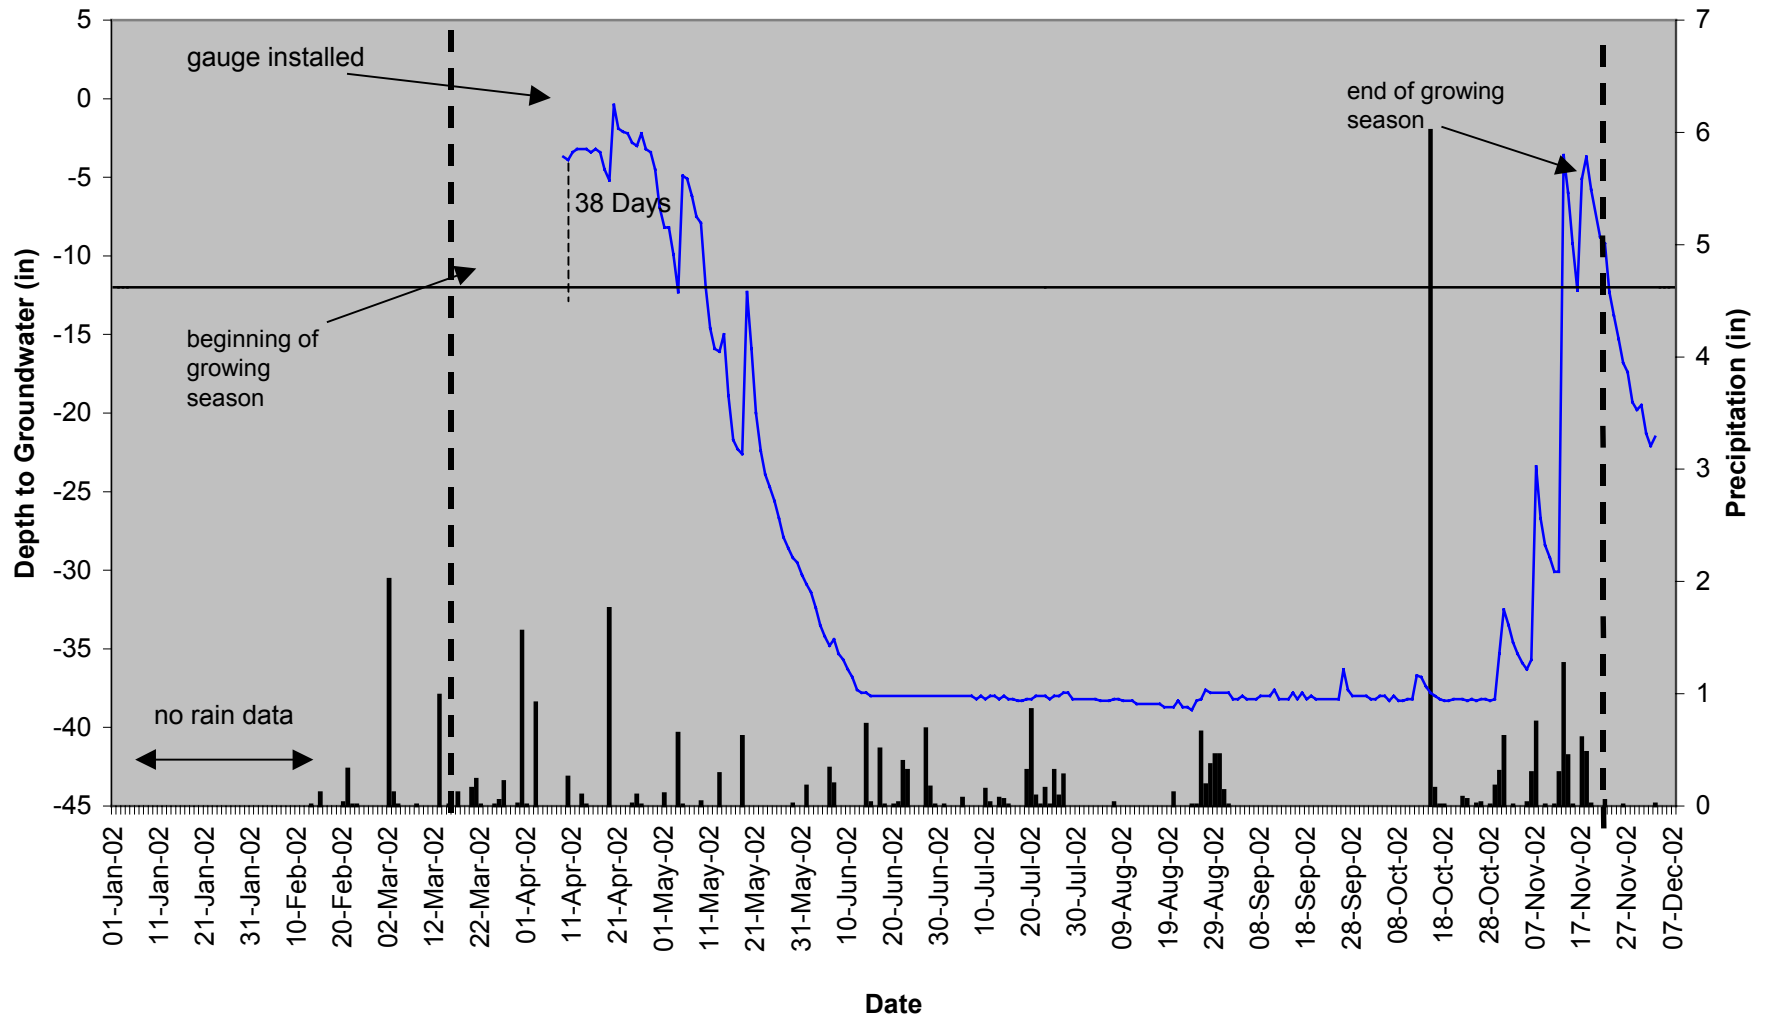
ABC F10

- F10 experienced gauge malfunctions during installation of the gauge (March 13-April 8)
- RF2 stopped recording data (May 9-July 11)
- RD2 stopped recording data (May 18-July 11)
- RD1, RD3 experienced gauge malfunctions at the end of the growing season from (November 1-December)
- RD3, RD4, RD5 were all installed April 3, therefore no data was recorded for these gauges until after installation.
- RD5 stopped recording data (June 19-July 11)

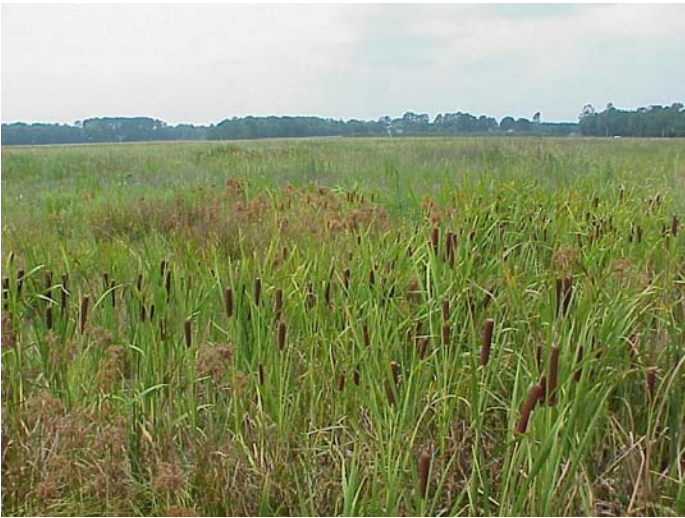
Photo 9 (Swale)

Zone 2: Other species noted: smartweed, foxtail, fennel, *Aster* sp., ragweed, *Juncus* sp., and *Scirpus* sp. Cattails and standing water were noted in the swales.
