ANNUAL REPORT FOR 2003

**ABC Wetland Mitigation Site
Beaufort County
Project No. 8.T221801
TIP No. R-2510WM**

Prepared By:
Office of Natural Environment & Roadside Environmental Unit
North Carolina Department of Transportation
December 2003

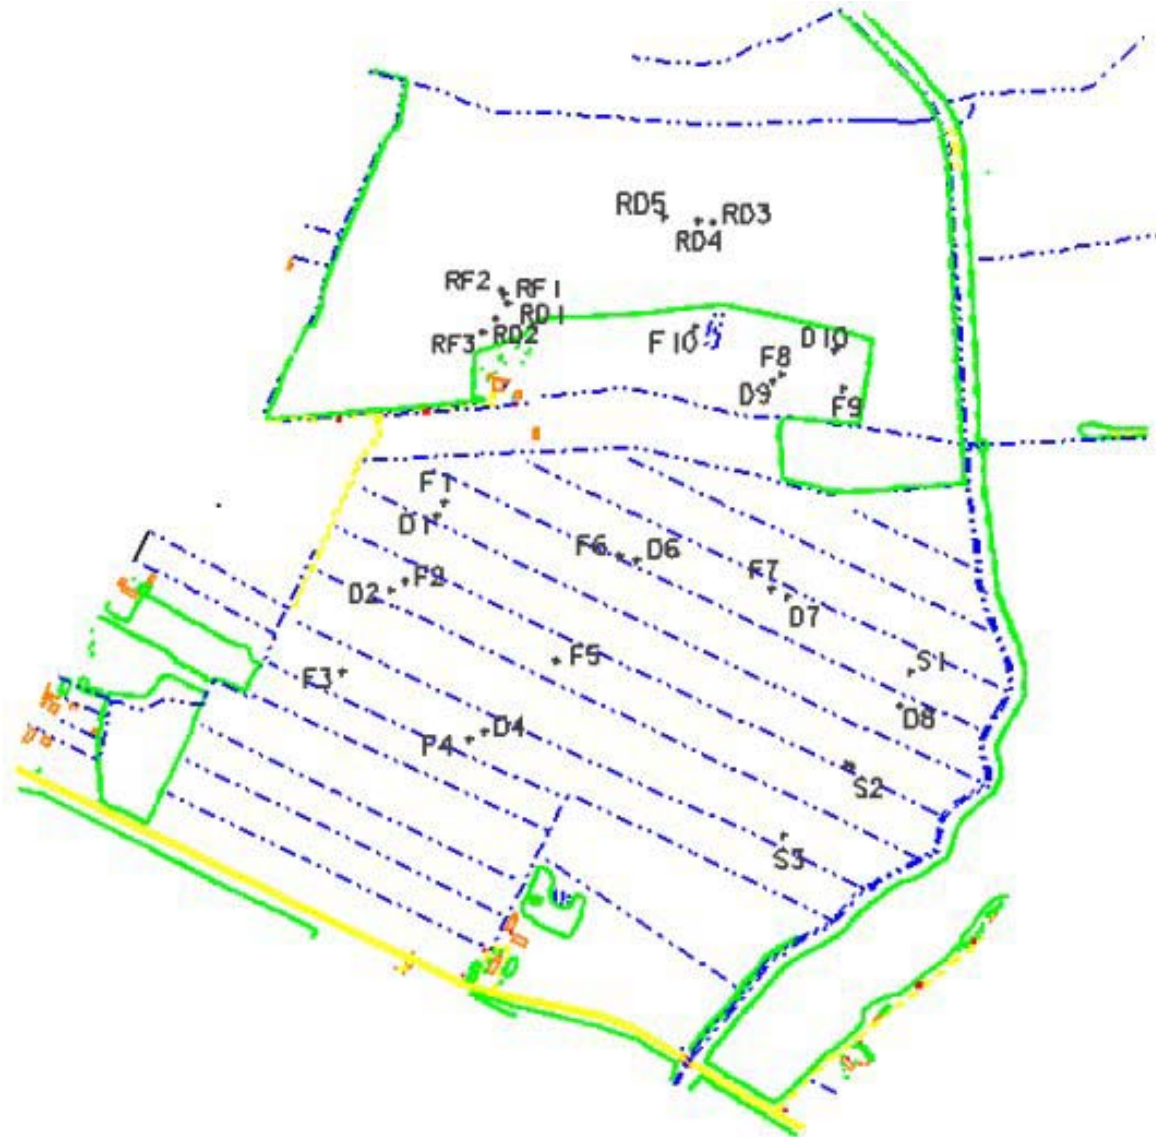
Figure 2. Monitoring Gauge Location Map

Following construction, twenty-one groundwater gauges were placed on the site in accordance with specifications in U.S. Army Corps of Engineers', Installing Monitoring Recorders/Piezometers in Wetlands (WRP Technical Note HY-IA-3.1, August 1993). Sixteen monitoring gauges were installed in 2001 to provide representative coverage within each of the wetland physiographic landscape areas on the site. In 2002, eight additional groundwater gauges were installed on site; three of those gauges were installed in the reference wetland. Currently, eight of the twenty-nine groundwater-gauges are located within the reference wetland, approximately 0.2 miles north of the mitigation site (Figure 2). The groundwater gauges record daily groundwater levels across the site. In addition, an onsite rain gauge records daily rainfall totals; this data is used to see how the groundwater table responds to rainfall events.

Micro-topographical features, such as semi-permanently inundated/saturated depressions and swales of various sizes, were created for the purpose of water storage as well as habitat diversity. Eleven gauges (D1, D2, D4, D6, D7, D8, D9, D10, S1, S2, and S3) were placed within saturated depressions, while nine gauges (F1, F2, F3, F4, F5, F6, F7, F8, and F9) were placed in non-depressional areas throughout the site at ground elevation. Eight gauges were placed in similar landscape positions within the reference community. Reference gauges RD1, RD2, RD3, RD4, and RD5 were placed in depressions while gauges RF1, RF2, and RF3 were placed at base elevation.

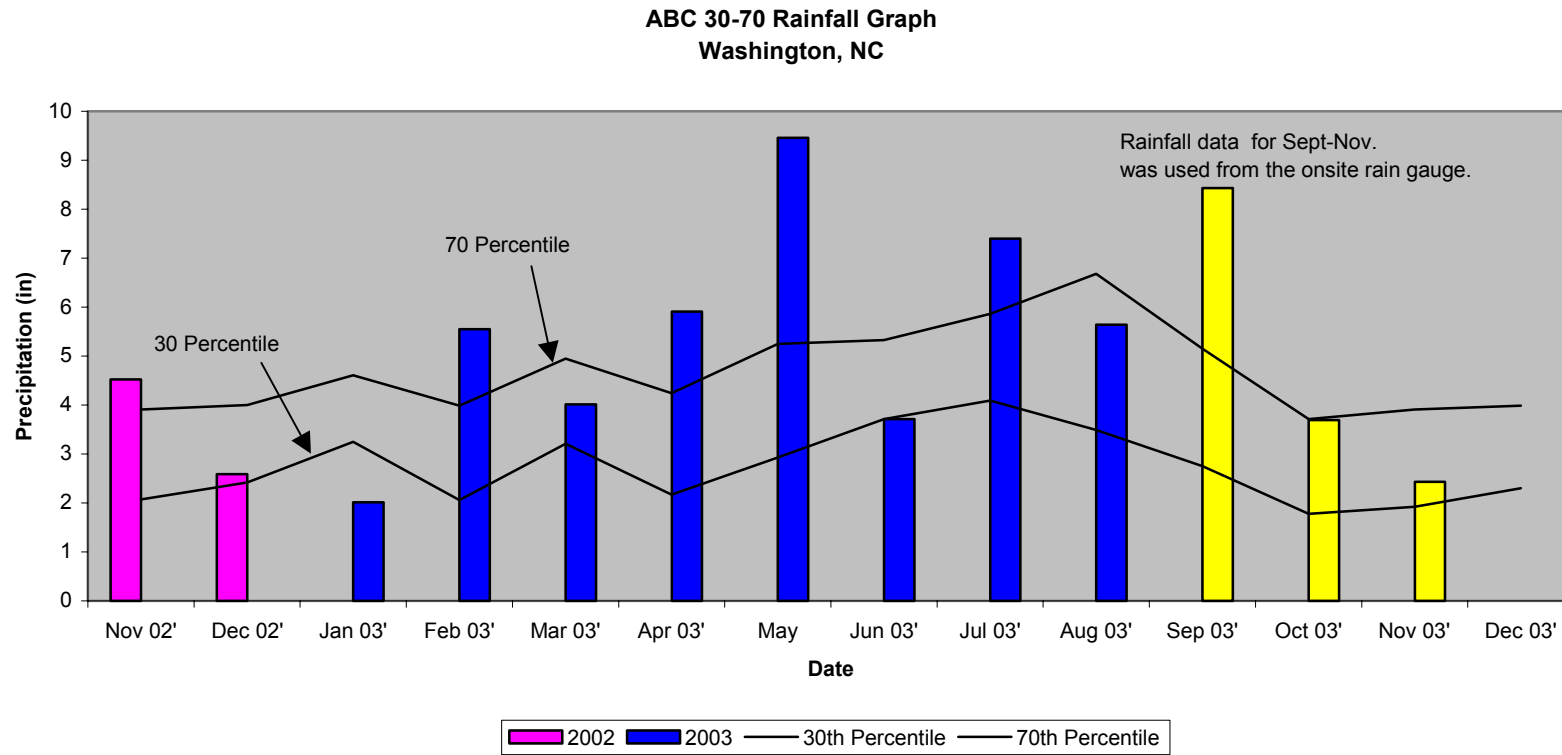
Figure 4. 30-70 Percentile Graph

The majority of the ABC Site is characterized as a precipitation driven system; the wetland hydroperiod is completely dependent upon local weather patterns. Figure 4 is a comparison of monthly rainfall for the period of November 2002 through November 2003 to historical precipitation (collected between 1972 and 2003) for Washington, North Carolina. The rainfall data for September-November 2003 was collected from the onsite rain gauge. This comparison gives an indication of how 2003 relates to historical data in terms of climate conditions. The NC State Climate Office provided all local rainfall information.

For the 2003-year, November (02'), February, April, May, July, and September experienced above average rainfall. The months of January and June recorded below average rainfall for the site. December (02'), March, August, October, and November experienced average rainfall. Overall, 2003 experienced an average rainfall year.

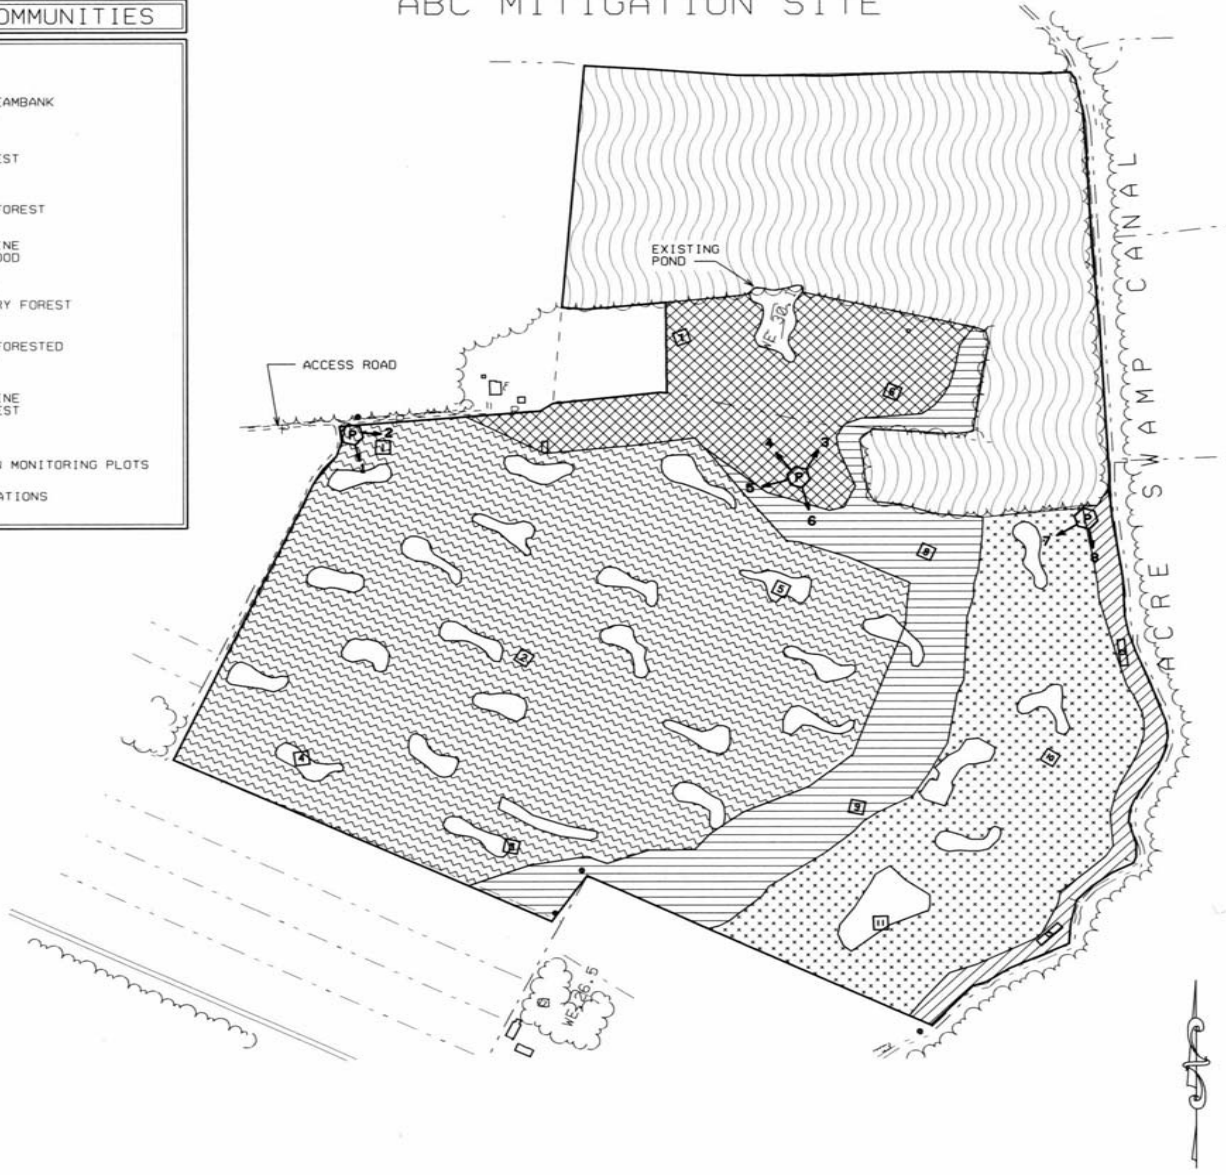
ABC MITIGATION SITE

PLANT COMMUNITIES

VEGETATION MONITORING PLOTS

PHOTO LOCATIONS
