MITIGATION PLAN

ALEXANDER FARM MITIGATION SITE

Alexander County, NC
NCDEQ Contract No. 7416
DMS Project No. 100048

Catawba River Basin
HUC 03050101

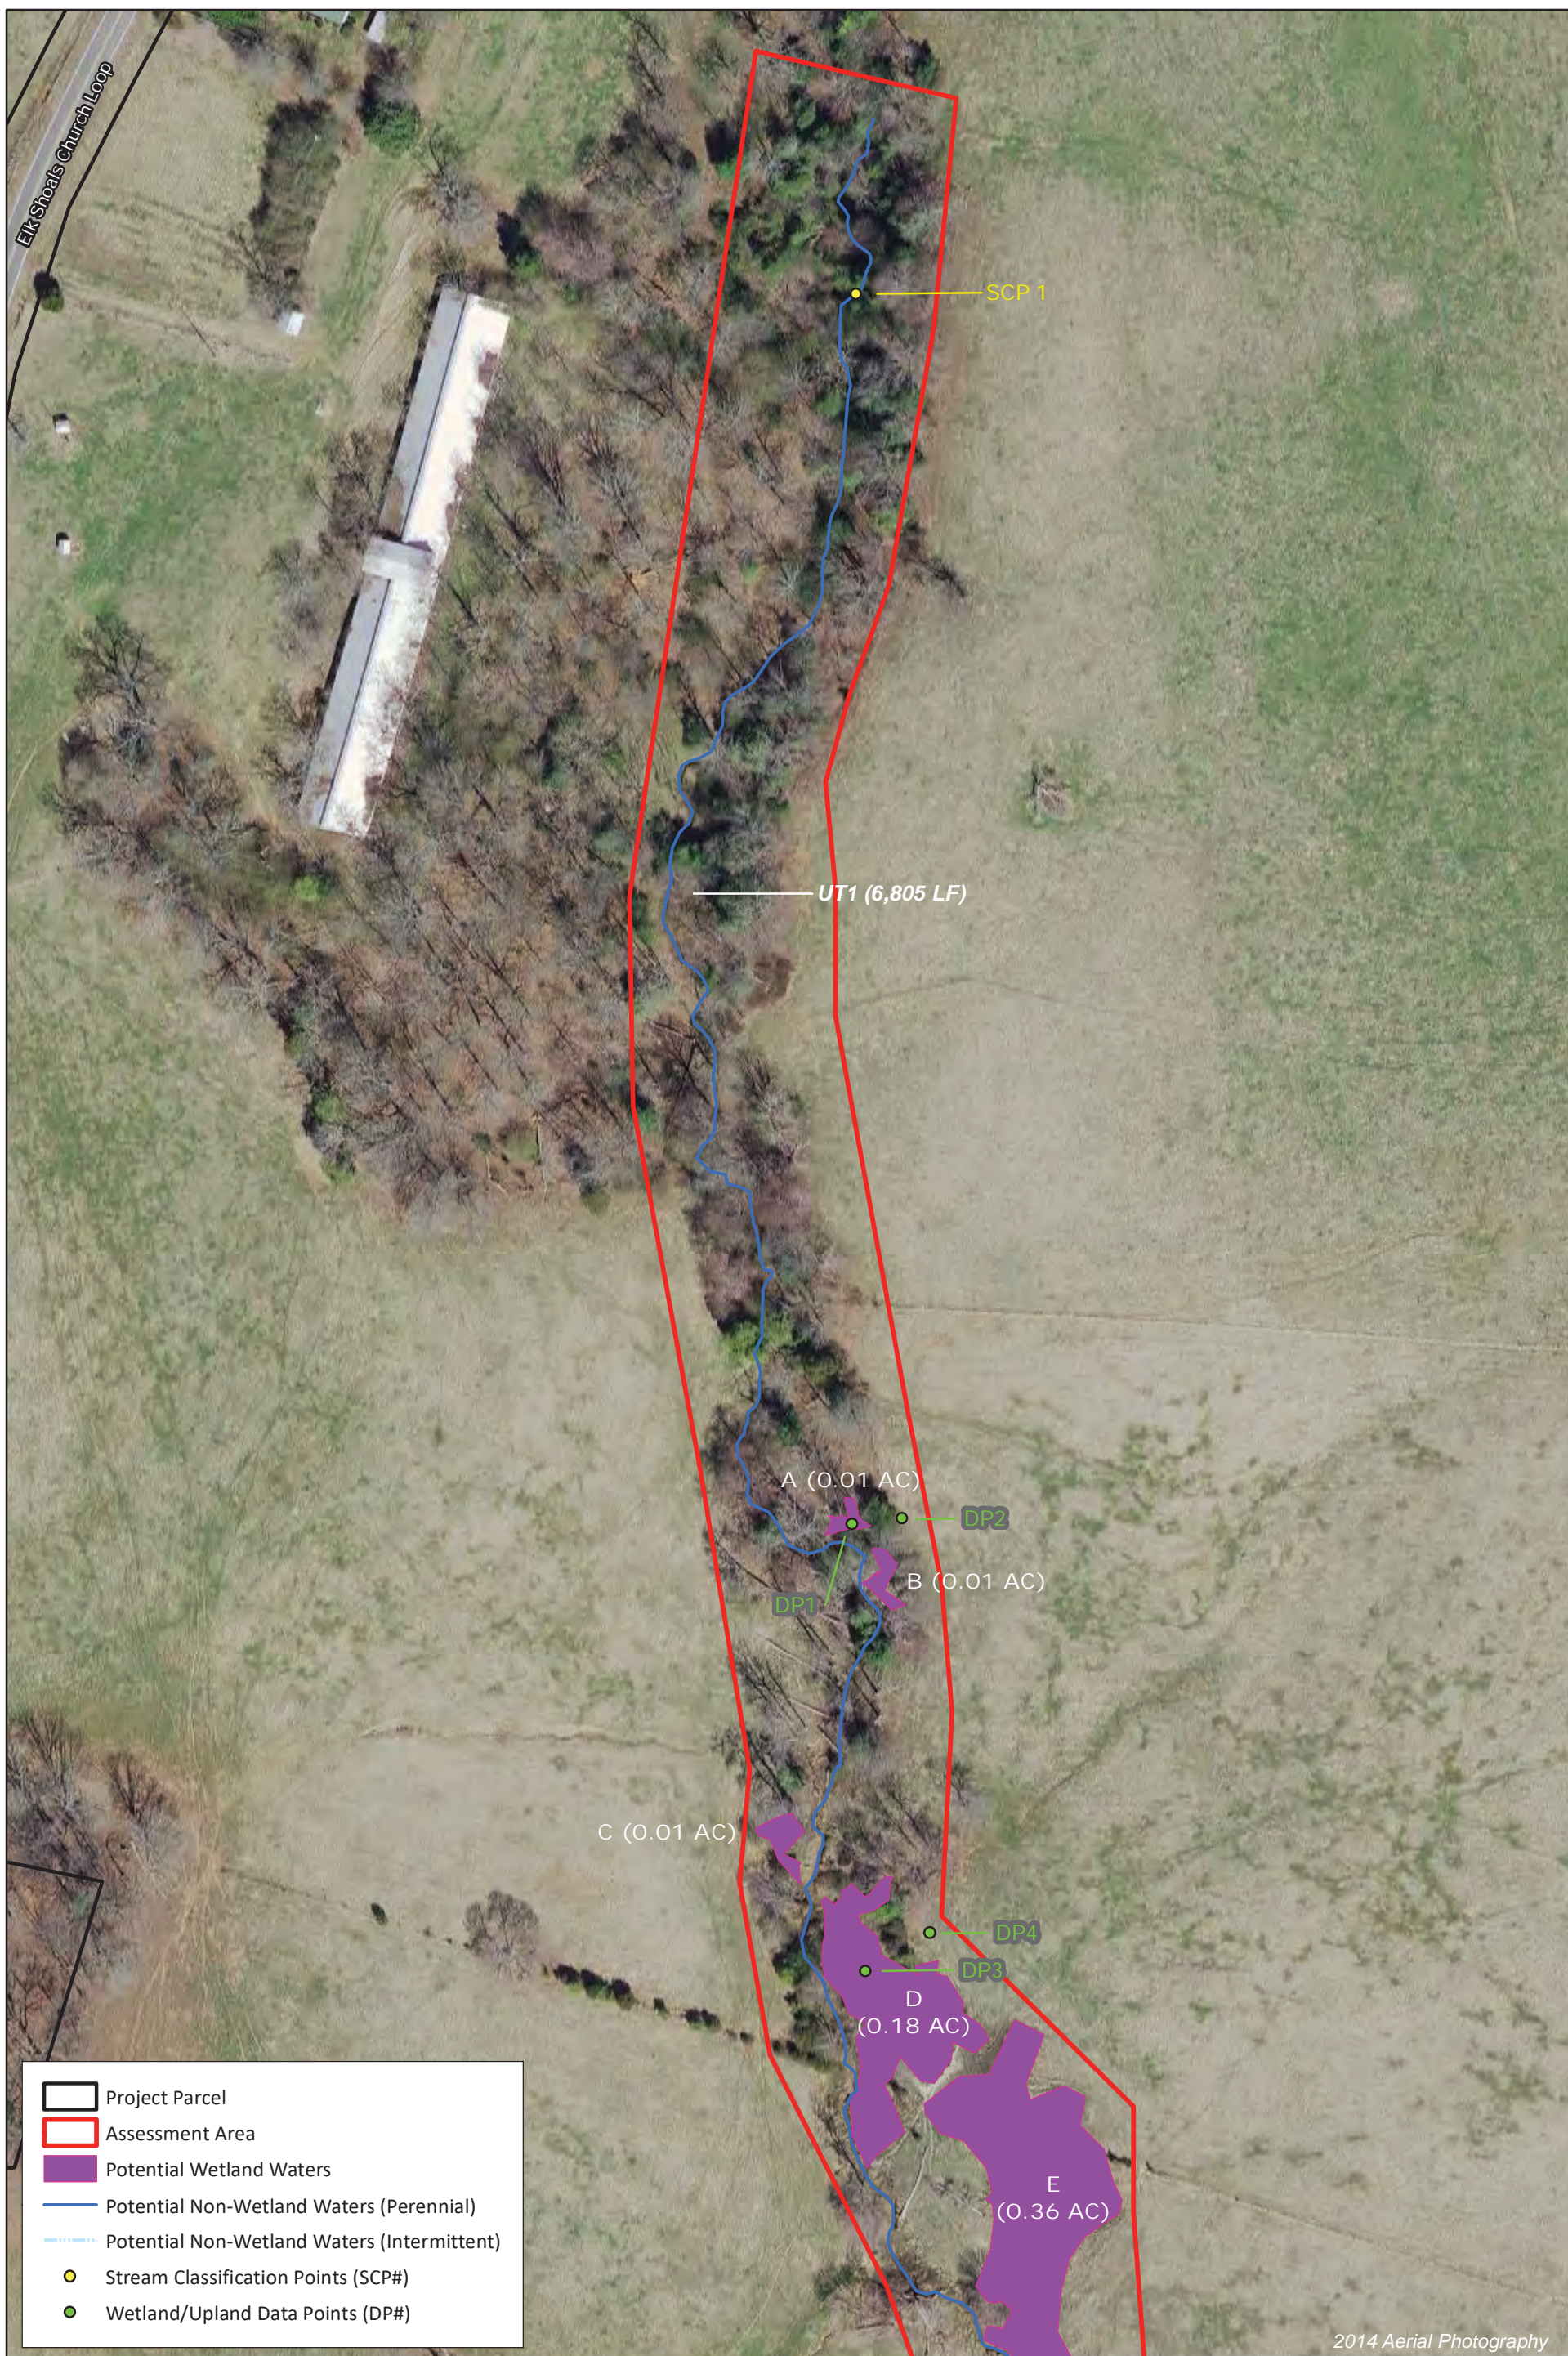
2014 Aerial Photography

- Project Parcel
- Assessment Area
- Potential Wetland Waters
- Potential Non-Wetland Waters (Perennial)
- Potential Non-Wetland Waters (Intermittent)
- Stream Classification Points (SCP#)
- Wetland/Upland Data Points (DP#)

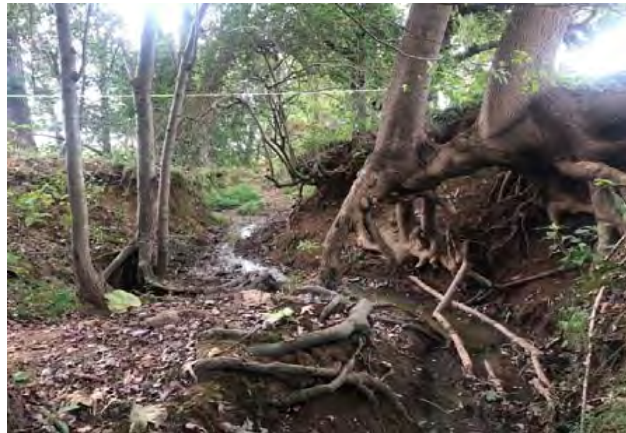
Cross-Section Plots Alexander Farm

4.0	x-section area (ft.sq.)
5.3	width (ft)
0.7	mean depth (ft)
1.0	max depth (ft)
6.2	wetted perimeter (ft)
0.6	hydraulic radius (ft)
7.2	width-depth ratio

Survey Date: 09/2018
 Field Crew: Wildlands Engineering

View Downstream

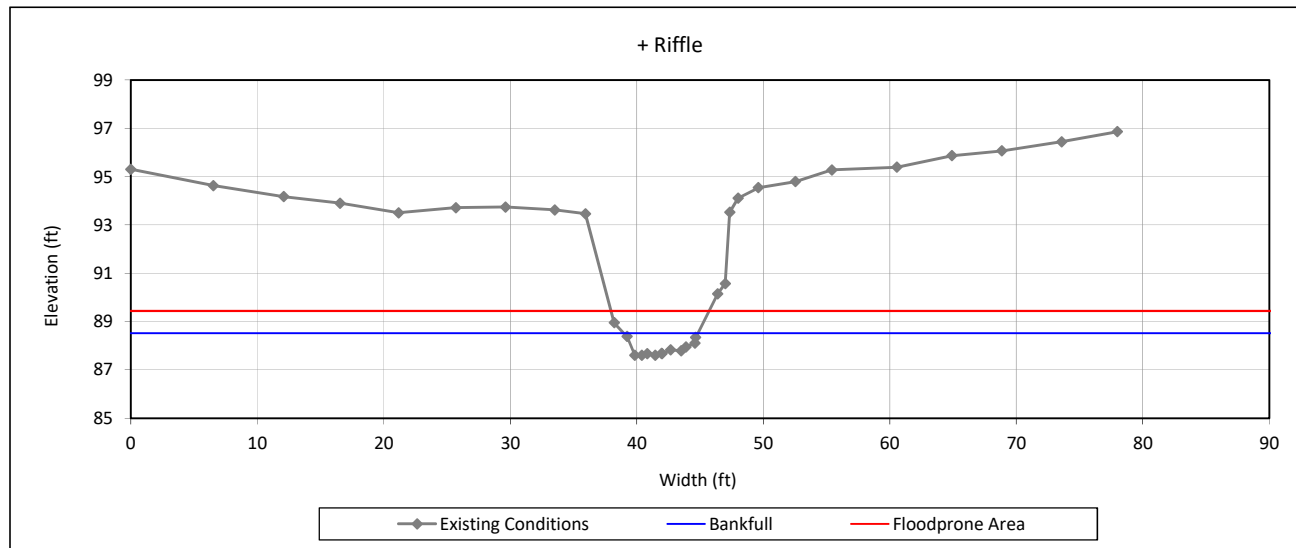
Cross-Section XS 2 - UT1 Reach 1B

Bankfull Dimensions

4.0	x-section area (ft.sq.)
5.8	width (ft)
0.7	mean depth (ft)
0.9	max depth (ft)
6.6	wetted perimeter (ft)
0.6	hydraulic radius (ft)
8.5	width-depth ratio
7.4	W flood prone area (ft)
1.3	entrenchment ratio
6.4	low bank height ratio

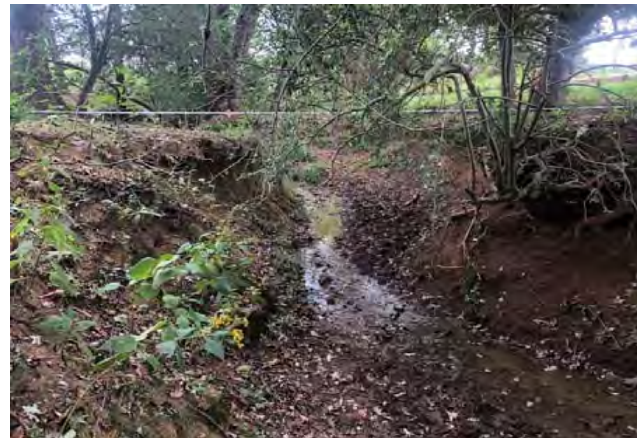
Cross-Section Plots Alexander Farm

Survey Date: 08/2018

View Downstream

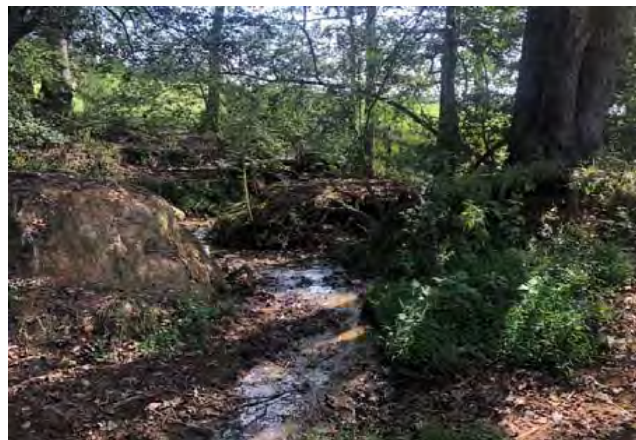
Cross-Section Plots Alexander Farm
 Mitigation Site NCDMS Project No.
 100048 Existing Conditions - 2018

- 4.4 x-section area (ft.sq.)
- 7.2 width (ft)
- 0.6 mean depth (ft)
- 0.8 max depth (ft)
- 7.8 wetted perimeter (ft)
- 0.6 hydraulic radius (ft)
- 12.0 width-depth ratio
- 8.2 W flood prone area (ft)
- 1.1 entrenchment ratio
- 5.9 low bank height ratio

Survey Date: 08/2018
Field Crew: Wildlands Engineering

View Downstream

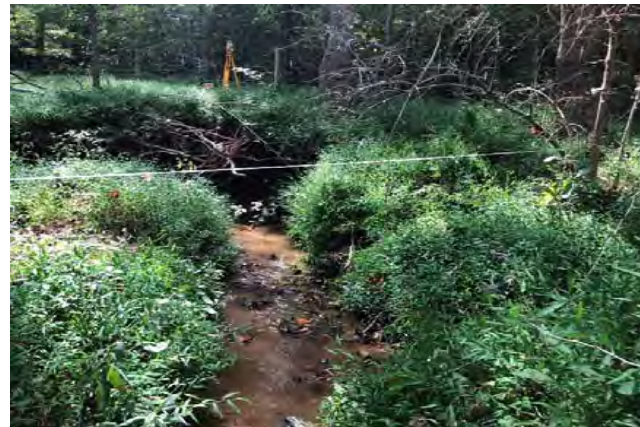
Cross-Section Plots Alexander Farm

8.8	x-section area (ft.sq.)
9.1	width (ft)
1.0	mean depth (ft)
1.9	max depth (ft)
10.3	wetted perimeter (ft)
0.9	hydraulic radius (ft)
9.4	width-depth ratio
27.4	W flood prone area (ft)
3.0	entrenchment ratio
1.0	low bank height ratio

Survey Date: 08/2018
 Field Crew: Wildlands Engineering

View Downstream

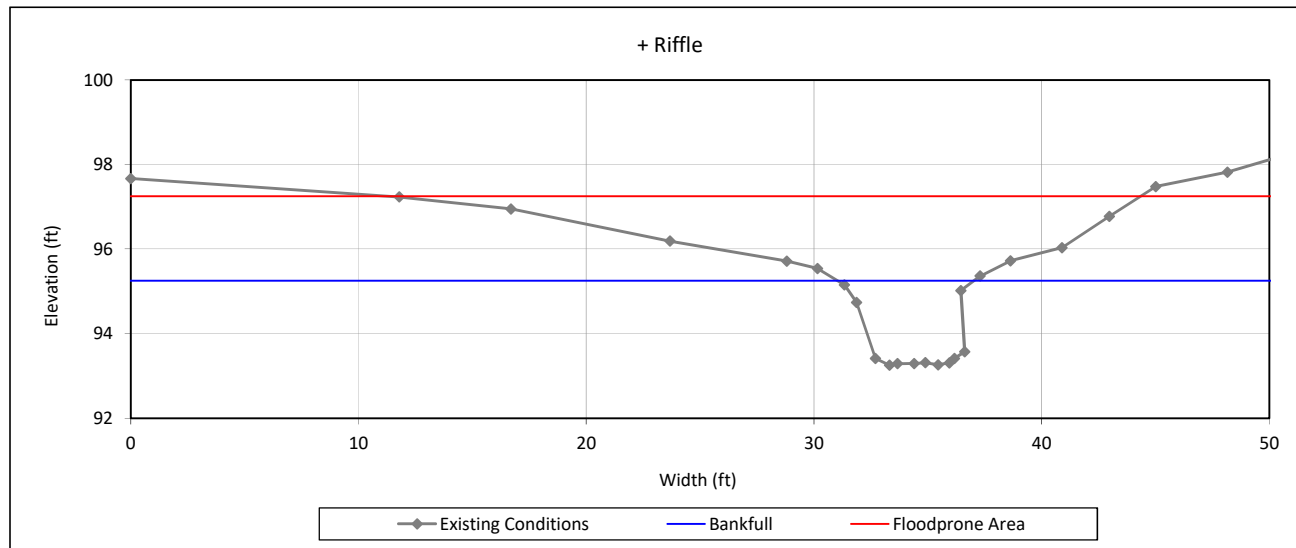
Cross-Section XS 5 - UT1 Reach 4A

Bankfull Dimensions

8.6	x-section area (ft.sq.)
6.0	width (ft)
1.4	mean depth (ft)
2.0	max depth (ft)
8.6	wetted perimeter (ft)
1.0	hydraulic radius (ft)
4.1	width-depth ratio
54.0	W flood prone area (ft)
9.1	entrenchment ratio
2.1	low bank height ratio

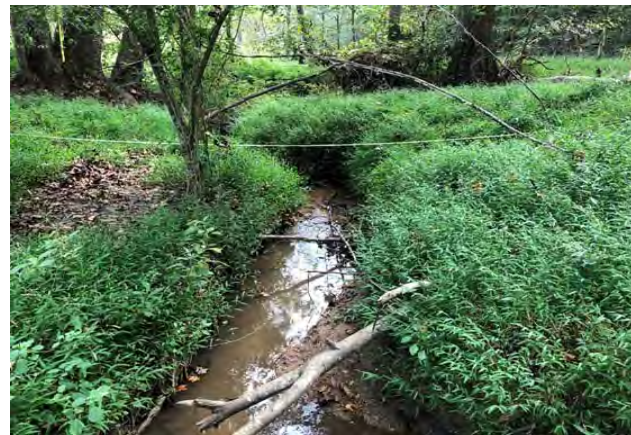
Cross-Section Plots Alexander Farm
 Mitigation Site NCDMS Project No.
 100048 Existing Conditions - 2018

Survey Date: 08/2018

View Downstream

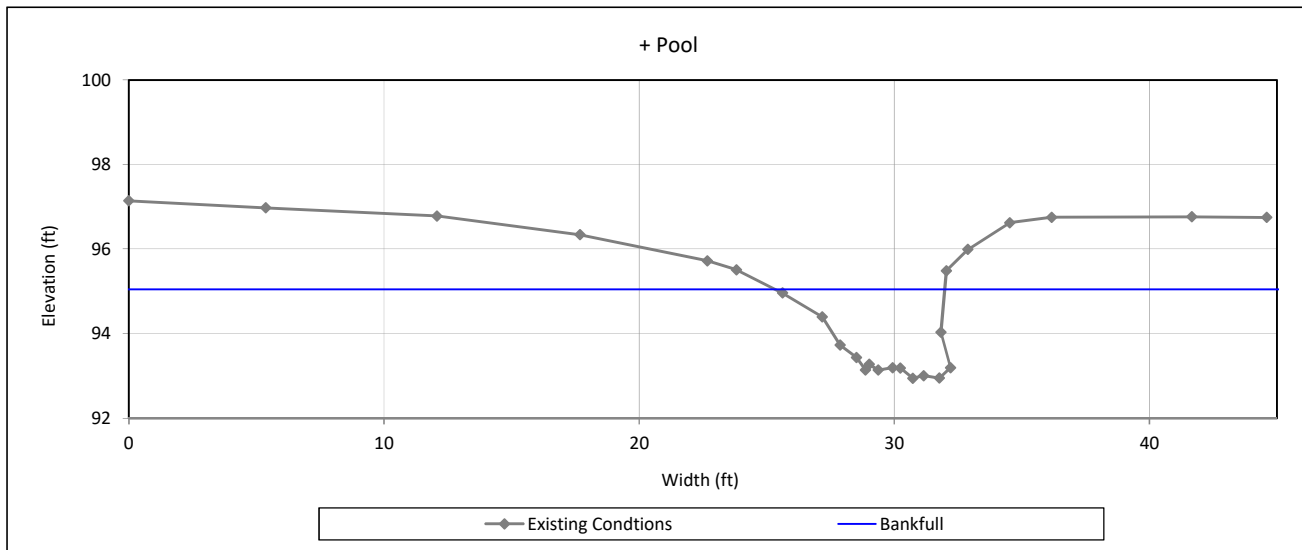
Cross-Section XS 6 - UT1 Reach 4A

Bankfull Dimensions

8.9	x-section area (ft.sq.)
6.6	width (ft)
1.3	mean depth (ft)
2.1	max depth (ft)
9.6	wetted perimeter (ft)
0.9	hydraulic radius (ft)
5.0	width-depth ratio

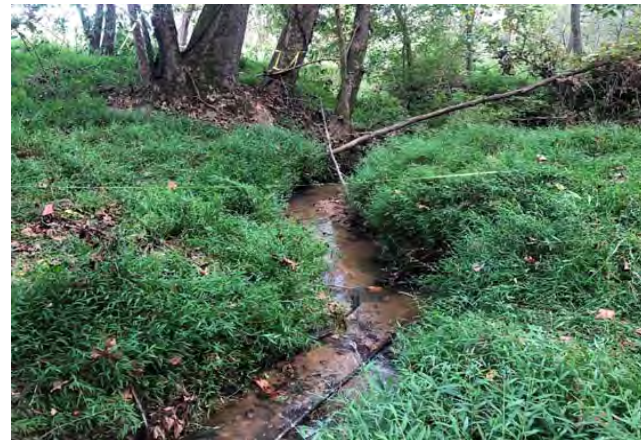
Cross-Section Plots Alexander Farm

Survey Date: 09/2018
 Field Crew: Wildlands Engineering

View Downstream

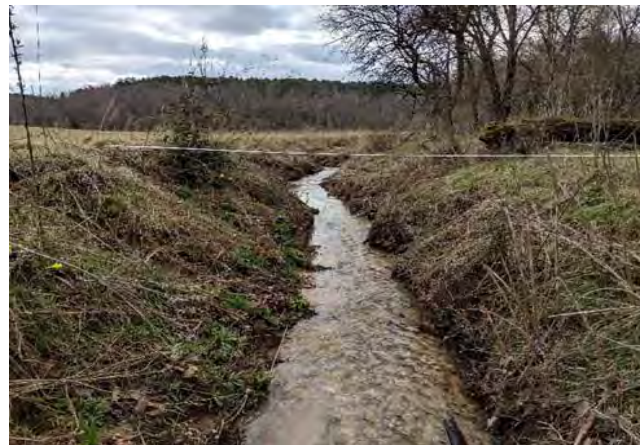
Cross-Section Plots Alexander Farm

10.3	x-section area (ft.sq.)
8.6	width (ft)
1.2	mean depth (ft)
2.0	max depth (ft)
10.0	wetted perimeter (ft)
1.0	hydraulic radius (ft)
7.2	width-depth ratio
15.4	W flood prone area (ft)
1.8	entrenchment ratio
2.0	low bank height ratio

Survey Date: 09/2018
Field Crew: Wildlands Engineering

View Downstream

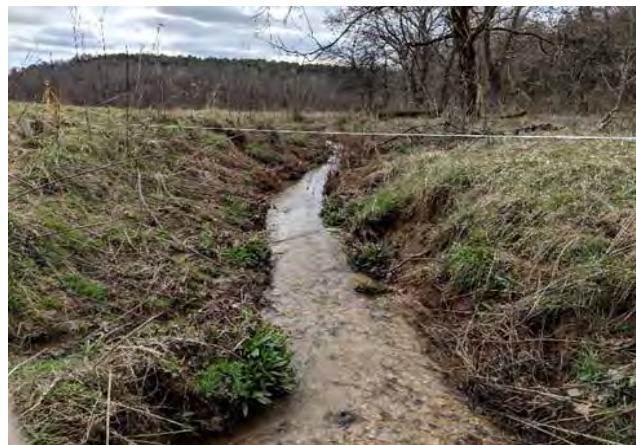
10.1	x-section area (ft.sq.)
8.2	width (ft)
1.2	mean depth (ft)
2.1	max depth (ft)
9.6	wetted perimeter (ft)
1.1	hydraulic radius (ft)
6.6	width-depth ratio
16.5	W flood prone area (ft)
2.0	entrenchment ratio
2.1	low bank height ratio

Survey Date: 09/2018
Field Crew: Wildlands Engineering

View Downstream
