FINAL
AS-BUILT BASELINE
MONITORING REPORT (MY0)

ALLIANCE HEADWATERS MITIGATION SITE
Johnston County, North Carolina

NCDEQ Contract No. 6832
DWR ID No. 20160405
DMS ID No. 97086
USACE Action ID No. SAW-2016-00882
RFP No. 16-006477

Neuse River Basin
HUC 03020201

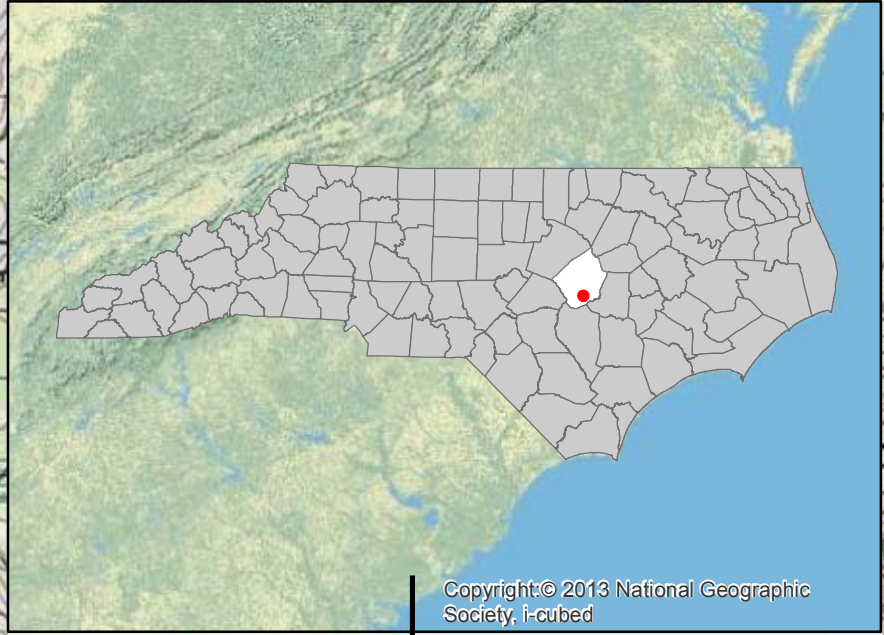
Figure 1. Project Location
Figures 2 & 2A-2B. Current Conditions Plan View
Vegetation Plot Photographs

The Alliance Headwaters Mitigation Site (Site) is in Johnston County, approximately six miles southeast of Four Oaks and one mile east of US 701 (Figure 1, Appendix A). The project is located within NC Division of Mitigation Services (DMS) targeted watershed for the Neuse River Basin

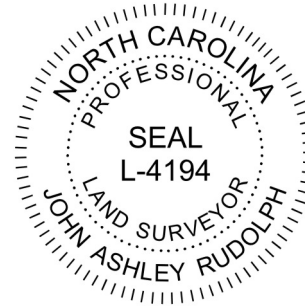
Baseline	As needed		
Avg. Water Surface Slope	0.0049			
Rifle Length	29			
Avg. Rifle Slope	0.0101			
Pool Length	11

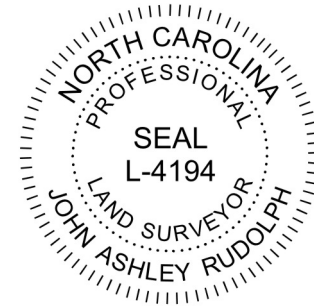
Baseline	As needed		
Avg. Water Surface Slope	0.0049			
Riffle Length	29			
Avg. Riffle Slope	0.0101			
Pool Length	11

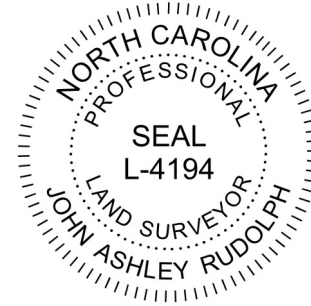
Baseline	As needed		
Avg. Water Surface Slope	0.0028			
Riffle Length	30			
Avg. Riffle Slope	0.0062			
Pool Length	13

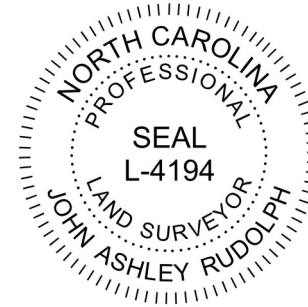
Baseline	As needed		
Avg. Water Surface Slope	0.0028			
Riffle Length	30			
Avg. Riffle Slope	0.0062			
Pool Length	13

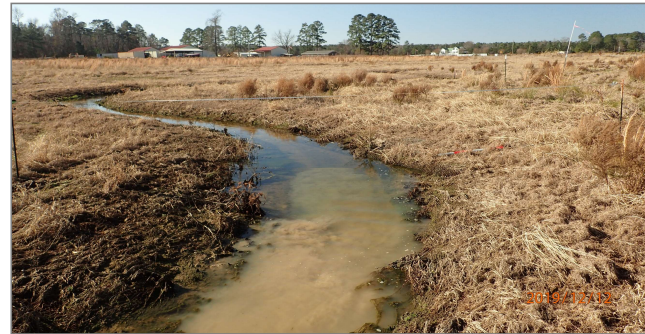
Site	Alliance Headwaters
Watershed:	Neuse River, 03020201
XS ID	UT 1 Reach 3, XS - 1
Feature	Pool
Date:	12/12/2019
Field Crew:	Perkinson, Keith

Station	Elevation
0.0	104.35
1.9	104.34
3.2	104.38
4.8	104.10
6.4	103.98
8.3	103.57
9.0	103.50
9.8	103.13
10.4	102.95
10.8	102.73
11.4	102.32
12.0	102.05
12.9	102.03
13.5	102.06
14.0	102.23
14.6	102.25
15.2	102.29
16.0	102.64
16.5	102.90
17.2	102.89
17.7	102.87
18.3	103.15
19.4	103.43
20.3	103.73
22.0	103.94
23.4	103.96
27.0	104.07

SUMMARY DATA	
Bankfull Elevation:	103.9
Bankfull Cross-Sectional Area:	14.5
Bankfull Width:	15.4
Flood Prone Area Elevation:	NA
Flood Prone Width:	NA
Max Depth at Bankfull:	1.9
Low Bank Height:	1.9
Mean Depth at Bankfull:	0.9
W / D Ratio:	NA
Entrenchment Ratio:	NA
Bank Height Ratio:	1.0

Stream Type C5

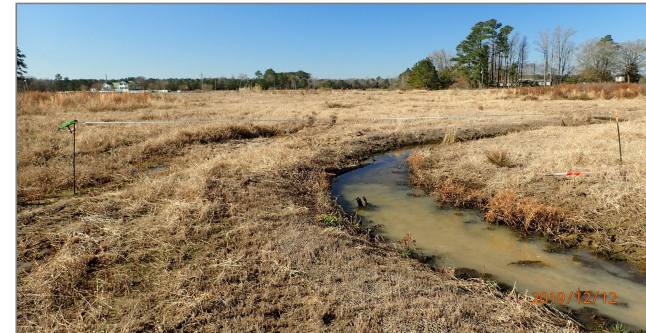
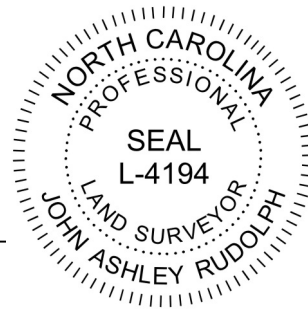
Site	Alliance Headwaters
Watershed:	Neuse River, 03020201
XS ID	UT 1 Reach 3, XS - 2
Feature	Pool
Date:	12/12/2019
Field Crew:	Perkinson, Keith

Station	Elevation
0.0	104.87
2.0	104.88
3.4	104.88
4.5	104.88
5.7	104.65
7.0	104.35
8.0	104.04
8.3	104.04
9.8	104.05
10.6	103.53
10.9	103.58
12.1	103.12
13.0	103.12
13.8	102.82
14.5	102.84
15.1	102.54
15.5	102.57
16.3	103.13
17.2	103.13
17.6	103.61
18.4	103.99
19.2	104.24
19.9	104.36
20.8	104.87
22.8	105.24
24.8	105.29
27.3	105.11
30.0	105.11
30.2	104.95

SUMMARY DATA	
Bankfull Elevation:	104.9
Bankfull Cross-Sectional Area:	18.5
Bankfull Width:	16.4
Flood Prone Area Elevation:	NA
Flood Prone Width:	NA
Max Depth at Bankfull:	2.3
Low Bank Height:	2.3
Mean Depth at Bankfull:	1.1
W / D Ratio:	NA
Entrenchment Ratio:	NA
Bank Height Ratio:	1.0

Stream Type C5

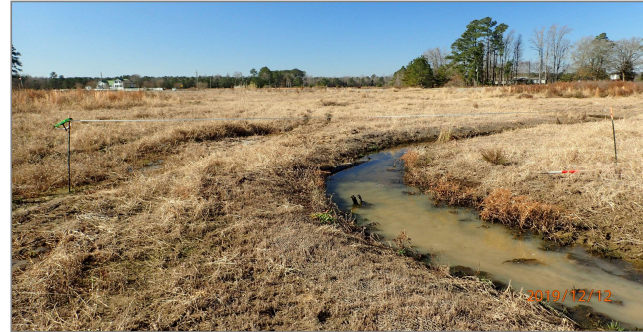
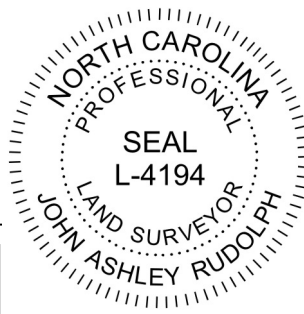
Site	Alliance Headwaters
Watershed:	Neuse River, 03020201
XS ID	UT 1 Reach 3, XS - 3
Feature	Riffle
Date:	12/12/2019
Field Crew:	Perkinson, Keith

Station	Elevation
0.0	105.69
3.4	105.75
7.3	105.75
8.8	105.77
9.9	105.83
10.8	105.23
11.6	105.26
12.4	104.92
12.9	104.92
13.7	104.95
13.9	104.58
14.4	104.61
15.3	104.58
15.8	104.46
16.4	104.32
16.9	104.32
17.0	104.61
18.2	104.86
18.6	104.89
20.0	105.35
20.5	105.71
21.3	105.8
22.5	105.7
25.2	105.8
27.7	105.8
29.9	105.6

SUMMARY DATA	
Bankfull Elevation:	105.7
Bankfull Cross-Sectional Area:	8.4
Bankfull Width:	10.4
Flood Prone Area Elevation:	107.1
Flood Prone Width:	100.0
Max Depth at Bankfull:	1.4
Low Bank Height:	1.4
Mean Depth at Bankfull:	0.8
W / D Ratio:	12.9
Entrenchment Ratio:	9.6
Bank Height Ratio:	1.0

Stream Type	C5
-------------	----

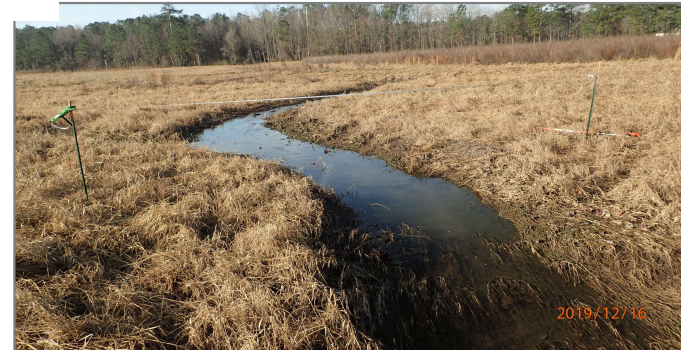
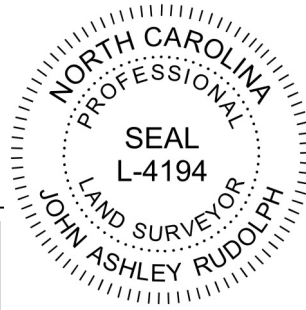
Site	Alliance Headwaters
Watershed:	Neuse River, 03020201
XS ID	UT 1 Reach 2, XS - 7
Feature	Pool
Date:	12/12/2019
Field Crew:	Perkinson, Keith

Station	Elevation
0.0	114.3
2.8	114.1
4.2	114.4
5.4	114.2
6.3	114.0
7.1	113.7
7.7	113.6
8.2	113.1
8.6	112.6
9.2	112.4
9.7	112.2
10.2	112.4
10.8	112.5
11.2	112.8
11.7	113.3
12.5	113.5
12.8	113.7
13.3	113.9
14.0	114.0
14.7	114.1
16.5	114.1
18.7	114.1
20.5	114.3

SUMMARY DATA	
Bankfull Elevation:	114.0
Bankfull Cross-Sectional Area:	6.8
Bankfull Width:	8.0
Flood Prone Area Elevation:	NA
Flood Prone Width:	NA
Max Depth at Bankfull:	1.8
Low Bank Height:	1.8
Mean Depth at Bankfull:	0.9
W / D Ratio:	NA
Entrenchment Ratio:	NA
Bank Height Ratio:	1.0

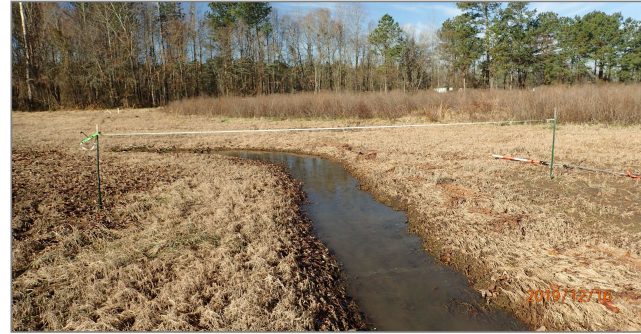
Alliance Headwaters, UT 1 Reach 1, XS - 8, Riffle

Station	Elevation
0.0	115.25
3.5	115.23
5.9	115.28
7.3	115.12
7.8	115.00
8.3	115.04
8.9	114.66
9.4	114.48
9.9	114.29
10.6	114.20
11.2	114.23
12.0	114.27
12.3	114.46
13.2	114.62
13.9	114.81
14.5	115.09
15.4	115.13
16.7	115.13
19.5	115.14
21.5	115.25

SUMMARY DATA	
Bankfull Elevation:	115.1
Bankfull Cross-Sectional Area:	3.6
Bankfull Width:	7.1
Flood Prone Area Elevation:	116.0
Flood Prone Width:	100.0
Max Depth at Bankfull:	0.9
Low Bank Height:	0.9
Mean Depth at Bankfull:	0.5
W / D Ratio:	14.0
Entrenchment Ratio:	14.1
Bank Height Ratio:	1.0

Stream Type	C5
--------------------	----

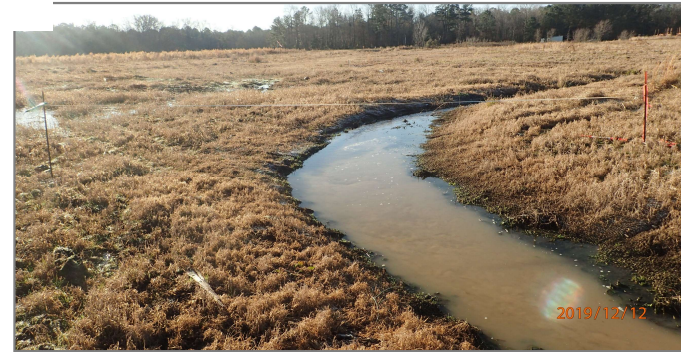
Site	Alliance Headwaters
Watershed:	Neuse River, 03020201
XS ID	UT 2, XS - 1
Feature	Pool
Date:	12/12/2019
Field Crew:	Perkinson, Keith

Station	Elevation
0.0	104.1
3.0	104.1
5.9	104.0
7.0	104.0
8.2	103.7
9.0	103.7
9.6	103.5
10.4	103.4
11.0	103.2
11.3	103.1
11.6	103.0
12.0	102.9
12.5	102.7
12.8	102.5
13.2	102.5
13.8	102.5
14.4	102.4
14.8	102.5
15.1	102.7
15.4	102.9
16.0	103.1
16.6	103.4
16.8	103.5
17.4	103.7
18.2	104.0
19.1	104.0
21.3	104.0
23.6	104.0
26.3	104.1

SUMMARY DATA	
Bankfull Elevation:	104.0
Bankfull Cross-Sectional Area:	8.8
Bankfull Width:	11.8
Flood Prone Area Elevation:	NA
Flood Prone Width:	NA
Max Depth at Bankfull:	1.6
Low Bank Height:	1.6
Mean Depth at Bankfull:	0.7
W / D Ratio:	NA
Entrenchment Ratio:	NA
Bank Height Ratio:	1.0

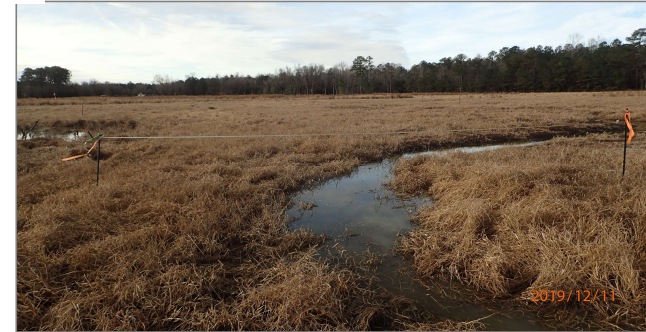
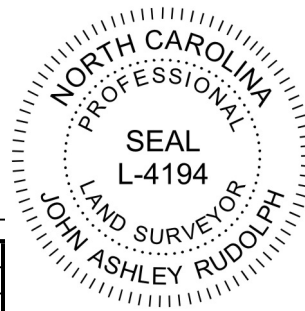
Site	Alliance Headwaters
Watershed:	Neuse River, 03020201
XS ID	UT 3 Reach 2, XS - 1
Feature	Pool
Date:	12/12/2019
Field Crew:	Perkinson, Keith

Station	Elevation
0.0	110.6
3.4	110.6
4.9	110.5
5.8	110.4
6.4	110.4
6.9	110.4
7.7	110.1
8.4	109.8
9.0	109.7
9.9	109.4
10.9	109.1
11.8	108.9
12.4	108.8
13.0	108.8
13.7	108.8
14.3	108.8
15.0	109.1
15.7	109.5
16.2	109.7
16.5	109.9
17.1	110.1
17.4	110.2
18.1	110.4
19.4	110.5
21.8	110.5
23.3	110.3
24.8	110.1

SUMMARY DATA	
Bankfull Elevation:	110.4
Bankfull Cross-Sectional Area:	10.2
Bankfull Width:	11.0
Flood Prone Area Elevation:	112.0
Flood Prone Width:	100.0
Max Depth at Bankfull:	1.6
Low Bank Height:	1.6
Mean Depth at Bankfull:	0.9
W / D Ratio:	11.9
Entrenchment Ratio:	9.1
Bank Height Ratio:	1.0

Stream Type	C5
--------------------	----

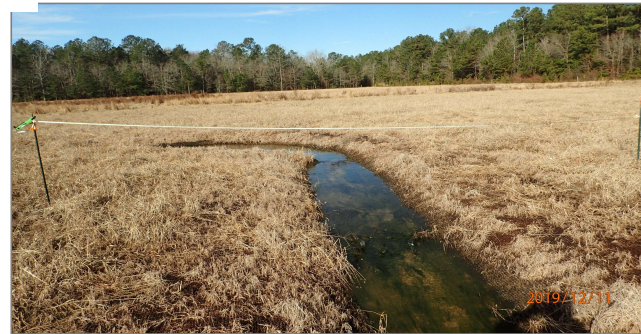
Station	Elevation
0.0	111.6
3.7	111.6
6.9	111.4
7.9	111.4
8.5	111.2
9.3	111.2
10.0	111.0
10.1	110.8
10.8	110.5
11.4	110.5
12.2	110.5
13.2	110.4
14.0	110.5
14.8	110.5
15.1	110.6
15.5	111.0
15.8	111.1
16.4	111.2
17.1	111.5
17.7	111.6
18.5	111.6
19.5	111.7
22.7	111.8
25.2	112.0

SUMMARY DATA	
Bankfull Elevation:	111.4
Bankfull Cross-Sectional Area:	5.4
Bankfull Width:	8.9
Flood Prone Area Elevation:	112.4
Flood Prone Width:	100.0
Max Depth at Bankfull:	1.0
Low Bank Height:	1.0
Mean Depth at Bankfull:	0.6
W / D Ratio:	14.7
Entrenchment Ratio:	11.2
Bank Height Ratio:	1.0

Stream Type	C5
-------------	----

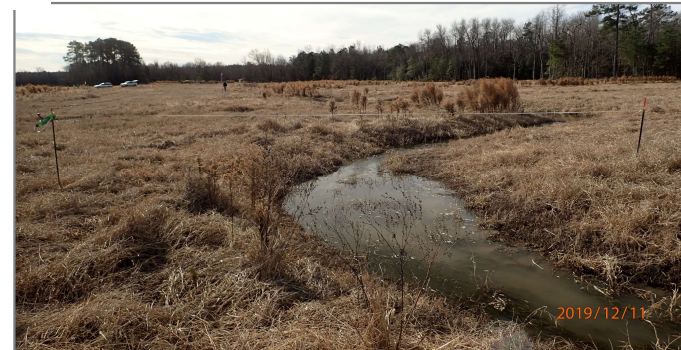
Station	Elevation
0.0	113.9
2.9	113.7
4.1	113.6
6.0	113.6
7.5	113.2
8.4	113.1
9.3	113.0
10.1	112.6
11.3	112.4
12.2	112.2
13.3	112.0
14.0	111.8
14.9	111.8
15.6	112.0
16.1	112.2
16.4	112.3
16.8	112.6
17.3	112.9
18.0	113.1
19.0	113.3
19.6	113.5
20.1	113.7
21.1	114.1
22.5	114.0
24.5	113.9
26.8	113.9

SUMMARY DATA	
Bankfull Elevation:	113.6
Bankfull Cross-Sectional Area:	12.7
Bankfull Width:	13.6
Flood Prone Area Elevation:	NA
Flood Prone Width:	NA
Max Depth at Bankfull:	1.7
Low Bank Height:	1.7
Mean Depth at Bankfull:	0.9
W / D Ratio:	NA
Entrenchment Ratio:	NA
Bank Height Ratio:	1.0

Stream Type	C5
--------------------	----

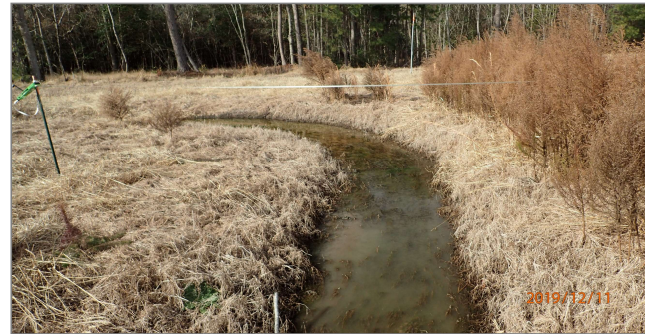
Site	Alliance Headwaters
Watershed:	Neuse River, 03020201
XS ID	UT 3 Reach 1, XS - 4
Feature	Riffle
Date:	12/12/2019
Field Crew:	Perkinson, Keith

Station	Elevation
0.0	115.5
4.1	115.5
8.3	115.6
9.9	115.5
10.8	115.3
11.0	115.1
11.6	114.7
12.1	114.7
12.7	114.6
13.4	114.6
14.2	114.7
14.7	114.8
15.2	114.9
15.6	115.1
15.9	115.1
16.6	115.3
17.3	115.6
18.0	115.6
19.6	115.6
20.6	115.8
22.5	115.8
24.1	115.8

SUMMARY DATA	
Bankfull Elevation:	115.5
Bankfull Cross-Sectional Area:	4.3
Bankfull Width:	7.3
Flood Prone Area Elevation:	116.5
Flood Prone Width:	100.0
Max Depth at Bankfull:	1.0
Low Bank Height:	1.0
Mean Depth at Bankfull:	0.6
W / D Ratio:	12.4
Entrenchment Ratio:	13.7
Bank Height Ratio:	1.0

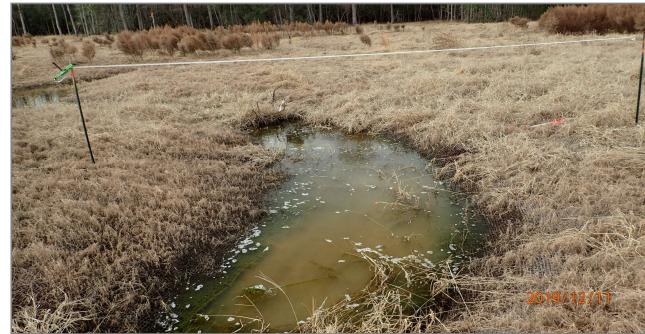
Station	Elevation
0.0	114.57
2.1	114.67
4.3	114.63
5.1	114.31
5.8	114.31
6.7	113.99
7.5	113.75
8.0	113.42
8.7	112.92
9.6	112.92
10.5	113.01
11.2	113.12
11.8	113.35
12.8	113.63
13.5	113.76
14.4	113.88
15.4	113.90
16.8	114.32
17.9	114.45
18.6	114.46
20.1	114.44

SUMMARY DATA	
Bankfull Elevation:	114.3
Bankfull Cross-Sectional Area:	7.9
Bankfull Width:	10.9
Flood Prone Area Elevation:	115.7
Flood Prone Width:	100.0
Max Depth at Bankfull:	1.4
Low Bank Height:	1.4
Mean Depth at Bankfull:	0.7
W / D Ratio:	15.0
Entrenchment Ratio:	9.2
Bank Height Ratio:	1.0

Stream Type C5

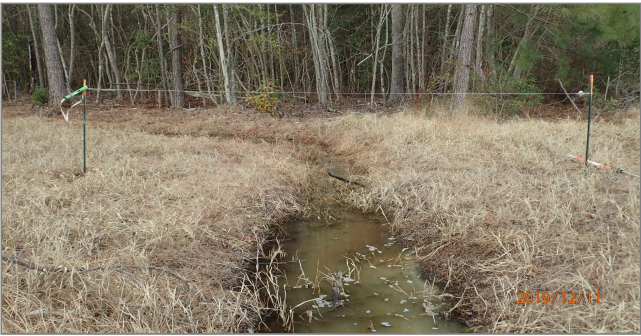
Site	Alliance Headwaters
Watershed:	Neuse River, 03020201
XS ID	UT 3, XS - 2
Feature	Riffle
Date:	12/12/2019
Field Crew:	Perkinson, Keith

Station	Elevation
0.0	115.56
2.8	115.56
4.8	115.59
5.7	115.47
6.3	115.30
6.9	115.03
7.3	114.92
8.0	114.81
9.0	114.82
9.4	114.68
9.9	114.76
10.3	114.76
10.9	115.10
11.3	115.24
11.8	115.33
12.5	115.65
13.2	115.87
14.0	115.77
15.6	115.67
17.2	115.81

SUMMARY DATA	
Bankfull Elevation:	115.6
Bankfull Cross-Sectional Area:	3.8
Bankfull Width:	7.5
Flood Prone Area Elevation:	116.5
Flood Prone Width:	100.0
Max Depth at Bankfull:	0.9
Low Bank Height:	0.9
Mean Depth at Bankfull:	0.5
W / D Ratio:	14.8
Entrenchment Ratio:	13.3
Bank Height Ratio:	1.0

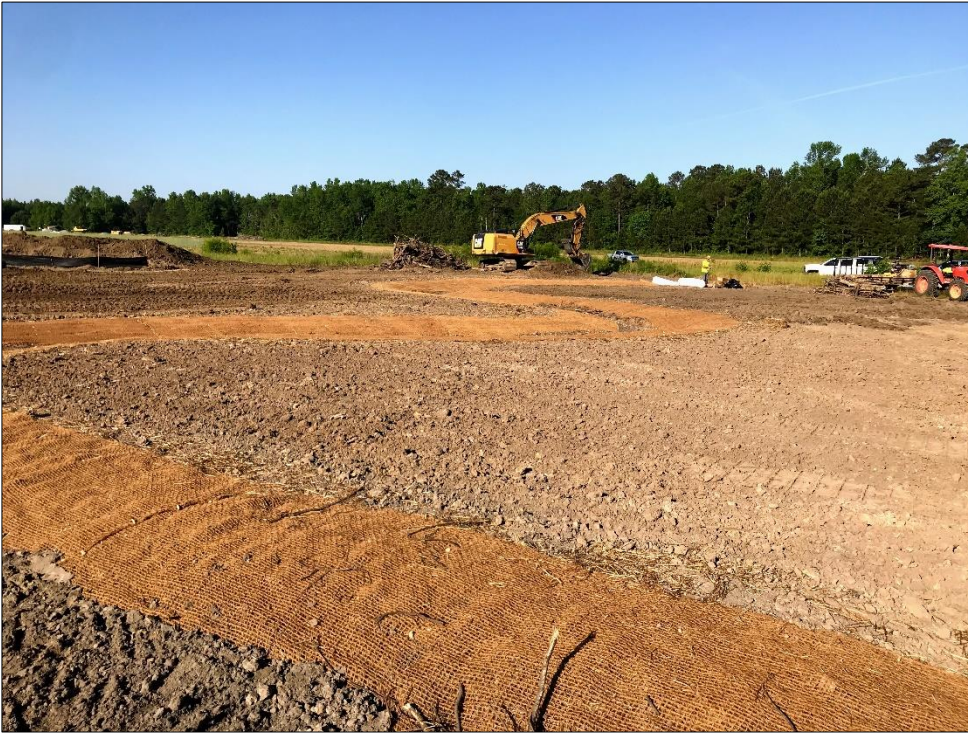
Channel Construction - 05/16/2020

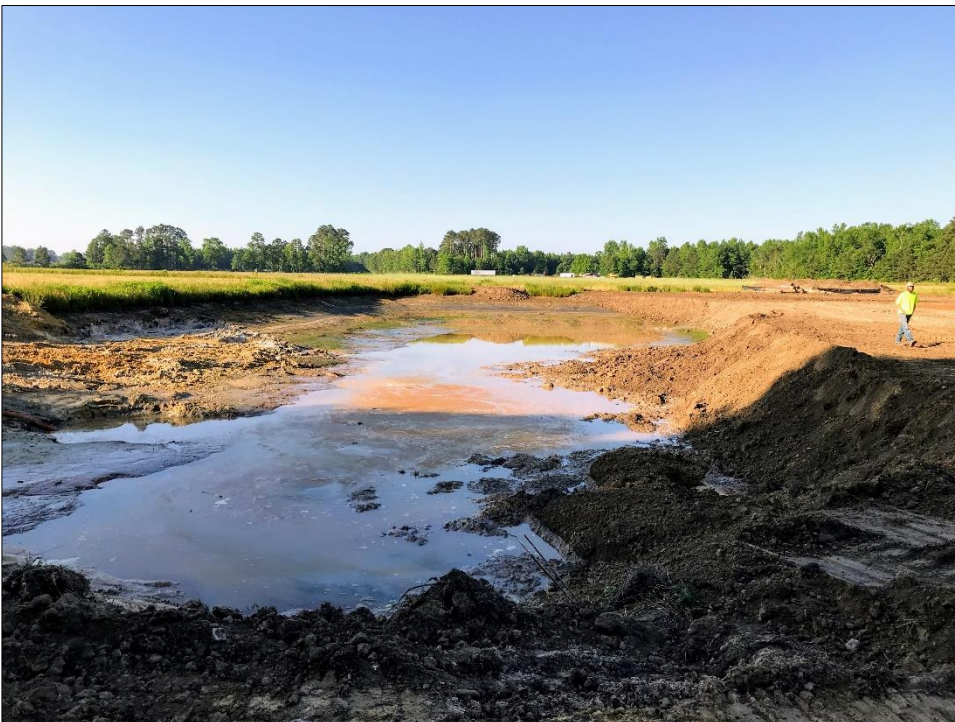
Eastern Easement, Pond draining and filling - 05/16/2020

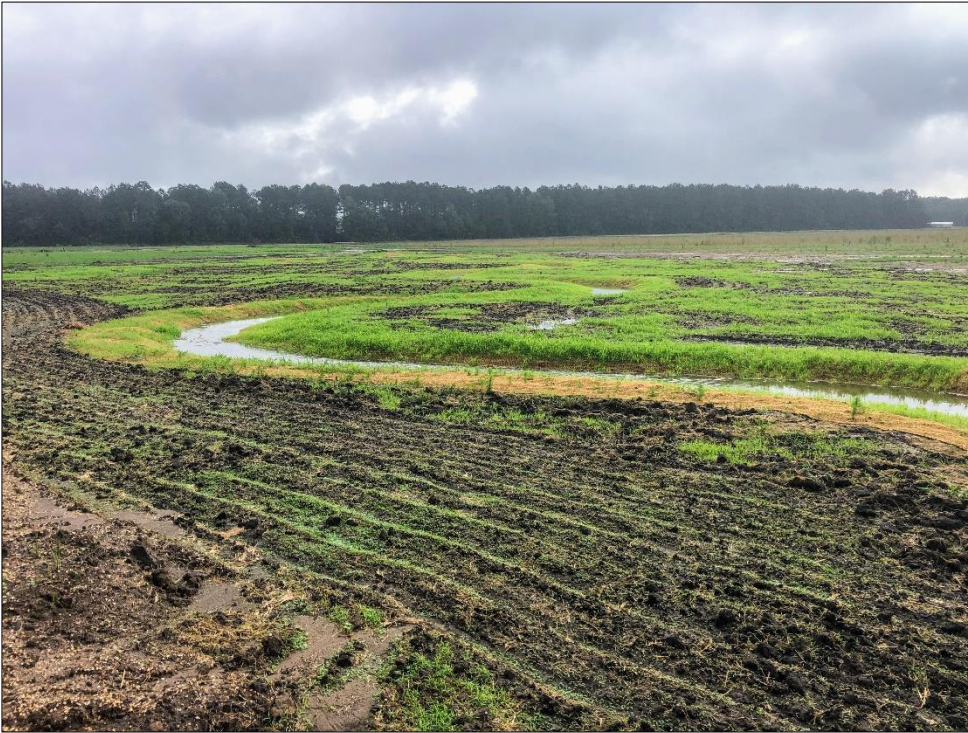
Eastern Easement, post 1.5" summer rain - 06/10/2019

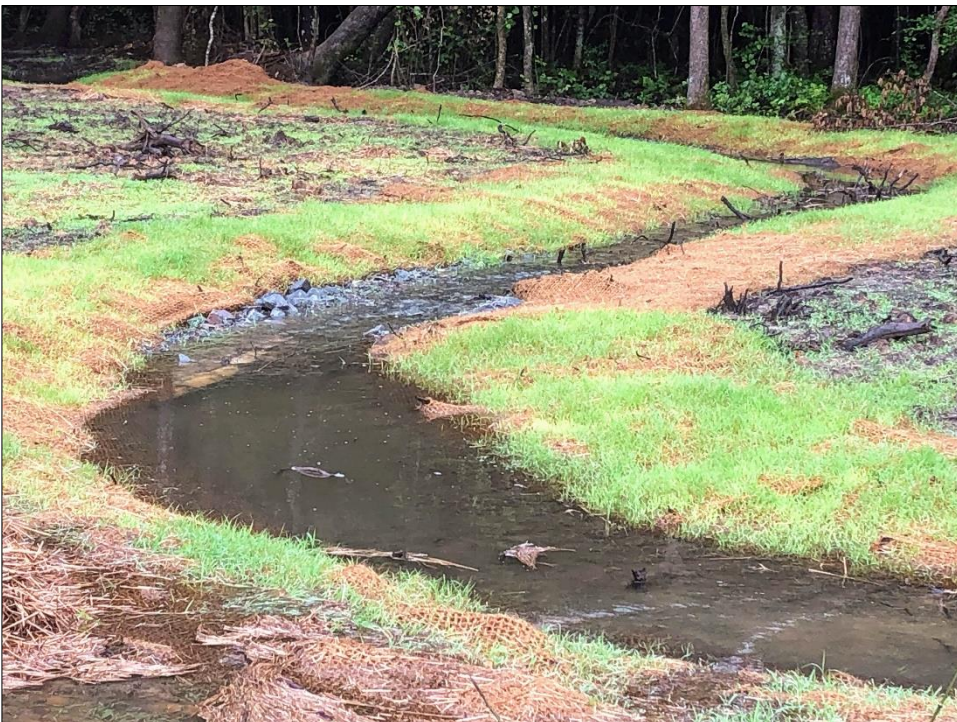
Eastern Easement, UT-4 near origin point, post 1.5" summer rain - 06/10/2019

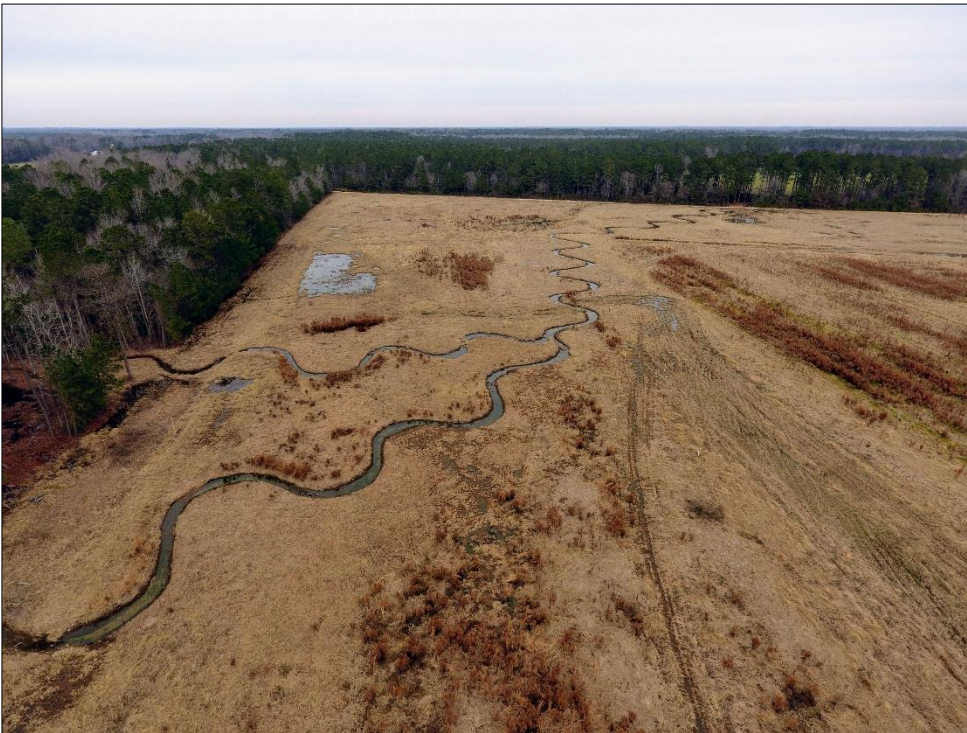
Eastern Easement, UT-3/UT-4, 12/22/2019

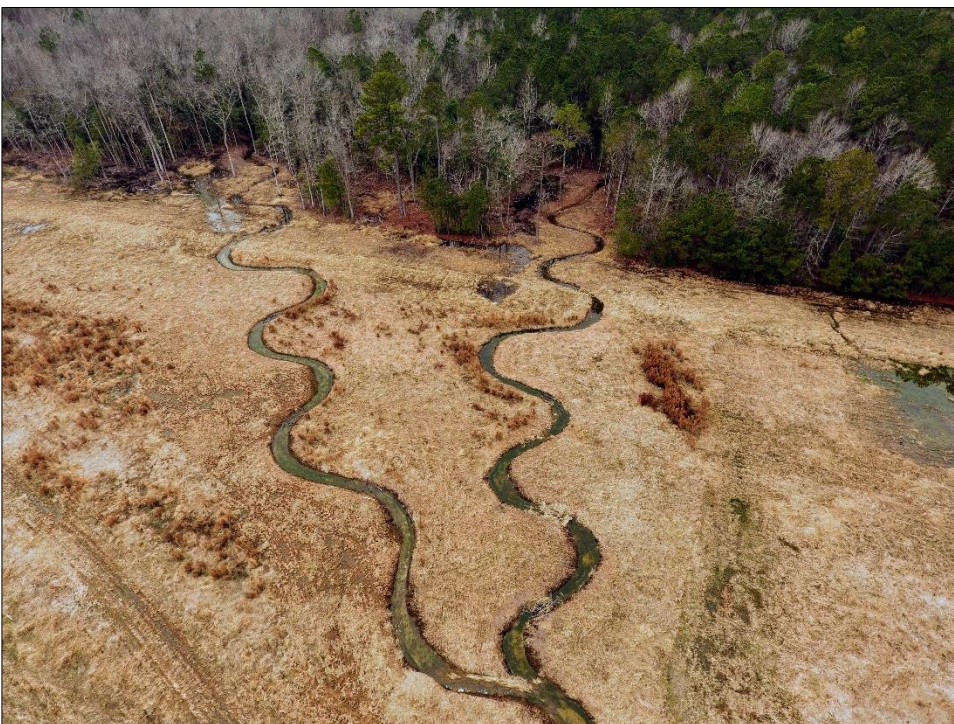
Eastern Easement, UT-3/UT-4, near origin point, 12/22/2019

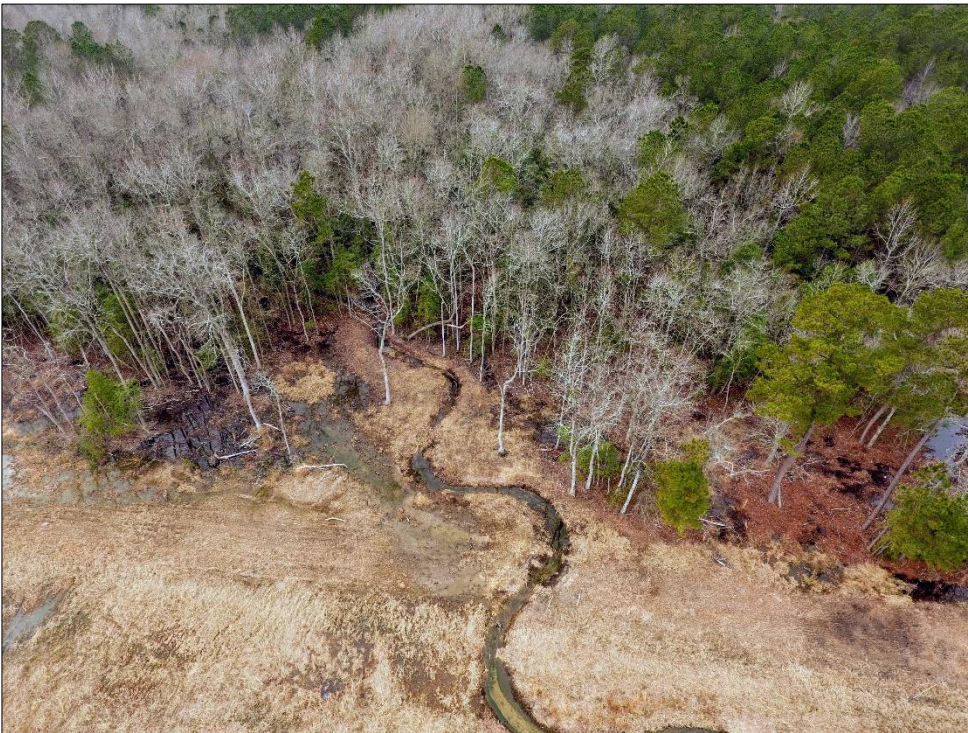
Eastern Easement, UT-3 origin point, 12/22/2019

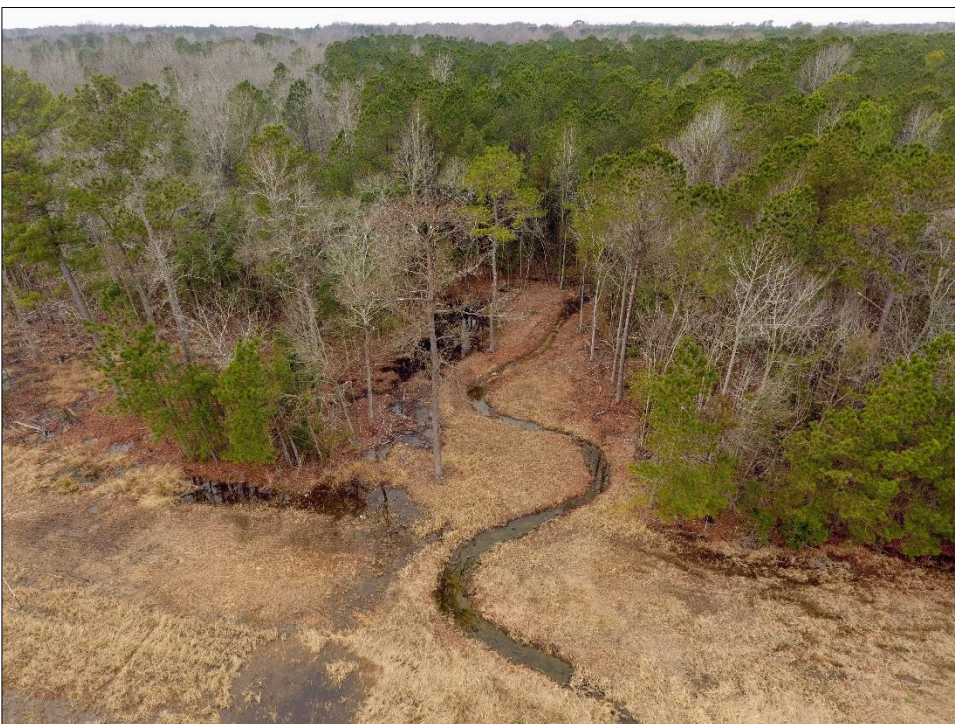
Eastern Easement, UT-4 origin point, 12/22/2019

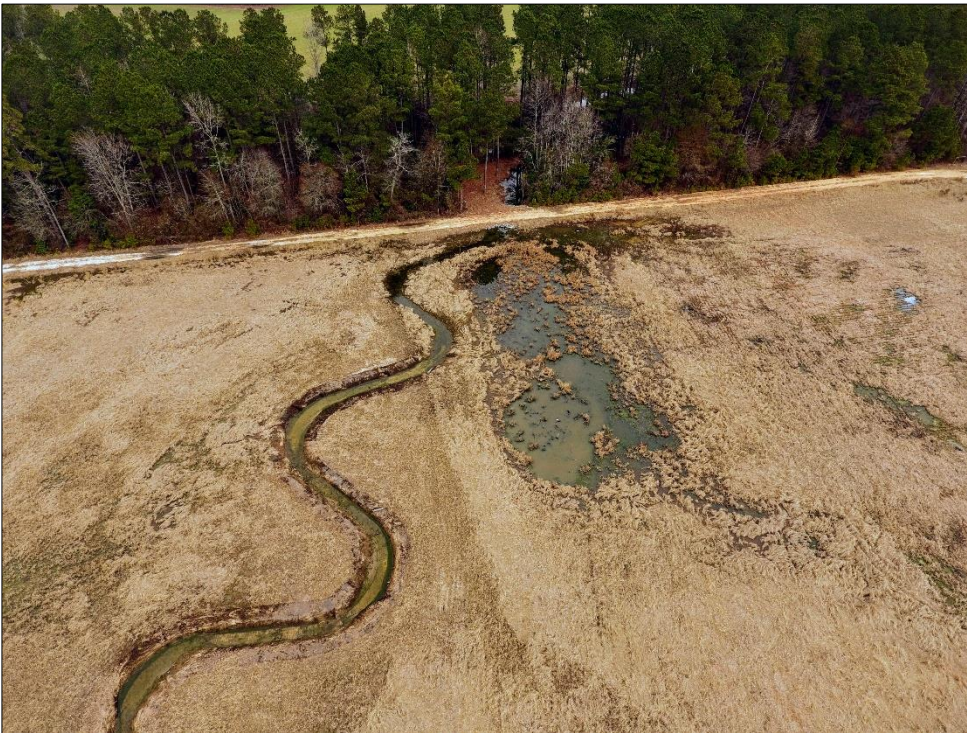
Eastern Easement, outfall, 12/22/2019

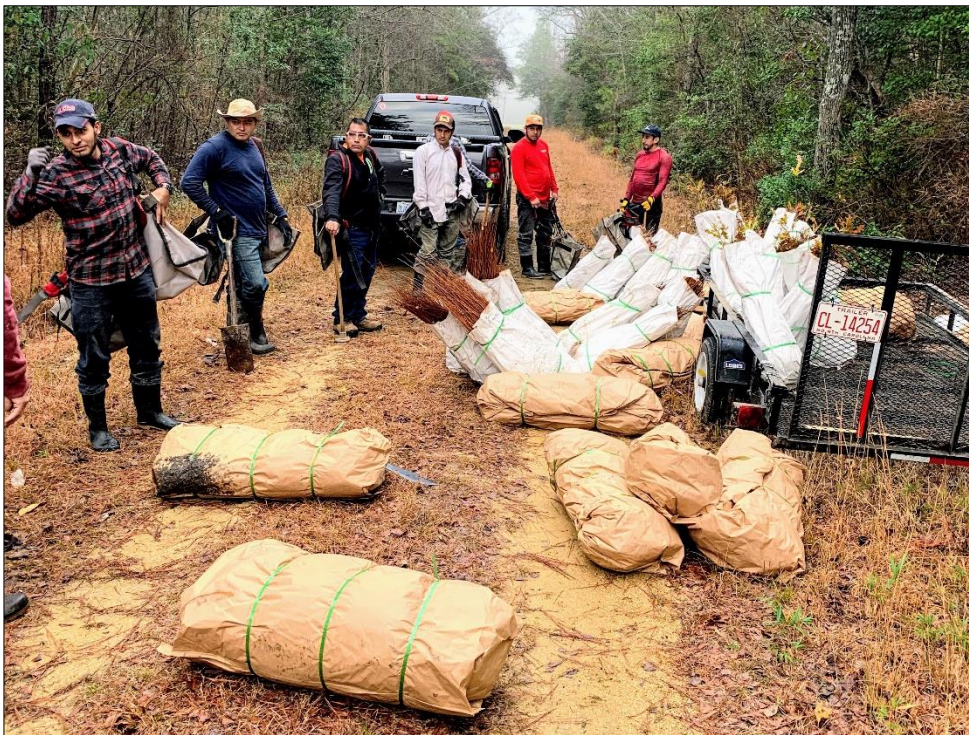
Bare-root planting - 01/15/2020

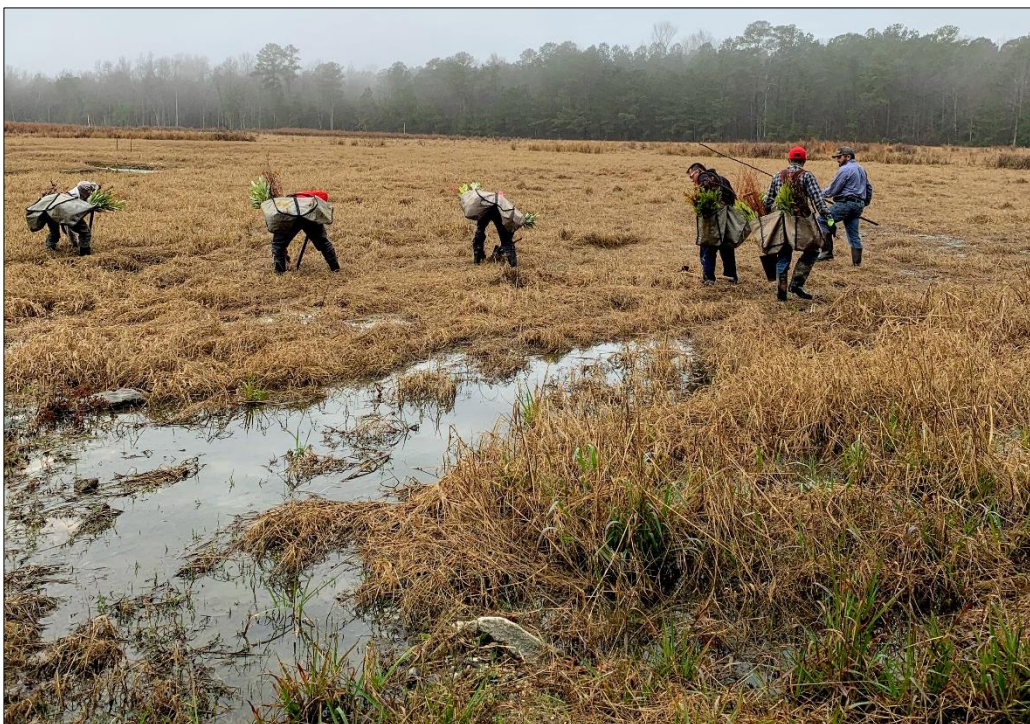
Bare-root planting - 01/15/2020

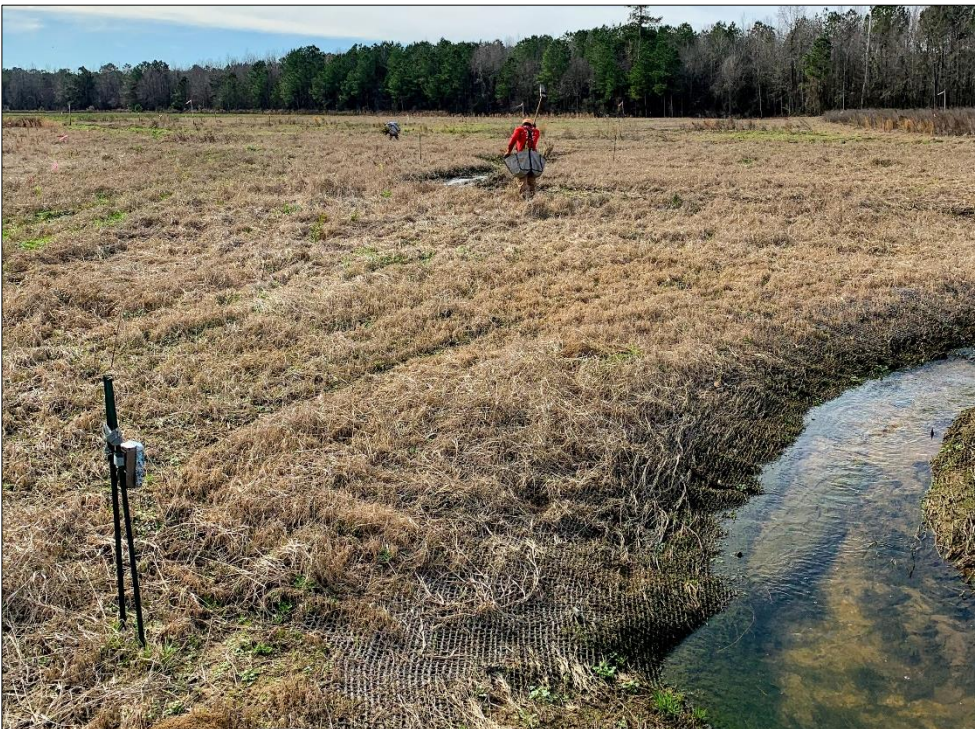
Bare-root planting - 01/15/2020 + flow gauge - UT3

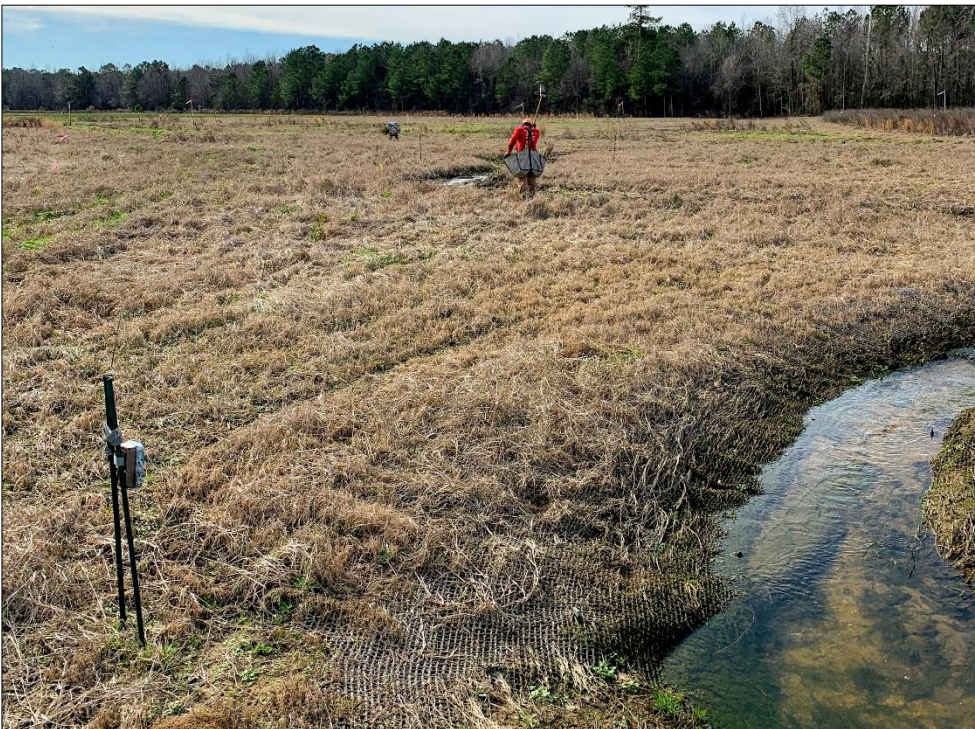
Bare-root planting - 01/15/2020 + flow gauge - UT3

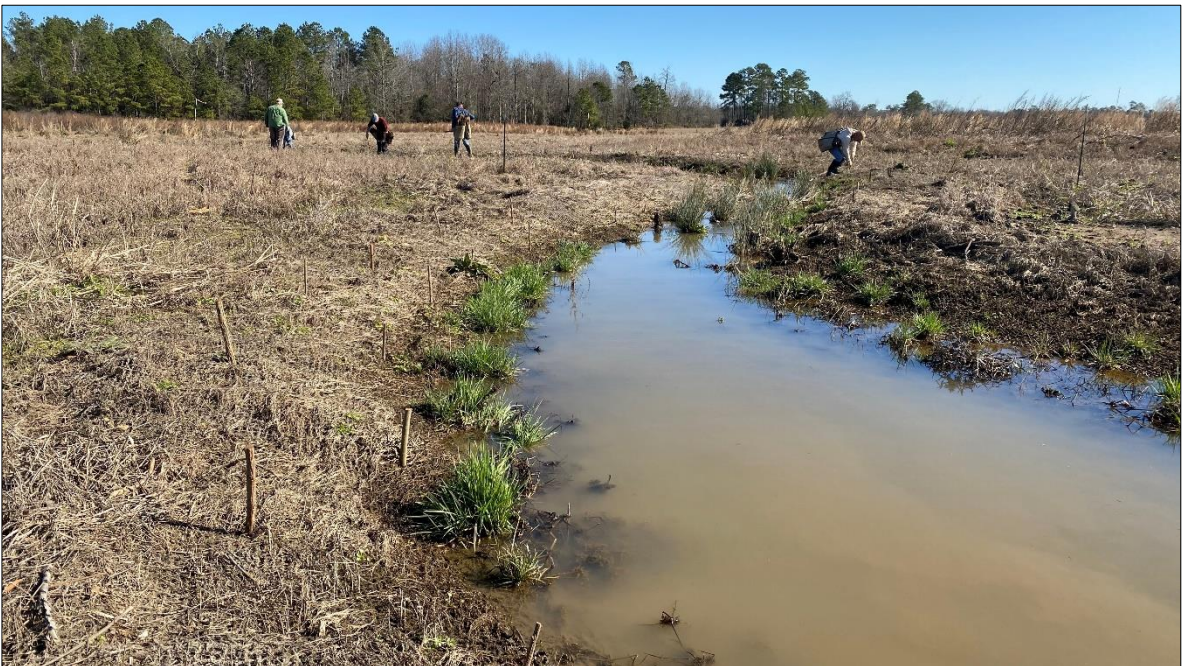
Live-stake planting - 01/28/202

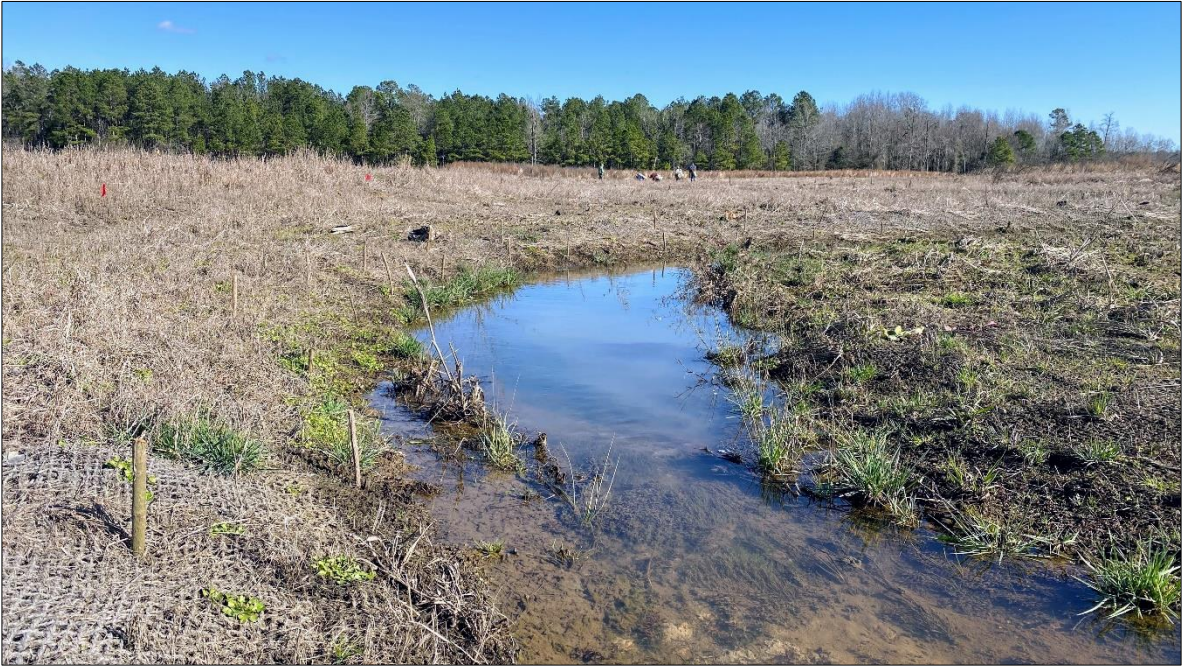
Live-stake planting - 01/28/202

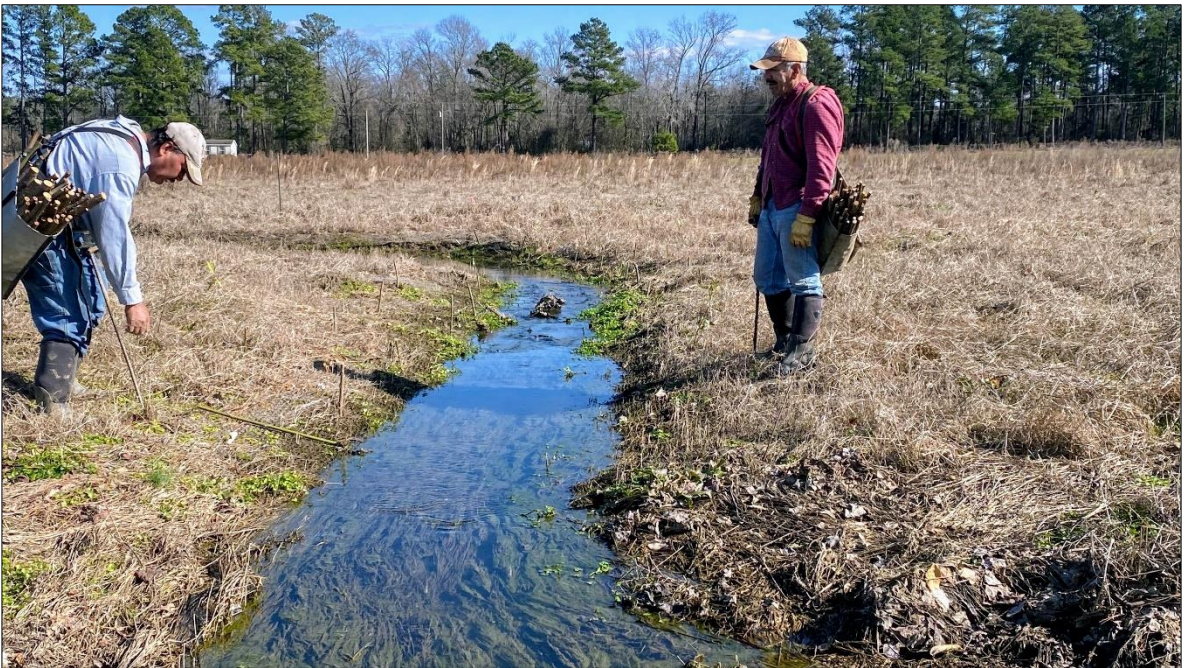
Live-stake planting - 01/28/202

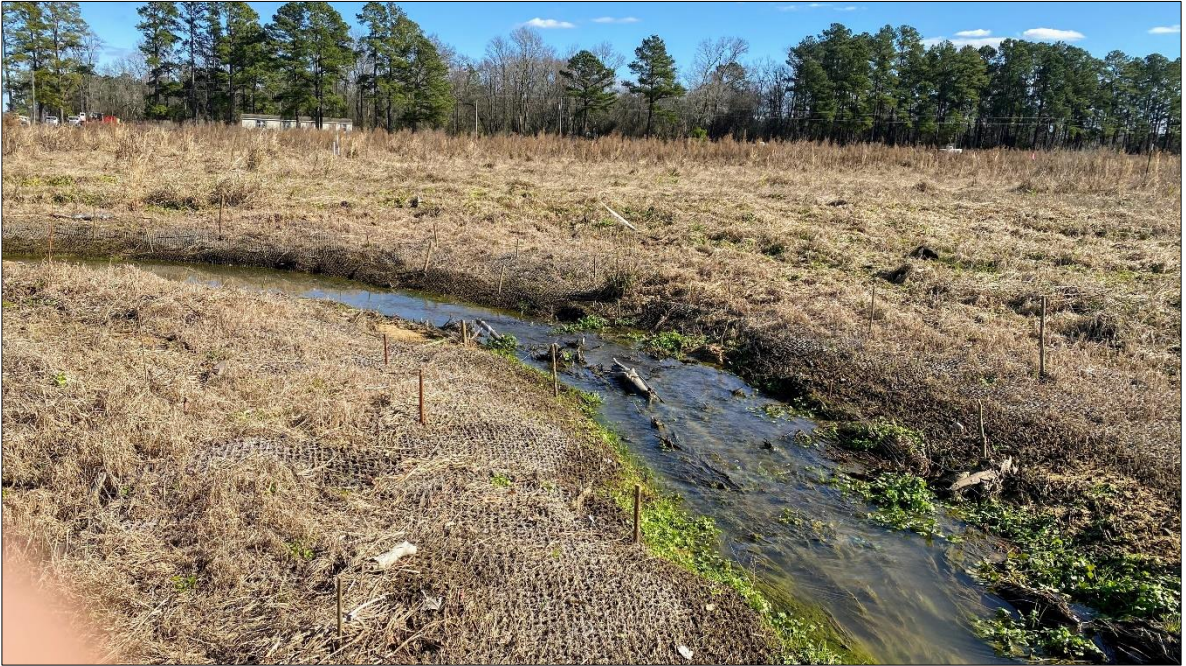
Live-stake planting - 01/28/202

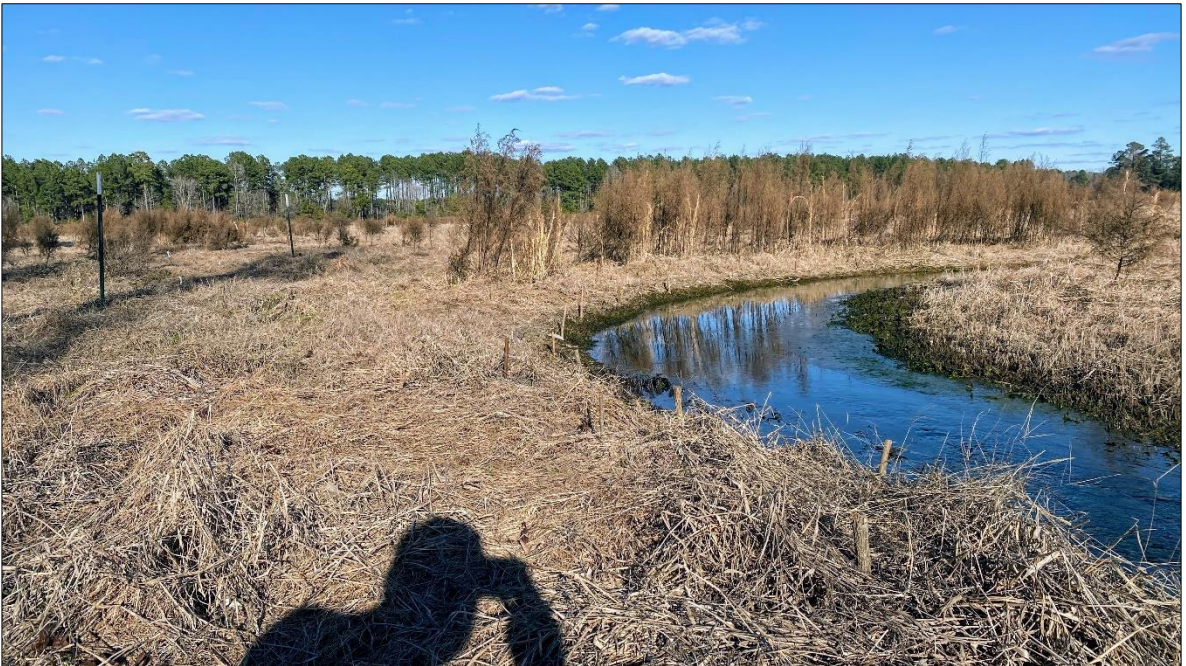
Live-stake planting - 01/28/202
