YEAR 2 (2008)
ANNUAL MONITORING REPORT
ANDERSON SWAMP WETLAND RESTORATION SITE
EDGEcombe COUNTY, NORTH CAROLINA

(CONTRACT D06048)
FULL DELIVERY PROJECT
TAR-PAMLICO RIVER BASIN
CATALOGING UNIT 03020102

November 2008

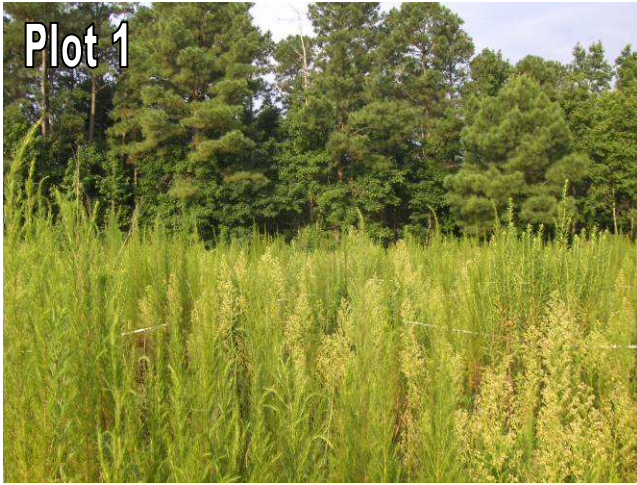
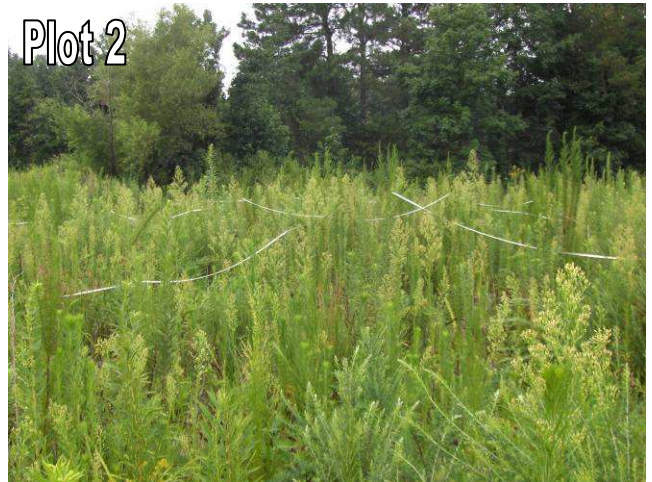
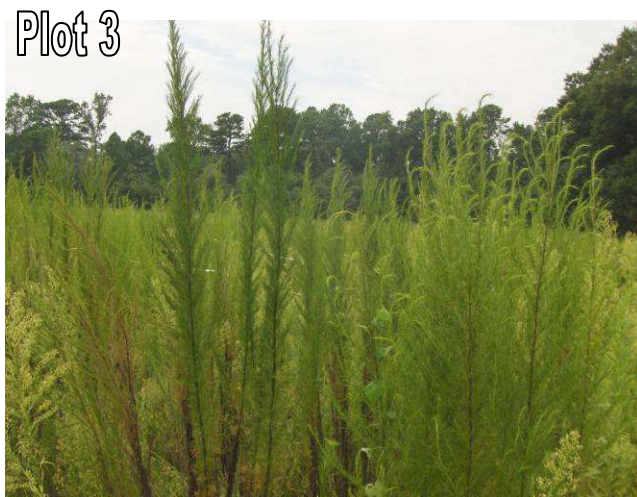
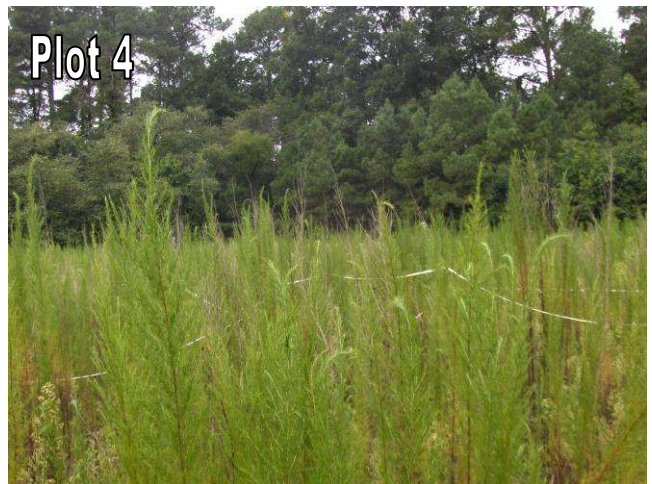
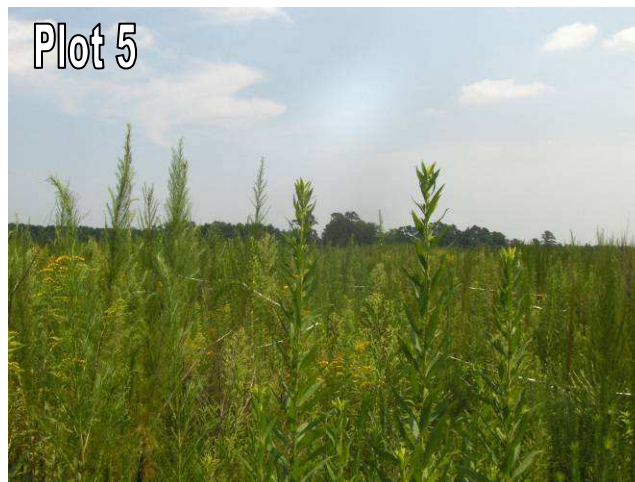
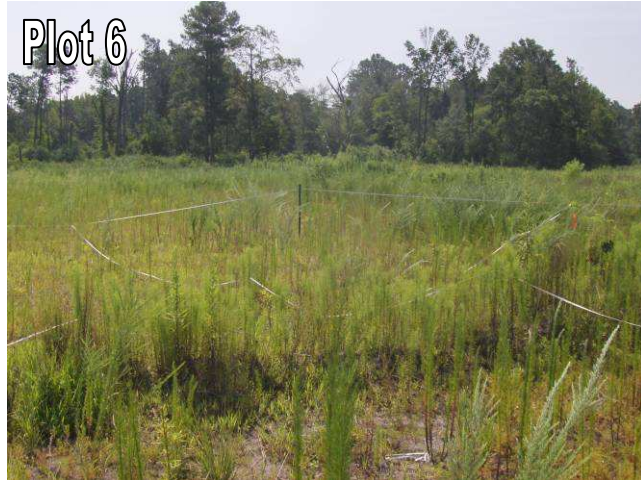
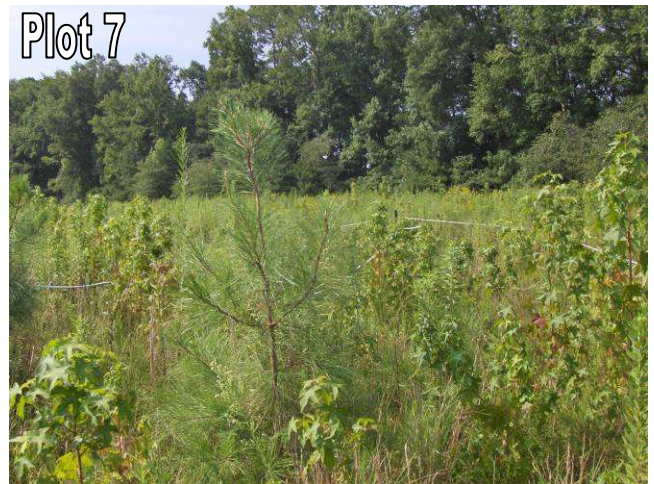
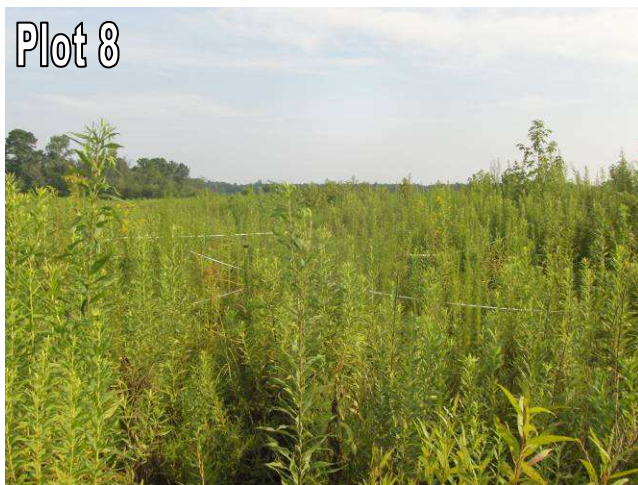
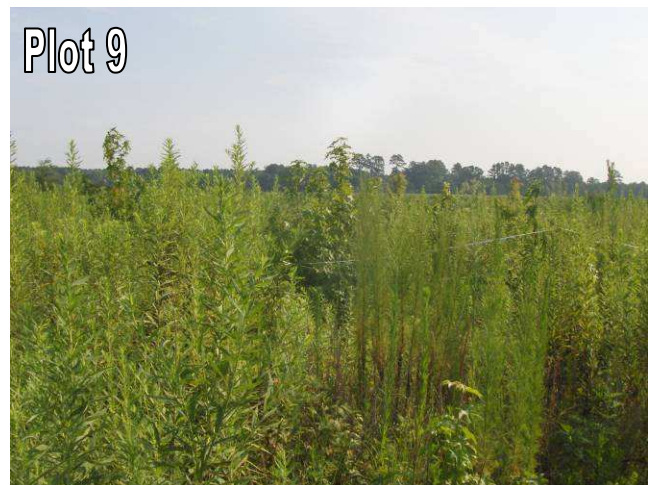
Anderson Swamp Wetland Restoration Site
Year 2 (2008) Annual Monitoring
Vegetation Plot Photos
Taken August 2008

Vegetation sampling across the Site was well-above the required average density with 630 planted stems per acre. No vegetation problem areas were noted during the Year 2 (2008) monitoring season.
