YEAR 3 (2009)
ANNUAL MONITORING REPORT
ANDERSON SWAMP WETLAND RESTORATION SITE
EDGEcombe COUNTY, NORTH CAROLINA

(CONTRACT D06048)
FULL DELIVERY PROJECT
TAR-PAMLICO RIVER BASIN
CATALOGING UNIT 03020102

October 2009

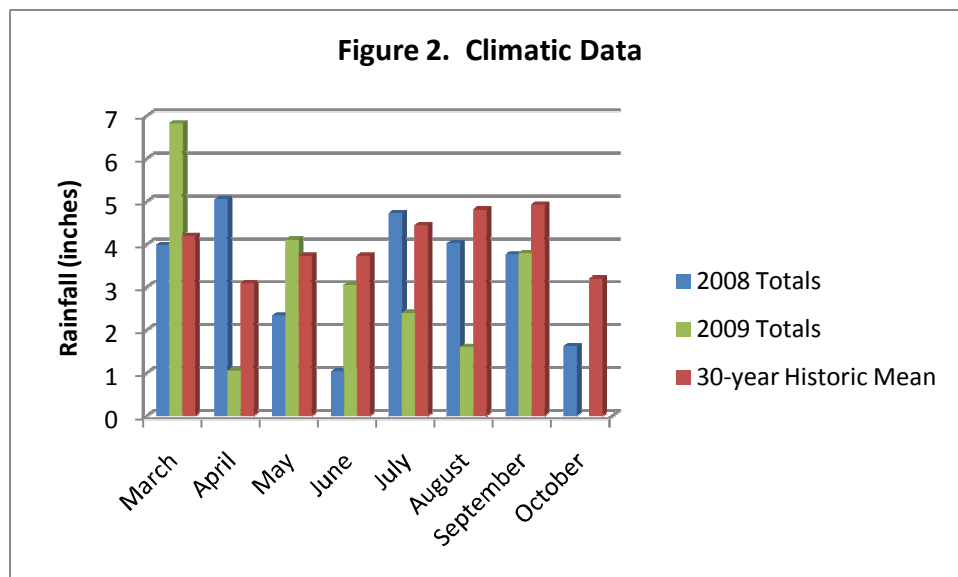
Three of the five monitored gauges within restoration areas were inundated/saturated within 12 inches of the surface for greater than 5 percent of the growing season, which extends from March 21 to November 10 (235 days) (Table 6). However, rain fall for the Year 3 (2009) growing season was below normal with 22.8 inches of rain occurring from March to September 2009 compared to the 30-year historic mean rainfall of 28.9 inches occurring from March to September. Since the Year 3 (2009) monitoring season rainfall was below normal, comparisons to reference groundwater gauges were made. Four of the five groundwater gauges should be considered successful for the Year 3 (2009) monitoring period; the only gauge that fell below the success criteria was Gauge 2. Gauge 2 is located on the edge of the easement and may be experiencing some draw down effects from the agricultural ditch to the east. Hydrographs containing groundwater and precipitation data for each gauge can be found in Appendix B.

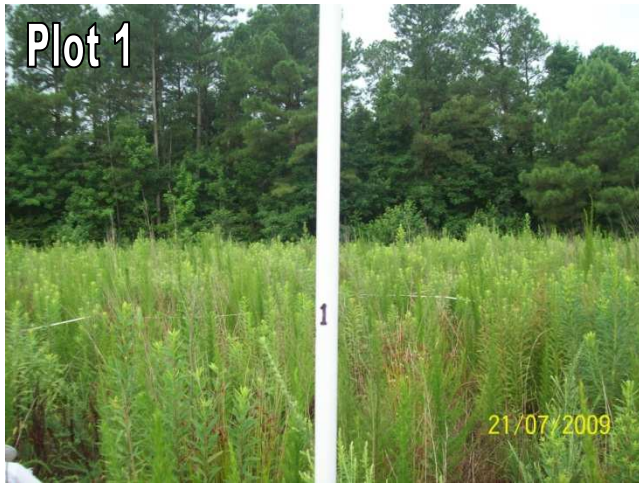
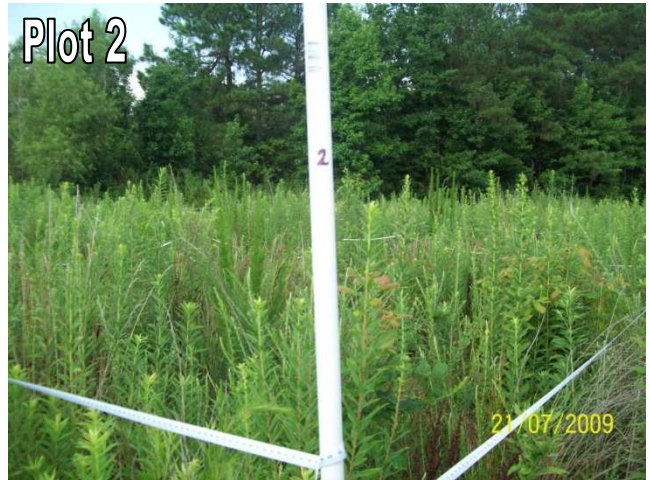
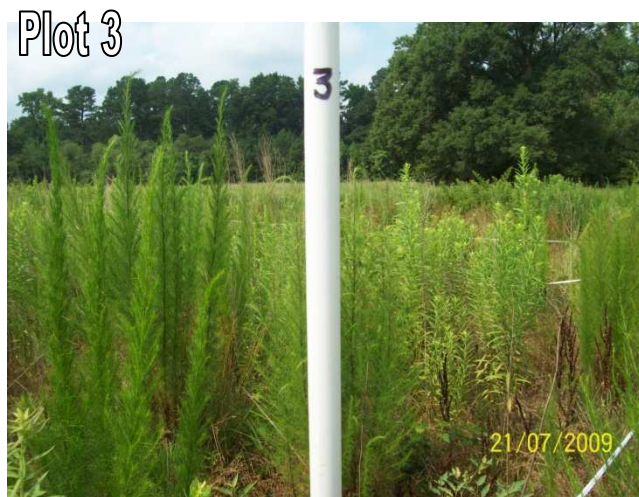
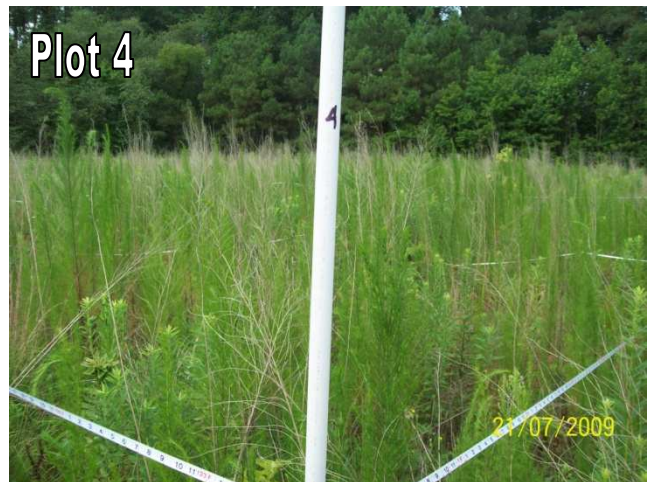
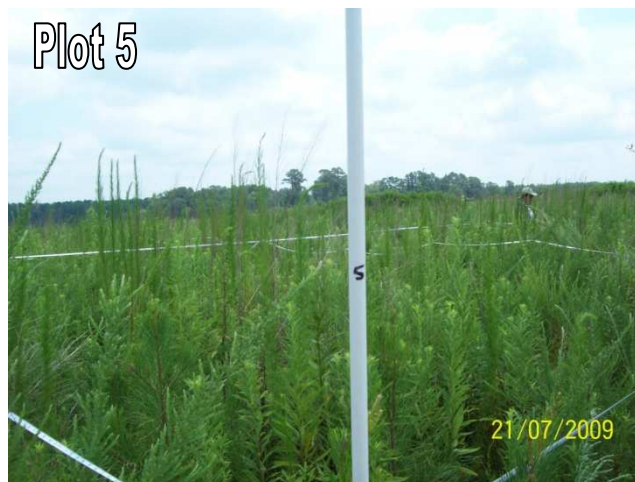
Anderson Swamp Wetland Restoration Site
Year 3 (2009) Annual Monitoring
Vegetation Plot Photos
Taken July 2009

Vegetation sampling across the Site was well-above the required average density with 634 planted stems per acre. No vegetation problem areas were noted during the Year 3 (2009) monitoring season.

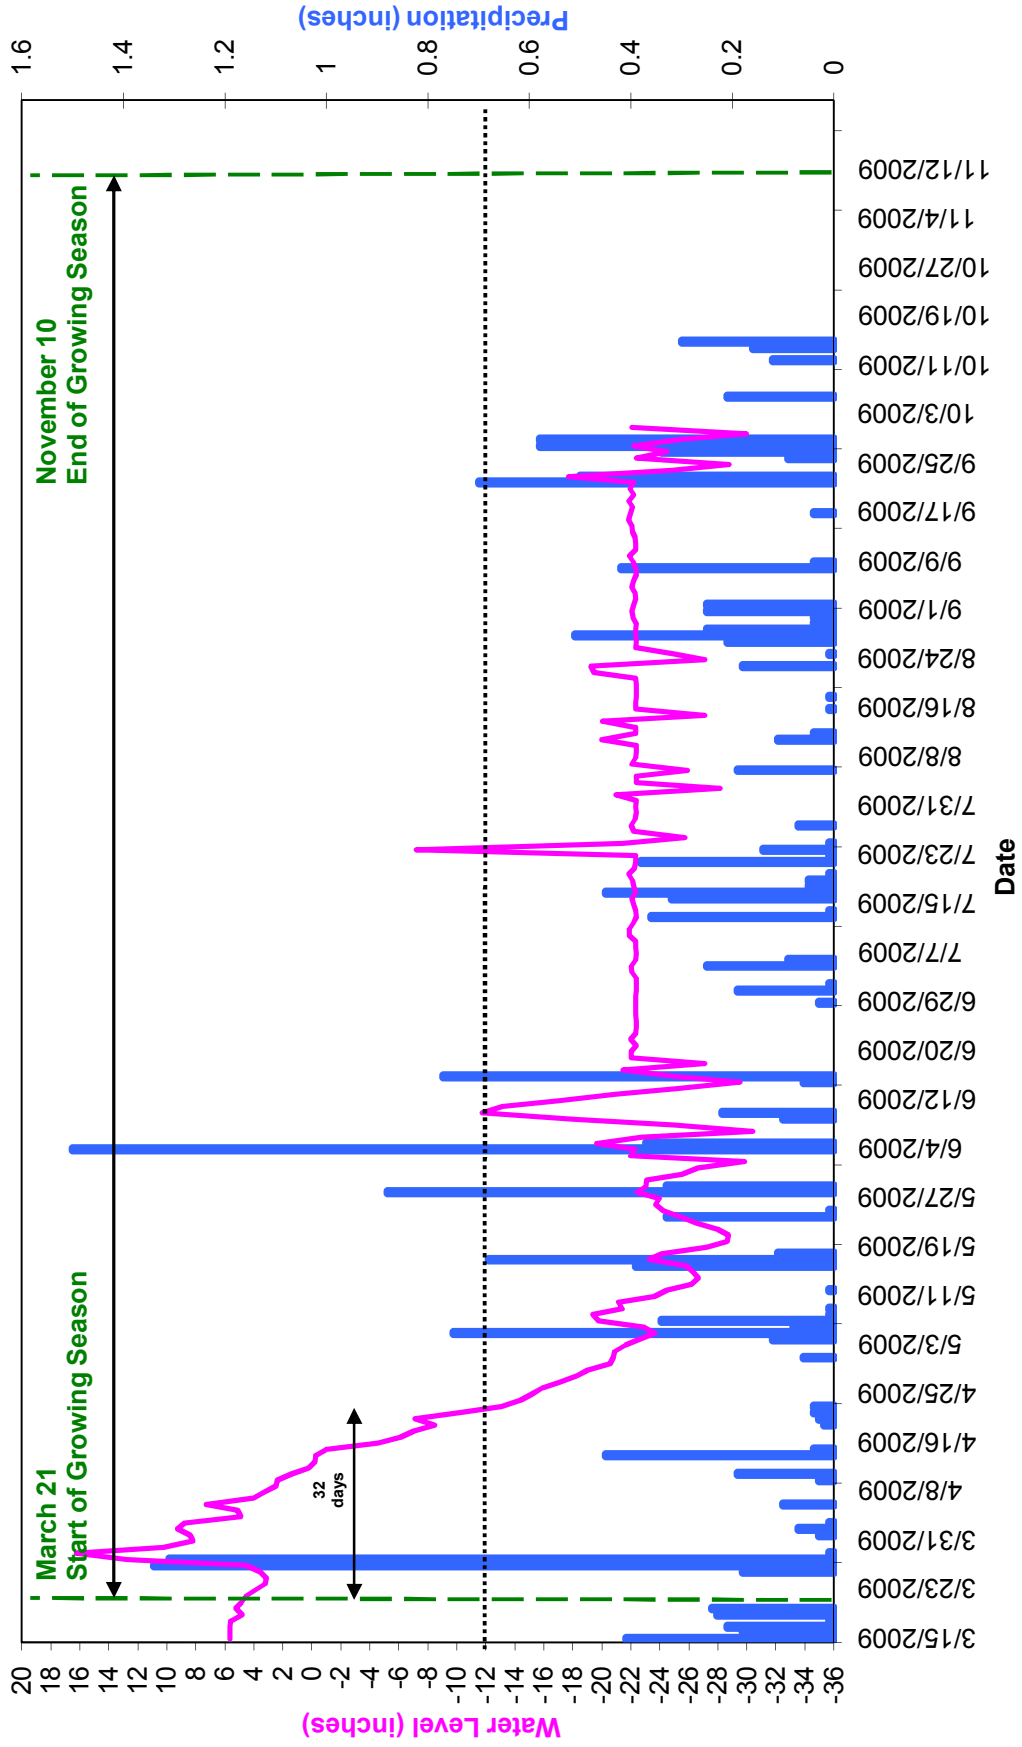
Anderson Swamp Groundwater Gauge 1 Year 3 (2009 Gauge Data)

Gauge	Success Criteria Achieved/Max Consecutive Days During Growing Season (Percentage)				
	Year 1 (2007)*	Year 2 (2008)*	Year 3 (2009)*	Year 4 (2010)	Year 5 (2011)
1	Yes/15 days (6 percent)	Yes/60 days (26 percent)	Yes/32 days (13.6 percent)		
2	No/1 days (0.4 percent)	No/2 days (0.8 percent)	No/2 days (0.8 percent)		
3	Yes/15 days (6 percent)	Yes/38 days (16 percent)	Yes/30 days (12.8 percent)		
4	Yes/6 days (3 percent)	Yes/31 days (13 percent)	Yes/23 days (9.8 percent)		
5	Yes/7 days (3 percent)	Yes/5 days (2 percent)	Yes/8 days (3.4 percent)		
Ref 1	Yes/7 days (3 percent)	Yes/5 days (2 percent)	Yes/6 days (2.6 percent)		
Ref 2	Yes/7 days (3 percent)	Yes/5 days (2 percent)	Yes/7 days (3.0 percent)
