YEAR 4 (2010)
ANNUAL MONITORING REPORT
ANDERSON SWAMP WETLAND RESTORATION SITE
EDGEcombe COUNTY, NORTH CAROLINA

(CONTRACT D06048)
FULL DELIVERY PROJECT
TAR-PAMLICO RIVER BASIN
CATALOGING UNIT 03020102

November 2010

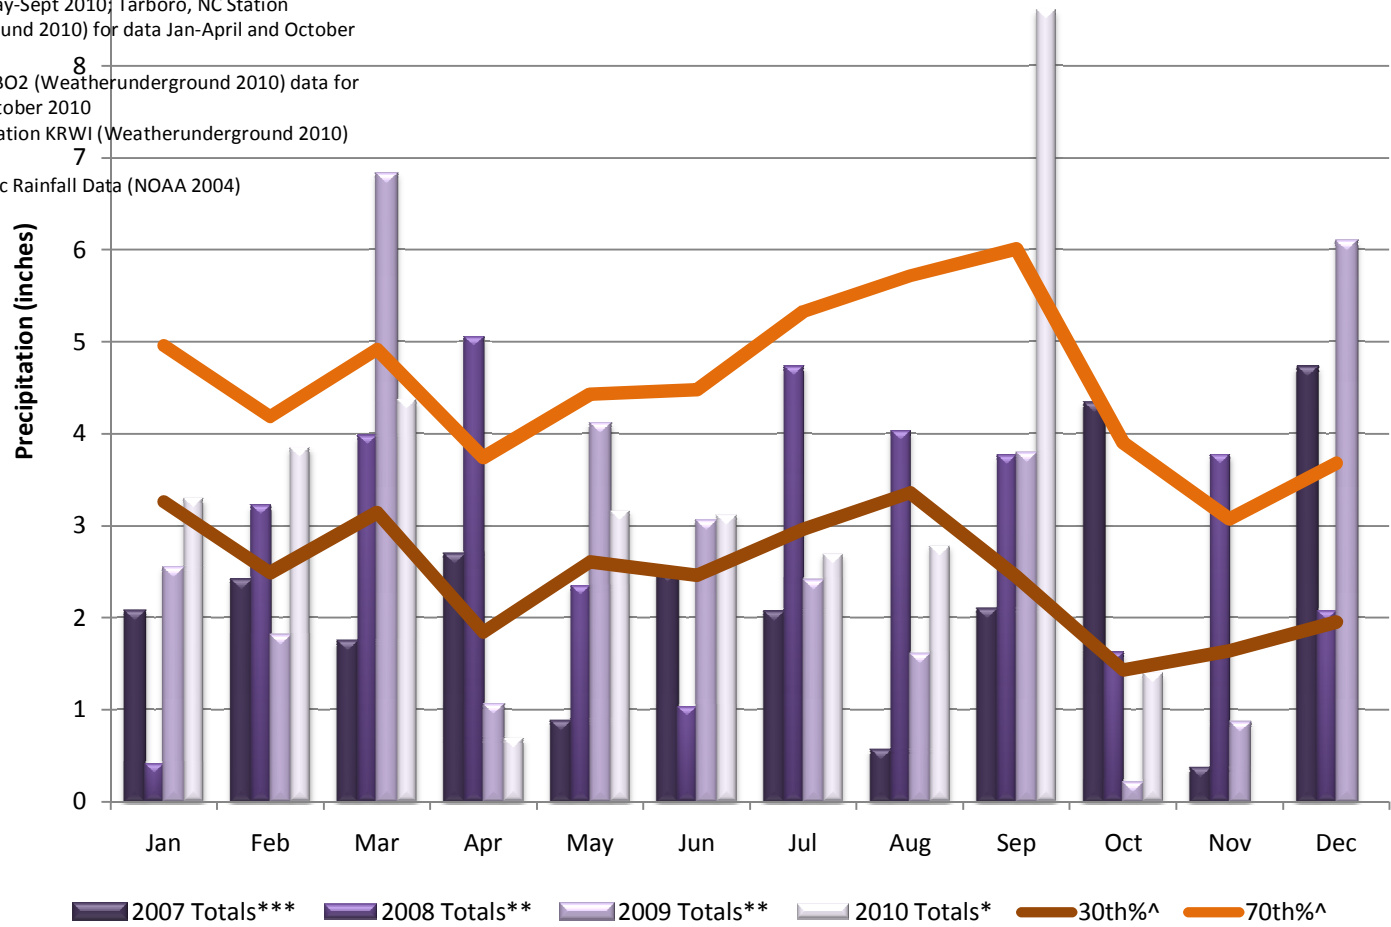
Figure 2. Annual Climatic Data vs. 30-year Historic Data

Month	2007 Totals***	2008 Totals**	2009 Totals**	2010 Totals*	30th%^	70th%^
Jan	2.07	0.41	2.54	3.3	3.26	4.96
Feb	2.41	3.22	1.8	3.85	2.49	4.19
Mar	1.74	3.98	6.82	4.37	3.14	4.92
Apr	2.69	5.05	1.05	0.69	1.84	3.74
May	0.87	2.34	4.11	3.16	2.61	4.43
Jun	2.49	1.03	3.05	3.11	2.46	4.48
Jul	2.06	4.73	2.4	2.69	2.96	5.33
Aug	0.56	4.03	1.6	2.78	3.36	5.72
Sep	2.09	3.76	3.79	8.61	2.45	6.01
Oct	4.33	1.62	0.2	1.4	1.43	3.9
Nov	0.36	3.77	0.86		1.64	3.07
Dec	4.72	2.07	6.09		1.95	3.68

*Onsite Rain Gauge Data for May-Sept 2010; Tarboro, NC Station KNCTARBO2 (Weatherunderground 2010) for data Jan-April and October 2010
 **Tarboro, NC Station KNCTARBO2 (Weatherunderground 2010) data for March 2008-April 2010, and October 2010
 ***Rocky Mount Airport, NC Station KRWI (Weatherunderground 2010) data for Jan 2007-Feb 2008
 ^Tarboro 1S, NC 30-year Historic Rainfall Data (NOAA 2004)

Three of the five monitored gauges within restoration areas were inundated/saturated within 12 inches of the surface for greater than 5 percent of the growing season, which extends from March 21 to November 10 (235 days) (Table 6). However, rainfall for the Year 4 (2010) growing season was below normal with 16.8 inches of rain occurring from March to August 2010 compared to the 30-year historic mean rainfall of 24.0 inches occurring from March to August. Since the Year 4 (2010) monitoring season rainfall was below normal, comparisons to reference groundwater gauges were made. All five groundwater gauges should be considered successful for the Year 4 (2010) monitoring period. Hydrographs containing groundwater and precipitation data for each gauge can be found in Appendix B.

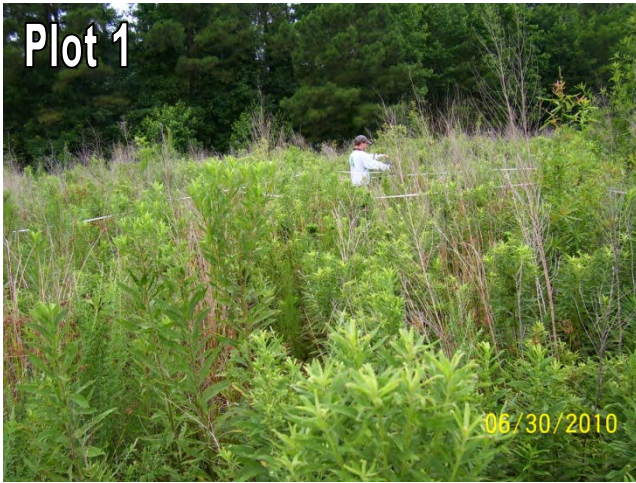
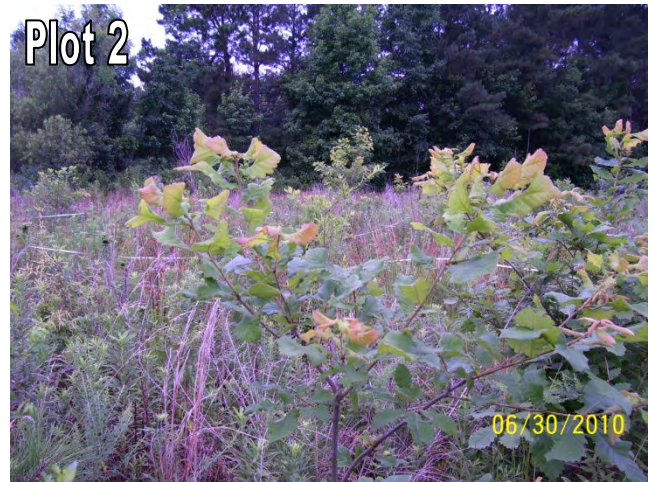
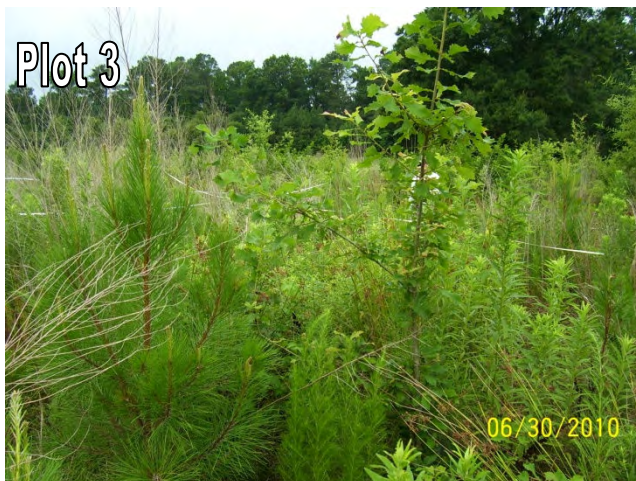
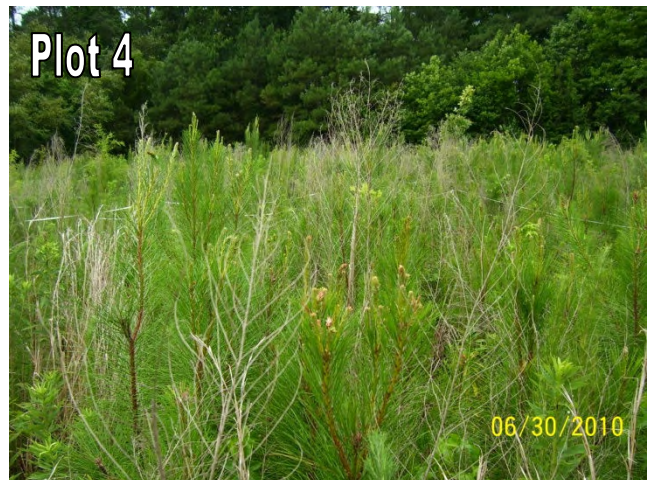
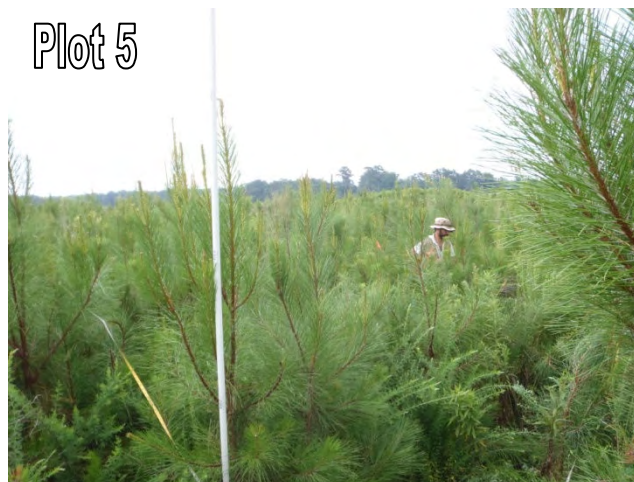
Anderson Swamp Wetland Restoration Site
Year 4 (2010) Annual Monitoring
Vegetation Plot Photos
Taken June 2010

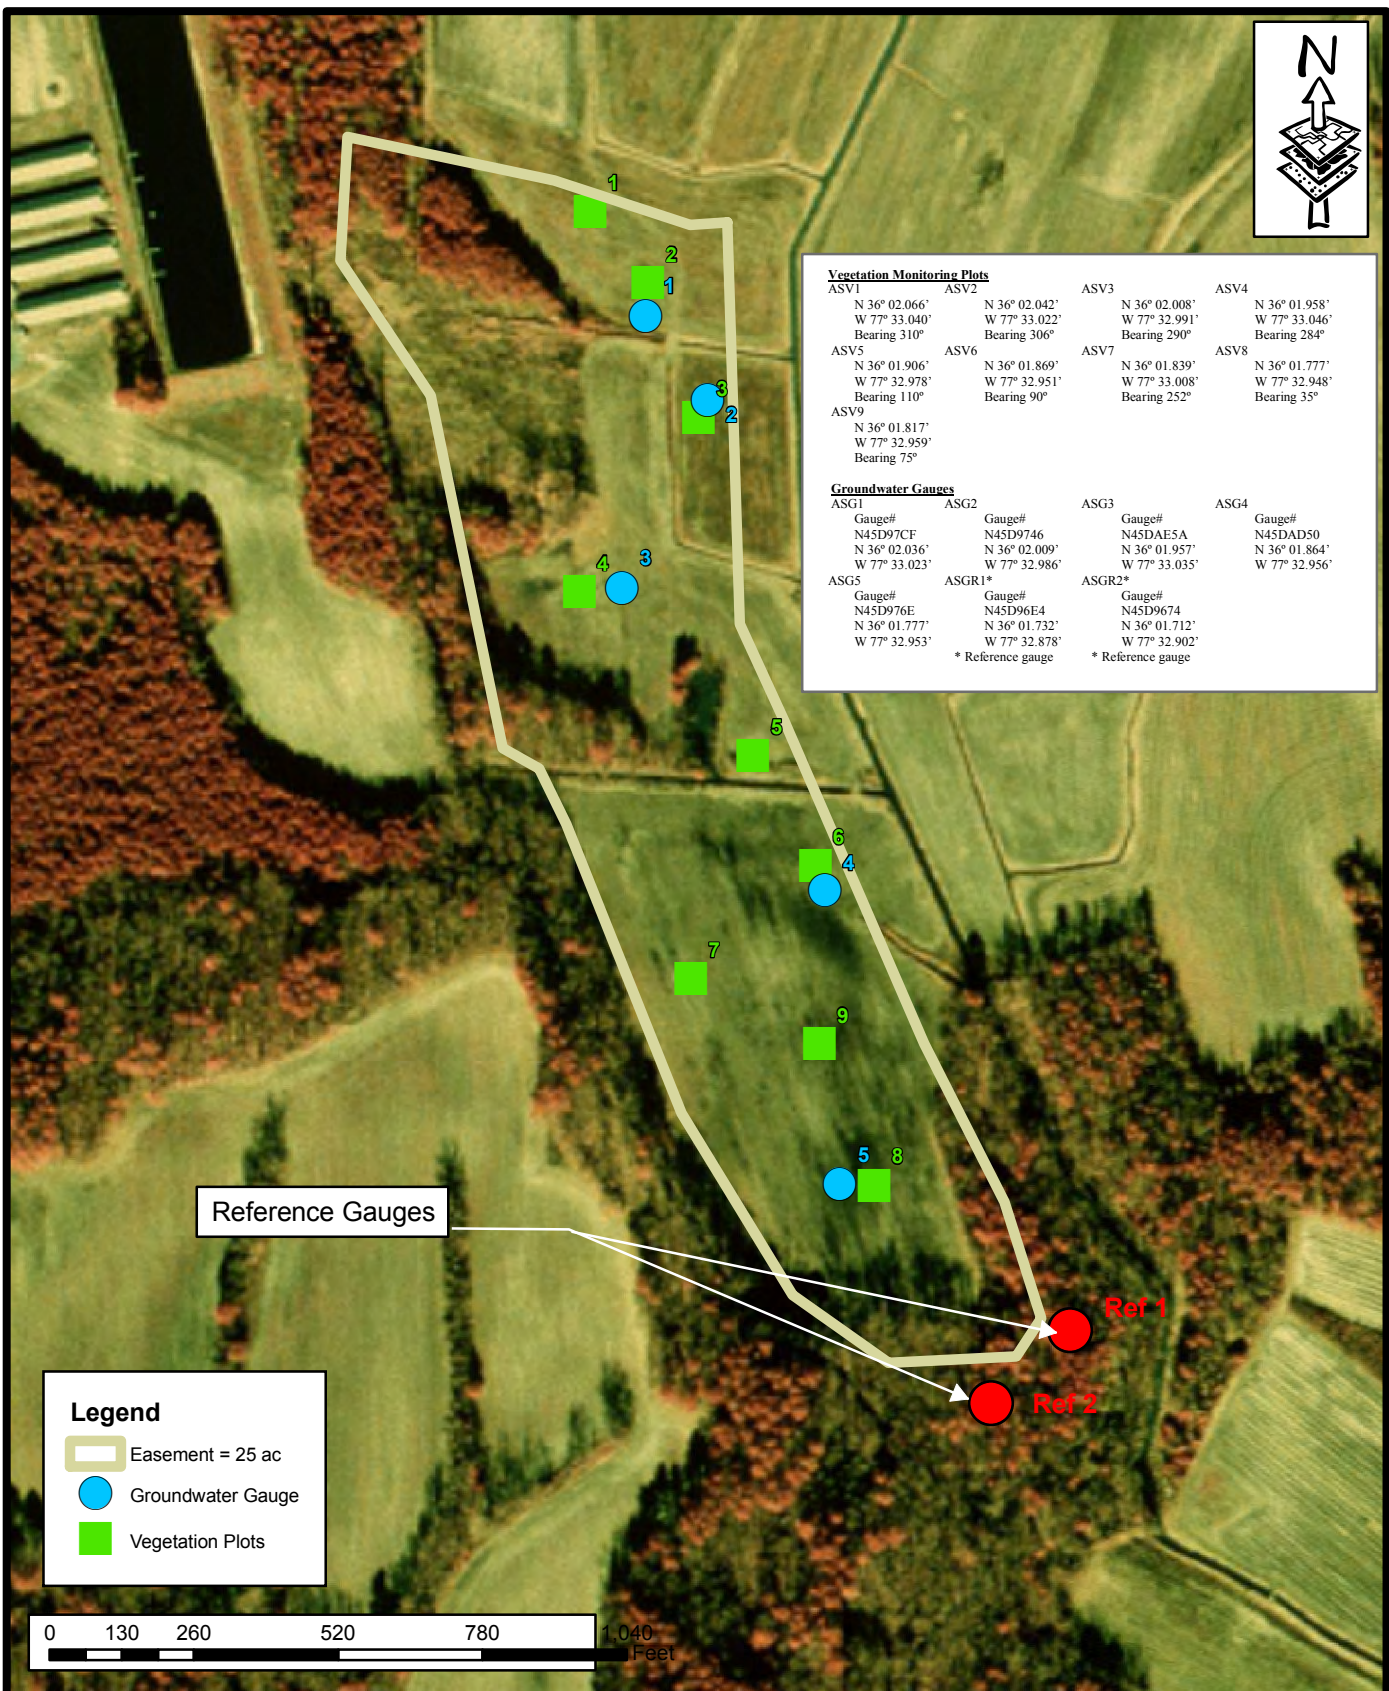
FIGURE
C1

Vegetation Monitoring Plots			
ASV1 N 36° 02.066' W 77° 33.040' Bearing 310°	ASV2 N 36° 02.042' W 77° 33.022' Bearing 306°	ASV3 N 36° 02.008' W 77° 32.991' Bearing 290°	ASV4 N 36° 01.958' W 77° 33.046' Bearing 284°
ASV5 N 36° 01.906' W 77° 32.978' Bearing 110°	ASV6 N 36° 01.869' W 77° 32.951' Bearing 90°	ASV7 N 36° 01.839' W 77° 33.008' Bearing 252°	ASV8 N 36° 01.777' W 77° 32.948' Bearing 35°
ASV9 N 36° 01.817' W 77° 32.959' Bearing 75°			
Groundwater Gauges			
ASG1 Gauge# N45D97CF N 36° 02.036' W 77° 33.023'	ASG2 Gauge# N45D9746 N 36° 02.009' W 77° 32.986'	ASG3 Gauge# N45DAE5A N 36° 01.957' W 77° 33.035'	ASG4 Gauge# N45DAD50 N 36° 01.864' W 77° 32.956'
ASG5 Gauge# N45D976E N 36° 01.777' W 77° 32.953'	ASGR1* Gauge# N45D96E4 N 36° 01.732' W 77° 32.878'	ASGR2* Gauge# N45D9674 N 36° 01.712' W 77° 32.902'	
	* Reference gauge	* Reference gauge

MONITORING PLAN
ANDERSON SWAMP RESTORATION SITE
 Edgecombe County, North Carolina

Monitoring activities for the Site, including relevant structures and utilities, project features, specific project structures, and monitoring features are detailed in the monitoring plan view in Appendix C. Site features including vegetation, wetland hydrology, and photographic documentation were monitored in Year 4 (2010).
