YEAR 5 (2011)
ANNUAL MONITORING REPORT
ANDERSON SWAMP WETLAND RESTORATION SITE
EDGEcombe COUNTY, NORTH CAROLINA

(CONTRACT D06048)
FULL DELIVERY PROJECT
TAR-PAMLICO RIVER BASIN
CATALOGING UNIT 03020102

November 2011

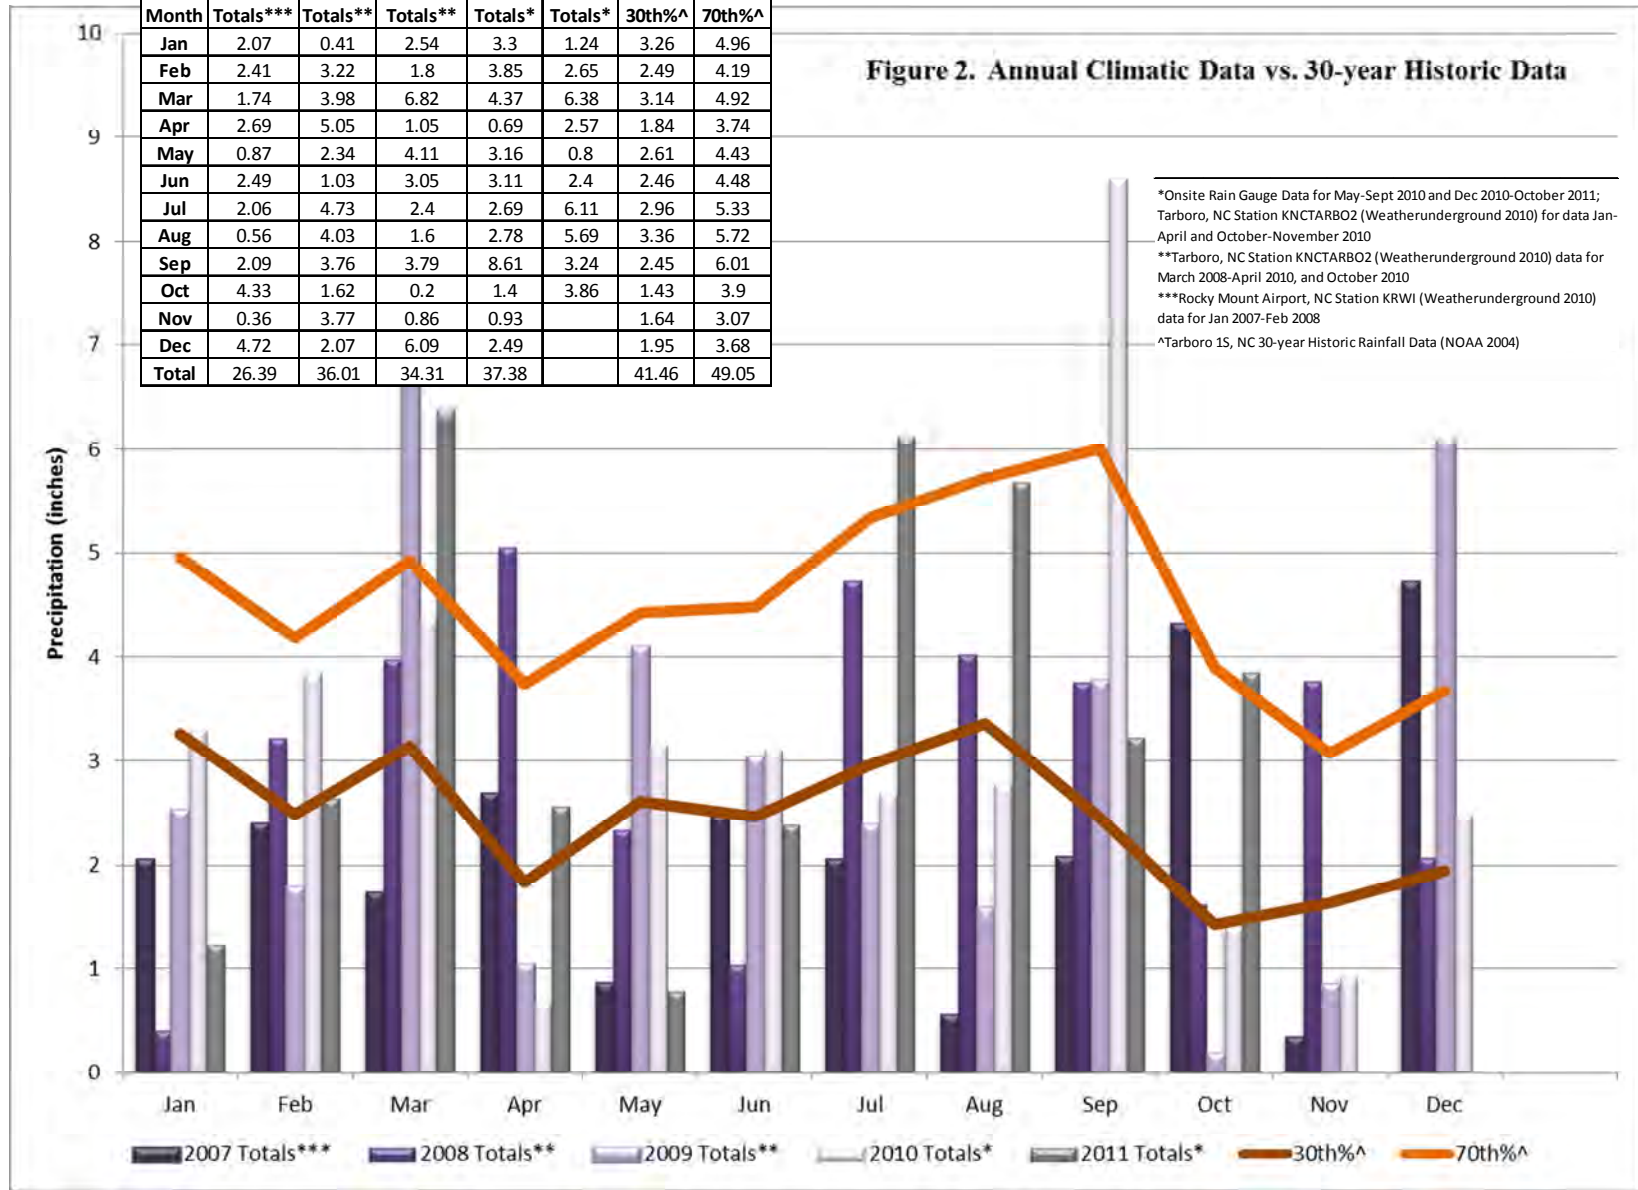
Figure 2. Annual Climatic Data vs. 30-year Historic Data

Month	2007 Totals***	2008 Totals**	2009 Totals**	2010 Totals*	2011 Totals*	30th% [^]	70th% [^]
Jan	2.07	0.41	2.54	3.3	1.24	3.26	4.96
Feb	2.41	3.22	1.8	3.85	2.65	2.49	4.19
Mar	1.74	3.98	6.82	4.37	6.38	3.14	4.92
Apr	2.69	5.05	1.05	0.69	2.57	1.84	3.74
May	0.87	2.34	4.11	3.16	0.8	2.61	4.43
Jun	2.49	1.03	3.05	3.11	2.4	2.46	4.48
Jul	2.06	4.73	2.4	2.69	6.11	2.96	5.33
Aug	0.56	4.03	1.6	2.78	5.69	3.36	5.72
Sep	2.09	3.76	3.79	8.61	3.24	2.45	6.01
Oct	4.33	1.62	0.2	1.4	3.86	1.43	3.9
Nov	0.36	3.77	0.86	0.93		1.64	3.07
Dec	4.72	2.07	6.09	2.49		1.95	3.68
Total	26.39	36.01	34.31	37.38		41.46	49.05

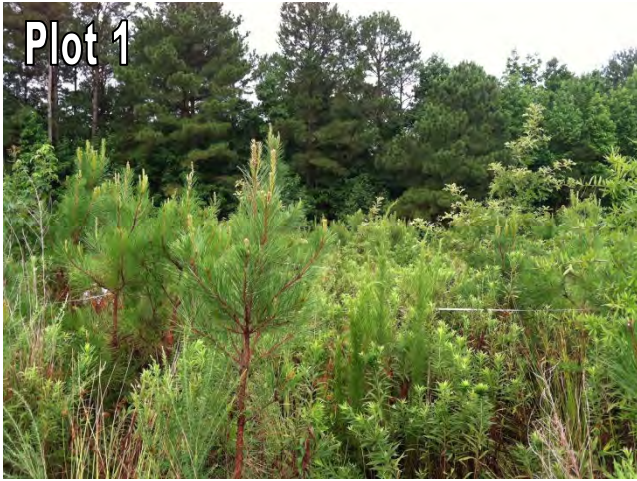
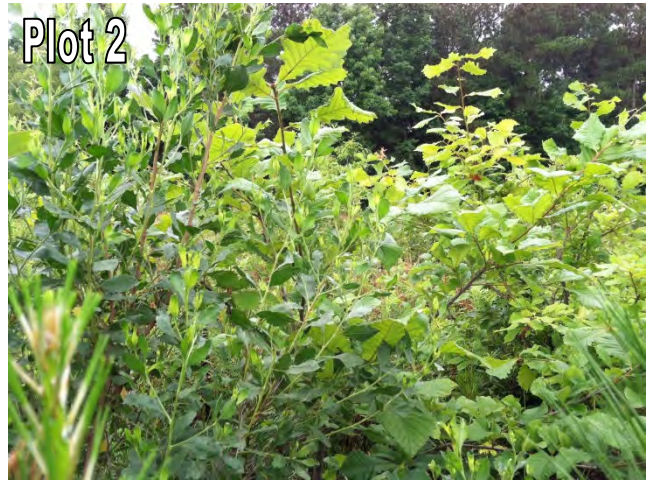
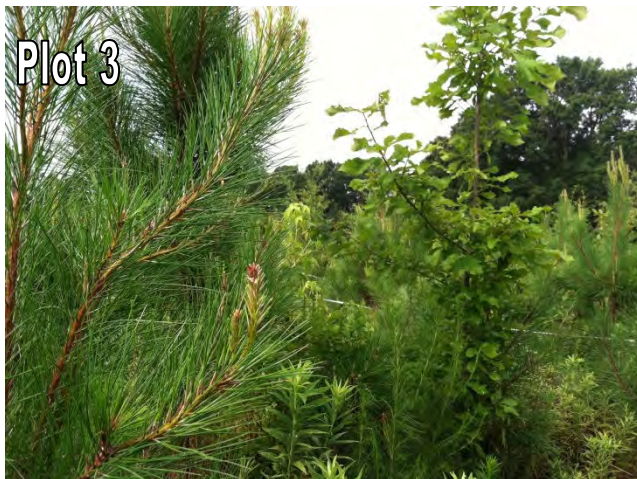
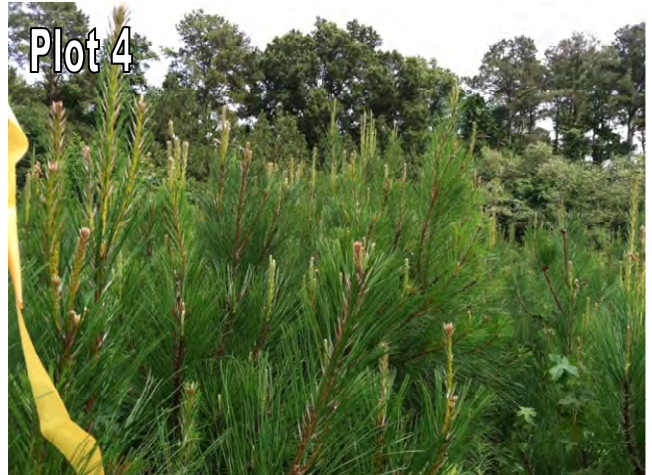
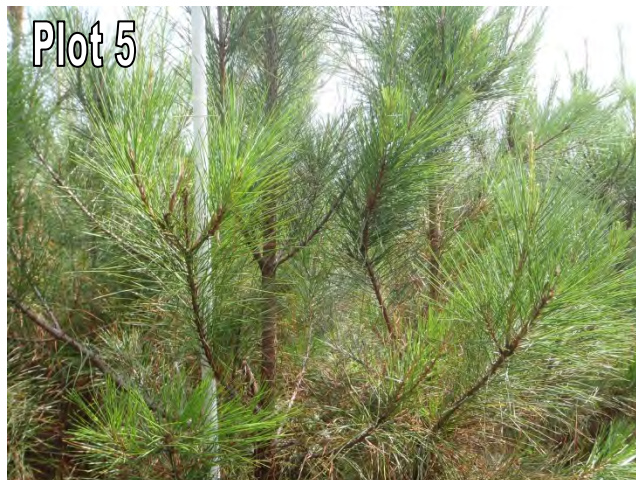
Anderson Swamp Wetland Restoration Site
Year 5 (2011) Annual Monitoring
Vegetation Plot Photos
Taken July 2011

Vegetation sampling across the Site was well-above the required average density with 643 planted stems per acre. No vegetation problem areas were noted during the Year 5 (2011) monitoring season.
