Final Mitigation Plan Apple Valley Project

**DMS Project #: 100063 | Contract #: 7531 | USACE Action ID: SAW- 2018-01150
DWR Project #: 20181028 | RFP: 16-007334**

November 2019

French Broad River Basin | HUC 06010105 | Henderson County, North Carolina

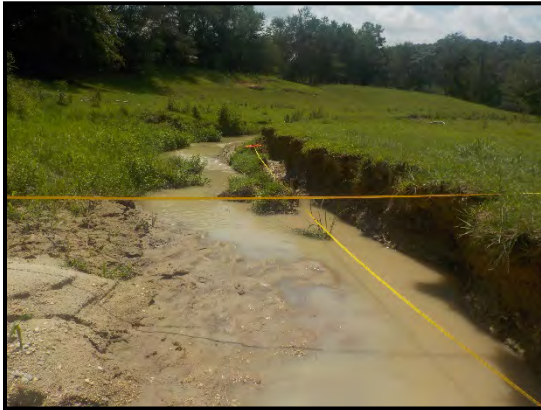
Reach AV1
Looking upstream

Reach AV1 begins at the northern limits of the project and flows south to the southern limits of the project at the Smith Road crossing. The reach is currently degrading and approaching a G-type channel. The channel valley is moderately confined and widens moving downstream on the reach. Livestock have full access to the stream except for approximately 200 feet at the most upstream end; subsequently the channel banks exhibit moderate erosion and slumping from hoof shear. The riparian buffers are mostly non-existent, with few scattered trees. Vegetation consists of mixed pasture grasses that are moderately grazed. At the upstream end, where livestock do not access, the vegetation consists of small trees and shrubby vegetation with a weedy understory.

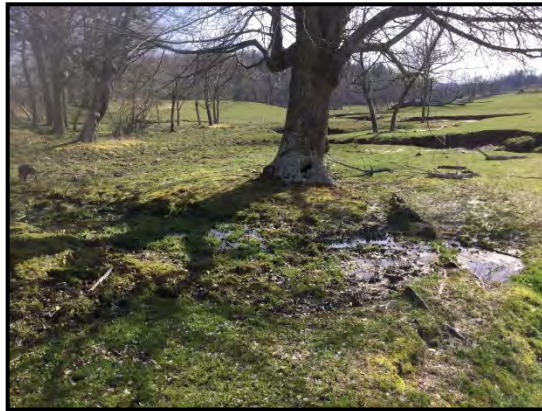
Wetland W1
Looking downstream

Wetland W1 is located on the left bank of reach AV1, approximately in the middle of the reach and on the low terrace between the top of bank and the toe of slope at the end of the floodplain. The wetland has been degraded by land clearing for agriculture and livestock grazing. Current vegetation consists of herbaceous wetland species but is regularly disturbed by livestock. One groundwater monitoring well was installed on the southern edge of W1 on November 11, 2018 and recorded the hydroperiod of the wetland through June 28, 2019 (**Figure 6**). While this period only captures part of a growing season, the wetland still more than met criteria with a hydroperiod of 24.0% (**Appendix B**). The well will be maintained through construction (2019) to capture the rest of the growing season.

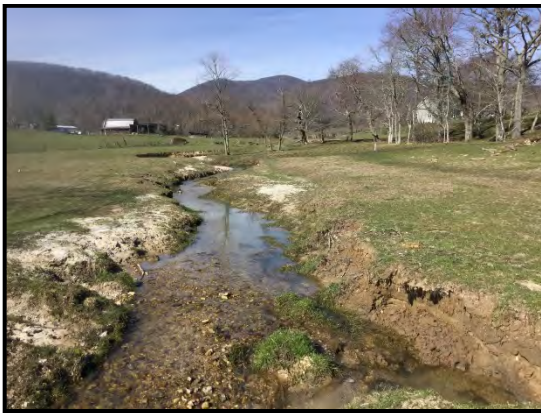
Potential wetland area H1
Looking upstream

Potential wetland area H1 is located along both banks of reach AV1 throughout its existing floodplain in the mapped hydric soils area (**Figure 6**). Hydric soils were mapped by a licensed soil scientist and exhibit characteristics of historically wet soils. This area was likely a riparian wetland prior to its development for agricultural uses and the subsequent downcutting of the Project reach (**Appendix B**). Land clearing for agriculture and cattle grazing have impacted this area, and channel incision has degraded hydrology. Two groundwater monitoring wells were installed on November 11, 2018 south of W1 and recorded the hydroperiod of the proposed wetland re-establishment area through June 28, 2019 (**Figure 6**). Well AW2 did not meet wetland criteria, with a hydroperiod of 1.8%, and showed groundwater elevation staying consistently deeper than 12” below the surface, except for significant rainfall events. In contrast, well AW3 did meet wetland criteria, with a hydroperiod of 24.4%, although groundwater elevation at this location was more responsive to precipitation events than well AW1 in Wetland W1 (**Appendix B**). These two wells will be maintained through construction to capture the rest of the growing season. Current vegetation is regularly disturbed by livestock but consists mainly of pasture grasses with few scattered trees.

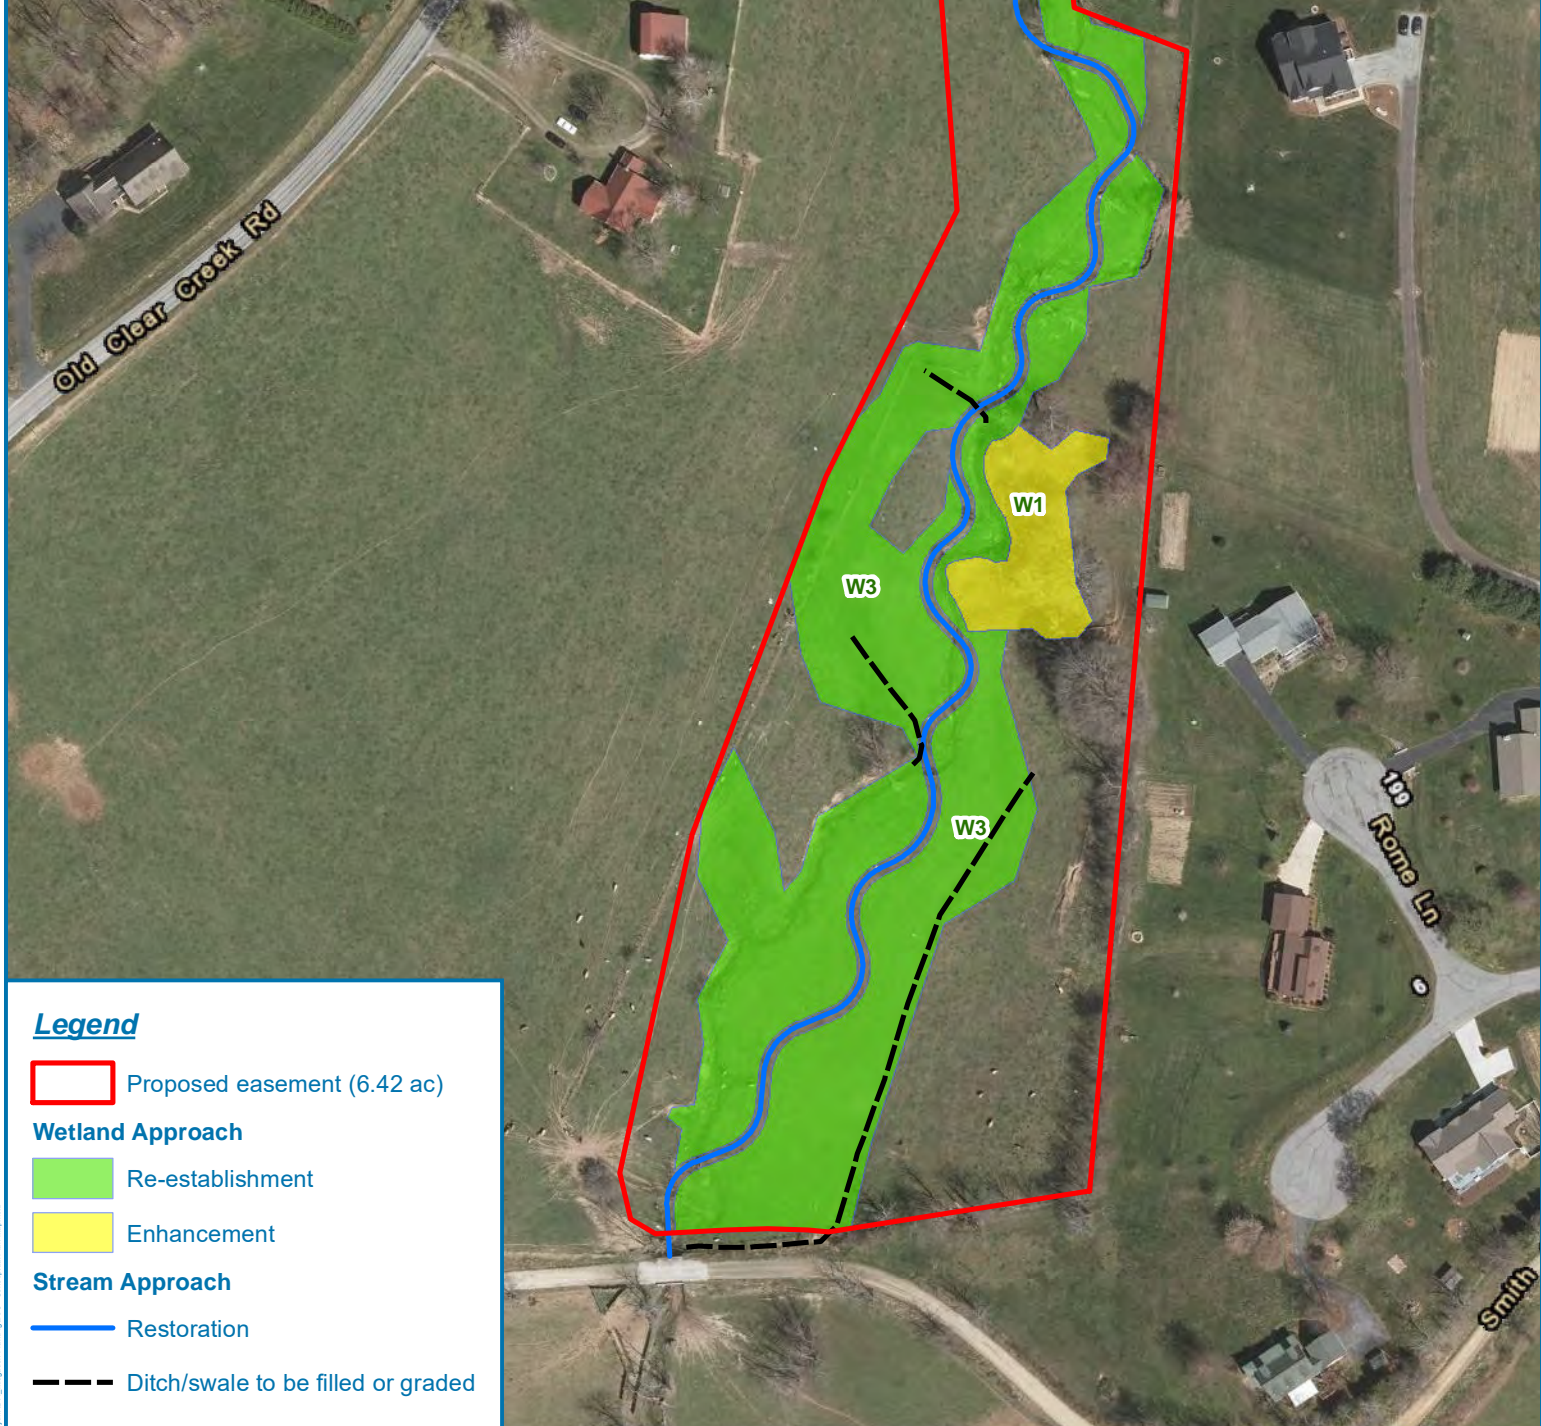
- Proposed easement (6.42 ac)
- Wetland Approach**
- Re-establishment
- Enhancement
- Stream Approach**
- Restoration
- Ditch/swale to be filled or graded

15. Sheet S3 – Please confirm whether the ditch/swale section from the easement boundary to the stream culvert crossing will be filled (as shown on Figure 8). If not, DWR recommends a ditch plug be installed at the easement boundary.

15. Sheet S3 – Please confirm whether the ditch/swale section from the easement boundary to the stream culvert crossing will be filled (as shown on Figure 8). If not, DWR recommends a ditch plug be installed at the easement boundary.
The swale in question is called out to be filled on Sheet W1 of the planset.

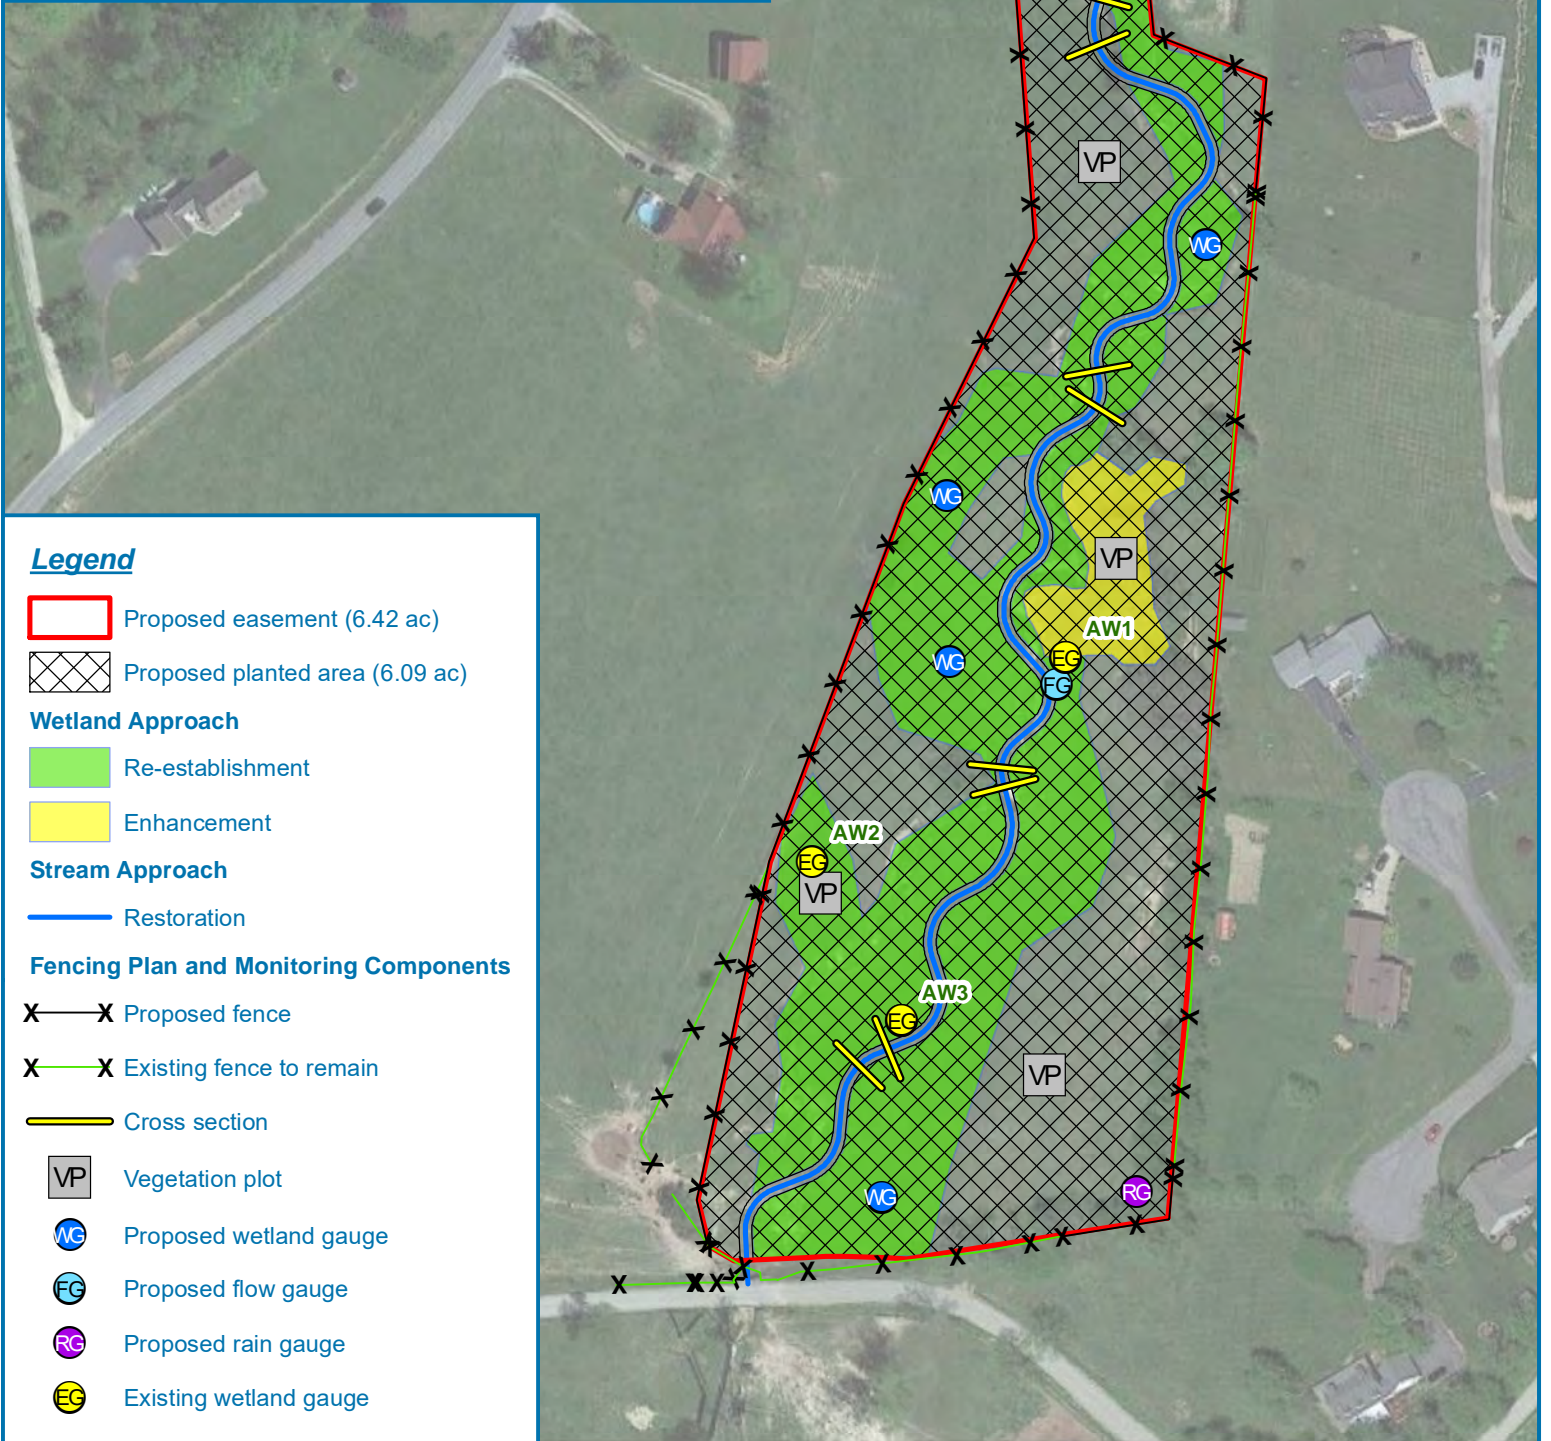
Random vegetation plots are not shown in this monitoring plan. Random plots will vary by location and dimension.

Stream gauge, wetland gauge, and vegetation plot locations are all proposed locations.

12. Figure 10 – DWR requests the installation of three (3) additional groundwater gauge, or relocation of either gauge AW2 or AW3 and installation of two (2) additional gauges. Recommended locations of new gauges are (1) in the wetland re-establishment area between the relic stream channel and proposed channel near Station 4+50, (2) in the wetland re-establishment area close to the western easement boundary between Stations 6+00 and 7+50, and (3) in the wetland re-establishment area close to the western easement boundary and veg plot between Stations 10+00 and 11+00.

12. Figure 10 – DWR requests the installation of three (3) additional groundwater gauge, or relocation of either gauge AW2 or AW3 and installation of two (2) additional gauges. Recommended locations of new gauges are (1) in the wetland re-establishment area between the relic stream channel and proposed channel near Station 4+50, (2) in the wetland re-establishment area close to the western easement boundary between Stations 6+00 and 7+50, and (3) in the wetland re-establishment area close to the western easement boundary and veg plot between Stations 10+00 and 11+00.
*Gauge AW2 has been moved and two gauges have been added to the suggested locations. **Figure 10 and Section 8.5** have been updated to reflect this change.*

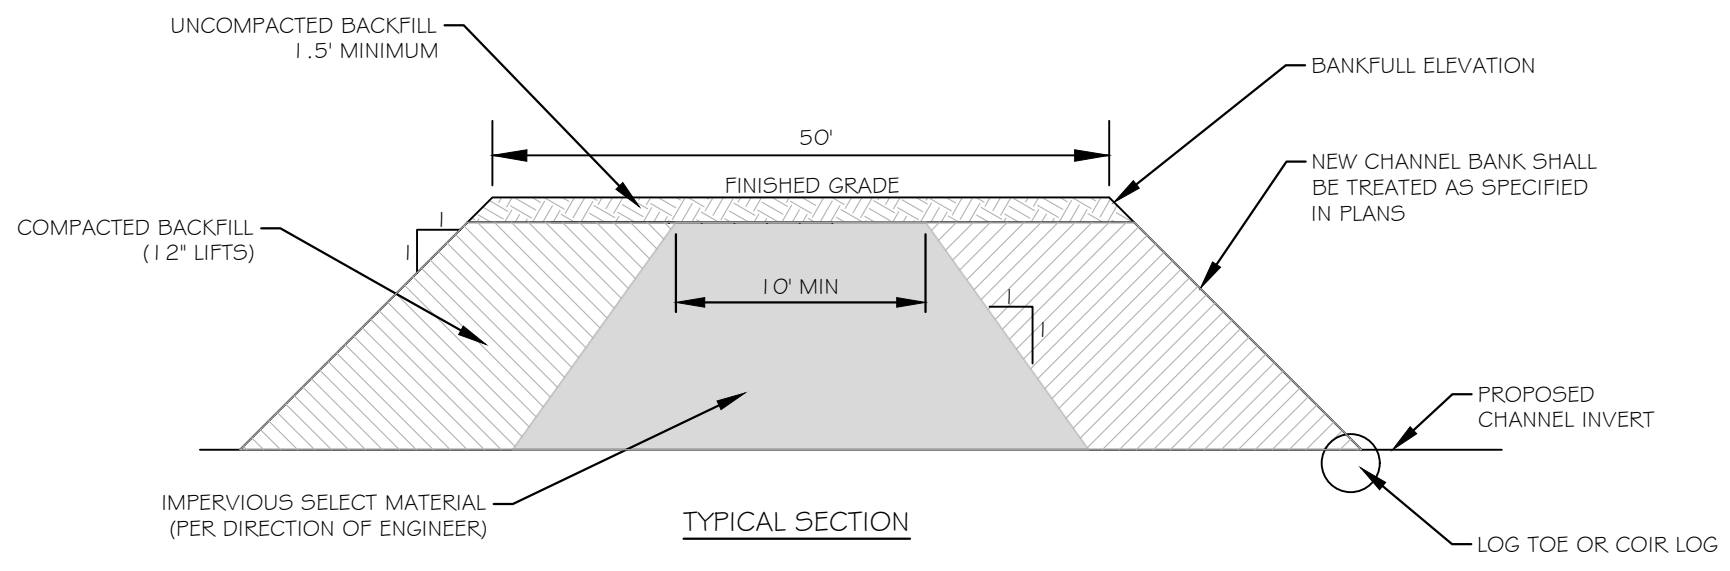
CHANNEL PLUG

- NOTES:
1. FILL EXISTING CHANNEL TO TOP OF BANK ELEVATION WHEN POSSIBLE.
 2. CHANNEL MUST BE FILLED IN 12" TO 18" LIFTS.
 3. IF CHANNEL CANNOT BE COMPLETELY FILLED TO TOP OF BANK, FILL TO TOP OF BANK FOR 25' OUT OF EVERY 100' SEGMENT.

8. Please specify on the design sheets which section of stream is planned for P2. Also please depict where the ditch plug will occur, and how much. It's recommended that at least 50 feet be plugged with high content clay soils.

8. Please specify on the design sheets which section of stream is planned for P2. Also please depict where the ditch plug will occur, and how much. It's recommended that at least 50 feet be plugged with high content clay soils.
Floodplain benching is not proposed on this project. References to P2 restoration have been removed from the document to clarify. Ditch plugs are not proposed on this project; however, channel plugs are proposed along portions of the channel that is to be abandoned. Additionally, the channel plug detail has been updated per comment; see detail Sheet D2. Floodplain drainage features (all swales) are called out to be filled on sheet W1 in the planset, and two callouts have been added to this sheet to clarify these features. References to "plugging ditches" within the document have been corrected to "filling ditches" to clarify this.

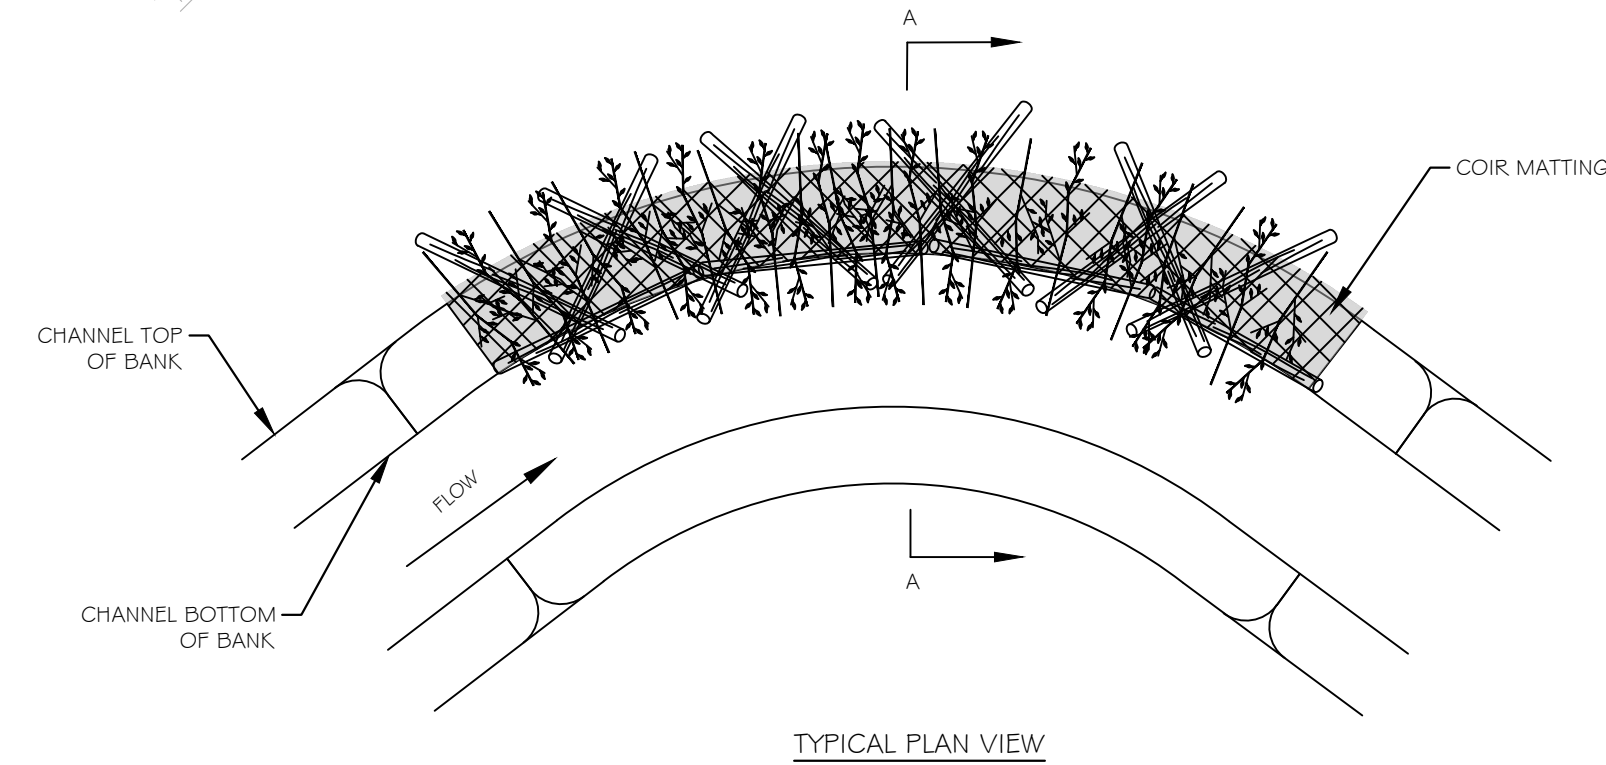
BRUSH TOE

1. OVER EXCAVATE THE OUTSIDE BEND OF THE CHANNEL. PLACE LARGER BRANCHES AND LOGS IN A CRISS-CROSS PATTERN. LOCK IN PLACE WITH FILL COVERING 6 IN TO 12 IN OF THE LARGER BRANCHES/SMALL LOGS.
2. PLACE SMALLER BRANCHES AND BRUSH OVER THE LARGER BRANCHES/SMALL LOGS (HARDWOOD SPECIES ONLY) AND COMPACT LIGHTLY TOGETHER. BACKFILL AND COMPACT TO LOCK IN PLACE.
3. PLACE LIVE CUTTINGS OVER THE SMALL BRANCHES AND BRUSH. ACCEPTABLE LIVE CUTTINGS SPECIES INCLUDE BLACK WILLOW (SALIX NIGRA) AND SILKY WILLOW (SALIX SERICEA). WILLOW CUTTINGS SHOULD BE RINSED AT CUTTING POINT TO ALLOW BETTER ROOTING.
4. INSTALL EROSION CONTROL (COIR) MATTING OVER COMPACTED SOIL PER DIRECTION OF ENGINEER. COIR MATTING SHOULD BE KEED INTO TOP OF BANK.
5. INSTALL 1 TO 3 ROWS OF LIVE STAKES ABOVE THE LIVE CUTTINGS LAYER PER DIRECTION OF ENGINEER.
