MONITORING REPORT (MY1)

ARABIA BAY WETLAND MITIGATION SITE

Hoke County, North Carolina

Data Collection: January - November 2020
Submission: December 2020

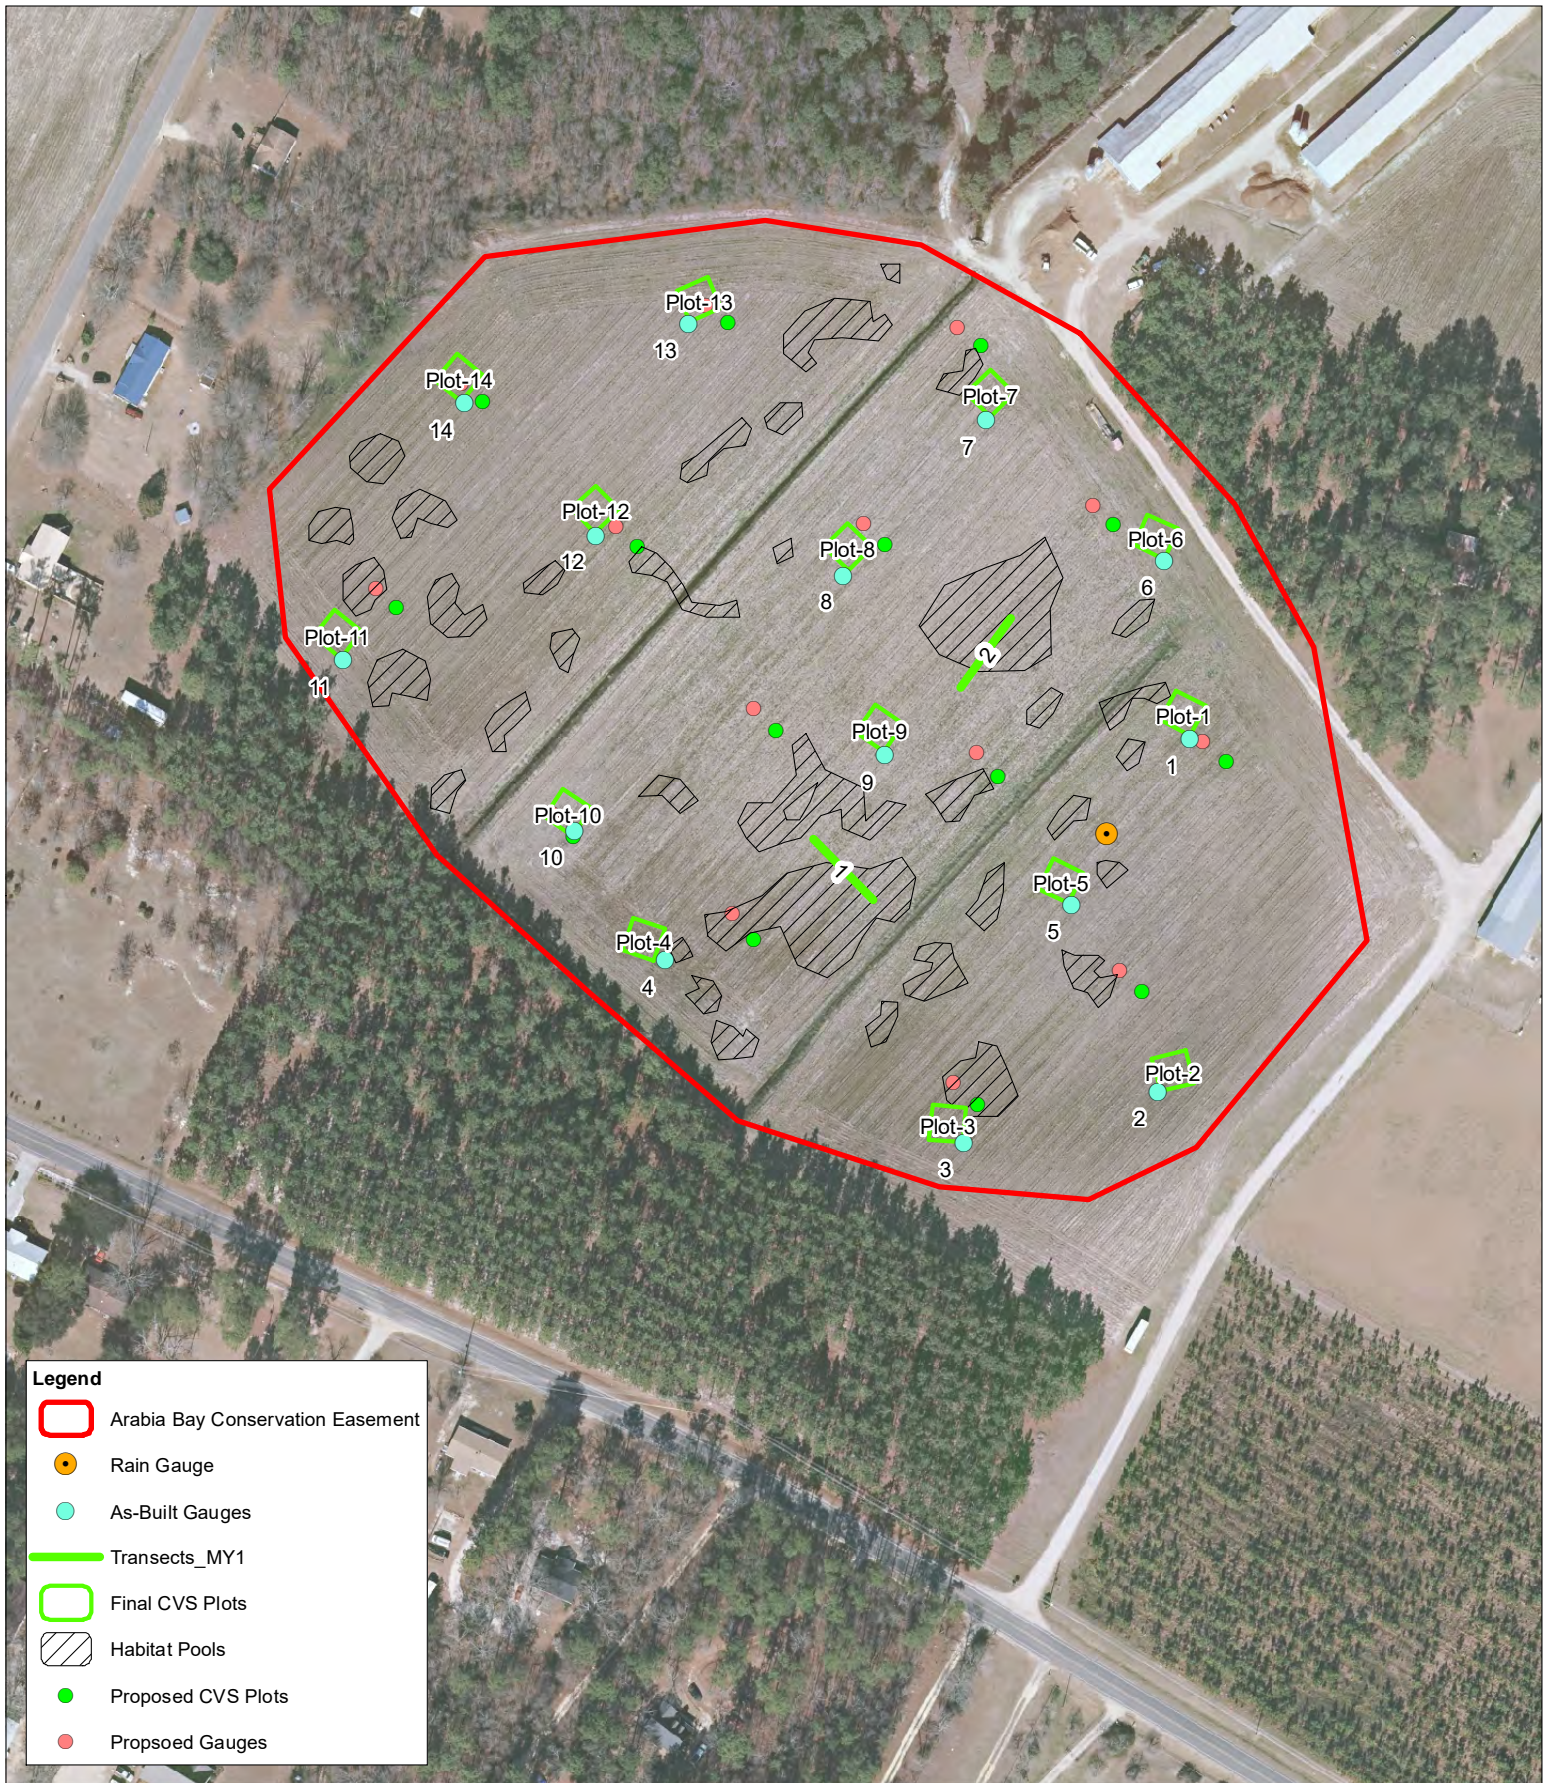
**Arabia Bay Wetland Mitigation Site
 Mit Plan Monitoring Device Location VS
 As-Built Location**

- c. Particularly for wetland restoration projects, it would be helpful to note if there are shifts (more than just a few feet) in monitoring locations (veg plots and wells) from the final monitoring plan.

[Understood – See Figure below comment responses "Arabia Bay Wetland Mitigation Site Mit Plan Monitoring Device Location VS As-Built Location".](#)

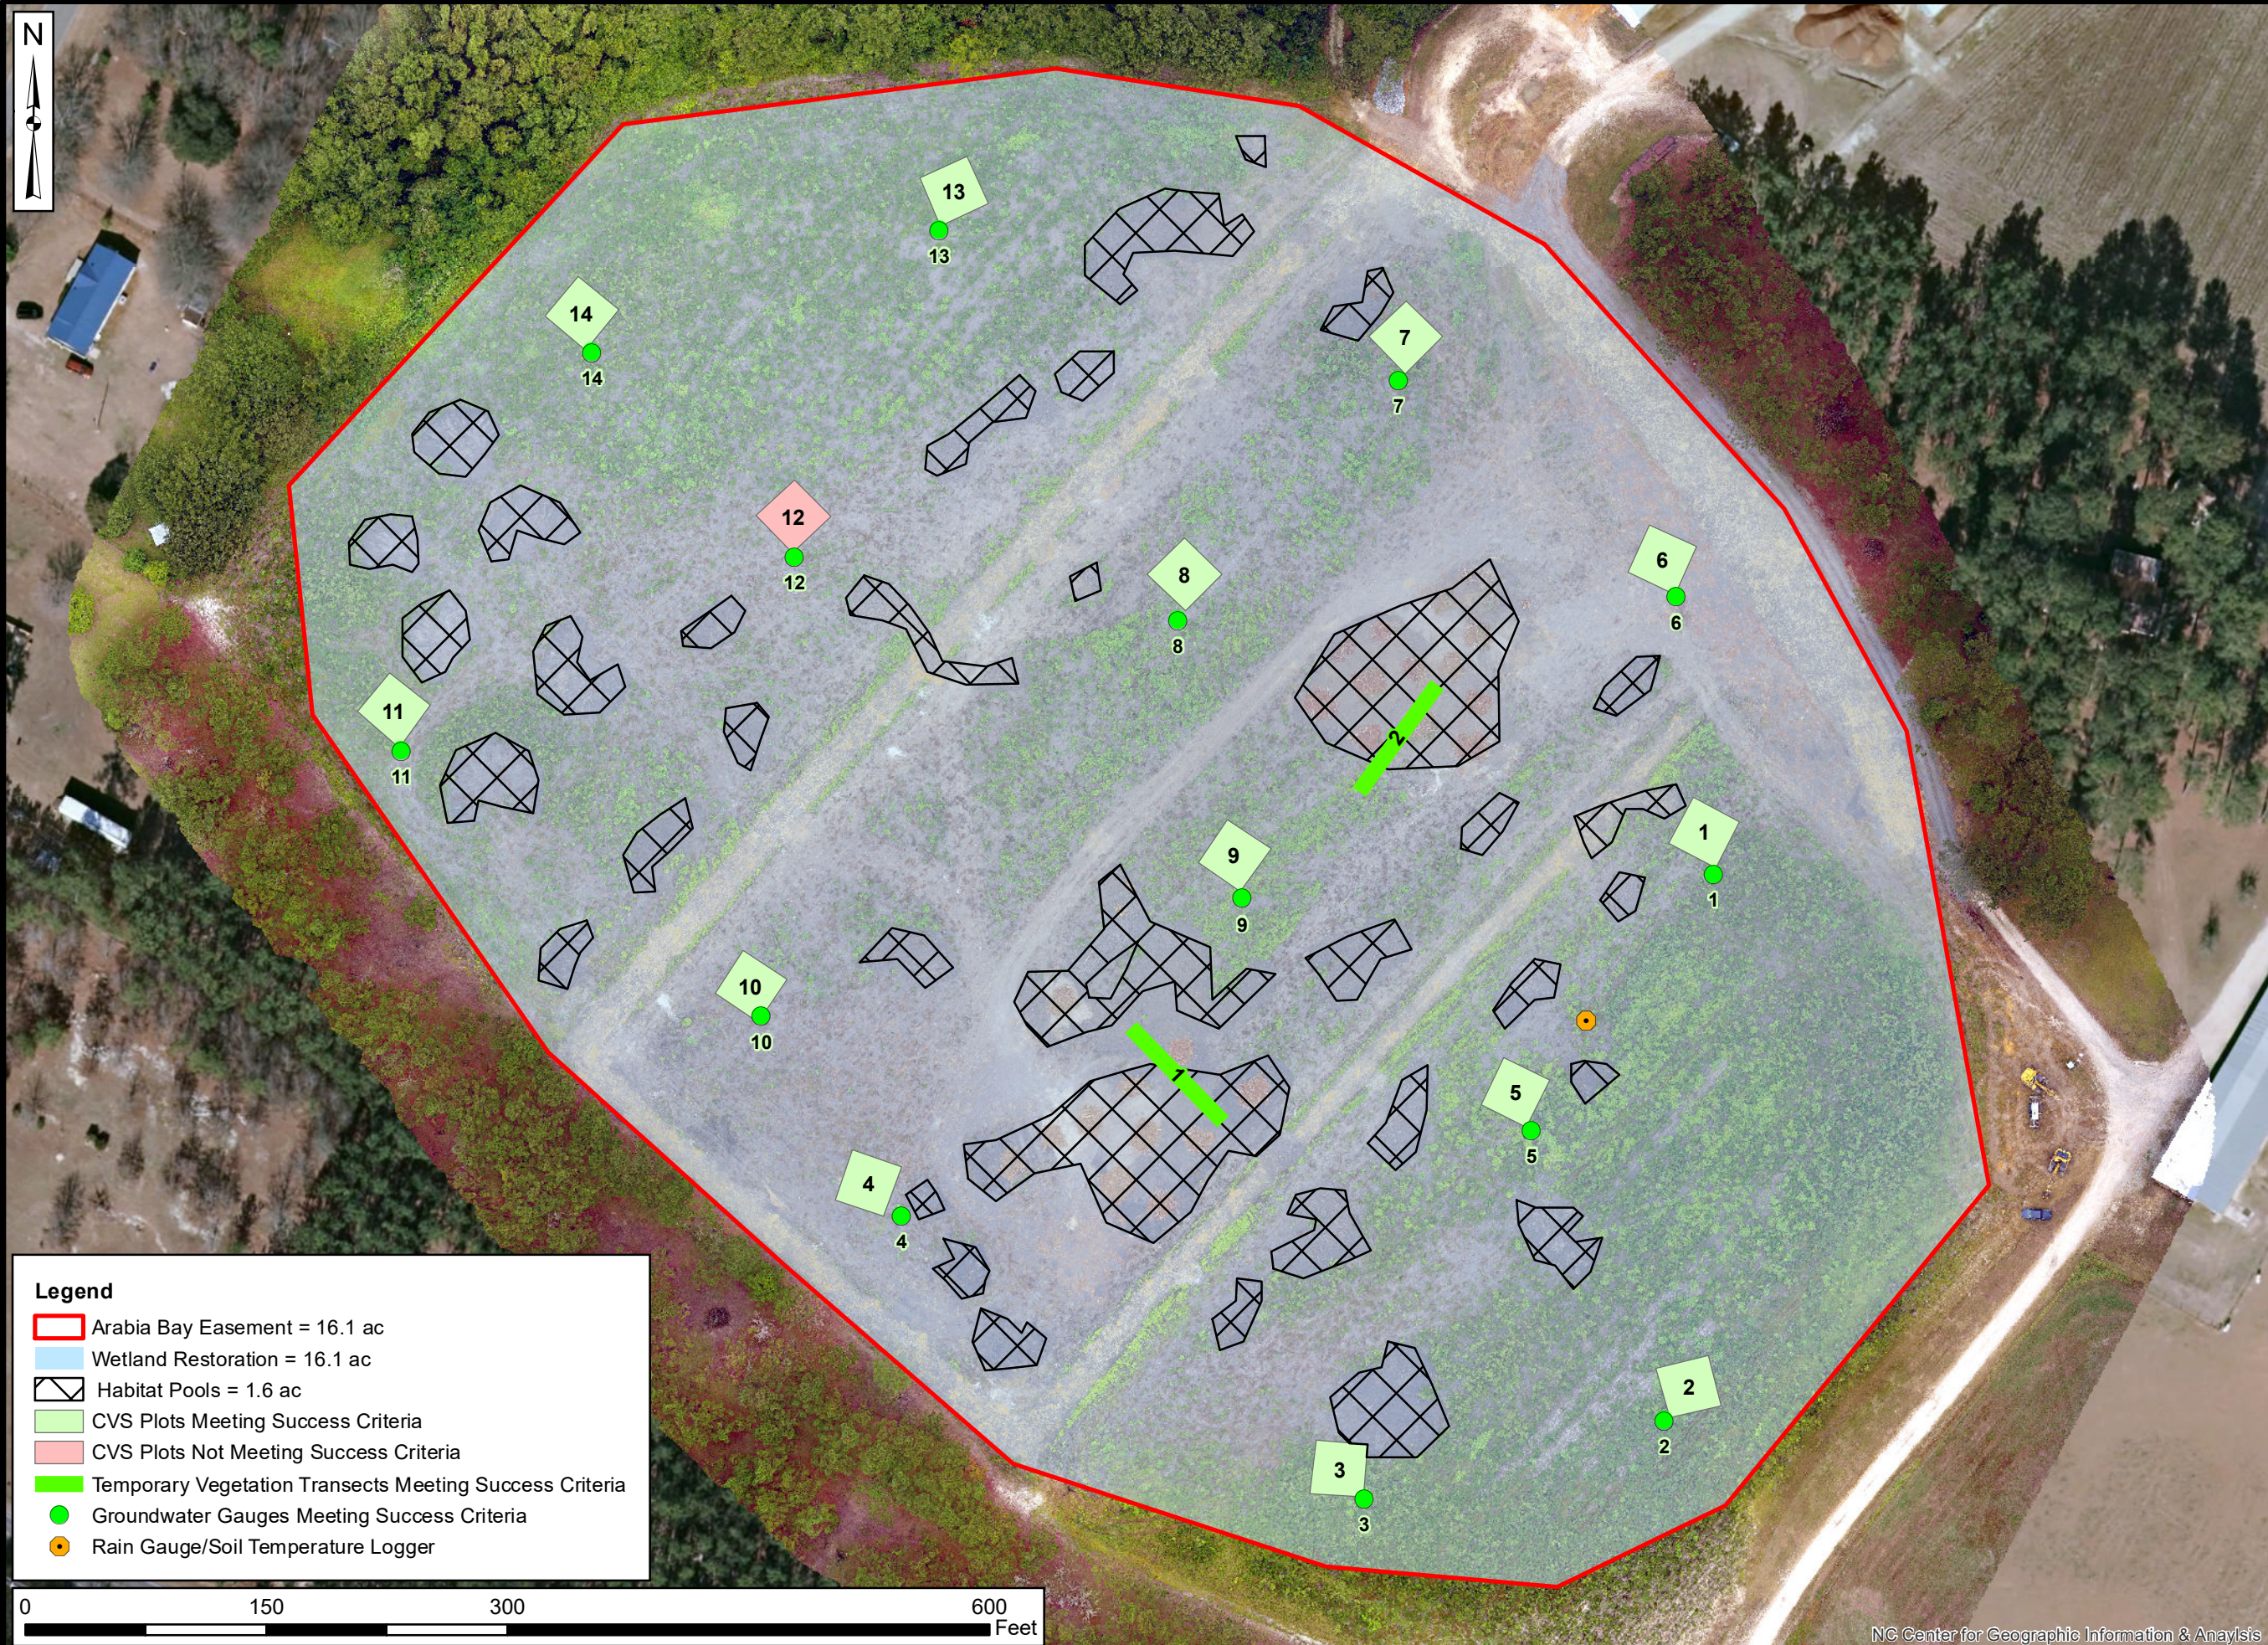
CURRENT CONDITIONS PLAN VIEW

These dates have been added to Table 2, located in the Monitoring Summary and within Appendix A.
4. Figure 2 –
 - a. Please confirm whether the total area of habitat pools is 1.6 acres (Fig. 2) or 1.8 acres (Sheet 3 of 4).

The discrepancy between 1.6 and 1.8 acres results from the surveyor applying a polygon simplification algorithm to their work, which softens the lines seen in Figure 2. Figure 2 shows the actual surveyed points of the habitat pools.
 - b. The location, size and quantity of habitat pools appear notably different from that presented in the final mitigation plan. The mitigation plan showed 14 pools located primarily around the perimeter of the restoration area. Figure 2 show 36 smaller pools, with the larger pools located near the center of the restoration area. DWR understands that some variability with size and location of pools from mit plan to as-built is expected, but would like a brief explanation for these construction field changes.

The change is the result of finding suitable clay for ditch plugs within the larger pools. As a result of harvesting clay in these areas, fewer and small pools were required elsewhere for fill material.
