ARMSTRONG PROPERTY WETLAND AND STREAM MITIGATION PLAN

**Hyde County
USGS Catalog Unit 03020104090010
EEP Project No 16-D06012
Design Firm: Albemarle Restorations, LLC**

APRIL 2008

2.0 AS-BUILT REPORT

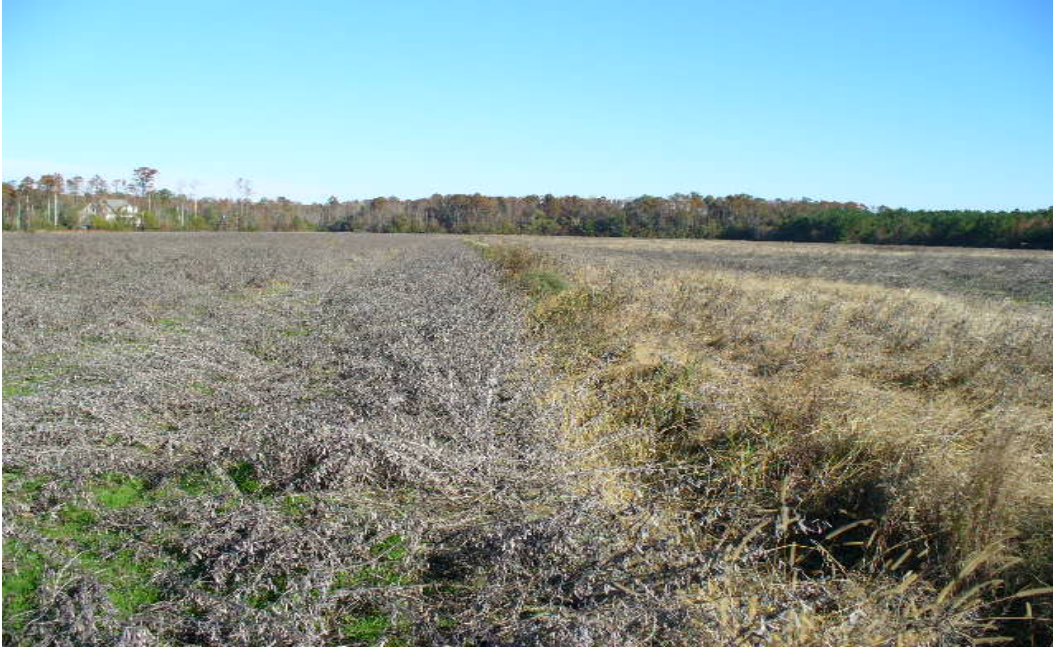
Photo 1: Crop field prior to riverine wetland restoration. Much of the restoration area was formerly cypress swamp which was cleared, drained and graded for agriculture

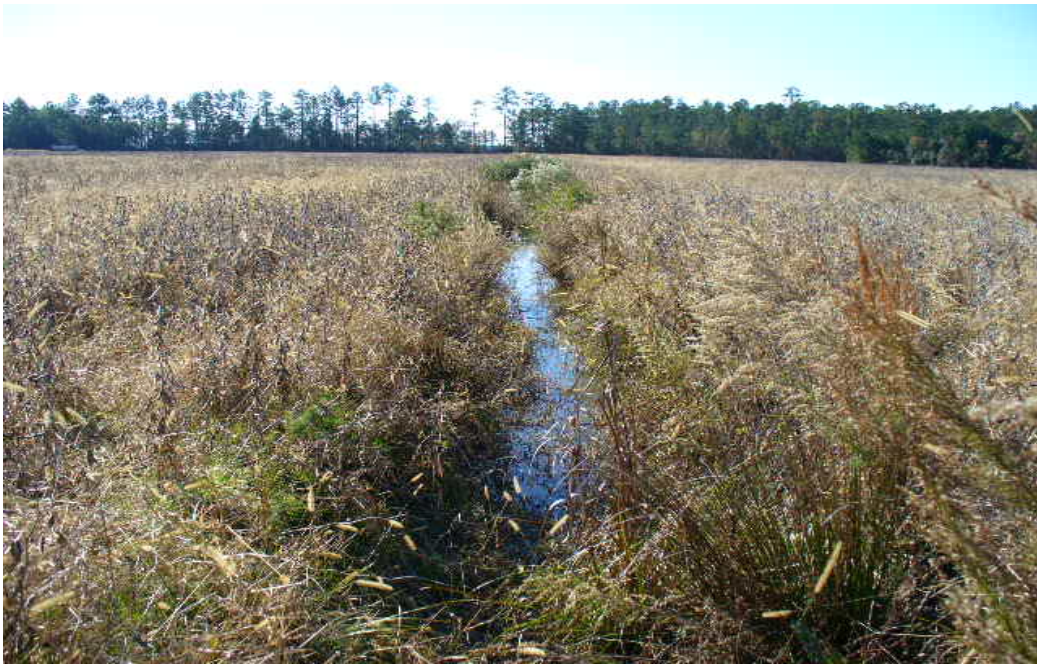
Photo 2: Ditched stream draining cropland. This ditch was the main stem of the proposed “swamp run” restoration and drains into Clark Mill Creek.

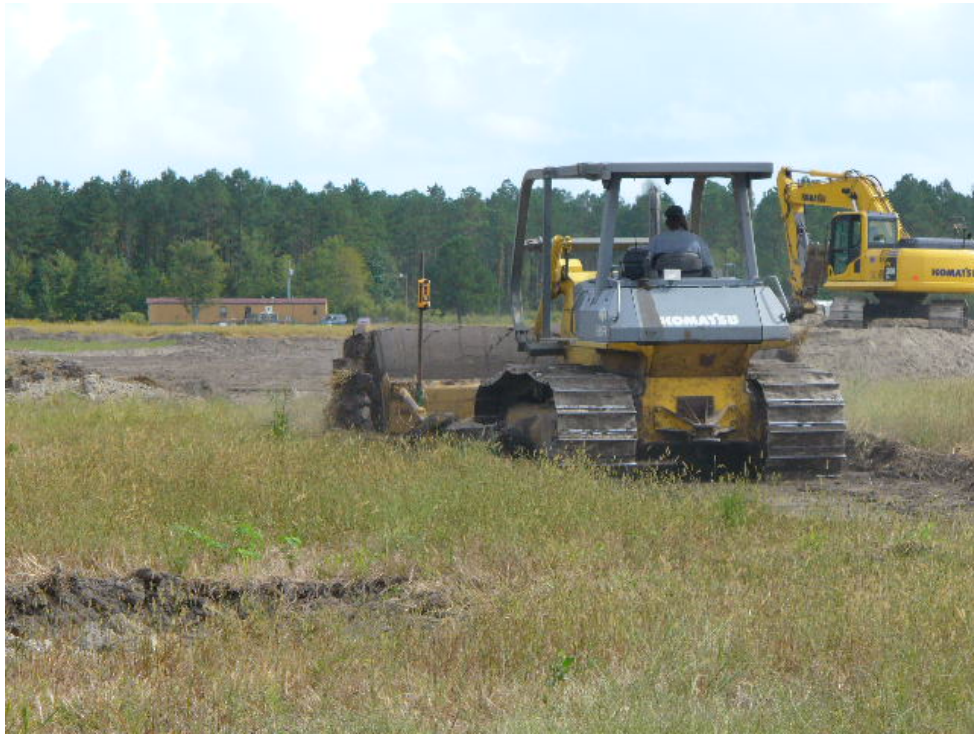
Photo 3. Initial cutting and stockpiling of topsoil for redistribution after final grading.

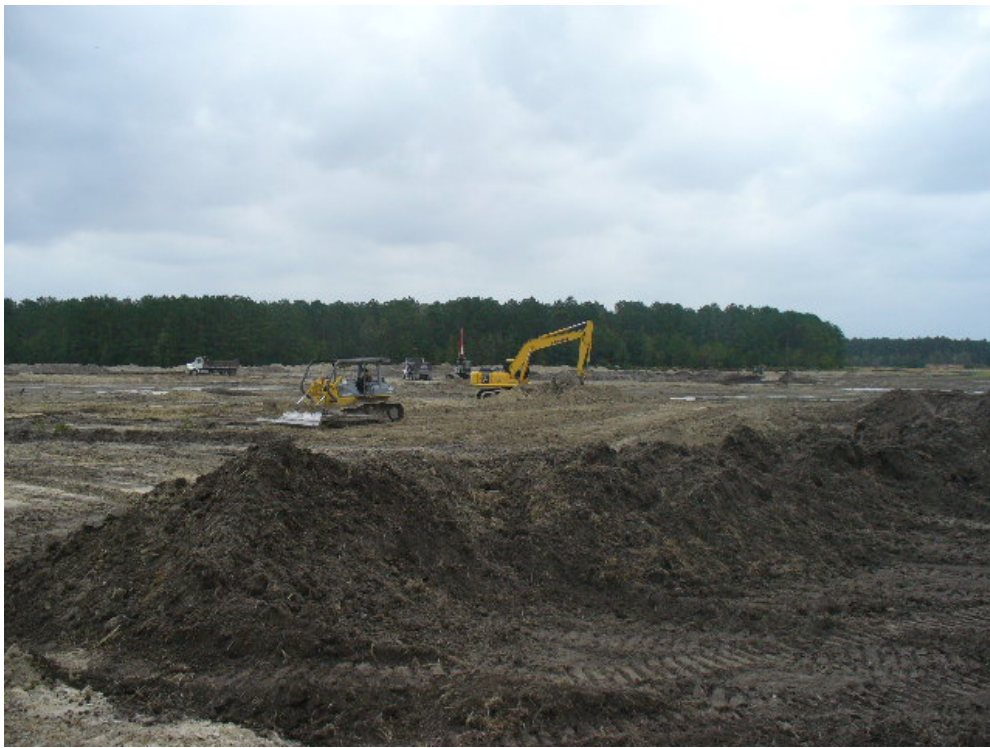
Photo 4. Cutting, filling and grading of restore swamp run.

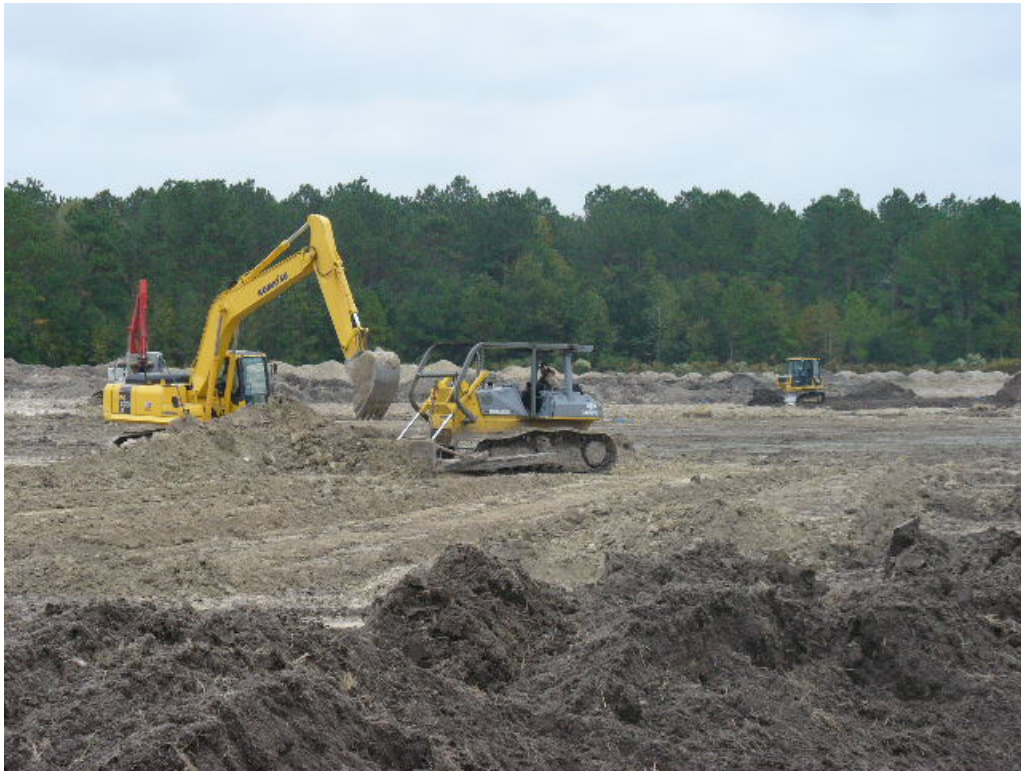
Photo 5. Redistribution of topsoil and final grading of restored swamp run and riverine wetlands.

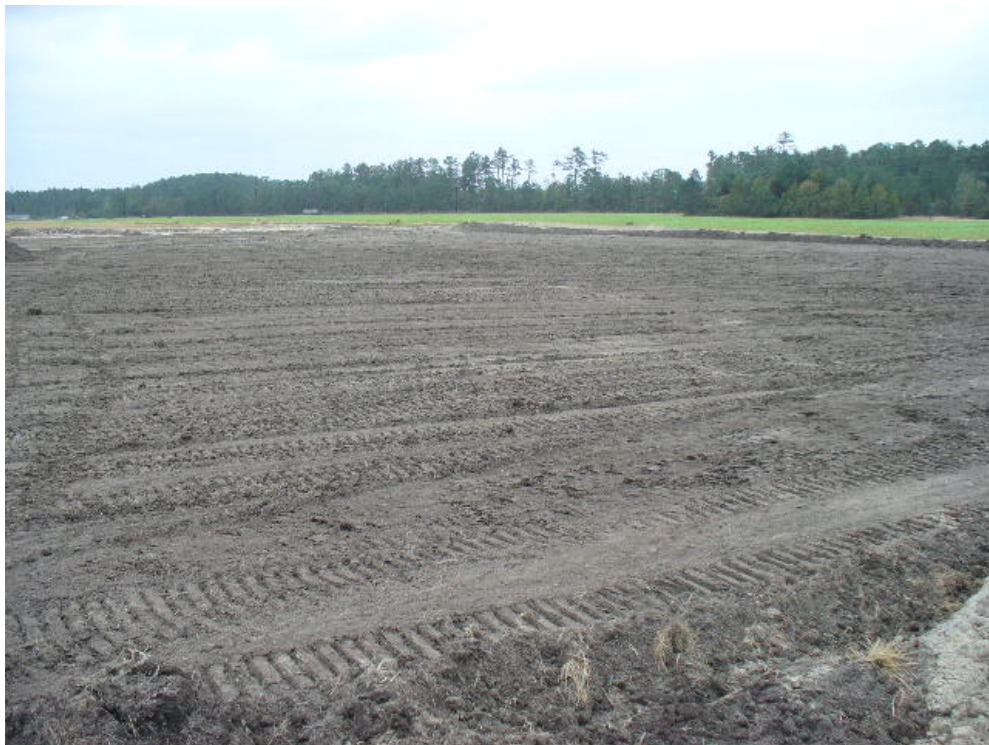
Photo 6. Restored swamp run after final grading.

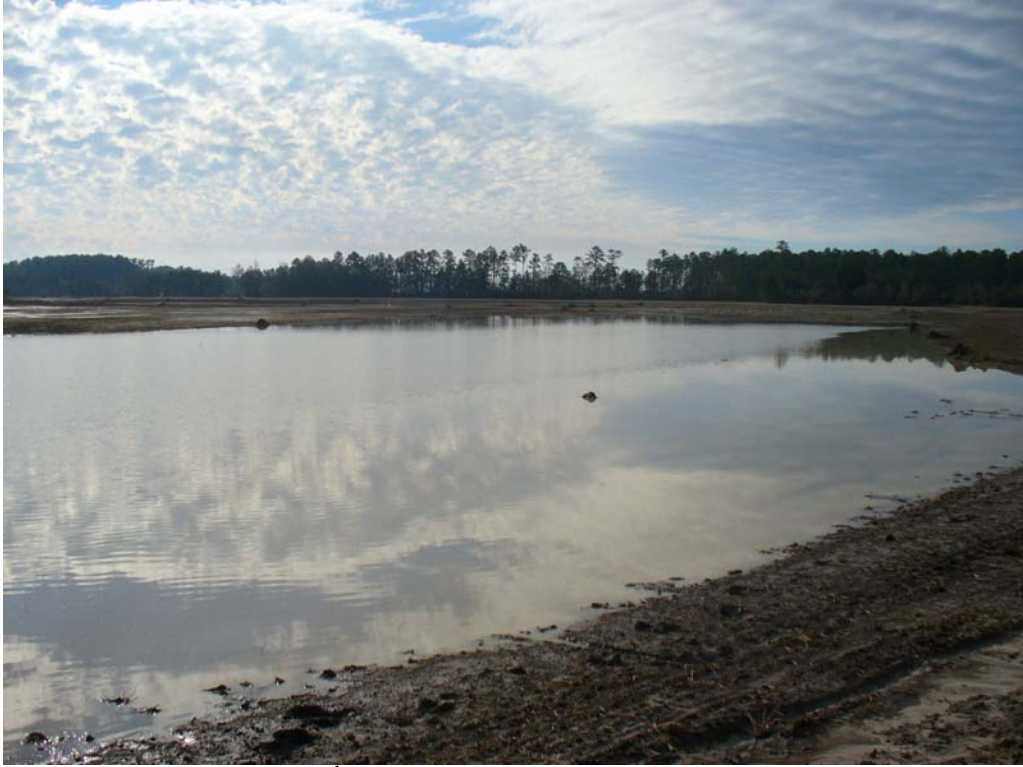
Photo 7. December 18th - restored swamp run after 3” rain, three weeks after completion of construction.

Within two months of project completion, the restored swamp run and adjacent riverine wetlands had experienced “overbank” flooding. The swamp run has been inundated during each periodic site visit since the project was completed. Photographs of the site taken in December 2007 & January 2008 are found in **Appendix A**.

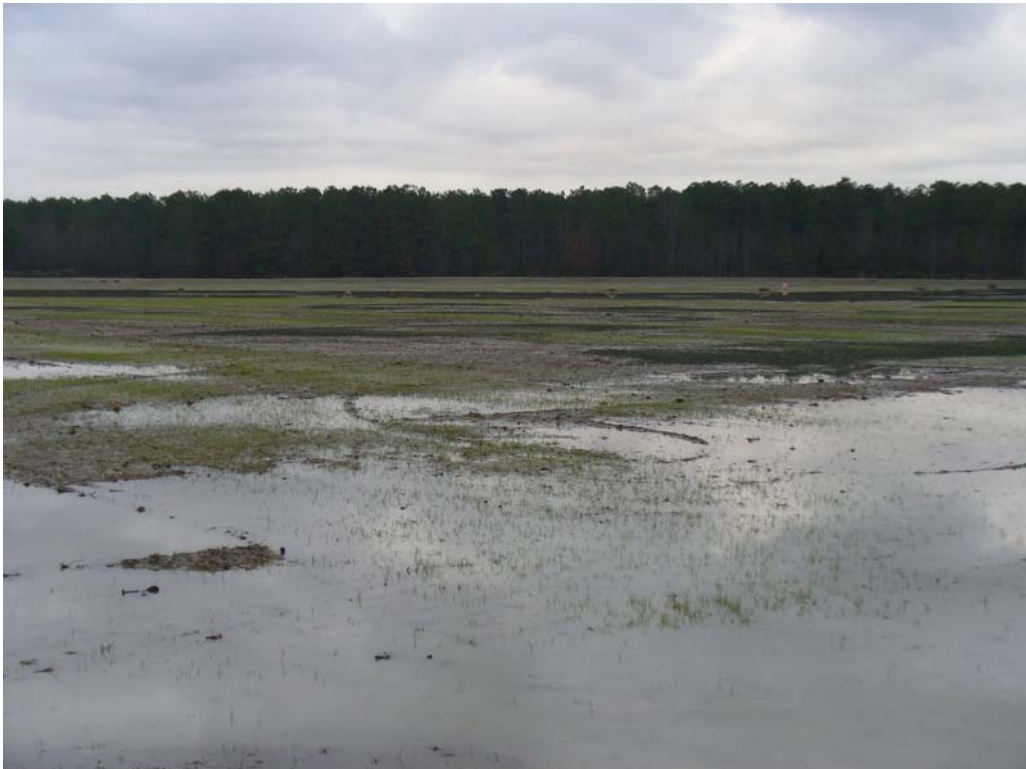
Photo 8. From January 21-22nd, the project experienced its first “out-of-bank” flooding event.

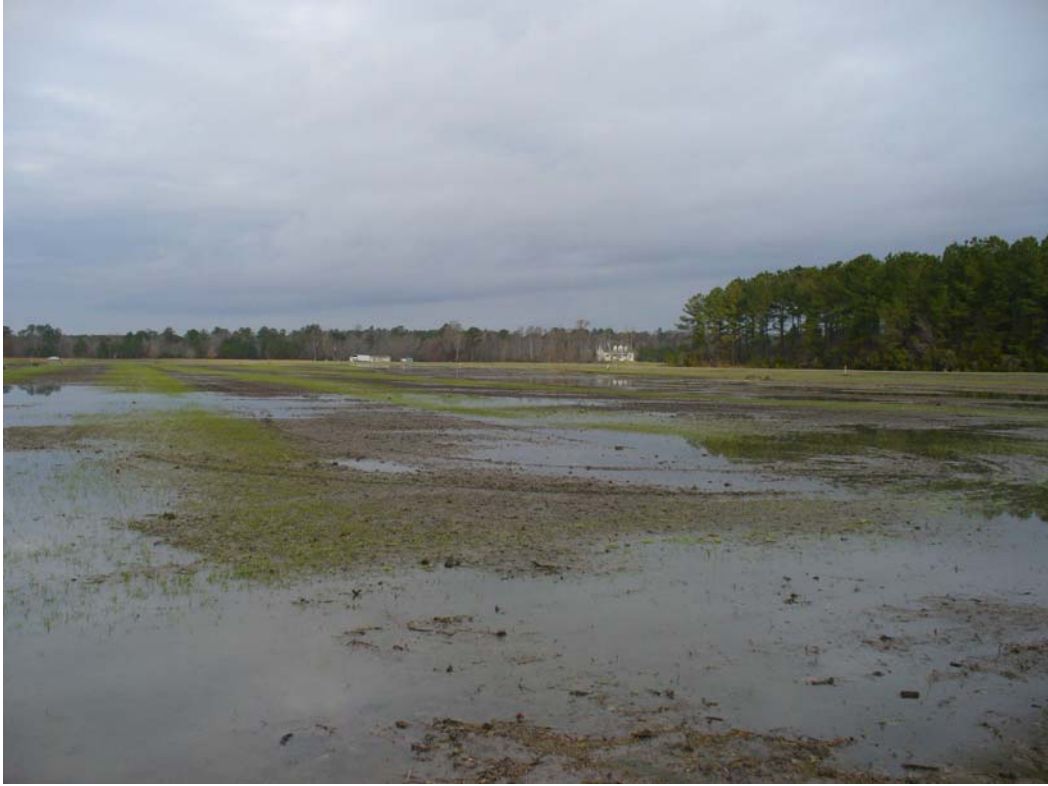
Photo 9. Overbank flooding into the restored riverine wetlands at the headwaters of the restored swamp run.

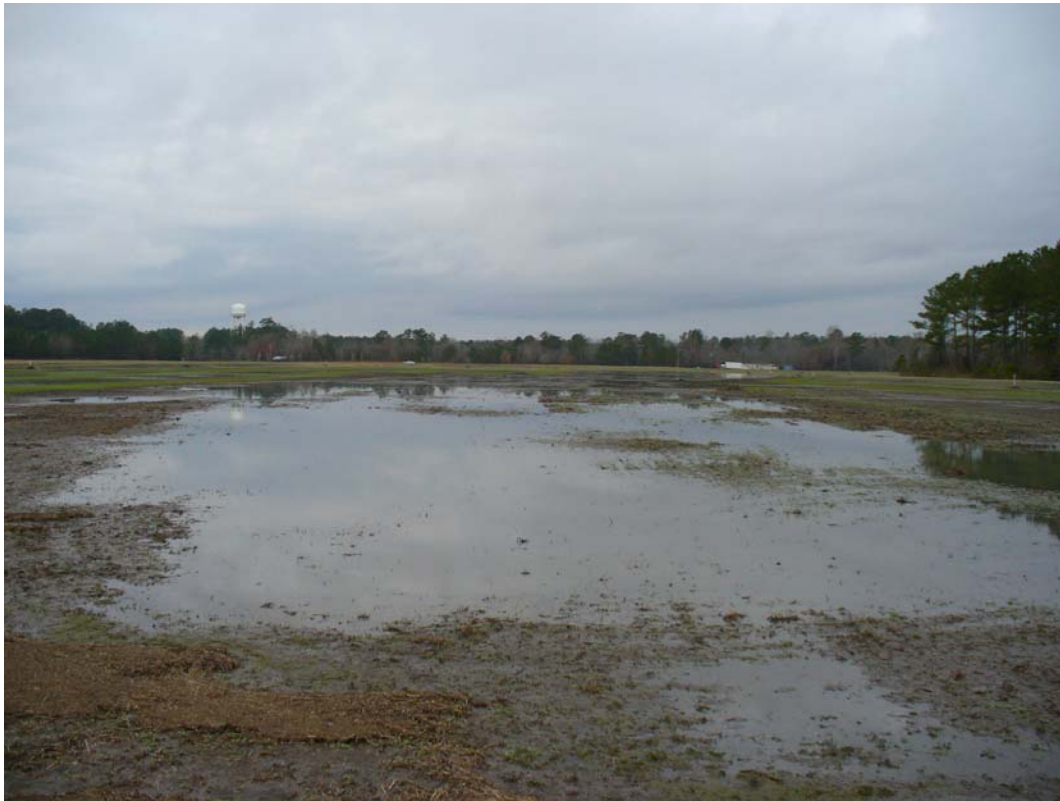
Photo 10. Driftlines from out-of bank flooding event, looking downstream.

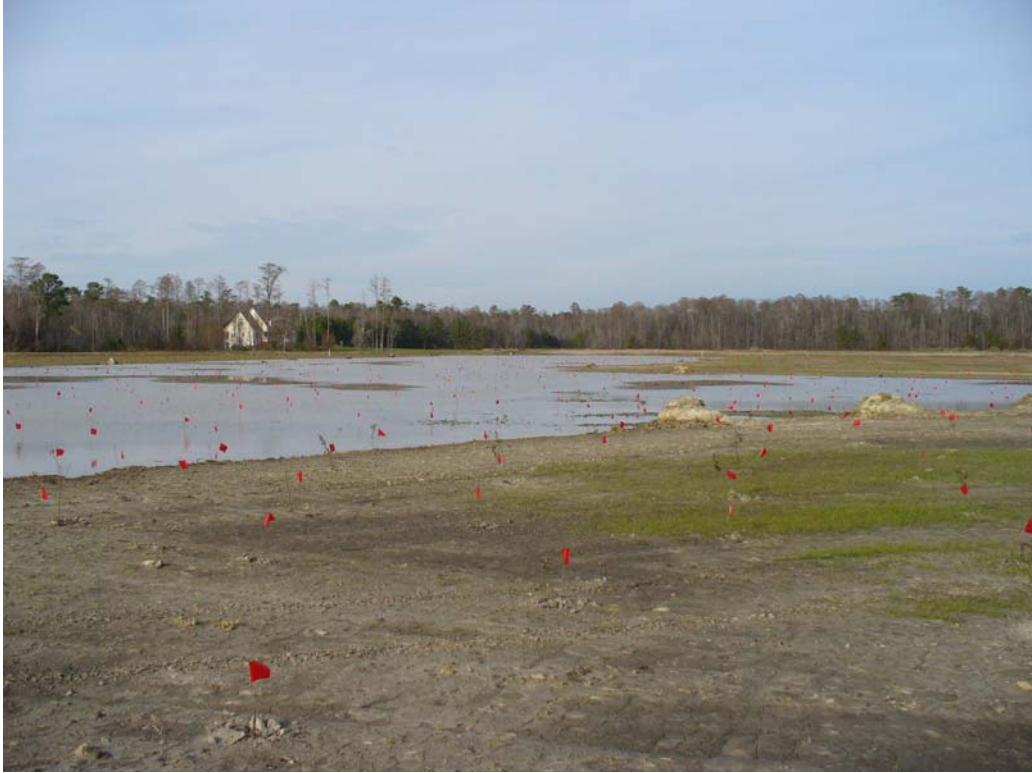
Photo 11. Project planted to trees and shrubs, looking downstream.

Tree and shrub planting on the project site was completed on January 28 and 29, 2008 using containerized and bare-root seedlings. The emergent wetland seed mixture was spread just after grading was completed. All planting was done in accordance with the approved restoration plan, the exception being the size of plant material. Due to availability of plant materials, smaller sized seedlings were installed than what was originally specified in the restoration plan. Also, the site was over planted at a rate of 430 stems per acre, as opposed to the 350 stems/acre specified in the restoration plan. **Table 3** below summarizes the species planted.

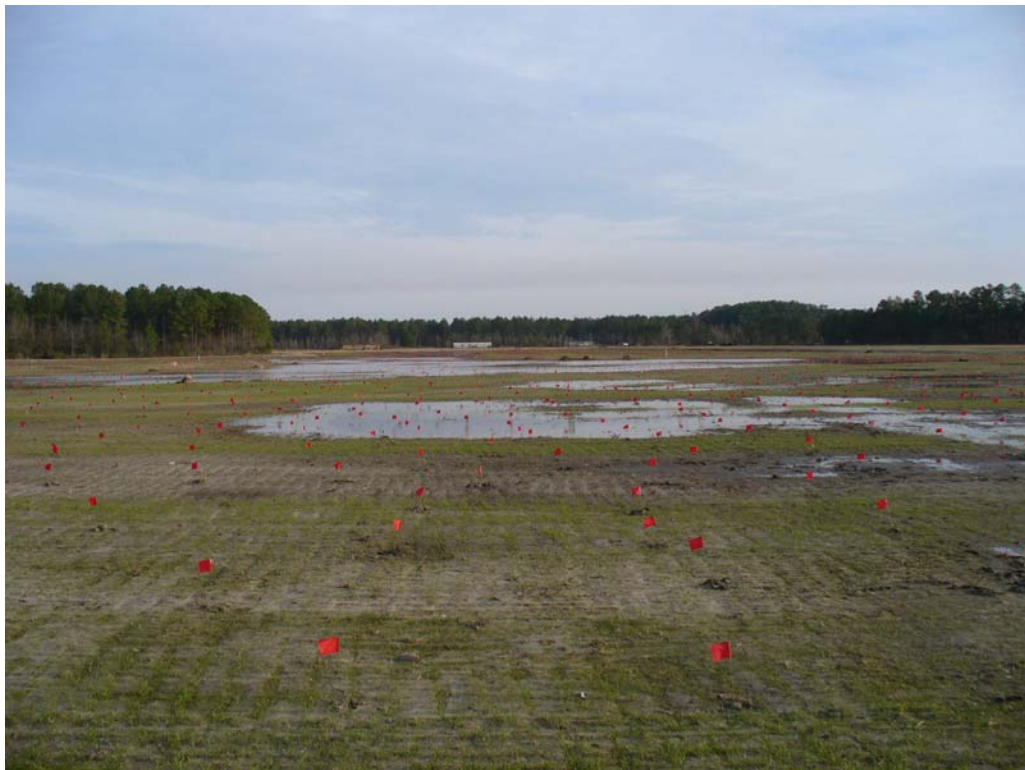
Photo 12. Project planted to trees and shrubs, looking upstream.

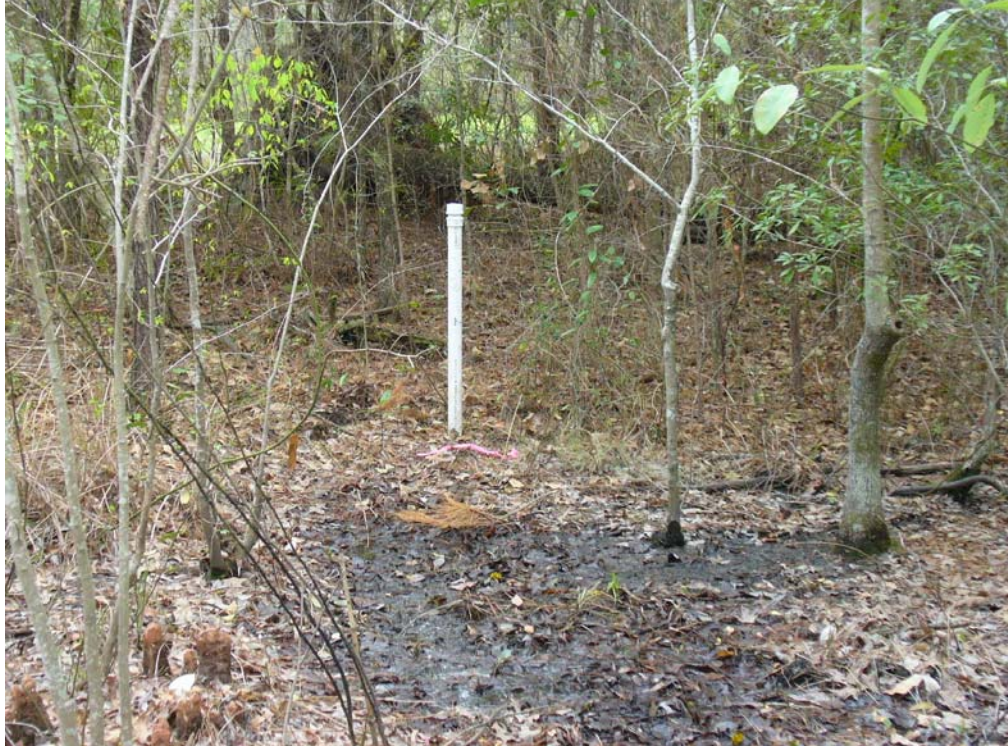
Photo 13. Reference wetland well #1 location, located in riparian wetlands Associated with unnamed tributary to Clark Mill Creek.

To further gauge the affect of seasonal and annual variations in precipitation and to set a target hydrologic range for the restored wetlands, a reference site will be monitored which is near to the restoration area (Sheet R-1, Appendix B). Two hydrologic monitoring wells were installed within the reference wetland. The wells are located in similar position in the landscape as the restored riverine wetlands, and will be monitored in the same manner as the project monitoring wells. In cases where severe drought or other natural occurrences effect groundwater levels which prevent hydrologic success criteria from being achieved, data collected at the reference site will be used to verify that fluctuations in groundwater elevations are due to natural occurrences and not to deficiencies in the project design.

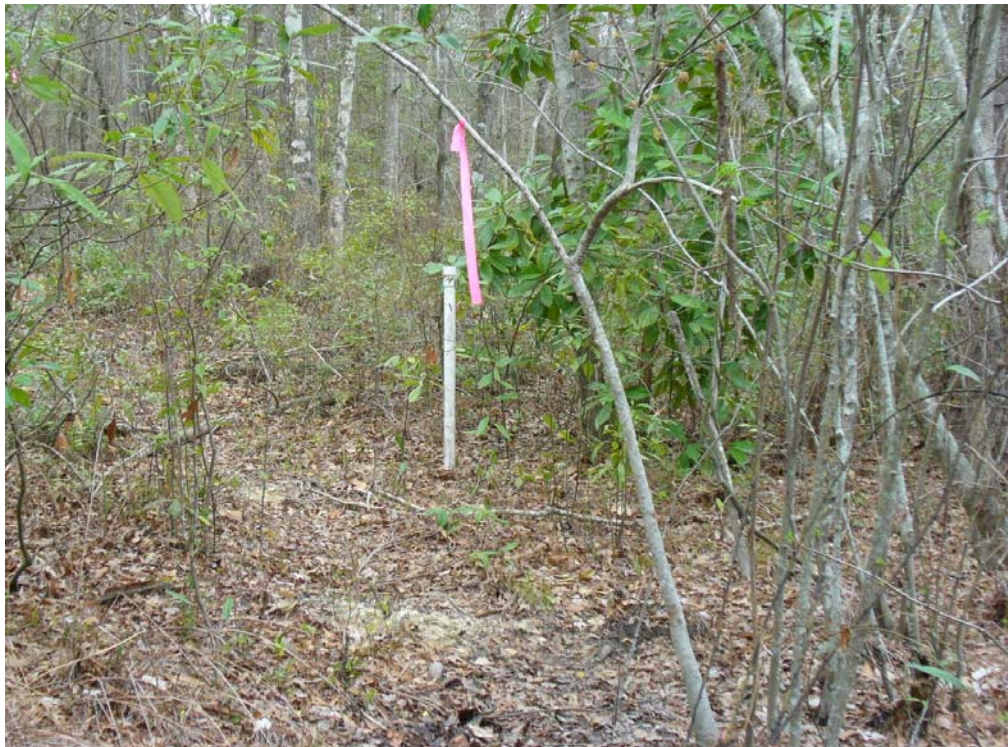
Photo 14. Reference wetland well #2 well location, located in riparian wetlands associated with unnamed tributary to Clark Mill Creek.

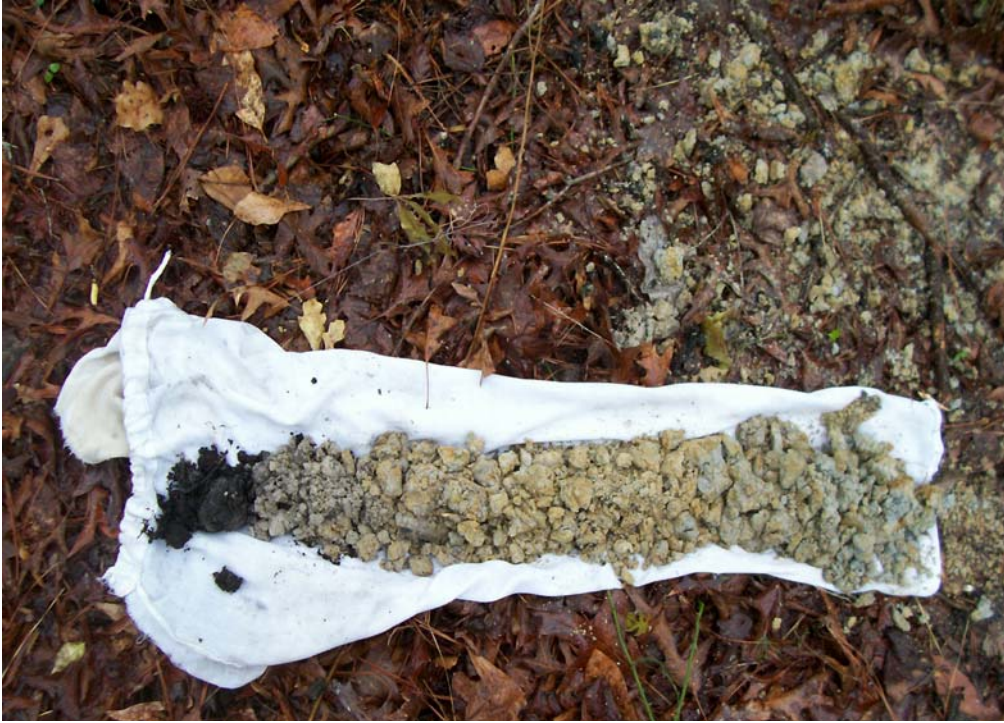
Photo 14. Reference wetland soil profile, representative of the Acredale soil series, located in riparian wetlands associated with unnamed tributary to Clark Mill Creek.

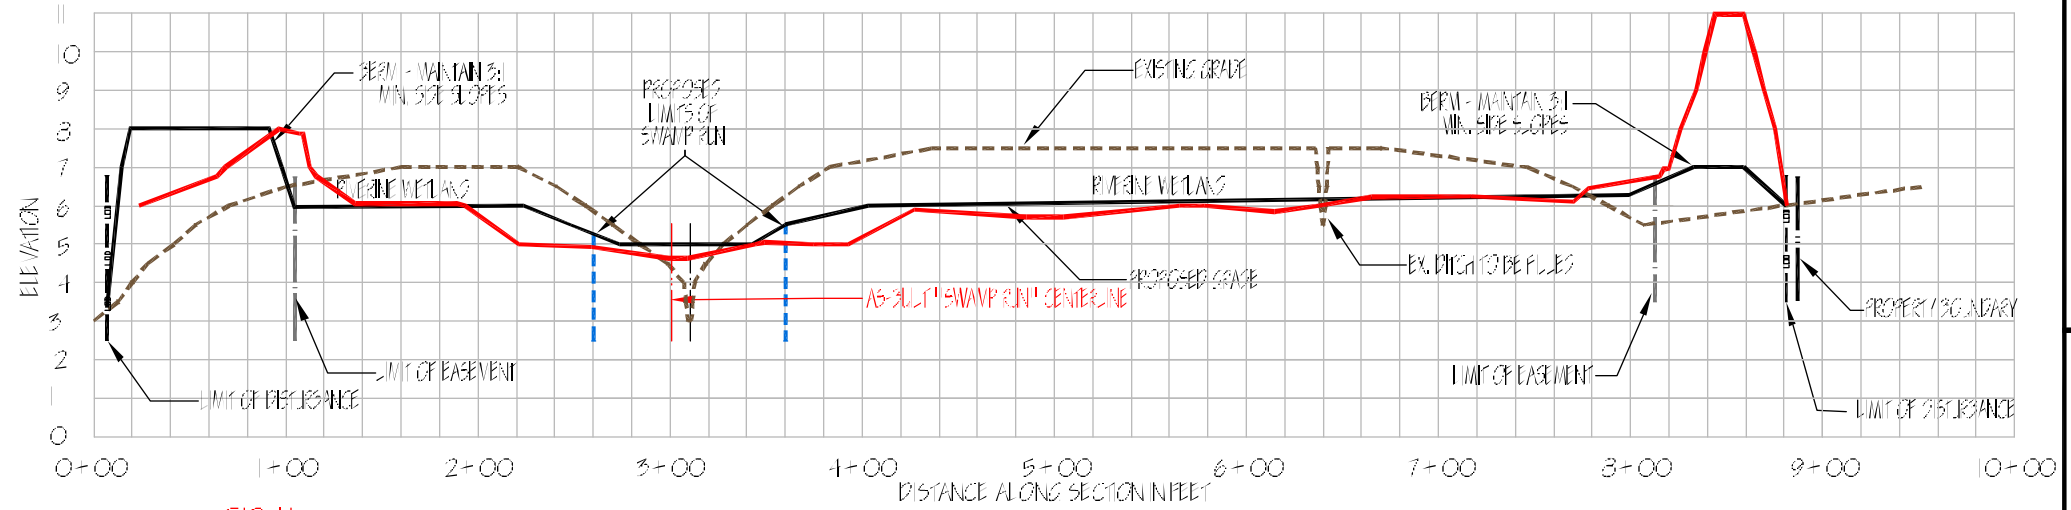
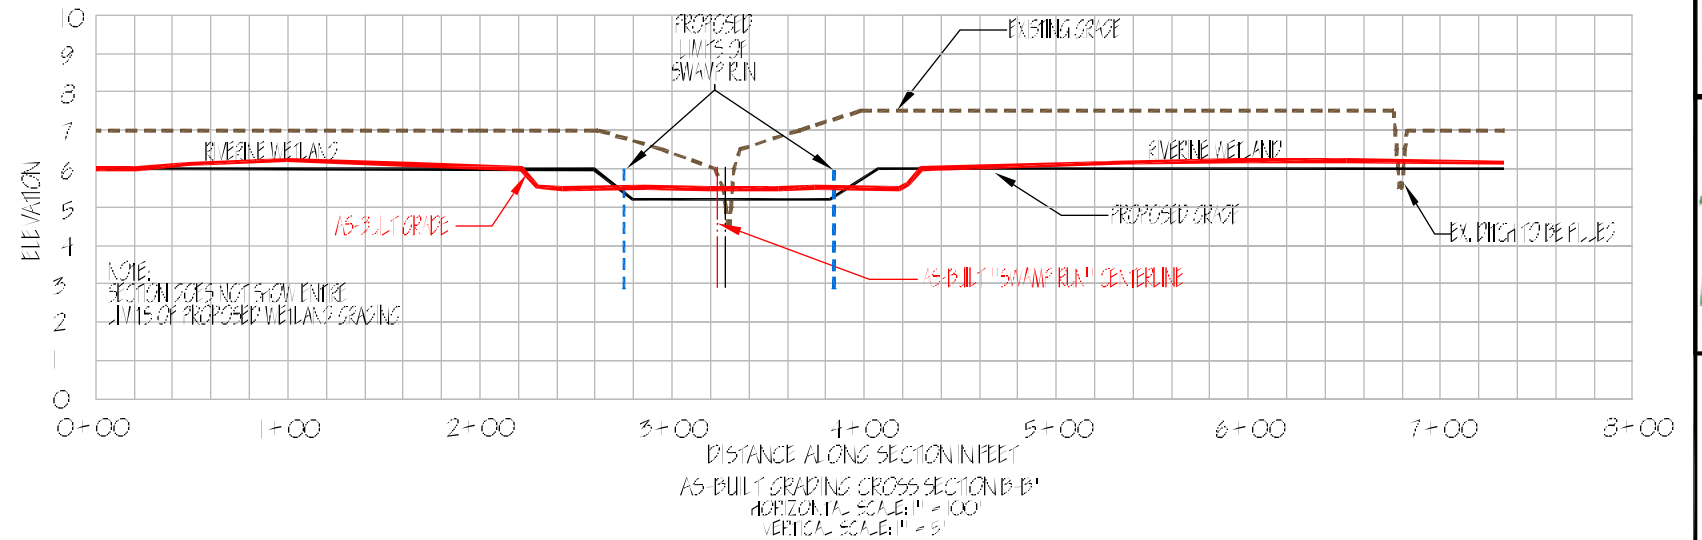
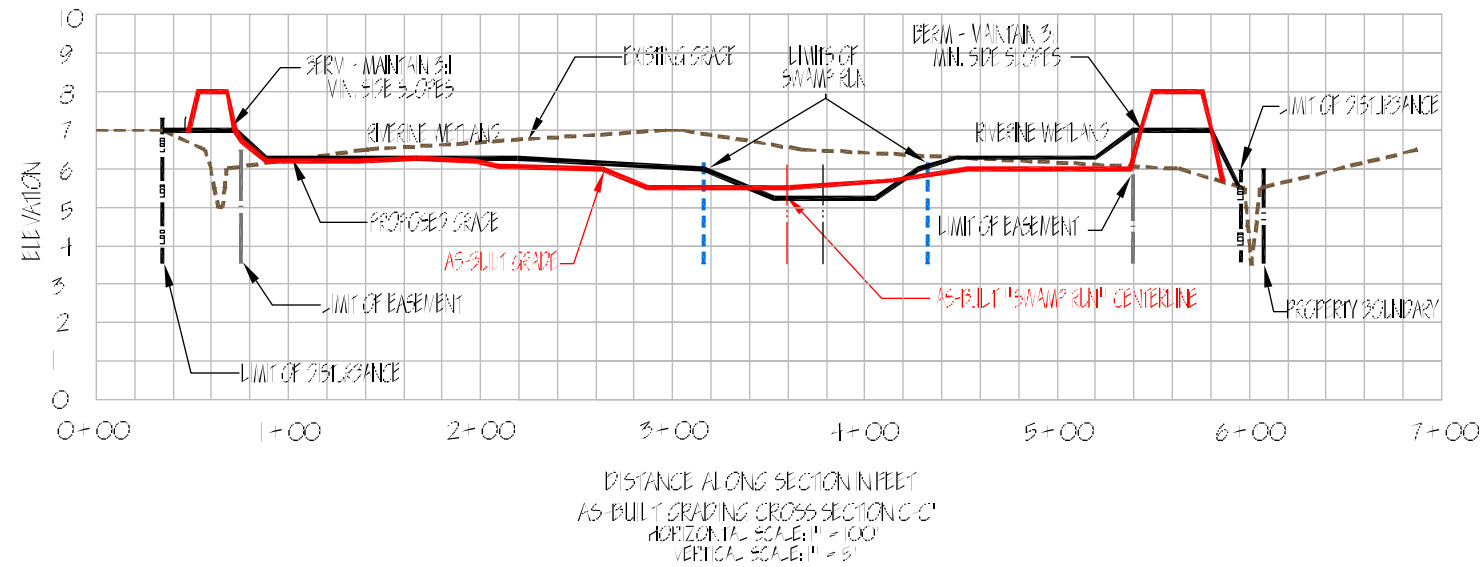
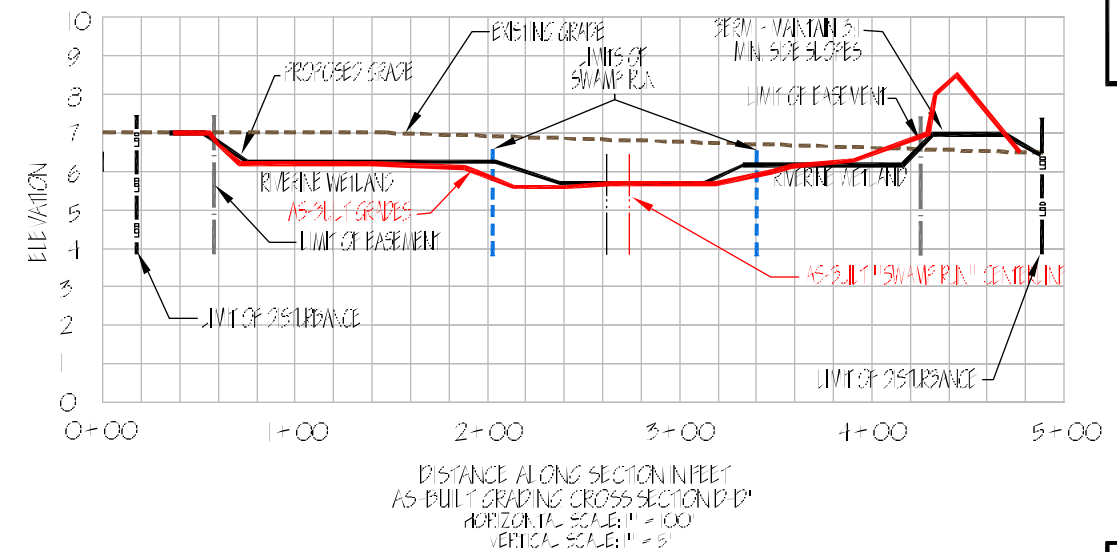
AS-BUILT GRADING SECTIONS
 W/REGA 2006

ARMSTRONG PROPERTY
 SWAMP RESTORATION AND WETLANDS AS-BUILT CROSS SECTION
 SWAMP RESTORATION AS-BUILT CROSS SECTION
 ARMSTRONG PROPERTY
 PROJECT # 14-000000-A

Three permanently monitored cross-sections will be surveyed once per year to determine the extent of surface inundation, and to a lesser extent, to demonstrate stability of the system. Measurements of ground surface elevation will be taken at each break in topography across the section. Surface water depth measurements will also be taken, and the lateral extent of inundation will be documented. Data will be presented in each monitoring report in graphical format. Sheet M-1 in Appendix B shows locations of the two proposed monitoring wells and installed cross-sections. The cross sections for the swamp run monitoring have been installed. Because the swamp run restoration is relatively new and few if any EEP projects have implemented swamp run restoration in the lower coastal plain with commensurate approved success criteria, the continuous recording well monitoring devices have not been installed. Upon approval of the proposed monitoring protocols contained within the Mitigation Plan, the swamp run wells and wrack monitoring stations will be installed.

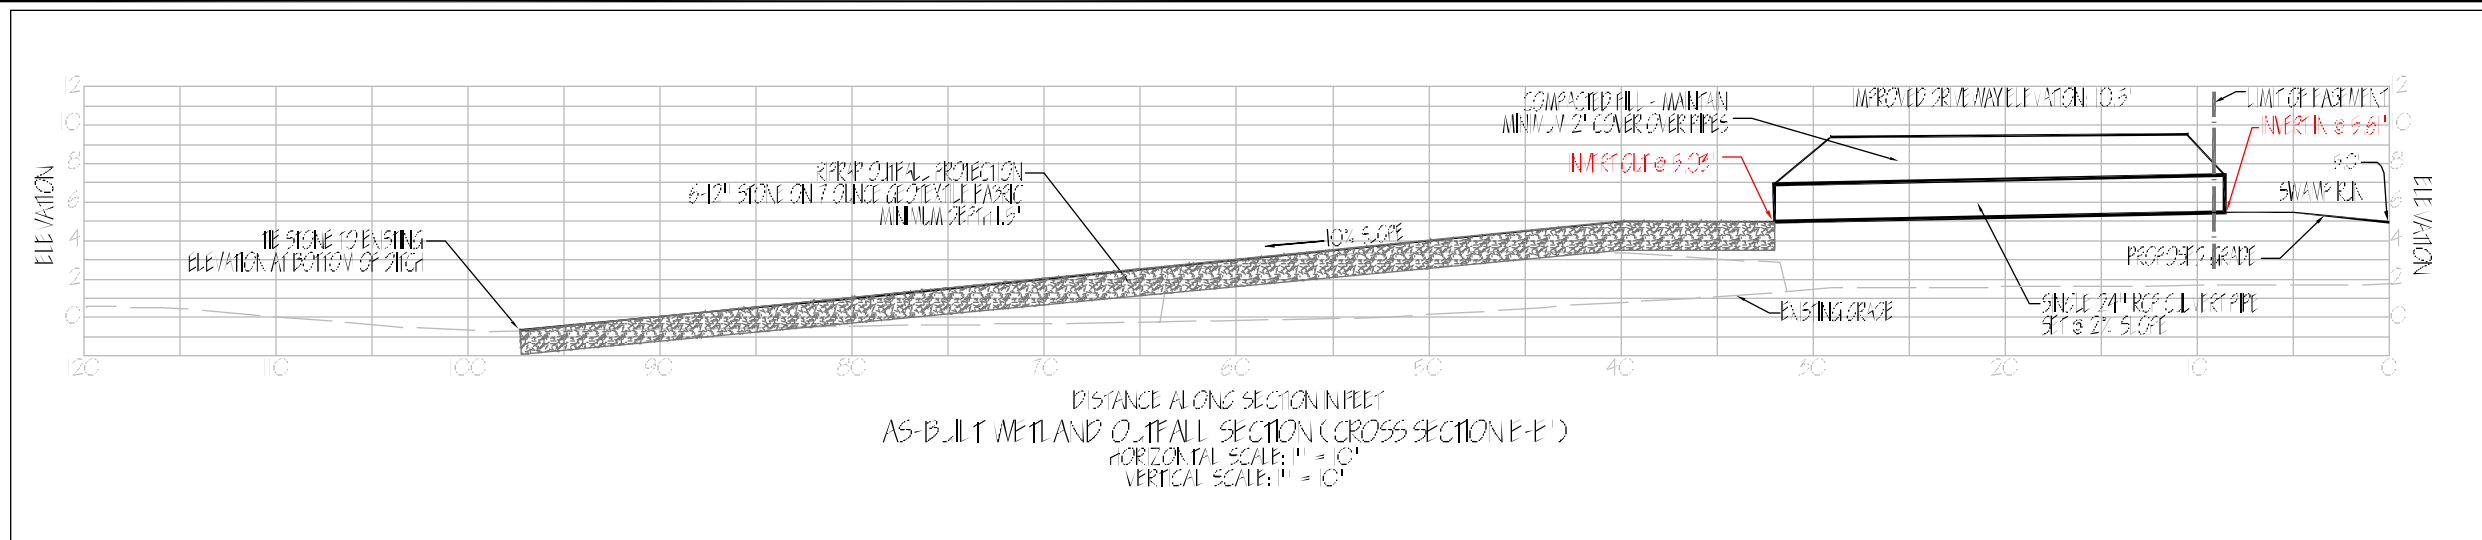
AS-BUILT DETAILS AND SECTIONS
 APRIL 2008

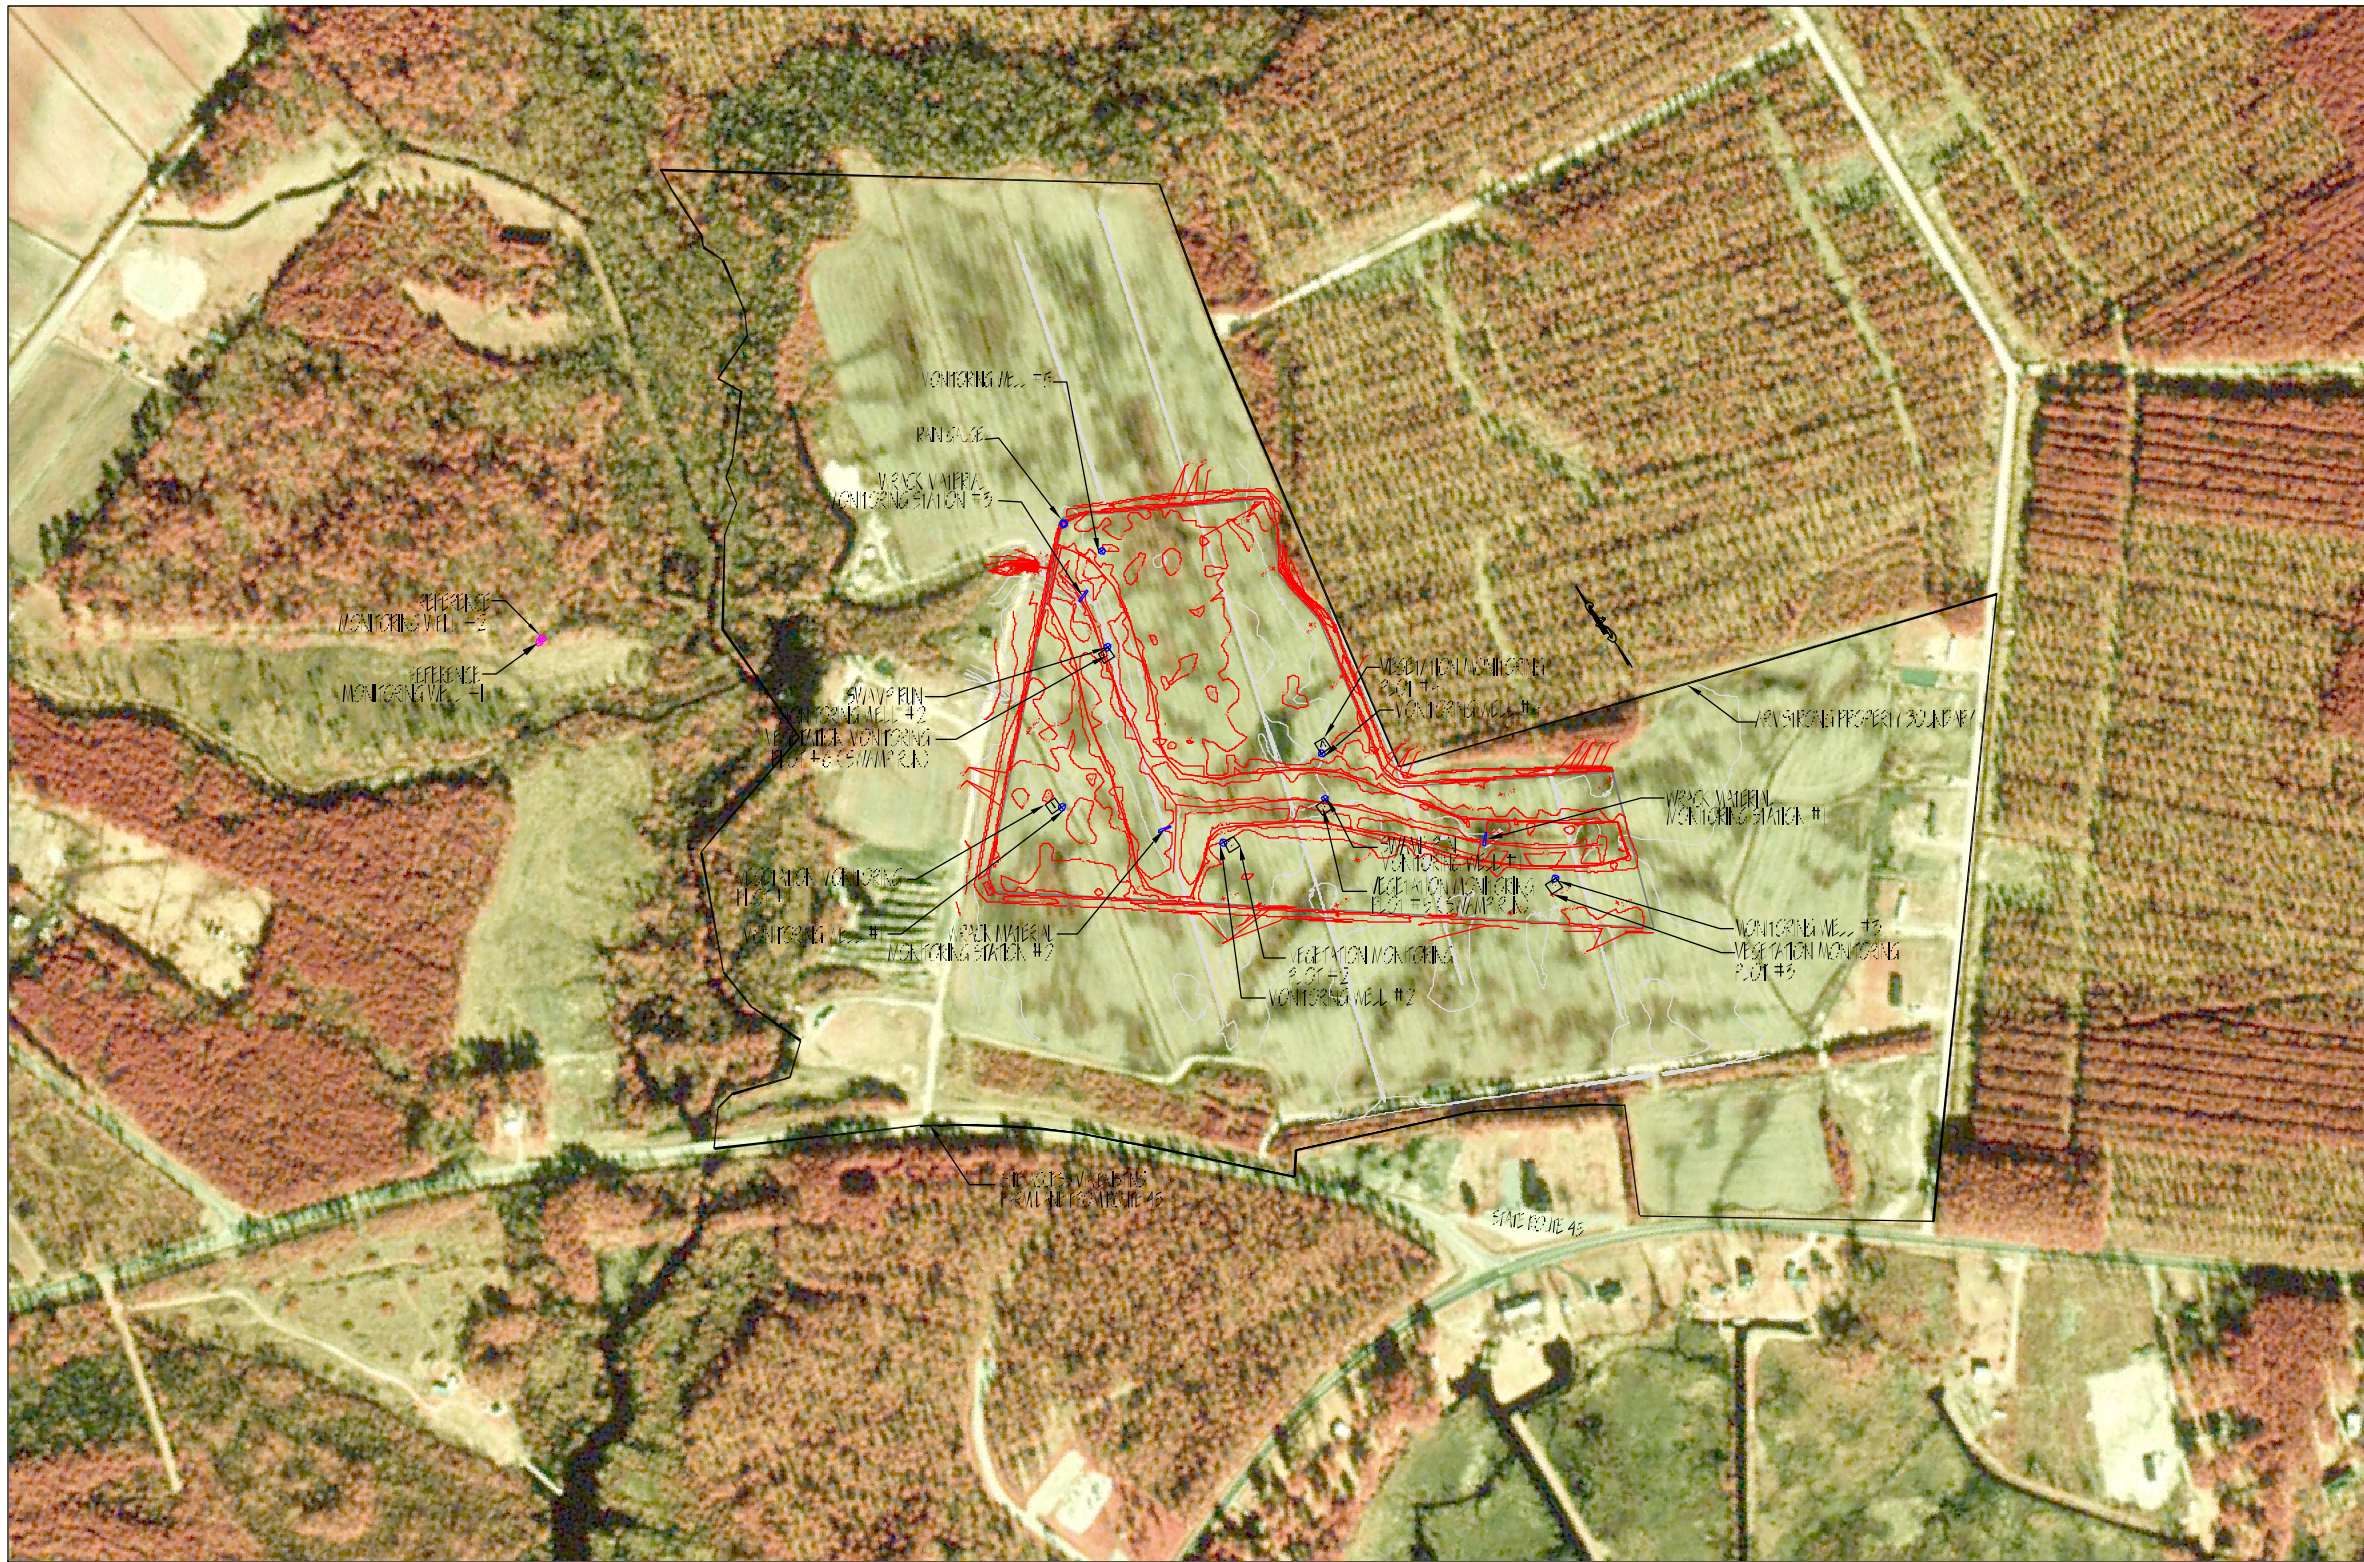
REFERENCE WELL EXHIBIT

In order to set a target vegetative community for the restored wetlands, a reference site was chosen which is near to the restoration area (Sheet R-1, Appendix B). The reference wetland for the target vegetative community is the same wetland where reference wells were installed for wetland hydrology monitoring. Vegetation in the reference wetland is dominated by woody plants including Sweet Bay Magnolia (*Magnolia virginiana*), Swamp White Oak (*Quercus bicolor*), Water Oak (*Quercus nigra*), Wax Myrtle (*Myrica cerifera*), American Holly (*Ilex opaca*), Loblolly Pine (*Pinus taeda*), Red Maple (*Acer rubrum*), Sweet Gum (*Liquidambar styracflua*), Black Gum (*Nyssa sylvatica*), and Bald Cypress (*taxodium distichum*). A Routine Wetland Determination Data Form was completed for the reference wetland and is included in Appendix D.
