**Armstrong Property Wetland and Stream Mitigation Project
Hyde County, NC**

**2013 Annual Monitoring Report Supplemental to Closeout Report
Year 6**

**NCEEP Project Number D06012-A
Tar-Pamlico River Basin 03020104**

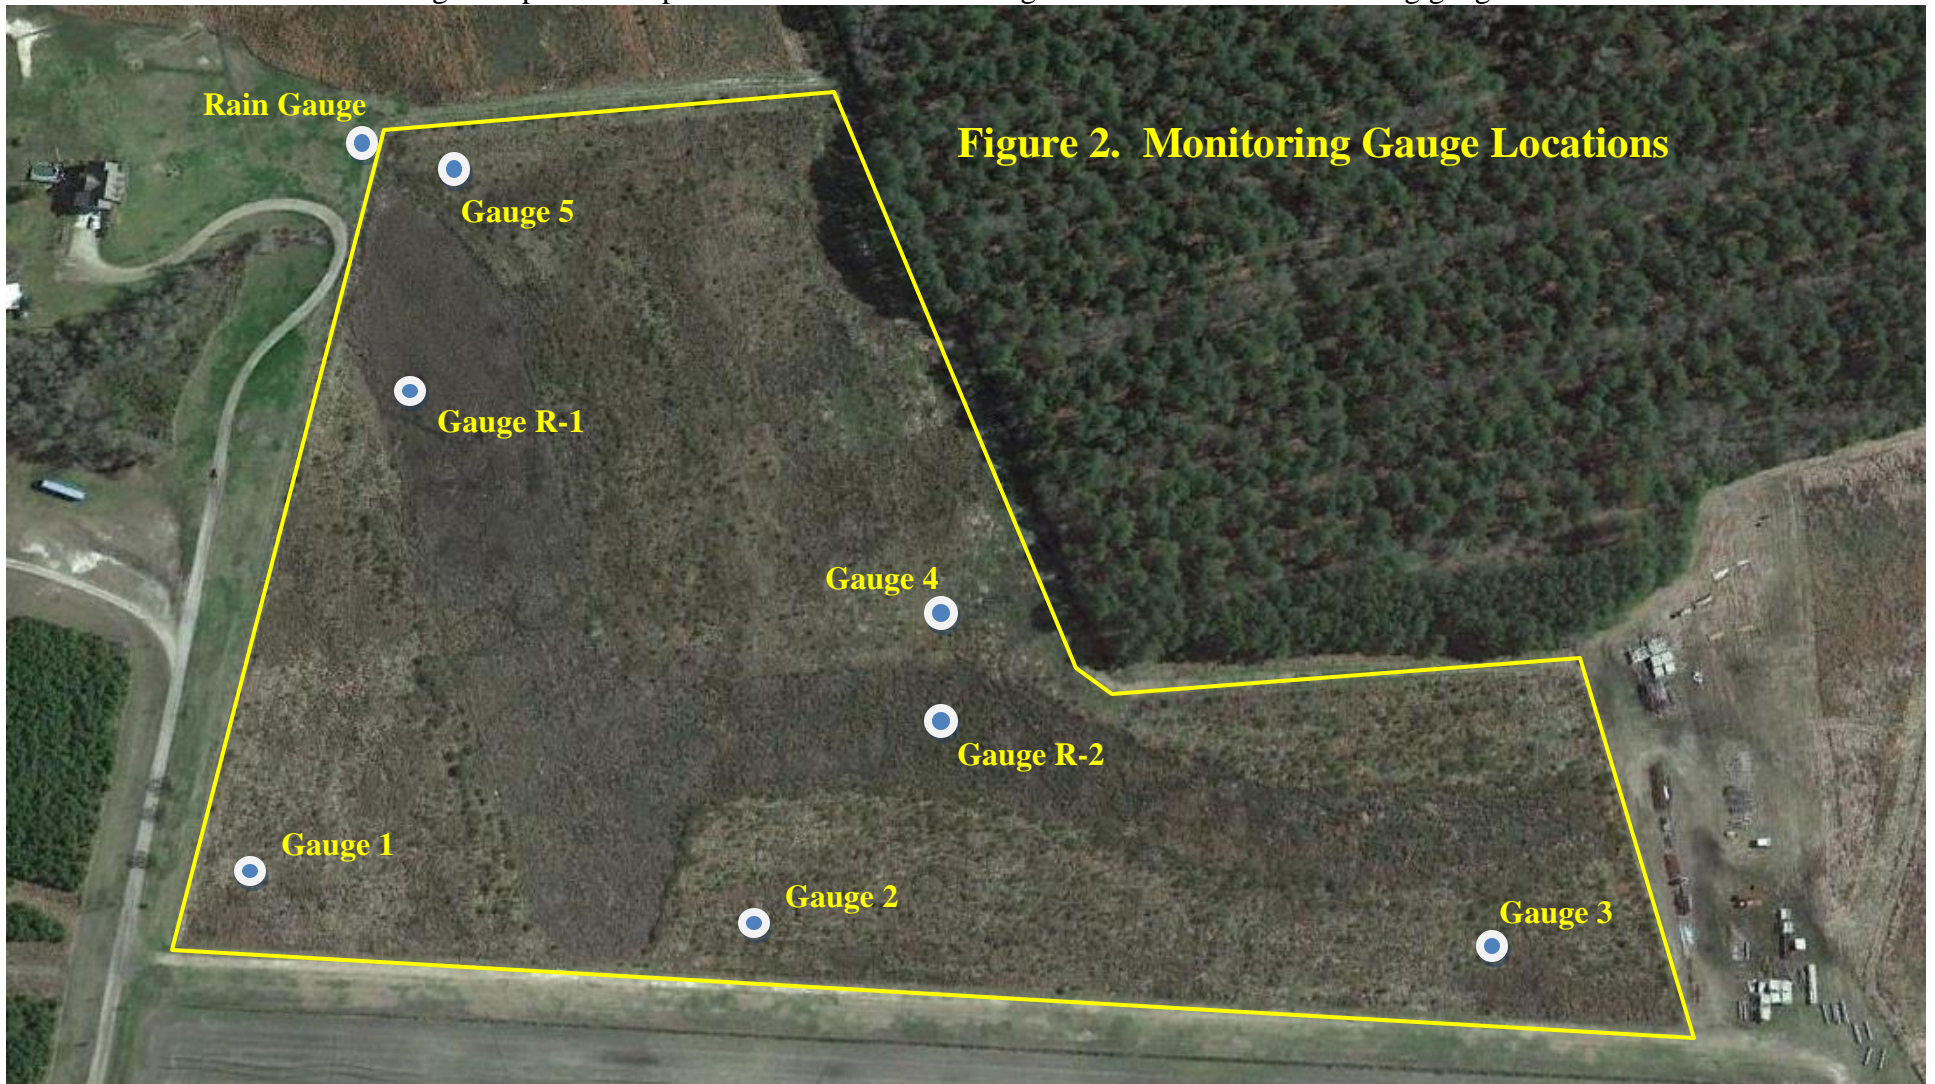
Figure 2 provides a plan view of the site showing the location of all monitoring gauges.

There are five continuous water level monitoring gauges deployed across the riverine portion of the site (Gauges 1 through 5) to monitor fluctuations in the water table and to determine if wetland hydrology is present. A rain gauge is also kept onsite and its data are compared to that collected at the NOAA cooperator site in Belhaven, NC. To further monitor the affect of seasonal and annual variations in precipitation in restored wetlands, hydrologic success of the site is assessed in relation to the reference wetland site where two more monitoring gauges are installed (Gauge 6 as a Swamp Run reference & Gauge 7 as a Riverine reference).
