ANNUAL REPORT FOR 2001

**Ballance Farm Mitigation Site
Currituck County
Project No. 6.049008T
TIP No. R-2228WM**

Prepared By:
Natural Systems Unit & Roadside Environmental Unit
North Carolina Department of Transportation
December 2001

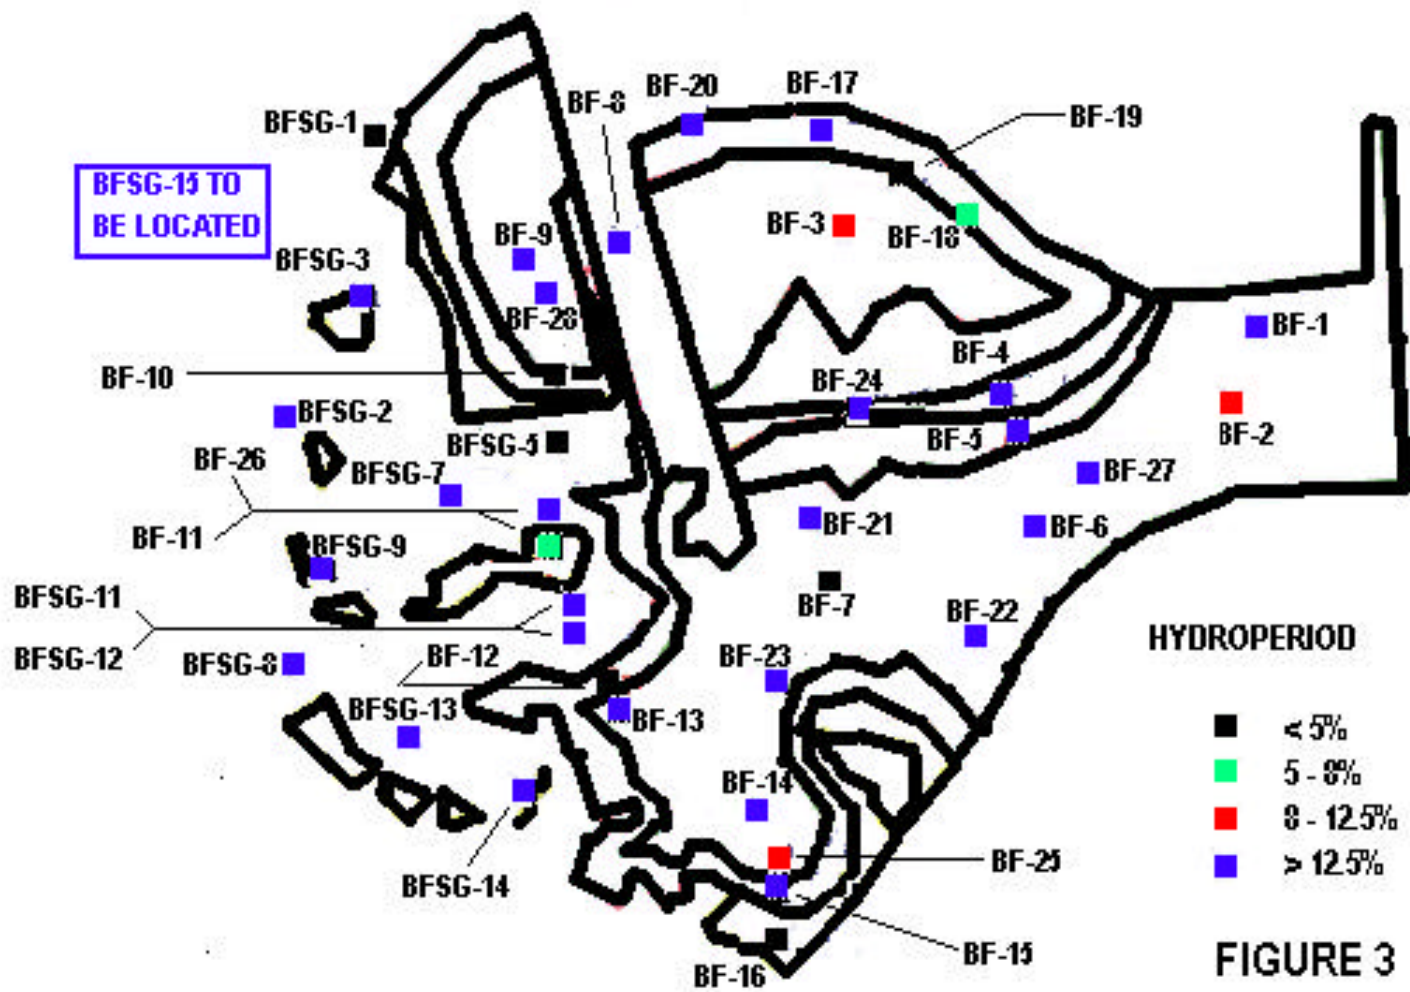
FIGURE 3

2001 BALLANCE FARM HYDROLOGIC MONITORING RESULTS

The maximum number of consecutive days that the groundwater was within twelve inches of the surface was determined for each gauge. This number was converted into a percentage of the 239-day growing season. The results are presented in Tables 1A and 1B. Appendix A contains a plot of the groundwater depth for each monitoring gauge and the surface water depth recorded by the surface gauge. The maximum number of consecutive days is noted on each graph. The Infinities rain gauge that is currently located on the site was utilized for the 2001 monitoring season, thus eliminating the need to use official rainfall information on the monitoring gauge graphs. Historical rainfall data was obtained from the North Carolina State Climatic Office. Figure 3 is a graphical representation of the hydrologic monitoring results.

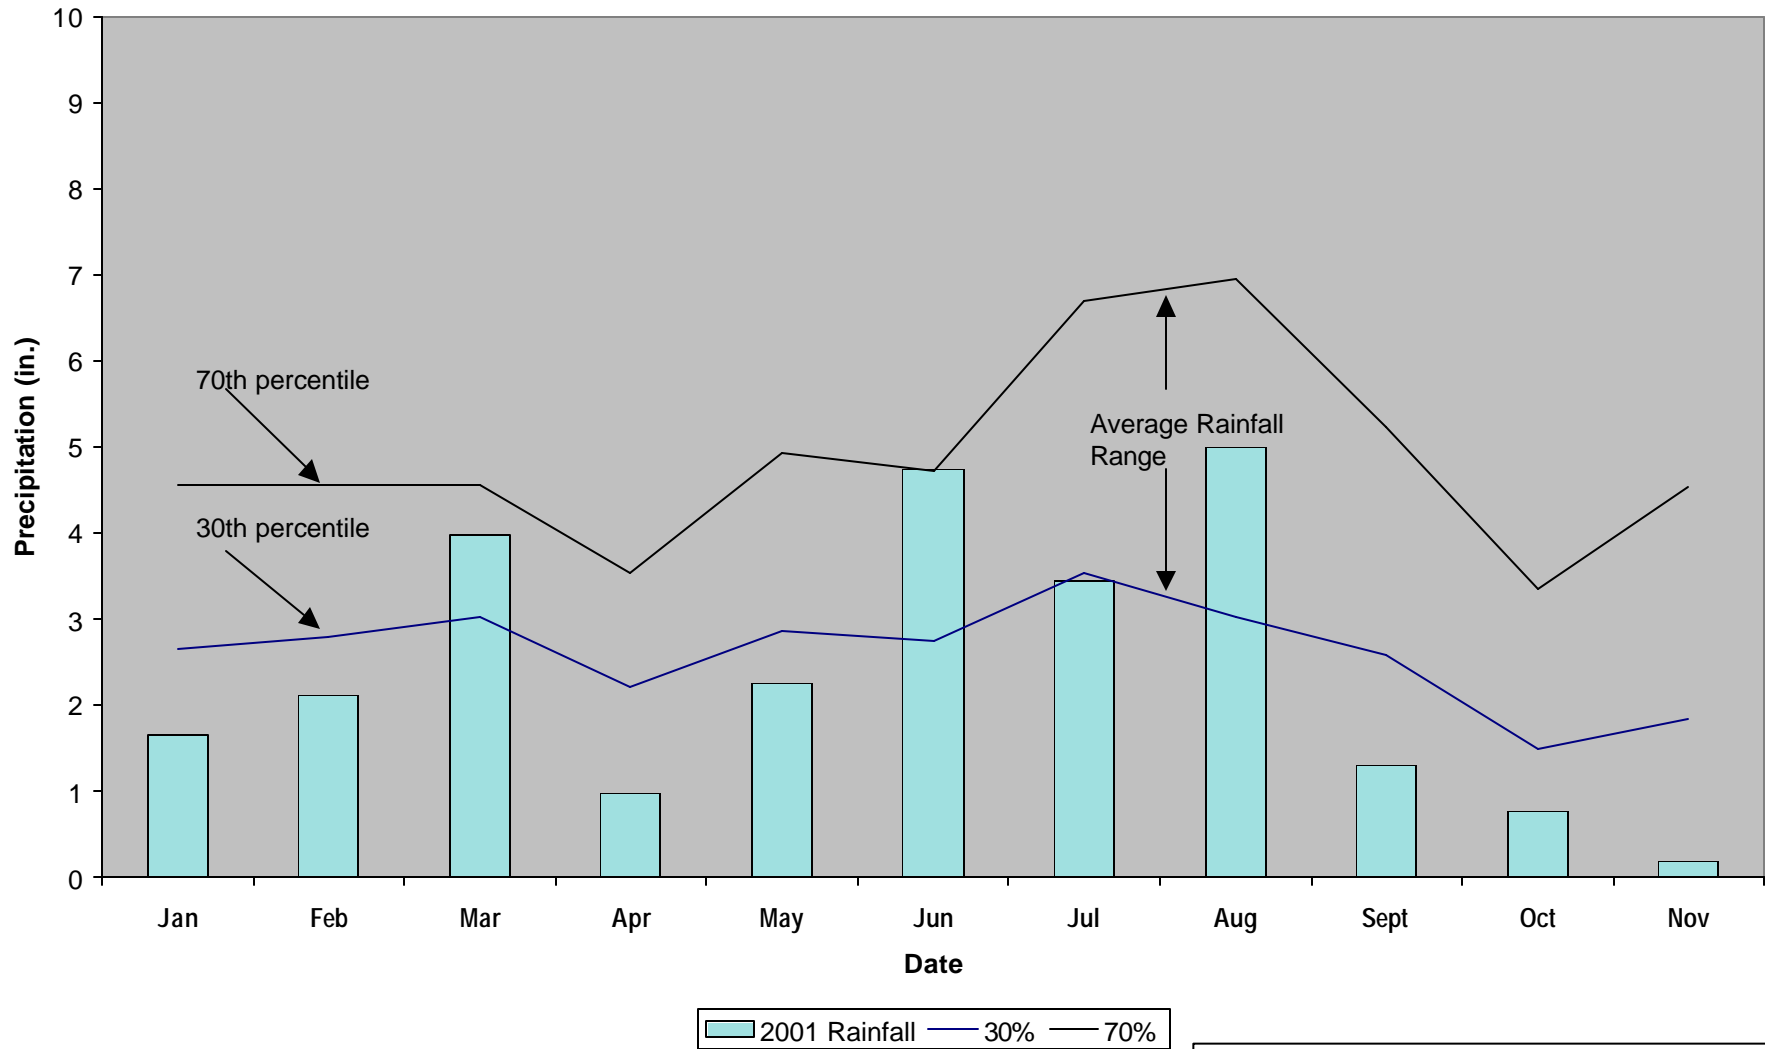
FIGURE 4: 30-70 Percentile Graph

Figure 4 represents an examination of the local climate in comparison with historical data to determine whether 2001 was “normal” in terms of climate conditions. The figure compares the rainfall from 2001 with that of historical rainfall (data collected between 1948 and 1996). All rainfall data was collected from the NC State Climate Office. The graph shows 2001 rainfall totals from January 2001 through the end of November 2001 which includes the growing season for this site. In the year 2001, February, March, and October had extremely below normal rainfall; July and November were below normal. May and June, showed significantly above average rainfall.

**Balance Farm 2001 30-70 Percentile Graph
Elizabeth City, NC**

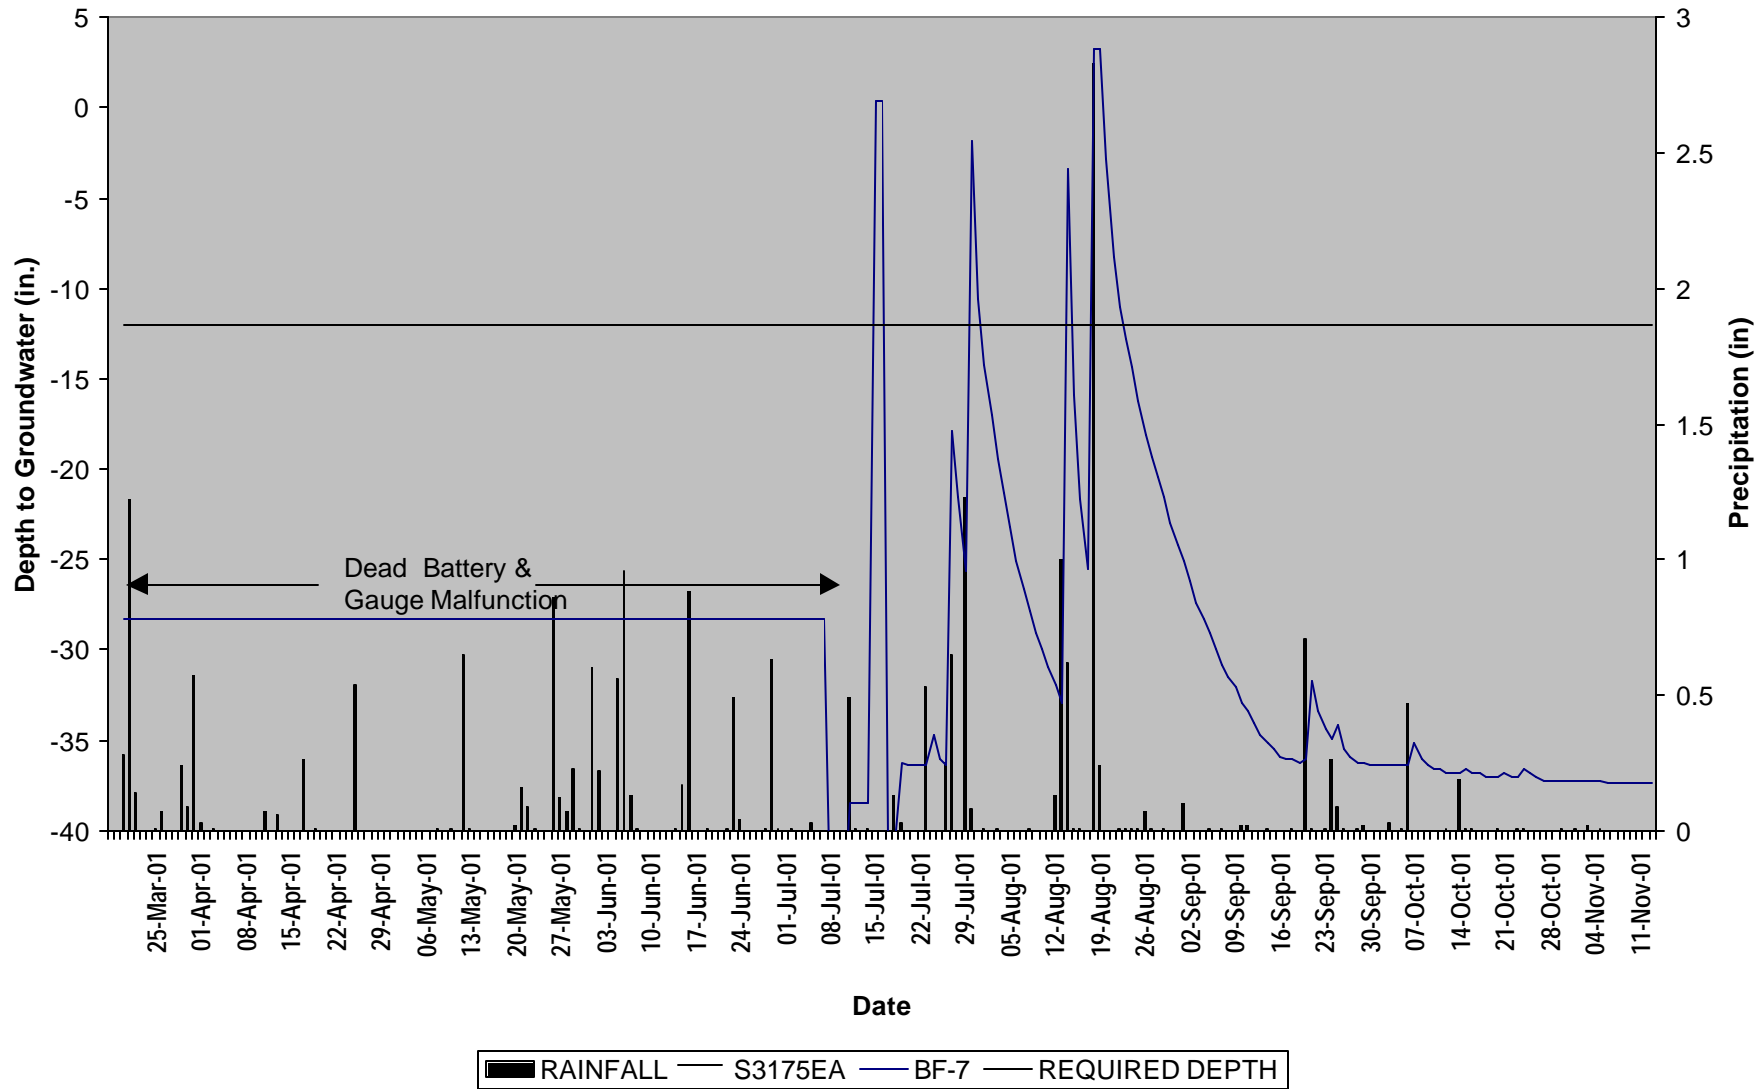
Ballance Farm Monitoring Gauge BF-7

Specific problems: Groundwater monitoring gauge BF-7 experienced battery problems on four occasions and did not record data for a portion of the growing season. It was replaced in late July 2001. Data for gauge number BF-18 could not be retrieved during a site visit. The gauge was replaced in early June 2001. Gauge BF-19 experienced battery problems and recorded erroneous data for nearly 2 months at the beginning of the growing season. Gauges BF-2, BF-16, BF-23 and BF-28 stopped recording data due to dead batteries during the last download of the growing season. Data was not recorded for one week in early October for all of the surface monitoring gauges.

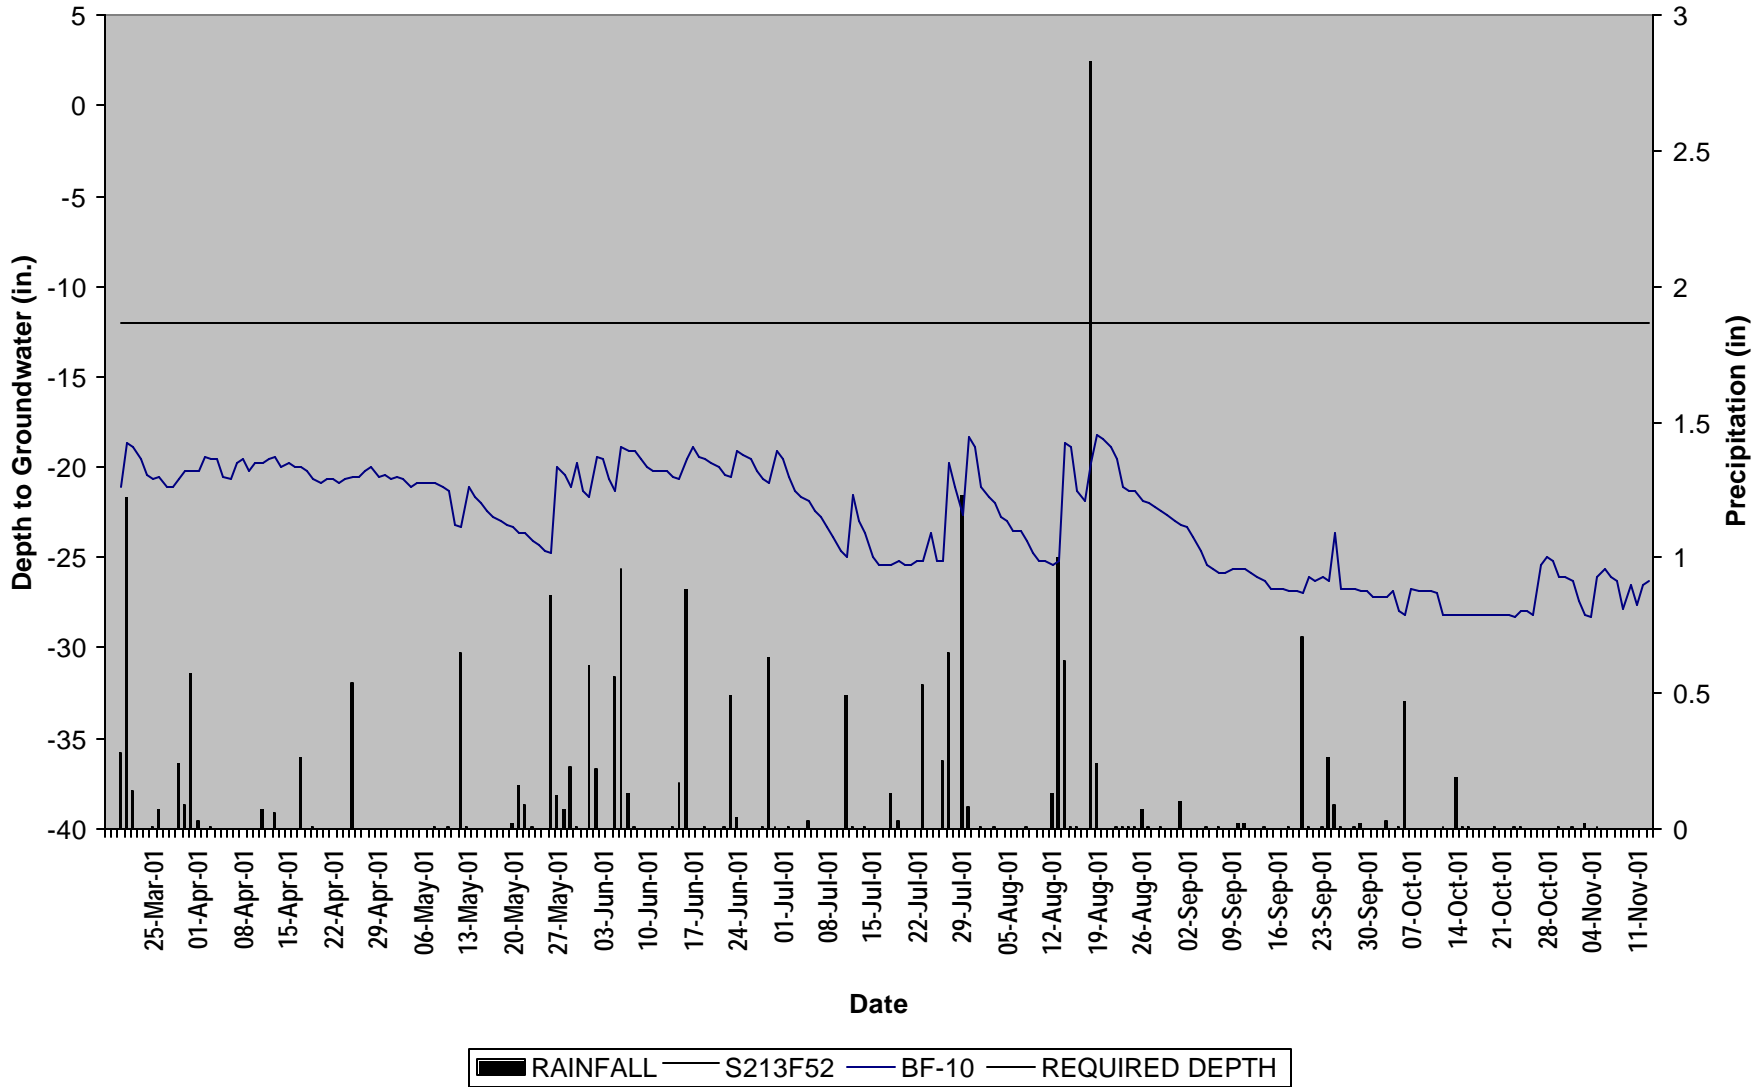
Ballance Farm Monitoring Gauge BF-10

Gauge BF-10 is situated at a 5.5-foot elevation and the groundwater was recorded consistently greater than 20 inches below the surface. This is consistent with its 2000 performance. Reviewing the closest adjacent gauges, BF-9 and BF-28, BF-9 is at elevation 5.1 feet and recorded groundwater within 12 inches of the surface for 14.6% of the growing season. BF-28 is at elevation 4.4 feet and recorded groundwater within 12 inches of the surface for 18.4% of the growing season. There is a difference in elevation of 13 inches between BF-10 and BF-28. BF-28 is situated at an elevation that is more representative of the surrounding area where BF-10 is situated in a locally high area that is not representative of the surrounding area.
