## FINAL MITIGATION PLAN

### Bandys Farm Stream and Wetland Mitigation Project Catawba County, North Carolina

NCDEQ Contract No. 210102-01  
DMS ID No. 100594  
USACE Action ID No. SAW-2021-02609  
NCDEQ DWR ID: 20211630V.1  
RFP No. 16-20210102 (Issued 5/14/2021)

Catawba River Basin  
HUC 03050101

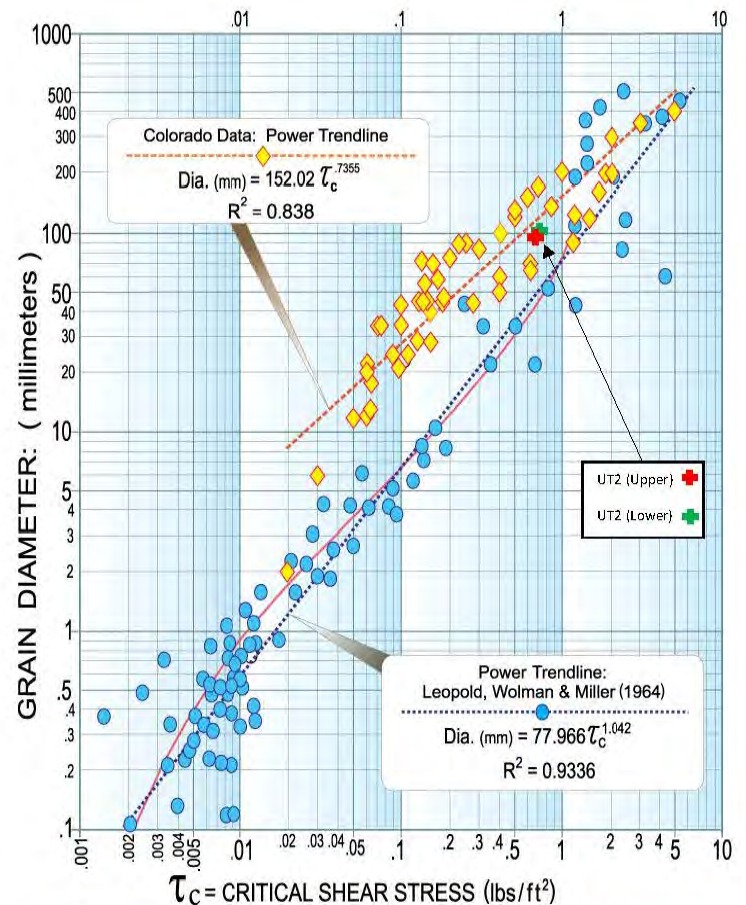
Laboratory and field data on critical shear stress required to initiate movement of grains (Leopold, Wolman, & Miller, 1964). The solid line is the Shields curve of the *threshold of motion*; transposed from the  $\theta$  versus  $R_g$  form into the present form, in which critical shear stress is plotted as a function of grain diameter.

Additional predicted values needed to entrain the measured D100 of the subpavement samples were also generated for shear stress, channel slope, and channel depth as shown in Table 14 below. The design values for UT2 fall somewhere in between the two predictive models, also lending confidence that the new channel can move the available reach sediment supply.

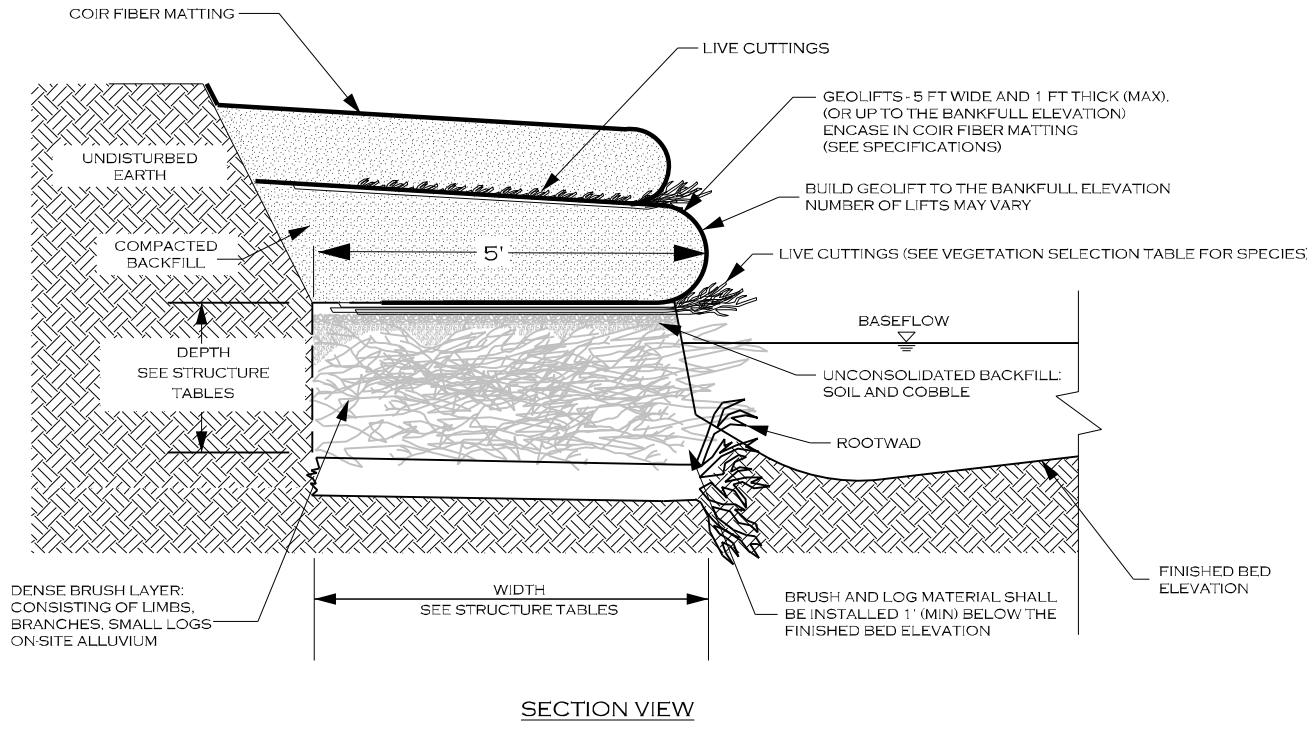
SECTION VIEW

- GEOLIFT THICKNESS CAN BE ADJUSTED AS NEEDED TO ENSURE LIFTS ARE CONSTRUCTED EVENLY UP TO THE BANKFULL ELEVATION.

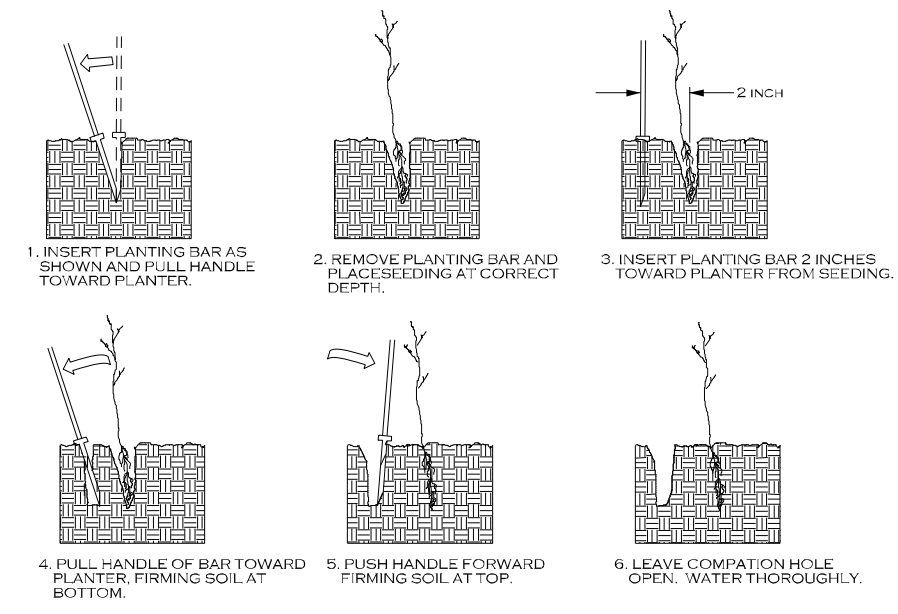
DIBBLE PLANTING METHOD USING THE KBC PLANTING BAR

**PLANTING BAG**  
DURING PLANTING, SEEDLINGS SHALL BE KEPT IN A MOIST CANVAS BAG OR SIMILAR CONTAINER TO PREVENT THE ROOT SYSTEMS FROM DRYING.

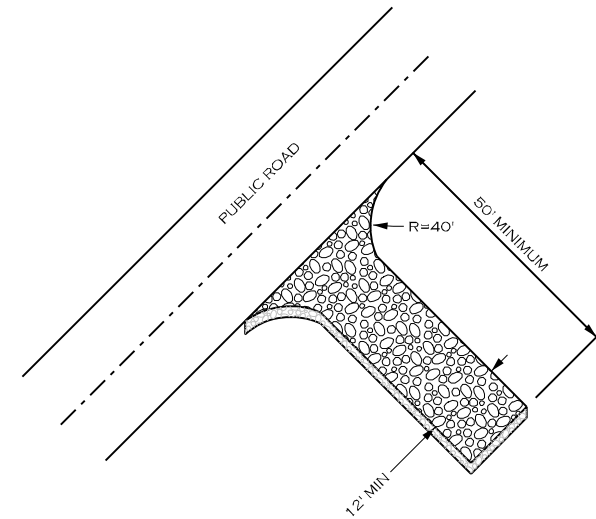
**GRAVEL CONSTRUCTION ENTRANCE**

1. PROVIDE TURNING RADIUS SUFFICIENT TO ACCOMMODATE EXPECTED EQUIPMENT.
2. LOCATE ENTRANCES TO PROVIDE FOR UTILIZATION BY ALL CONSTRUCTION VEHICLES.
3. PLACE FILTER FABRIC FOR DRAINAGE BENEATH STONE.
4. MUST BE MAINTAINED IN THE CONDITION WHICH WILL PREVENT TRACKING OR DIRECT MUD INTO STREETS.
5. ANY MATERIAL TRACKED ONTO THE ROADWAY MUST BE CLEANED UP IMMEDIATELY.
6. LOCATE GRAVEL CONSTRUCTION ENTRANCE AT ALL POINTS OF INGRESS AND EGRESS UNTIL SITE IS STABILIZED. PROVIDE FREQUENT CHECKS TO THE ENTRANCE AND TIMELY MAINTENANCE.
7. NUMBER AND LOCATION OF CONSTRUCTION ENTRANCES AS SHOWN ON PLANS, OR AS DIRECTED BY THE ENGINEER.
8. USE CLASS A STONE OR OTHER COURSE AGGREGATE APPROVED BY THE ENGINEER.
9. INSTALL CONSTRUCTION ENTRANCES IN A WAY TO PREVENT VEHICLES LEAVING THE PROJECT SITE FROM BYPASSING CONSTRUCTION ENTRANCES.
