Mitigation Plan  
Banner Branch Mitigation Project  
Stokes County, North Carolina  
FINAL VERSION

NCDEQ DMS Project Identification # 100080  
NCDEQ DMS Contract # 7610 and # 7701  
Roanoke River Basin (Cataloging Unit 03010103)  
USACE Action ID Number: SAW-2018-01760  
Contracted Under RFP # 16-007405  
DWR Project # 20181154

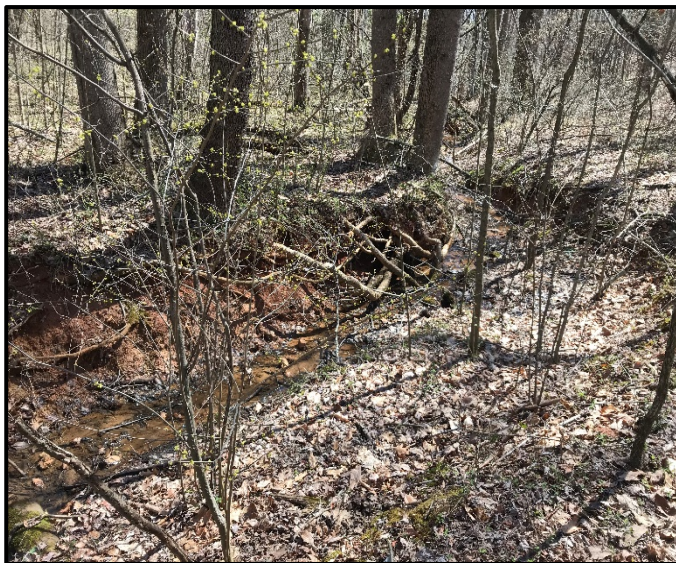
**UT1-R1:** UT1-R1 begins as a small perennial headwater tributary that extends from the upstream boundary of the project site, downstream just beyond the confluence with UT1C. UT1-R1 has an average valley slope of 3.4 percent and drainage area of 41.2 acres.

*Photo of UT1-R1 showing straightened channel conditions.*

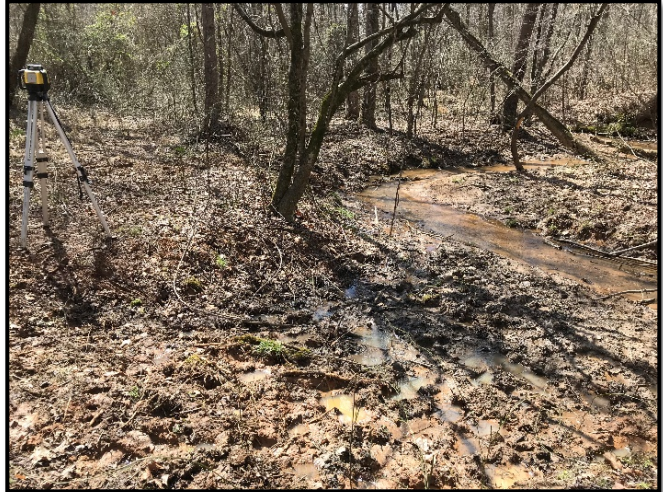
**UT1-R2:** UT1-R2 begins downstream of UT1C and flows to an existing culvert crossing. The valley slope is approximately 2.1 percent, and the drainage area is 135 acres. UT1-R2 appears to be relatively stable, with minimal bank erosion present and bank height ratios ranging from 1.2 to 1.7. The sinuosity is moderate and appropriate for the valley setting. Excess sediment was observed within the channel and adjacent floodplain as a result of a historic man-made impoundment and partially blocked culvert further downstream.

*Looking upstream at cattle wallowing area along UT1-R2.*

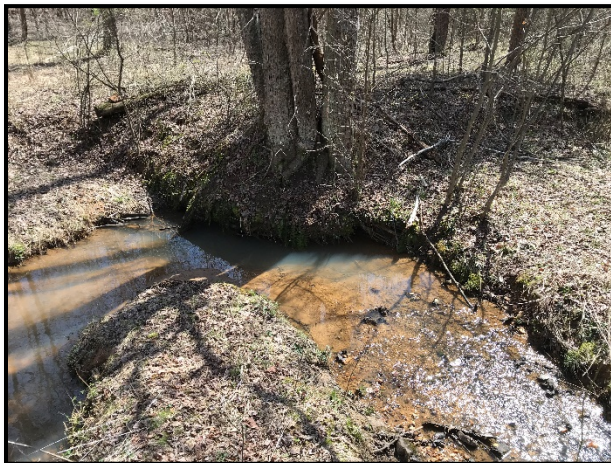
**UT1-R3:** UT1-R3 begins downstream of an existing culvert crossing. Along this reach, the degree of incision is low, with bank height ratios near 1.2. However, UT1-R3 has not experienced historic cattle intrusion and associated trampling for most of its length.

*Photo depicts stable stream channel conditions and in-stream habitat along UT1-R3.*

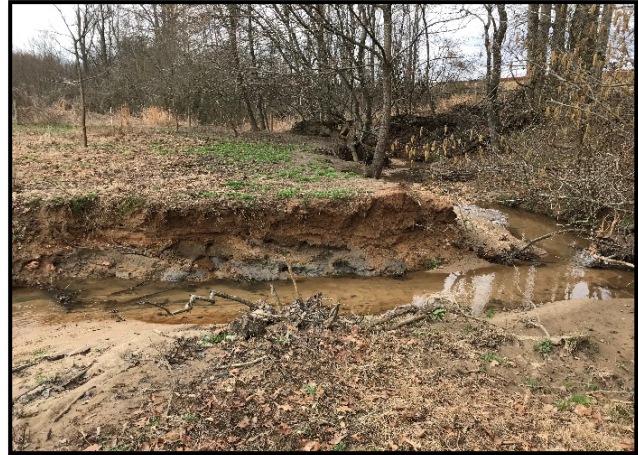
**BB-R1:** Banner Branch (BB) is a named tributary that begins to the east of the project area before its confluence with BB-R1 and UT1-R3. The upstream channel condition of BB is slightly incised, however the bed and banks are mostly stable and sediment supply is limited to coarse sand and fine gravel. The upper BB watershed has experienced minimal disturbances in the recent past and a mature canopy of vegetation exists across riparian buffer area. BB-R1 begins at UT1-R3 to its confluence with UT2. BB-R1 has a valley slope of 1.1 percent and a drainage area of 409.6 acres. The reach appears to be laterally unstable, with bank erosion present and bank height ratios greater than 1.2. BB-R1 is exposed to cattle intrusion and fecal coliform bacteria along its entire length and the riparian buffer is limited to herbaceous vegetation with a few small woody trees along its banks. BB-R1 is subject to water quality stressors, mainly in the form of cattle access, excess sediment and minimal riparian buffer widths. Based on the existing channel conditions and anthropogenic disturbances, this reach is classified as a 'B4c' stream type.

*BB-R1 looking downstream. Note the lack of adequate riparian buffer along the left floodplain.*

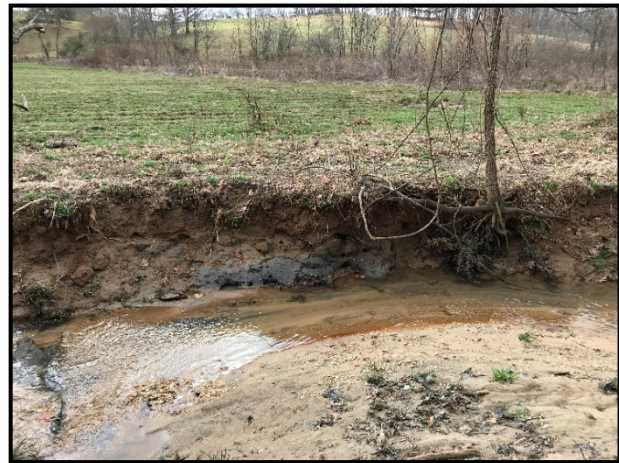
**BB-R2:** Similar to BB-R1, BB-R2 continues as a perennial tributary that has lost its historic floodplain function and has an average bank height ratio of 1.5. BB-R2 has a drainage area of 480 acres, and the valley slope is approximately 0.9 percent. The entire reach is subject to active water quality stressors, mainly resulting sediment inputs from bank erosion, hoof shear from unrestricted cattle access and riparian buffers less than 30 feet in width. Cattle intrusion and lateral bank erosion has also degraded aquatic habitat. Based on the existing channel conditions and historic anthropogenic disturbances, BB-R2 was classified as an incised 'E4' stream type.

*Looking downstream at BB-R2. Cattle have unrestricted access to this entire reach.*

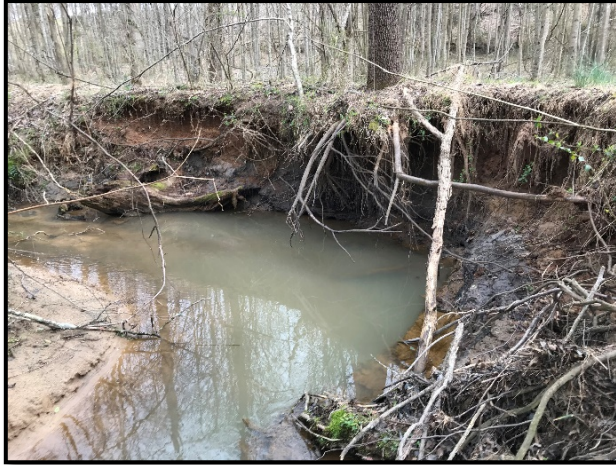
**BB-R3:** BB-R3 continues south from BB-R2 and has a drainage area of approximately 563.2 acres near its confluence with the UT4-R2 stream system. The channel is laterally unstable along the entire reach with native woody riparian buffer vegetation corridor greater than 30 feet on both sides of the channel. The valley slope is 0.6 percent along this reach, bank erosion is moderate, and most excess scour is located along the meander bends. The valley floor widens and flattens in this area, however the stream has lost connection to its relic floodplain.

***Looking at unstable conditions along BB-R3. Note the lateral bank erosion and lack of deep rooting vegetation.***

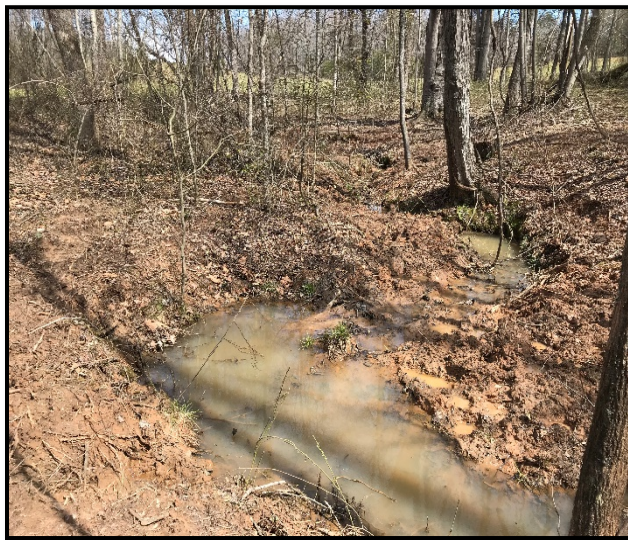
***Looking upstream at degraded channel conditions along upper UT1B.***

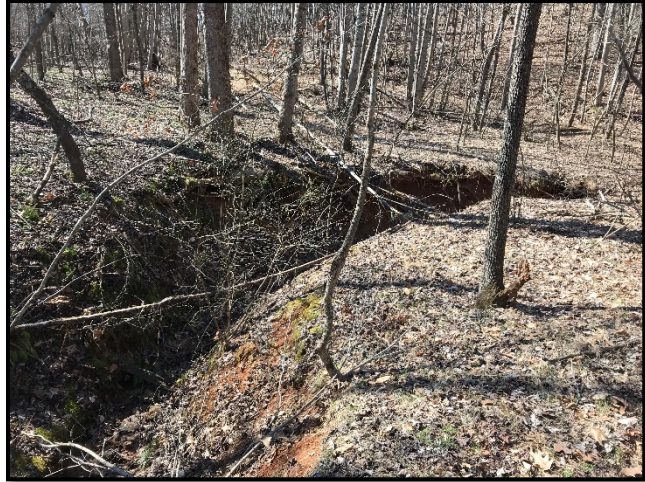
**UT1C:** UT1C jurisdictional flow originates near a property line and flows east before its confluence with UT1-R2. The valley slope is approximately 5.5 percent and the drainage area is 15.8 acres. Cattle do not have access to this reach, and according to the landowner, the stream in this area has not been disturbed and is located in its natural valley. A severe headcut was observed in the lower portion of the reach, but a majority of the reach is stable, and undisturbed riparian buffers greater than 30 feet in width along the entire streambanks. Based on the step-pool morphology and gravel/small cobble substrate, upper UT1C is classified as a 'B4' stream type and lower UT1C is classified as a 'F4'.

*Photo depicts degraded stream channel conditions along lower UT1C near an active headcut.*

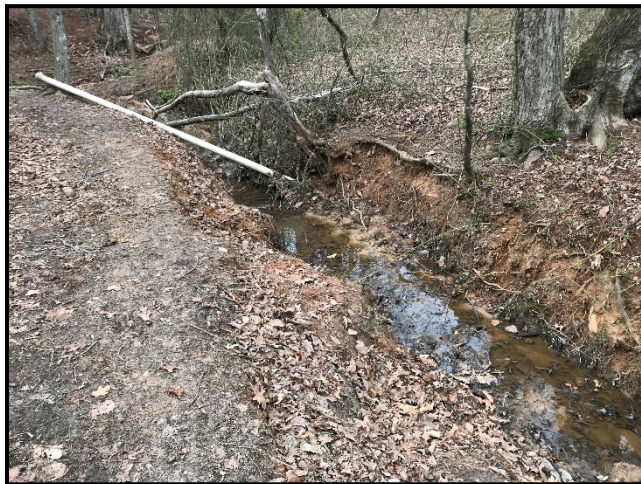
*Photo depicts degraded stream channel conditions and lack over buffer vegetation along UT2.*

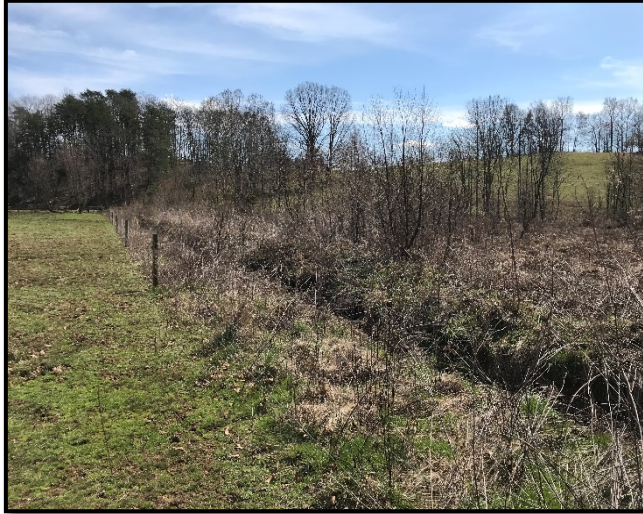
*Photo of UT3 showing a straightened channel conditions and lack of riparian buffer vegetation.*

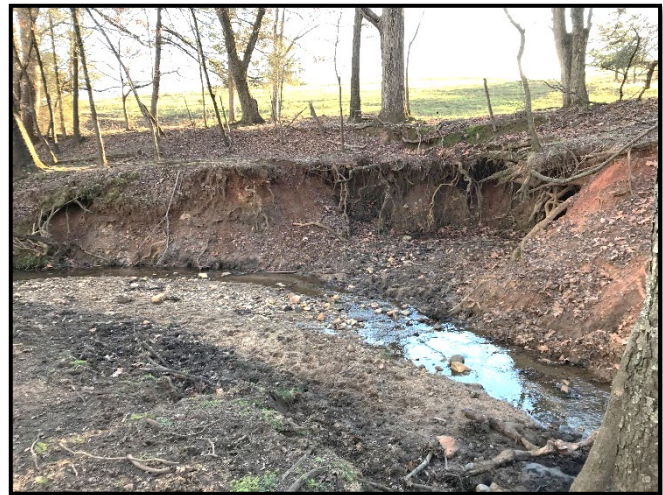
UT4-R1 is exposed to cattle intrusion along its entire length and the riparian buffer is limited to herbaceous vegetation with a few small woody trees along its banks. UT4-R1 is subject to water quality stressors, mainly in the form of fecal coliform bacteria from cattle access, excess sediment and minimal riparian buffer widths. Based on the existing channel conditions, this reach is classified as a 'B4c/F4' stream type.

*UT4-R1 looking downstream. Note the lack of adequate riparian buffer degraded channel conditions.*

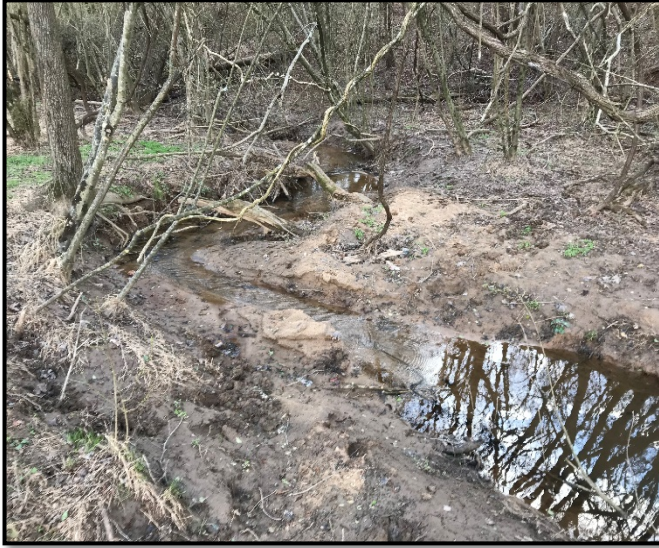
*Looking downstream at UT4-R2. Cattle have unrestricted access to this entire reach.*

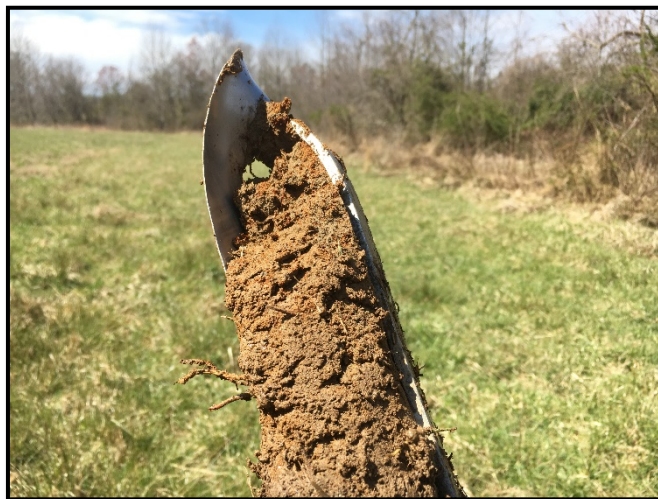
Degraded and/or drained riparian wetlands were documented within the project boundary. These areas contain hydric soils indicators and total approximately 3.584 acres of hydric soils and 3.889 acres of degraded jurisdictional wetlands. Figure 6 illustrates areas where conditions are favorable for improving wetland conditions. The predominant native wetland vegetation communities are largely devoid or not considered reference quality in areas proposed for restoration. On-site investigations of the soils within the project area were conducted in 2018 and 2019 by licensed soil scientist (LSS), George Lankford, LSS, with George K. Lankford, LLC (See Hydric Soils Investigation in the Appendix 2). The findings were based on hand-turned auger borings and indicate the presence of hydric soils along the floodplains of many of the project reaches. The hydric soils status is based upon the "*Field Indicators of Hydric Soils in the United States*" (USDA, NRCS, 2016, Version 8.1).

*Photo of hand auger boring located in the Banner Branch (BB-R2) floodplain showing hydric soil indicators.*

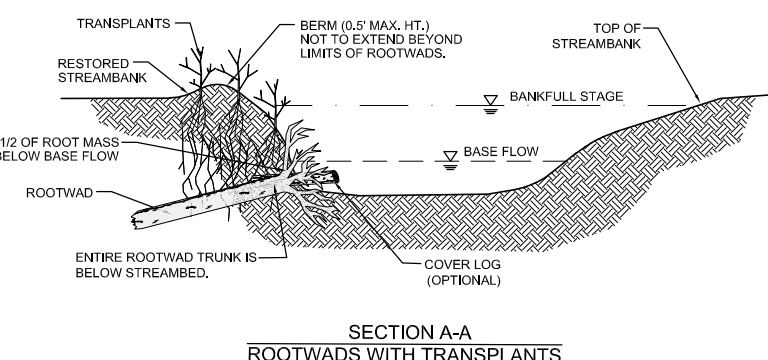
**ROOTWADS**  
NOT TO SCALE

SECTION A-A  
ROOTWADS WITHOUT TRANSPLANTS

SECTION A-A  
ROOTWADS WITH TRANSPLANTS

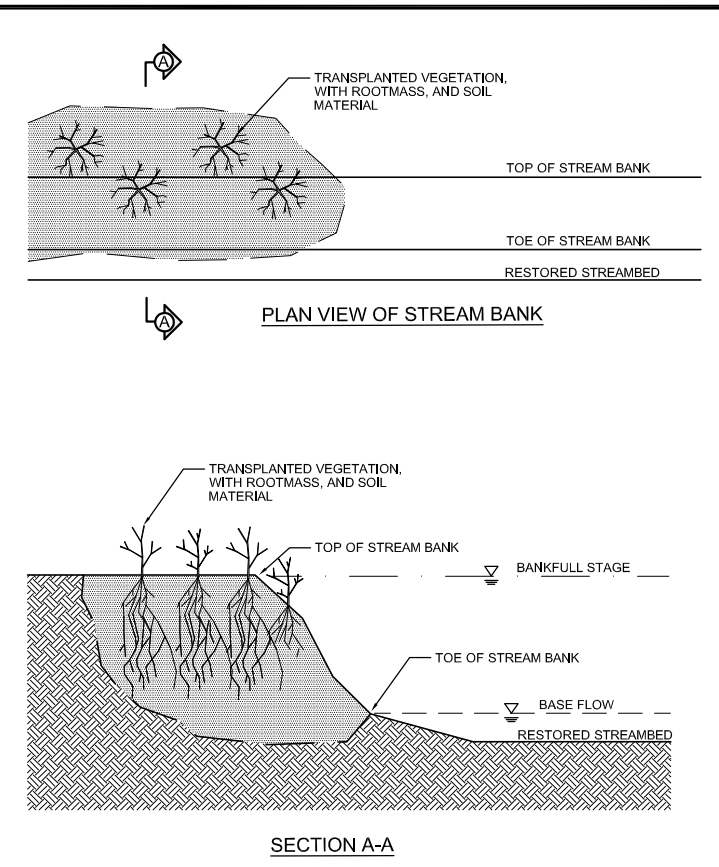
- NOTES:
1. EXCAVATE A HOLE IN THE RESTORED STREAM BANK THAT WILL ACCOMMODATE THE SIZE OF TRANSPLANT TO BE PLANTED. BEGIN EXCAVATION AT TOE OF THE STREAM BANK.
  2. EXCAVATE THE ENTIRE TRANSPLANT ROOT MASS AND AS MUCH ADDITIONAL SOIL MATERIAL AS POSSIBLE. IF ENTIRE ROOT MASS CAN NOT BE EXCAVATED AT ONCE, THE TRANSPLANT IS TOO LARGE AND ANOTHER SHOULD BE SELECTED.
  3. PLANT TRANSPLANT IN THE RESTORED STREAM BANK SO THAT VEGETATION IS ORIENTATED VERTICALLY.
  4. FILL IN ANY HOLES OR VOIDS AROUND THE TRANSPLANT AND COMPACT.
  5. ANY LOOSE SOIL LEFT IN THE STREAM SHOULD BE REMOVED.
  6. WHEN POSSIBLE, PLACE MULTIPLE TRANSPLANTS CLOSE TOGETHER SUCH THAT THEIR ROOT MASSES CONTACT.

**VEGETATION TRANSPLANTS**  
 NOT TO SCALE

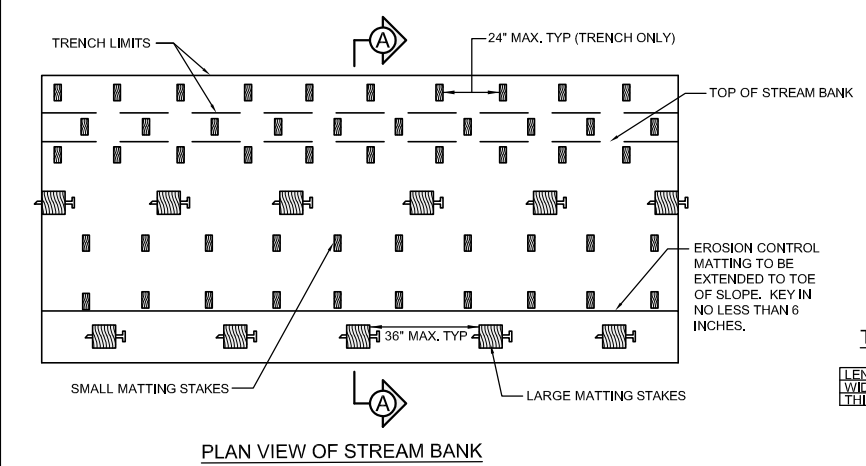
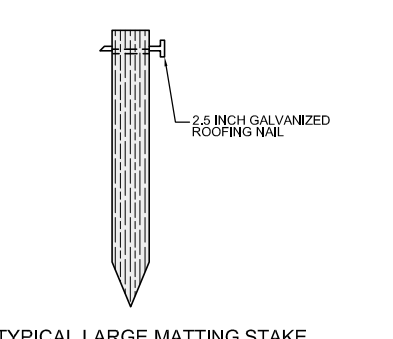
- NOTES:
1. RESTORED STREAM BANKS MUST BE SEEDED AND MULCHED PRIOR TO PLACEMENT OF EROSION CONTROL MATTING.
  2. SEE TECHNICAL SPECIFICATIONS FOR MATTING STAKE SPACING REQUIREMENTS.
  3. PLACE LARGE STAKES ALONG ALL MATTING SEAMS, IN THE CENTER OF STREAM BANK, AND TOE OF SLOPE.

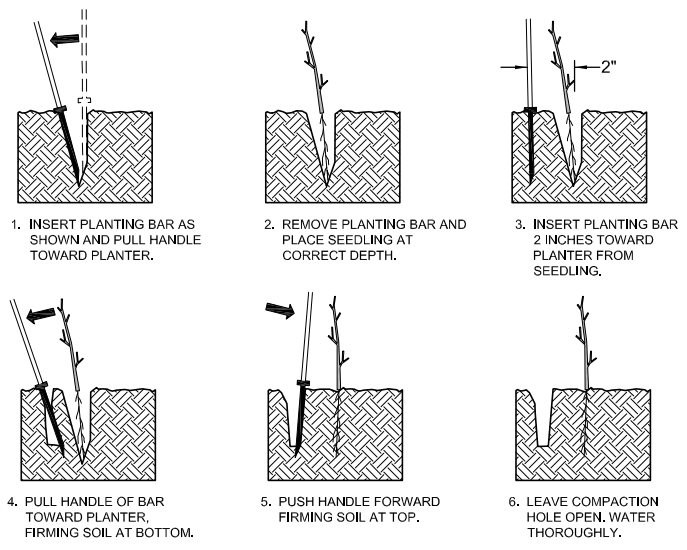
**PLANTING METHOD USING THE PLANTING BAR**

**NOTES:**  
 1. PLANT BARE ROOT VEGETATION TO THE WIDTH OF THE BUFFER/PLANTING ZONE AS SHOWN ON THE PLANS.  
 2. ALLOW FOR 8-15 FEET SPACING BETWEEN PLANTINGS, AS DEFINED IN THE TECHNICAL SPECIFICATIONS.

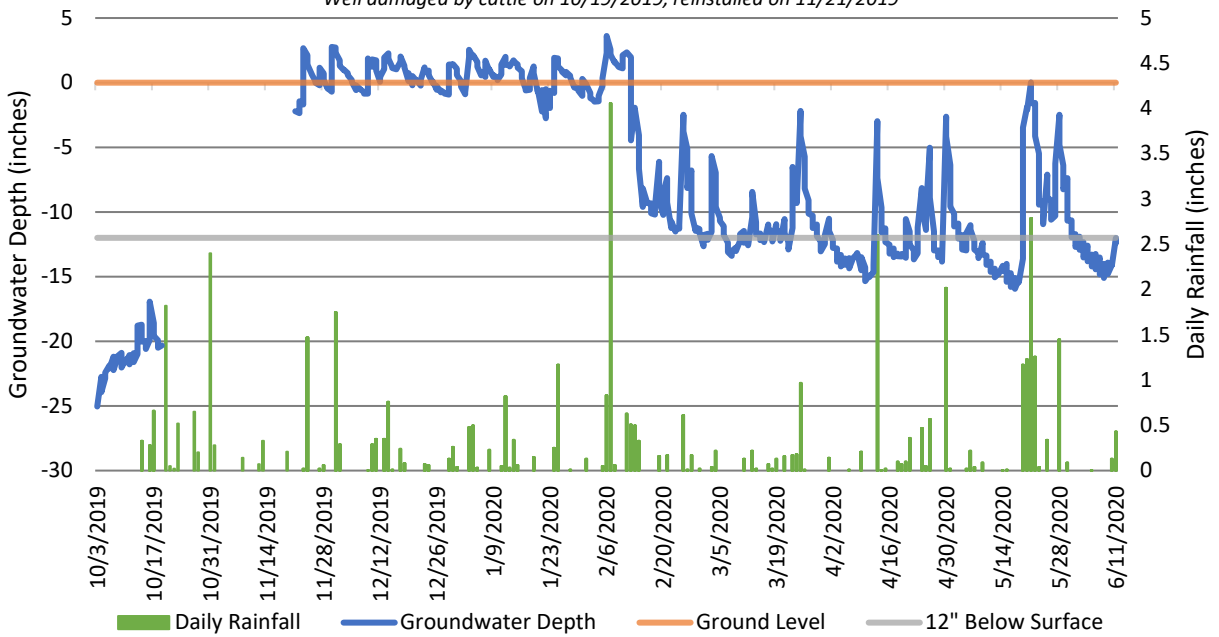
### Banner Branch Groundwater Well 4

*\*Well damaged by cattle on 10/19/2019, reinstalled on 11/21/2019*
