FINAL MITIGATION PLAN

BANNER FARM MITIGATION SITE

Henderson County, NC
NCDEQ Contract No. 7530
DMS ID No. 100062

French Broad River Basin
HUC 06010105

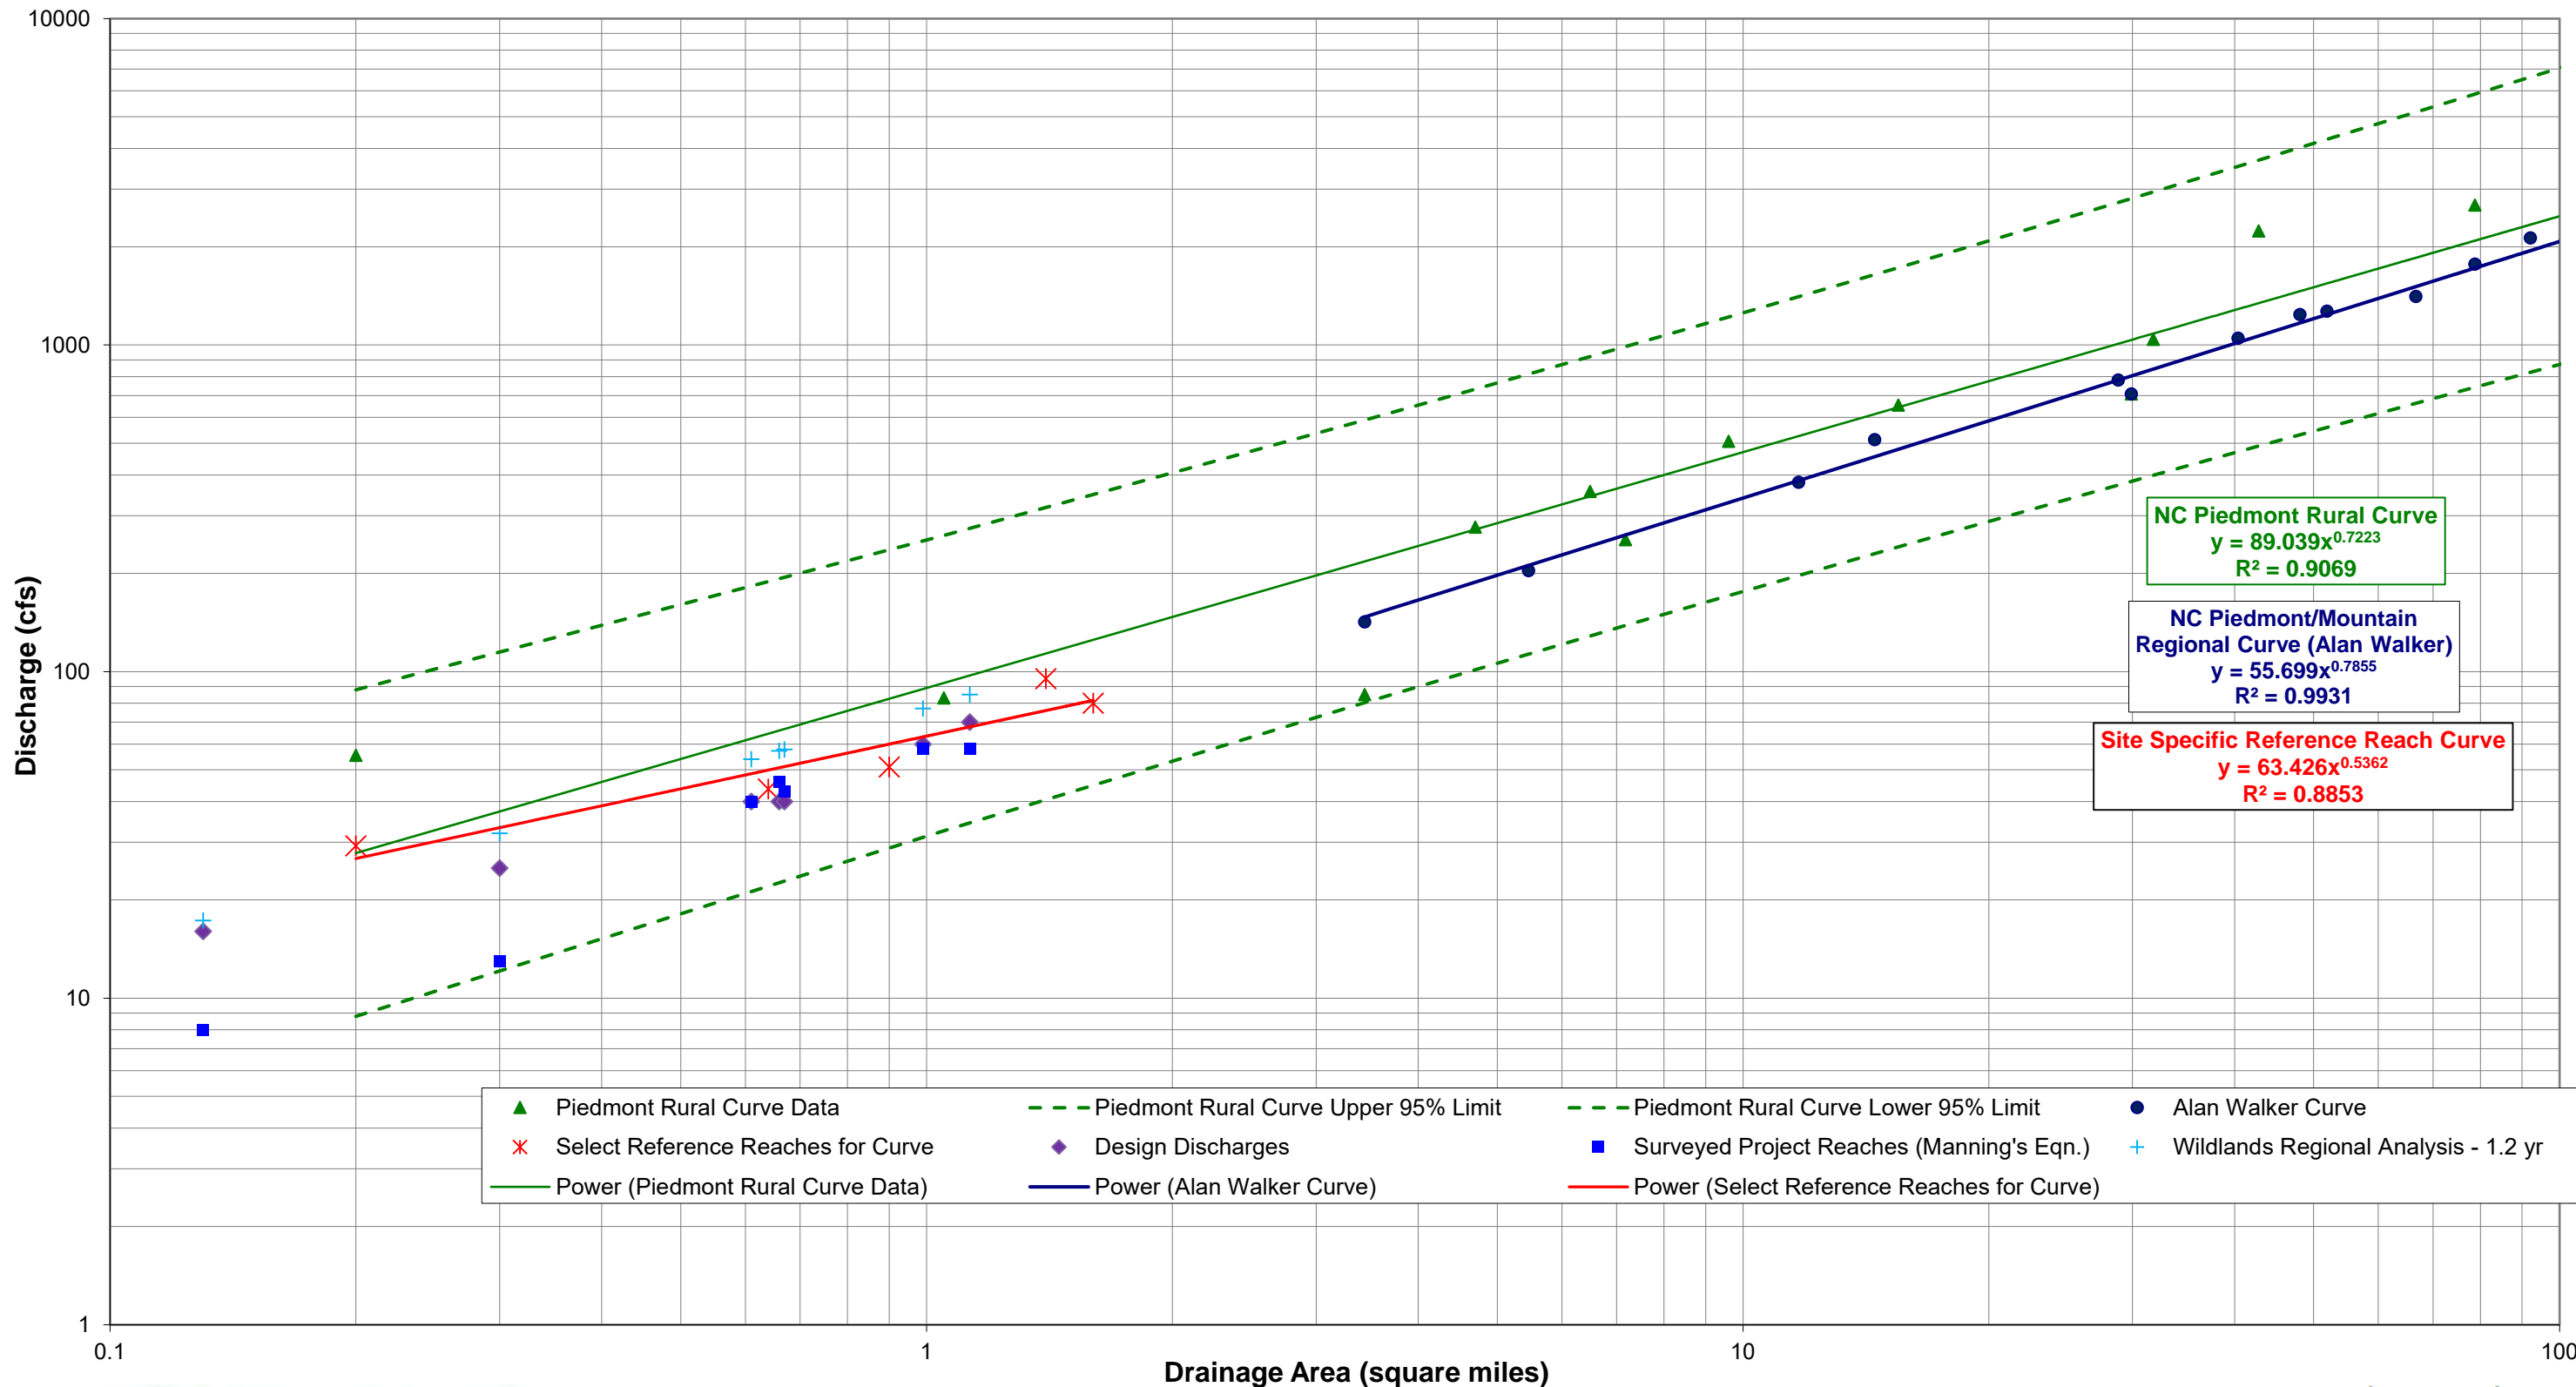
Figure 9 Discharge Analysis
 Banner Farm Mitigation Site
 French Broad River Basin 06010105
 Henderson County, NC

Banner Farm Design Bankfull Discharge Plot

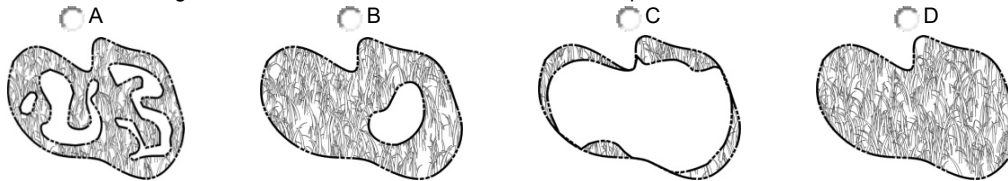
Select the figure that best describes the amount of interspersion between vegetation and open water in the growing season. Patterned areas indicate vegetated areas, while solid white areas indicate open water.

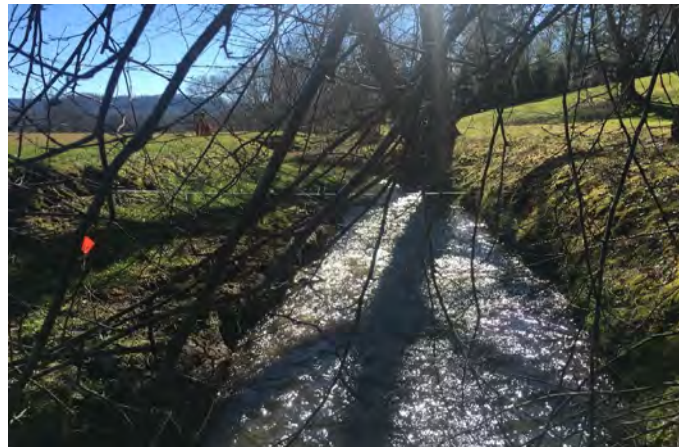
Cross Section 2, Banner Creek Reach 1

- 12.0 x-section area (ft.sq.)
- 9.8 width (ft)
- 1.2 mean depth (ft)
- 1.7 max depth (ft)
- 11.5 wetted perimeter (ft)
- 1.0 hyd radi (ft)
- 8.1 width-depth ratio
- 2.5 entrenchment ratio
- 2.2 low bank height ratio

View Downstream

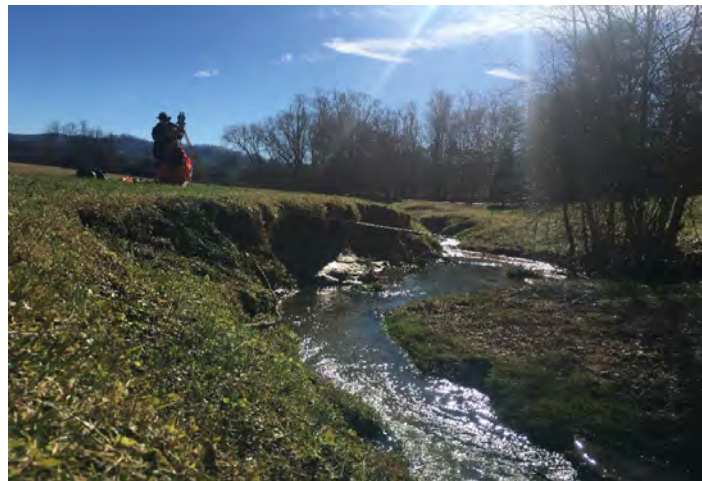
Cross Section 3, Banner Creek Reach 2

- 14.2 x-section area (ft.sq.)
- 14.3 width (ft)
- 1.0 mean depth (ft)
- 2.4 max depth (ft)
- 16.2 wetted perimeter (ft)
- 0.9 hyd radi (ft)
- 14.3 width-depth ratio
- 38.3 W flood prone area (ft)
- 2.7 entrenchment ratio
- 1.7 low bank height ratio

View Downstream

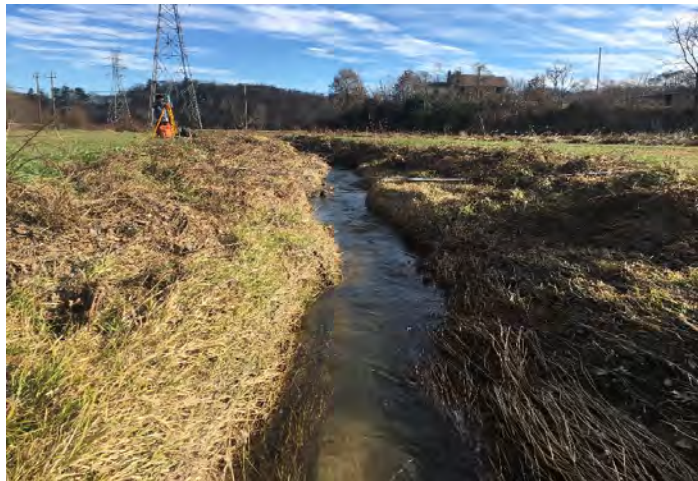
Cross Section 4, Banner Creek Reach 2

- 11.6 x-section area (ft.sq.)
- 10.4 width (ft)
- 1.1 mean depth (ft)
- 2.3 max depth (ft)
- 12.4 wetted perimeter (ft)
- 0.9 hyd radi (ft)
- 9.4 width-depth ratio
- 57.7 W flood prone area (ft)
- 5.5 entrenchment ratio
- 1.4 low bank height ratio

View Downstream

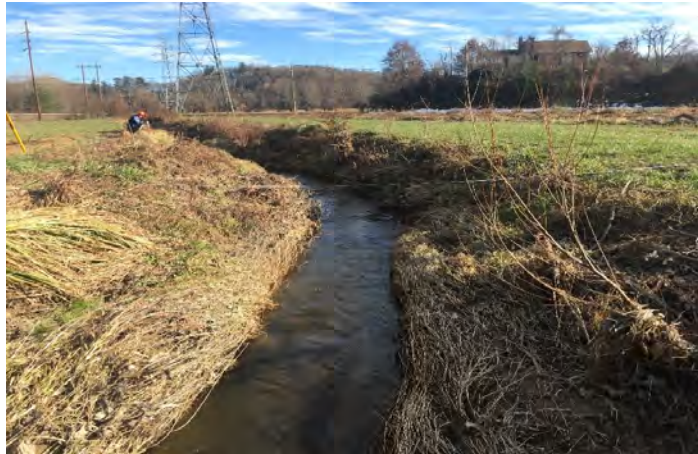
Cross Section 5, Banner Creek R3

- 9.4 x-section area (ft.sq.)
- 6.8 width (ft)
- 1.4 mean depth (ft)
- 2.3 max depth (ft)
- 9.7 wetted perimeter (ft)
- 1.0 hyd radi (ft)
- 4.9 width-depth ratio
- 8.9 entrenchment ratio
- 1.9 low bank height ratio

View Downstream

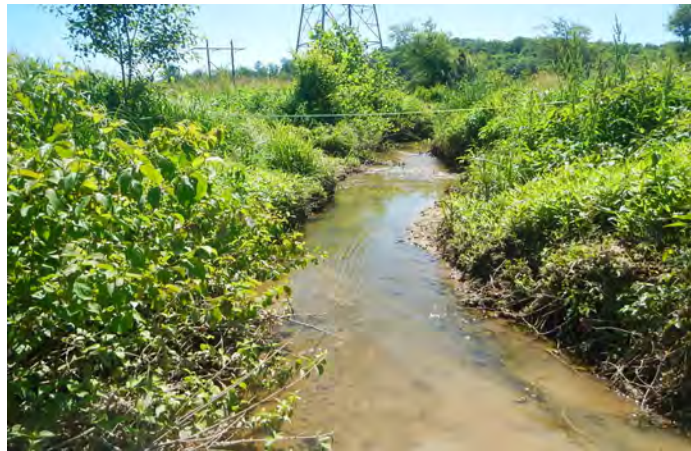
Cross Section 6, Banner Creek R3

- 16.4 x-section area (ft.sq.)
- 11.8 width (ft)
- 1.4 mean depth (ft)
- 3.1 max depth (ft)
- 13.8 wetted perimeter (ft)
- 1.2 hyd radi (ft)
- 8.4 width-depth ratio
- 3.2 entrenchment ratio
- 1.3 low bank height ratio

View Downstream

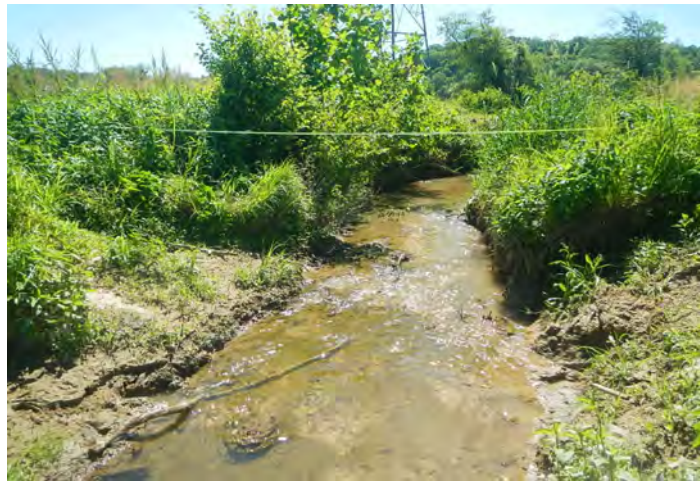
Cross Section 7, Banner Creek Reach 4 A

- 11.9 x-section area (ft.sq.)
- 7.4 width (ft)
- 1.6 mean depth (ft)
- 2.1 max depth (ft)
- 9.6 wetted perimeter (ft)
- 1.2 hyd radi (ft)
- 4.7 width-depth ratio
- 31.3 W flood prone area (ft)
- 4.2 entrenchment ratio
- 1.7 low bank height ratio

View Downstream

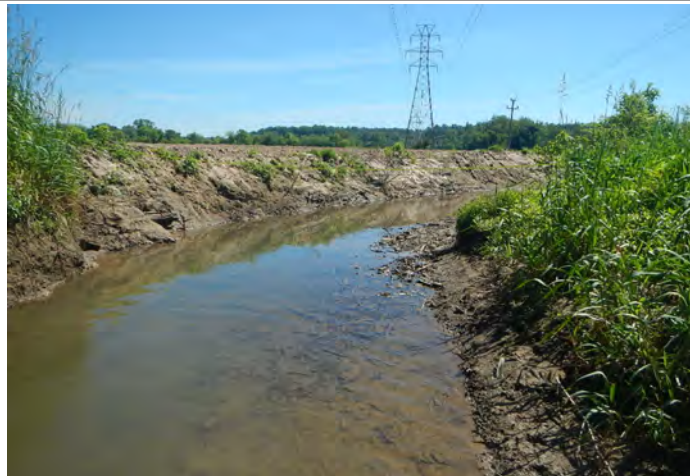
Cross Section 8, Banner Creek Reach 4 B

- 35.9 x-section area (ft.sq.)
- 17.0 width (ft)
- 2.1 mean depth (ft)
- 3.3 max depth (ft)
- 19.4 wetted perimeter (ft)
- 1.9 hyd radi (ft)
- 8.0 width-depth ratio
- 2.7 entrenchment ratio
- 1.4 low bank height ratio

View Downstream

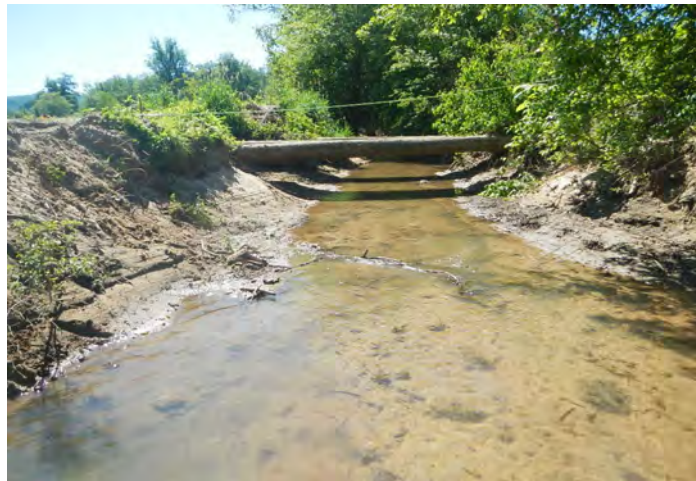
Cross Section 9, UT1 R1 A

Bankfull Dimensions

- 32.4 x-section area (ft.sq.)
- 19.4 width (ft)
- 1.7 mean depth (ft)
- 2.6 max depth (ft)
- 21.4 wetted perimeter (ft)
- 1.5 hyd radi (ft)
- 11.6 width-depth ratio
- 23.3 W flood prone area (ft)
- 1.2 entrenchment ratio
- 2.1 low bank height ratio

View Downstream

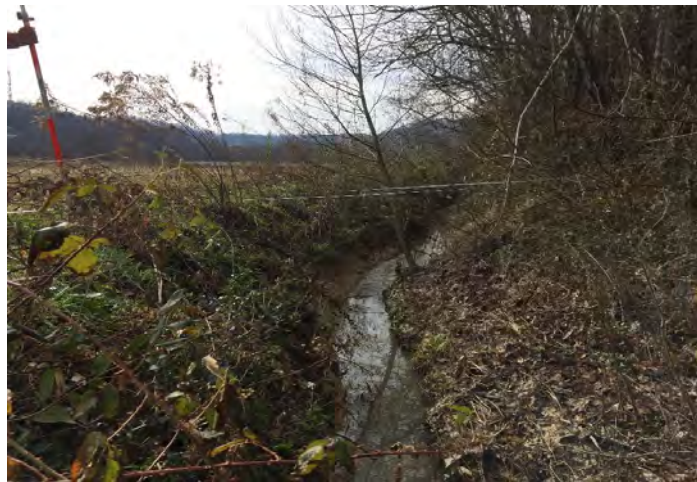
Cross Section 10, UT1 R1A Pool

Bankfull Dimensions

- 4.6 x-section area (ft.sq.)
- 4.5 width (ft)
- 1.0 mean depth (ft)
- 1.9 max depth (ft)
- 6.4 wetted perimeter (ft)
- 0.7 hyd radi (ft)
- 4.5 width-depth ratio
- 14.3 W flood prone area (ft)
- 3.2 entrenchment ratio
- 2.0 low bank height ratio

View Downstream

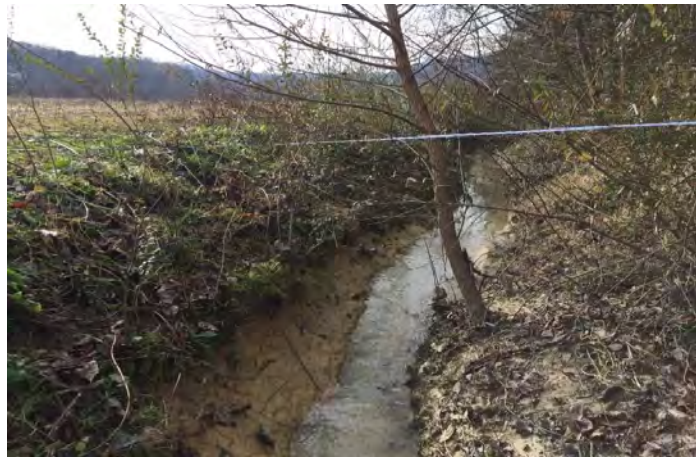
Cross Section 10, UT1 R1B Riffle

Bankfull Dimensions

- 3.6 x-section area (ft.sq.)
- 5.2 width (ft)
- 0.7 mean depth (ft)
- 1.7 max depth (ft)
- 6.5 wetted perimeter (ft)
- 0.6 hyd radi (ft)
- 7.5 width-depth ratio
- 2.9 entrenchment ratio
- 2.0 low bank height ratio

View Downstream

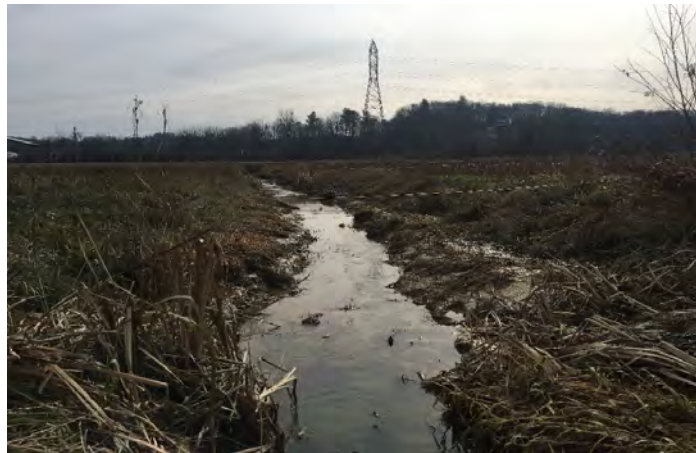
Cross Section 12, UT2 R2A Run

Bankfull Dimensions

- 7.9 x-section area (ft.sq.)
- 11.7 width (ft)
- 0.7 mean depth (ft)
- 1.4 max depth (ft)
- 12.4 wetted perimeter (ft)
- 0.6 hyd radi (ft)
- 17.4 width-depth ratio
- 2.0 entrenchment ratio
- 2.1 low bank height ratio

View Downstream

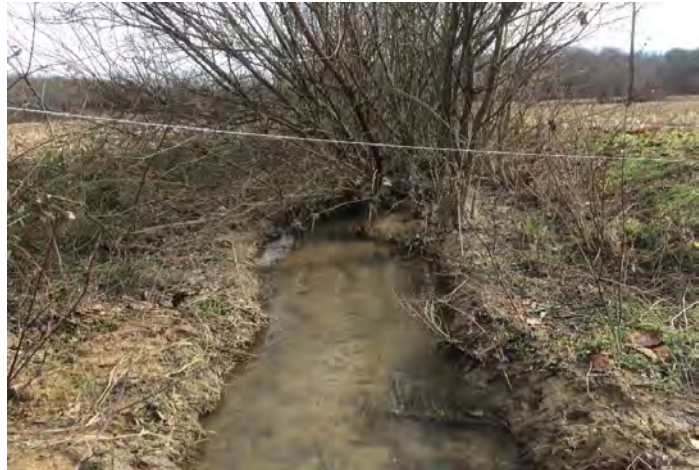
Cross Section 13, UT2 R2A Pool

Bankfull Dimensions

- 4.1 x-section area (ft.sq.)
- 4.6 width (ft)
- 0.9 mean depth (ft)
- 1.2 max depth (ft)
- 5.7 wetted perimeter (ft)
- 0.7 hyd radi (ft)
- 5.2 width-depth ratio
- 3.5 entrenchment ratio
- 1.4 low bank height ratio

View Downstream

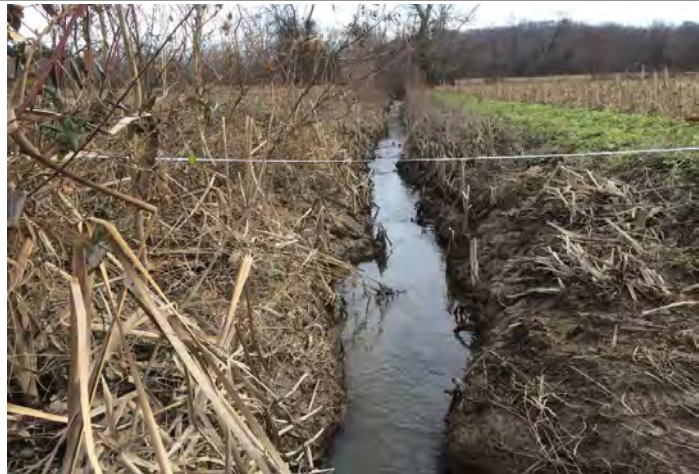
Cross Section 14, UT2 R2B Riffle

Bankfull Dimensions

- 6.2 x-section area (ft.sq.)
- 5.7 width (ft)
- 1.1 mean depth (ft)
- 2.5 max depth (ft)
- 8.5 wetted perimeter (ft)
- 0.7 hyd radi (ft)
- 5.3 width-depth ratio
- 2.3 entrenchment ratio
- 1.1 low bank height ratio

View Downstream

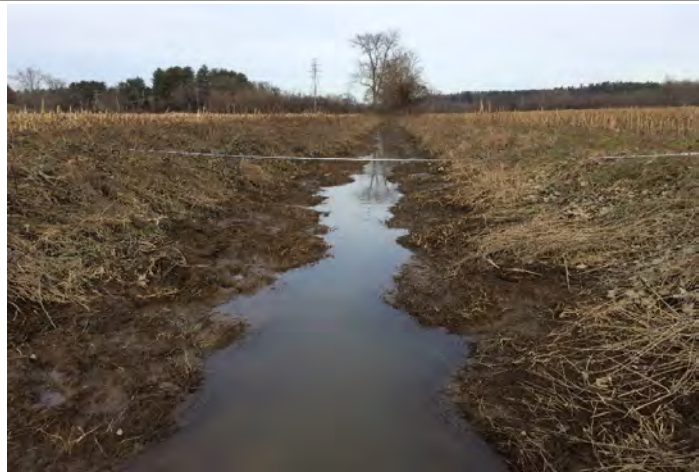
Bankfull Dimensions

- 6.5 x-section area (ft.sq.)
- 9.4 width (ft)
- 0.7 mean depth (ft)
- 1.8 max depth (ft)
- 11.2 wetted perimeter (ft)
- 0.6 hyd radi (ft)
- 13.5 width-depth ratio
- 1.6 entrenchment ratio
- 1.3 low bank height ratio

View Downstream
